# Chapter 9

## Back Analyses in Forensic Geotechnical Engineering

Richard N. Hwang

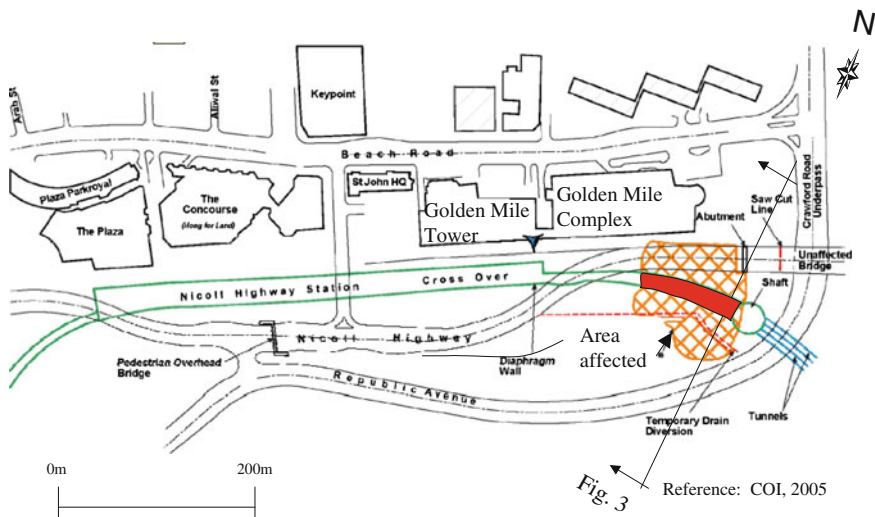
Fig. 9.1 Collapse of Nicoll highway

Failure started as the waling at the northern end of Strut S338 at the ninth level, refer to Fig. 9.2, buckled at 9 am on 20 April and failure propagated to other struts. By 3 pm of the day, all the struts for a 100 m section totally failed. As Nicoll Highway sank, gas, water, and electricity cables ruptured, causing power to go out for about 15,000 people and 700 businesses in the Marina and Suntec City area.

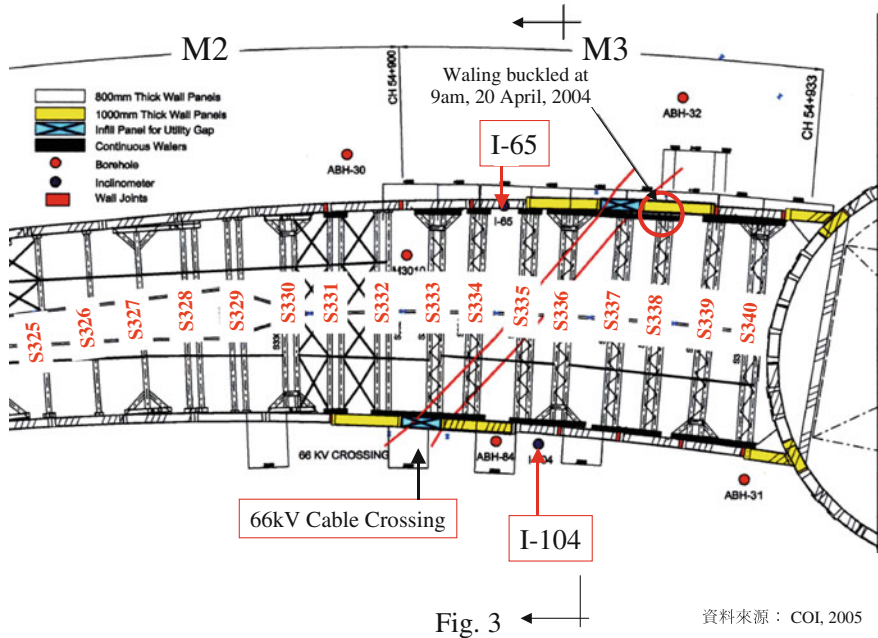
Fig. 9.2 Retaining system in section M3

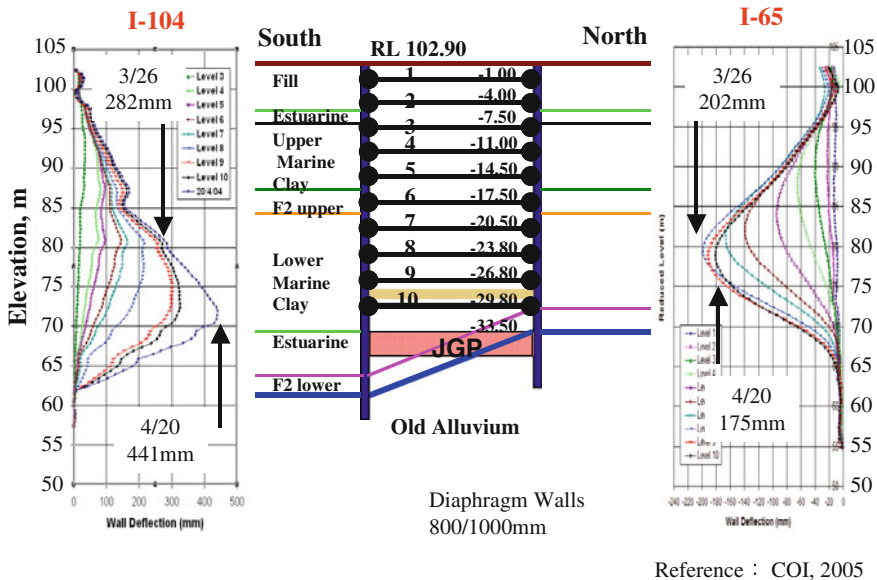
Fig. 9.3 Ground conditions and excavation scheme in section M3

As depicted in Fig. 9.3, the soft deposits on the two sides of the excavation differed in thickness while analyses were performed for only the southern half of the mesh on the assumption that the results would be conservative. This assumption may not be valid reality because the deflections of the southern wall tended to be larger due to the imbalance of earthpressures on the two sides of the excavation.

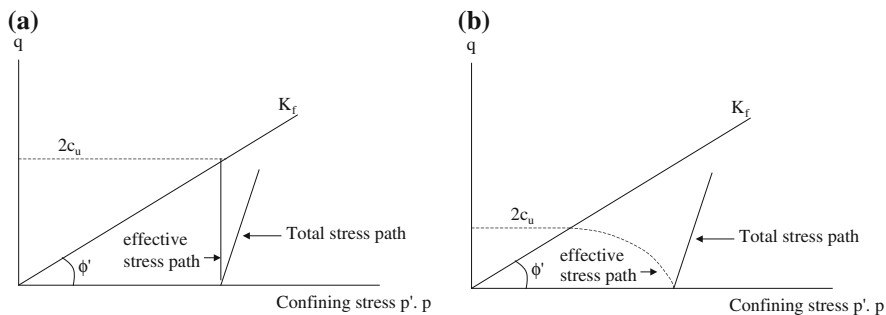
This, as depicted in Fig. 9.6, drastically over-estimated the undrained strength of clays and analyses indicated that wall deflections and the associated bending moments were grossly underestimated by a factor of, roughly, 2. However, except

**Fig. 9.6** Comparison of undrained strength of clay in Models A and B. **a** Model A. **b** Model B

Levels 6 and 9, the strut loads computed by using Model A were larger than those computed by using Model B. The strut loads computed by using Model B were 107 % of those computed by using Model A at Level 6 and 110 % at Level 9.

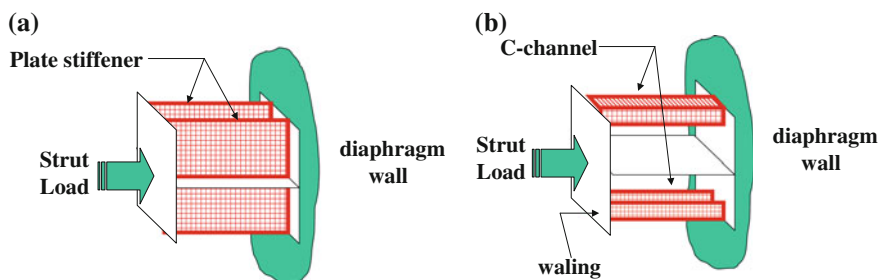
The Inquiry revealed that the loads at some of the connections between struts and walings were under-estimated either because a wrong type of joint was installed or because slays were omitted. Second, around February 2004, several instances of stiffener plate buckling as well as the buckling of a waling were reported at the Nicoll Highway Station, the contractor proposed replacing the stiffener plates by C-channels in an attempt to improve the performance of the connection. The replacement of double stiffener plates with C-channels, refer to Fig. 9.7, provided only minor improvement in terms of axial load bearing capacity for the waling connections, but this came at the expense of ductility. The change rendered it more susceptible to the brittle “sway” failure mode. This is clearly seen in results of the post collapse finite element analyses and physical tests. The poor detailing is exacerbated by the discontinuity of walings, as pointed out in the EAP study, which is particularly important at the curved south wall where deflection due to excavation caused separation of the joint between diaphragm wall panels.

**Fig. 9.7** Stiffeners of walings. **a** Original design. **b** Revised design
