Building Pathology and Rehabilitation

João M.P.Q. Delgado *Editor*

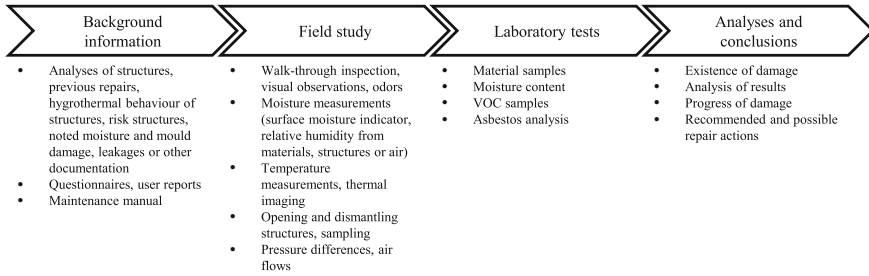
Fig. 1 Four main phases of moisture performance assessment and their main content (Annila et al. 2015a)

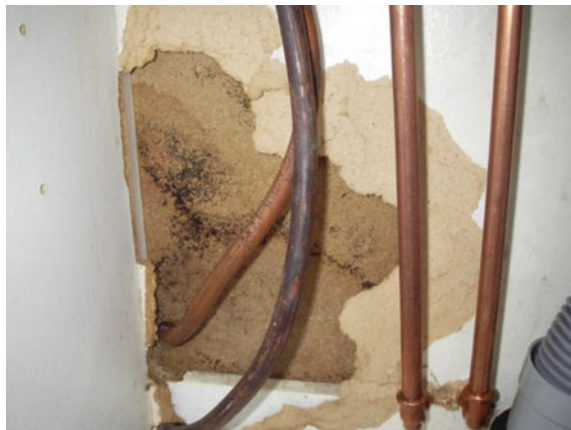
Fig. 4 Example of leak in a roof assembly detected during a moisture performance assessment

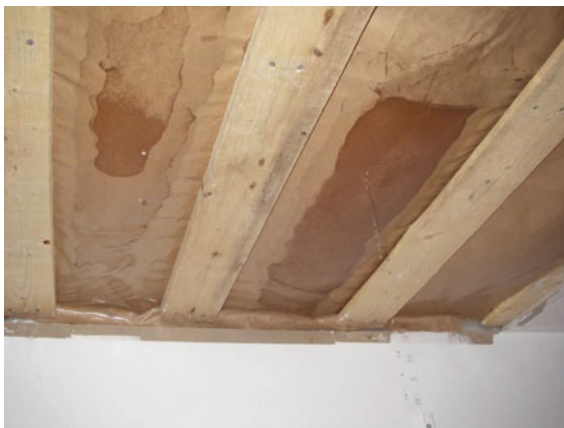
assessment reports analysed for the study, the results of surface moisture measurements had been complemented with more accurate moisture measurements of structures, which allows comparison of the results of surface moisture measurements and more accurate moisture measurements. The combination of the observations of TUT researchers and performed measurements constitute a reliable method properly used for determining the moisture content of structures although surface moisture measurements do not yield an accurate numerical value.

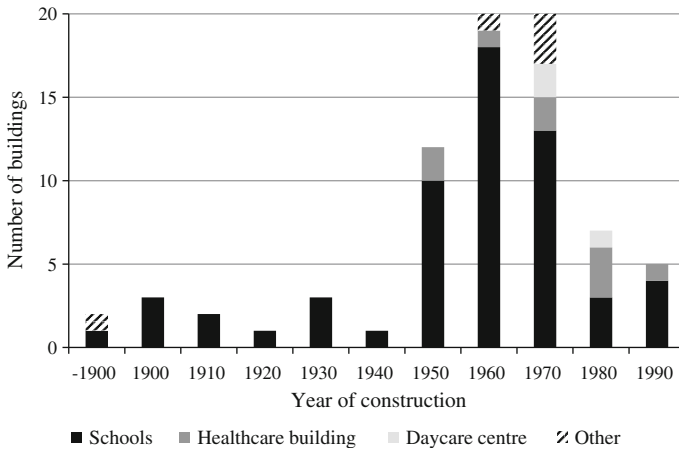
Fig. 5 Age distribution of examined buildings (Annala et al. 2015a)

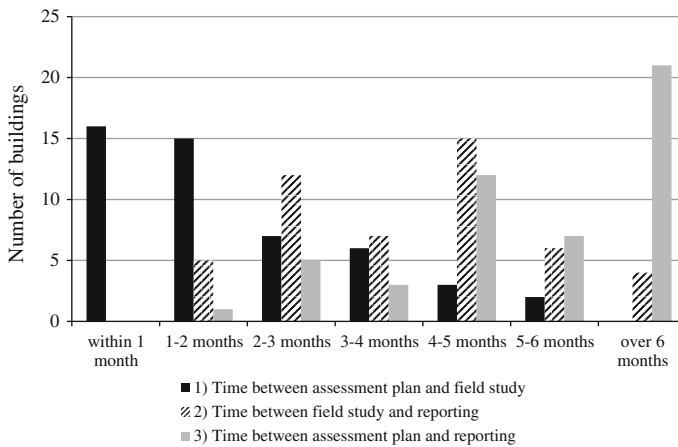
Fig. 6 Lengths of different phases of moisture performance assessments in research data

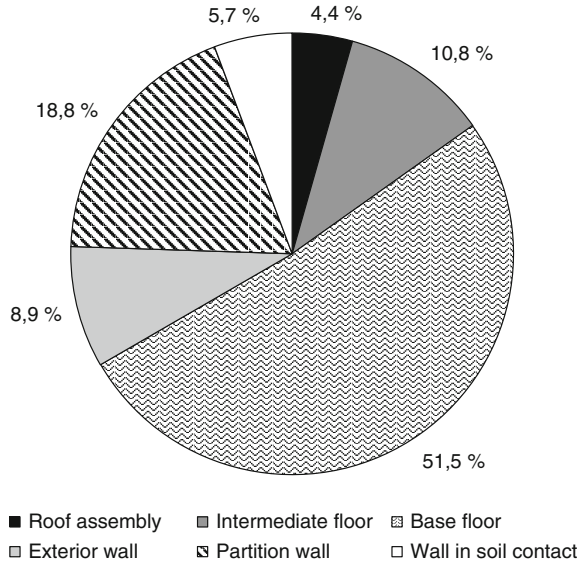
Fig. 8 Methods used to detect moisture and mould damage

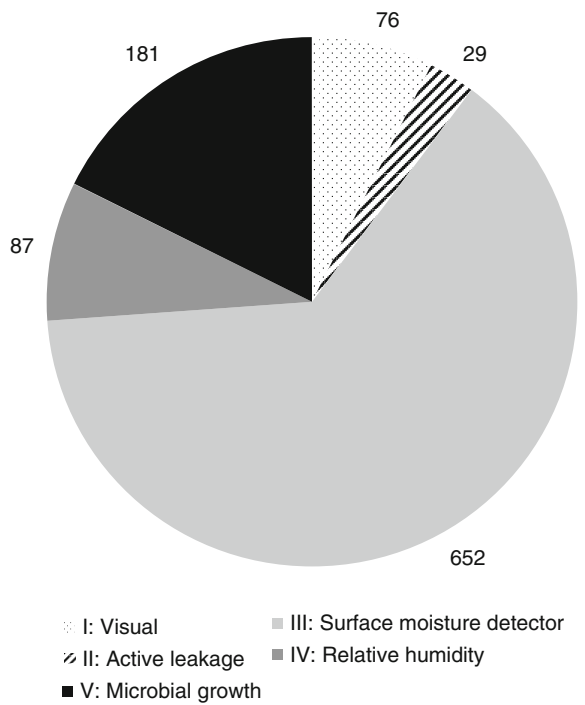
Table 3 Methods used to detect moisture and mould damage

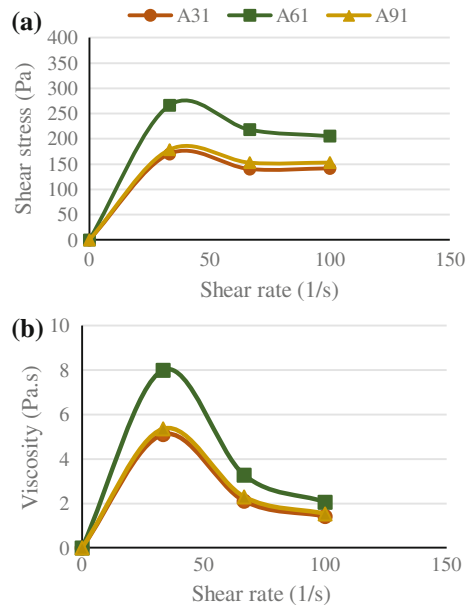
This fact reaffirms that the understanding of how the flow occurs in heterogeneous suspensions, such as coating mortars, is quite complex. So that, apparently, it should be considered not only the packaging and the particle size distribution of the aggregates, but its interaction with the paste of all the dispersion and how the particles react when subjected to tension, flowing in a homogeneous or heterogeneous way (with particles segregation).

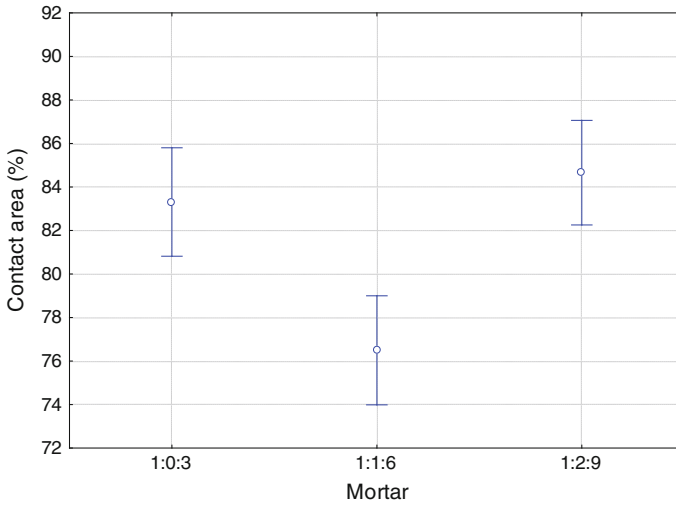
Fig. 6 ANOVA of mortars proportioning influence on interfacial contact area

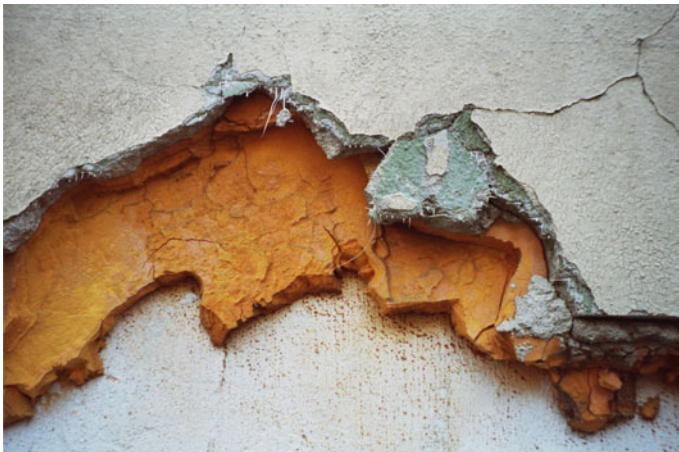
Fig. 1 Building with ETICS in PIR in Torrette di Mercogliano (Avellino). Insulation thickness: 3 cm; cementitious render: 2.0–2.5 cm; finishing coat: paint

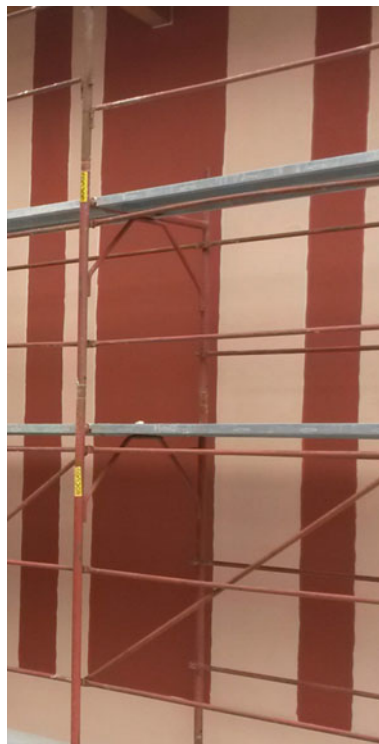
Some of these materials, as the XPS, the PUR, the PF, the PIR, are characterized by thermal expansion ratio greater than EPS, and therefore make difficult the task of reinforcement meshes and of base coats, for preventing that system, with the passing of time, breaks (as it can be seen in Figs. 1 and 2). Or else, like the cork, the PU or the PIR, have the tendency, as time goes by, to absorb and to hold back the moisture, chiefly through the not protected edges, changing their thermal and weather tightness characteristics (Pearson 2010, p. 74).

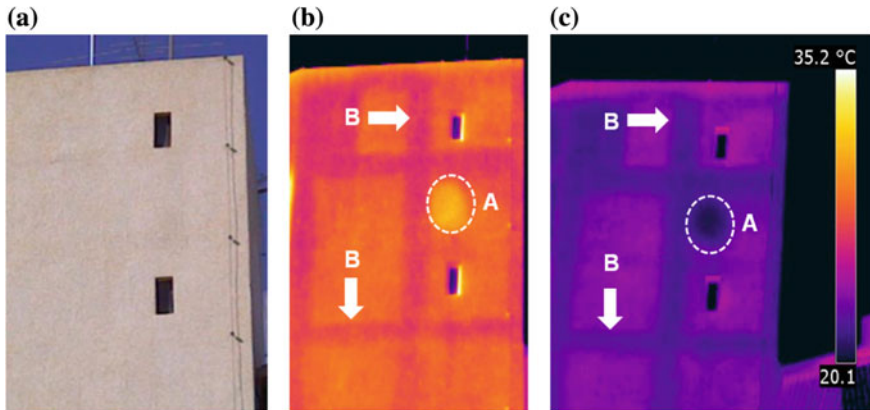
Fig. 1 Thermographic inspection detail: **a** facade image; **b** thermogram obtained during the heating up by the sun; **c** thermogram during cooling, without sunlight

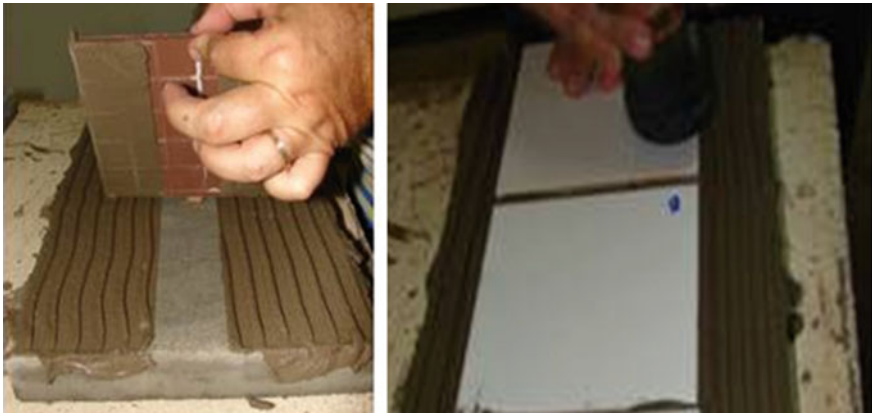
Fig. 2 Placement of the ceramic tiles with central defect

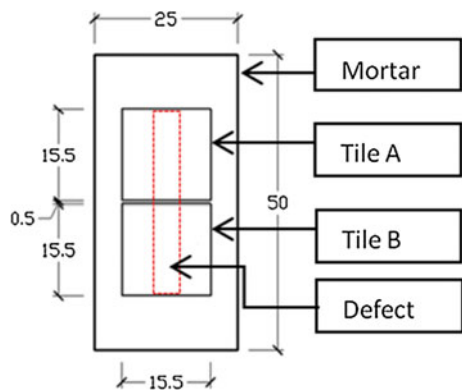
Fig. 4 Laboratory setup of the heating and cooling experiment

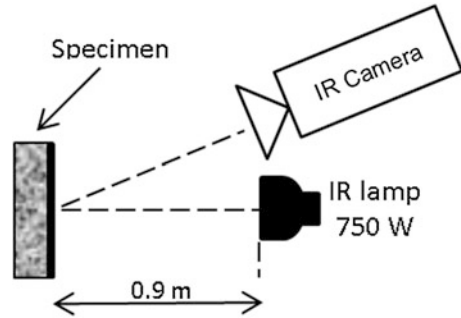
The specimen was subjected to a heating and cooling cycle in the laboratory, using a set of three infrared lamps of 250 W. The lamp set was positioned at a distance of 0.90 m. The heating period had a duration of 80 min, followed by the cooling down when the lamps were switched off. The cooling period had a duration of 85 min. The results presented are the average values obtained after three heating and cooling cycles (Fig. 4).

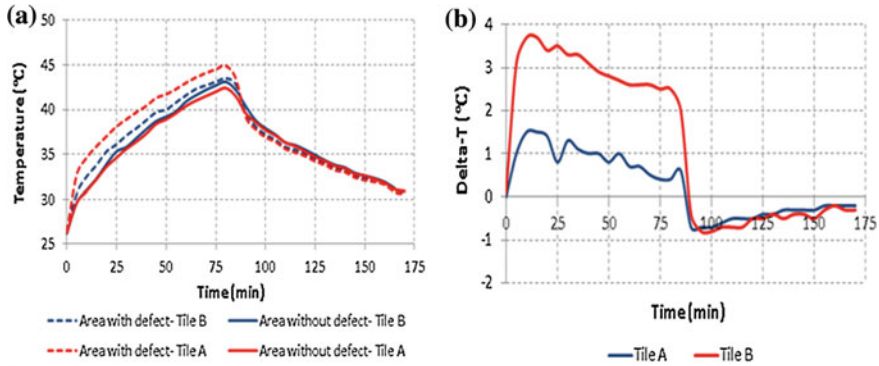
Fig. 5 Heating and cooling cycles. **a** Evolution of temperatures in the tiles' regions; **b** delta-T evolution

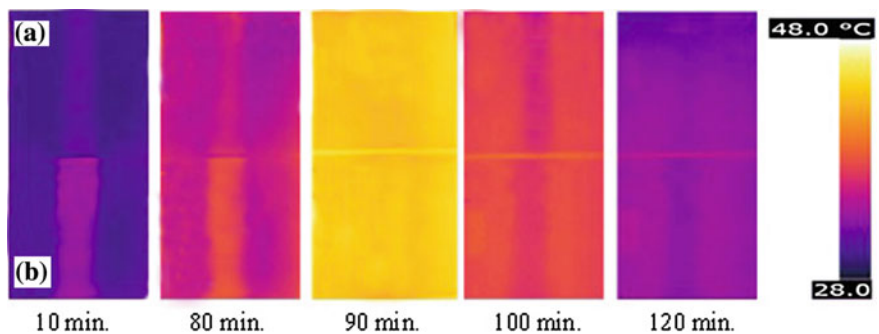
Fig. 6 Thermograms obtained at different times during the cycle

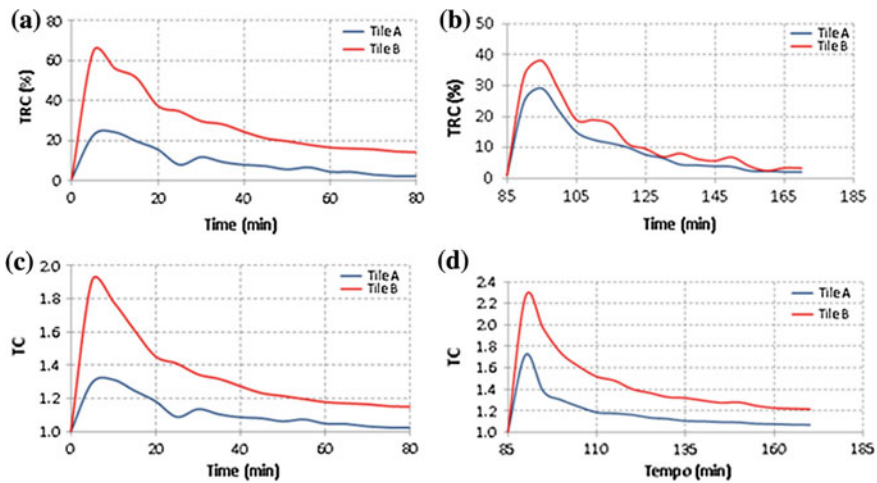
Fig. 7 Running thermal contrast (TRC) at **a** heating and **b** cooling. Thermal contrast (TC) at **c** heating and **d** cooling

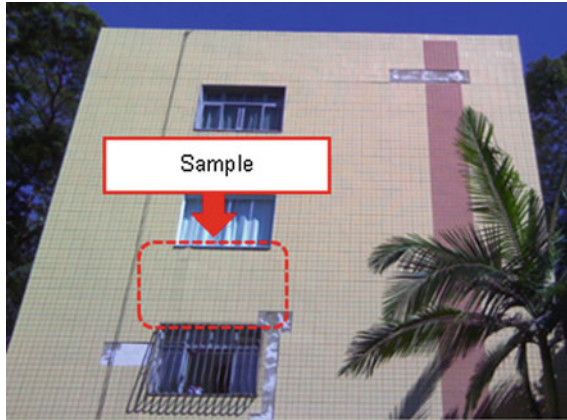
Fig. 8 Digital image of the facade showing the study area

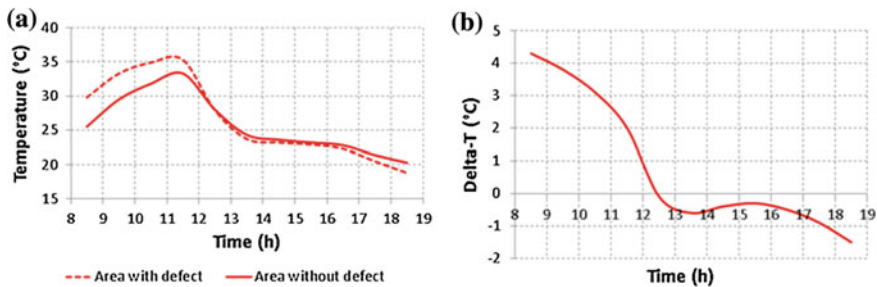
Fig. 9 Temperature analysis of the facade. **a** Evolution of temperatures in defective and nondefective areas; **b** delta-T evolution

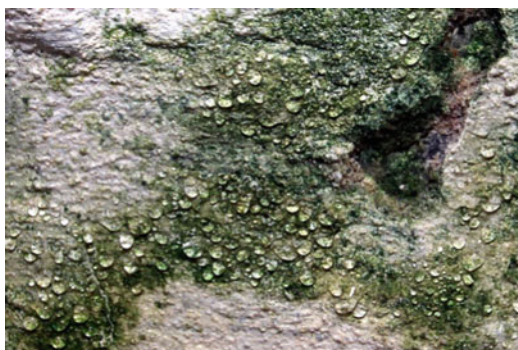
Condensed water on the top of algal growth
(Kaarma Church)

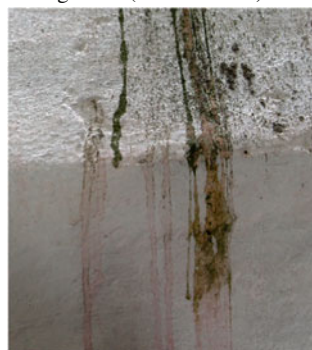
Pink bacteria and algae on
window sill (Muhu Church)

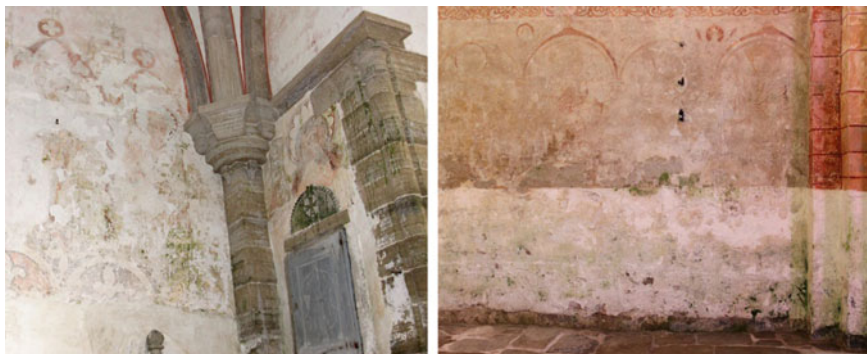
Fig. 2 Partially damaged wall paintings in Muhu (*left*) and Valjala (*right*) churches

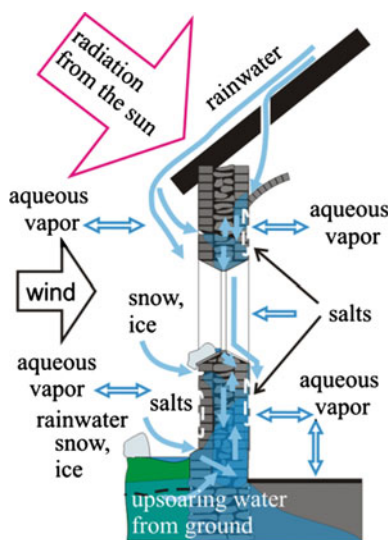
(KNO_3) efflorescence in the test-field occurred over the 10 years in Kaarma church, is presented in Fig. 4.

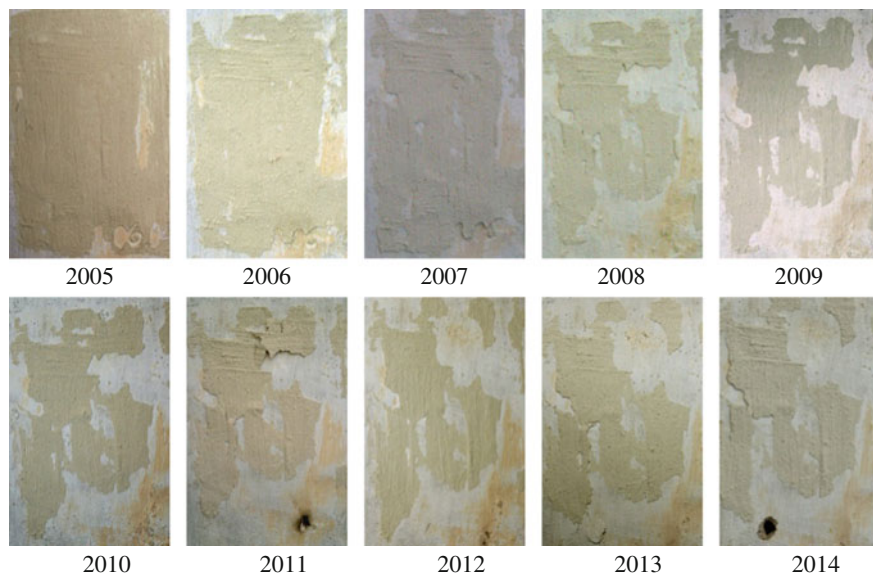
Fig. 4 Test field for the determination of behavior of lime paint in the presence of the salt efflorescence (Kaarma Church)

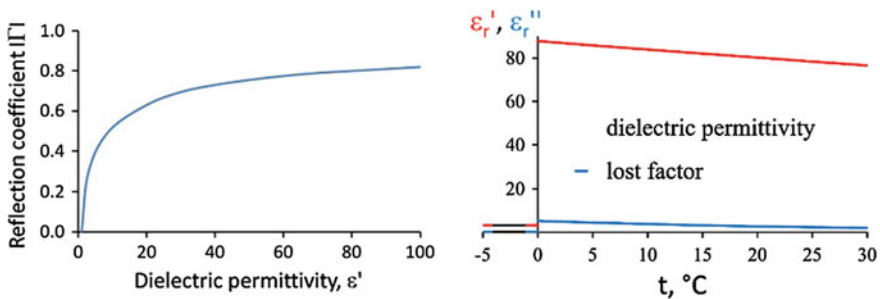
Fig. 5 Relationship between the dielectric permittivity of material ϵ and microwaves reflection coefficient Γ (left) (Agilent 2005) and temperature dependence of dielectric permittivity of water and ice at 2.45 GHz (right, calculated on the basis of Kaatze 2005)

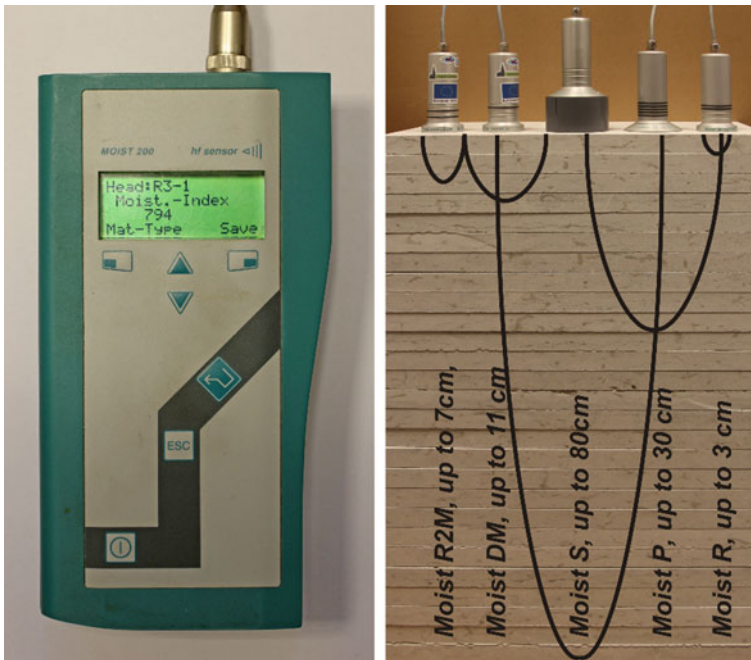
Fig. 6 Handheld moisture meter Moist 200 (*left*) with measuring heads and their penetration depths (*right*)

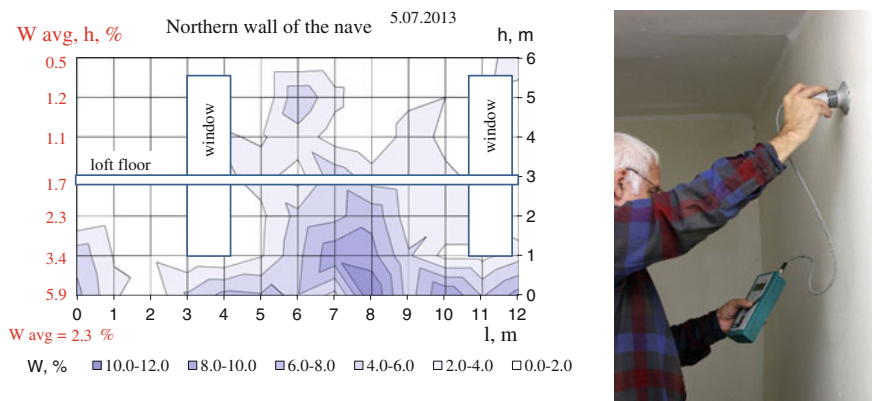
Fig. 7 Typical result of the moisture mapping. Measuring steps— 1×1 m. W—moisture content, % (left). Measurement in practice (right)

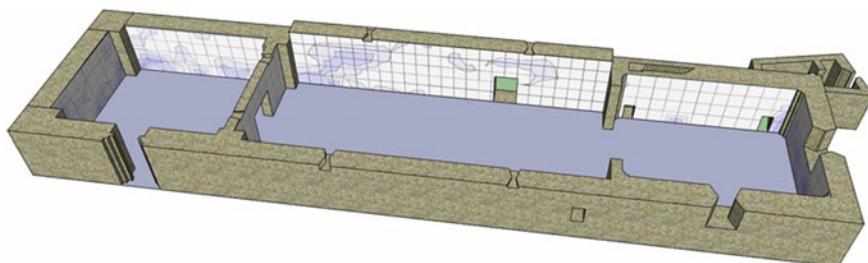
Fig. 8 Moisture content maps of the Põide Church presented on the cross-cut of the 3D model of the church (model created with Google SketchUp)

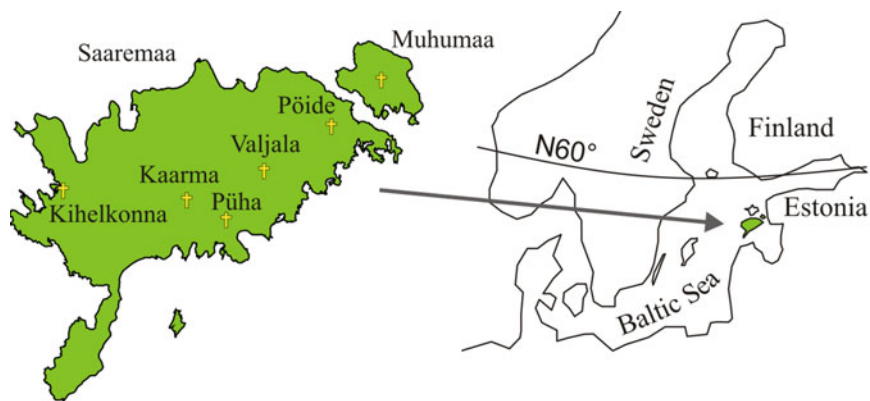
Kihelkonna
St. Michael's Church, ~1250

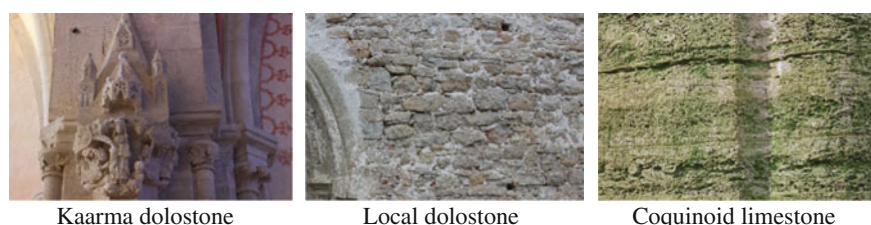
Fig. 10 Main building material in churches of Saaremaa, well workable Kaarma dolostone and local building stones

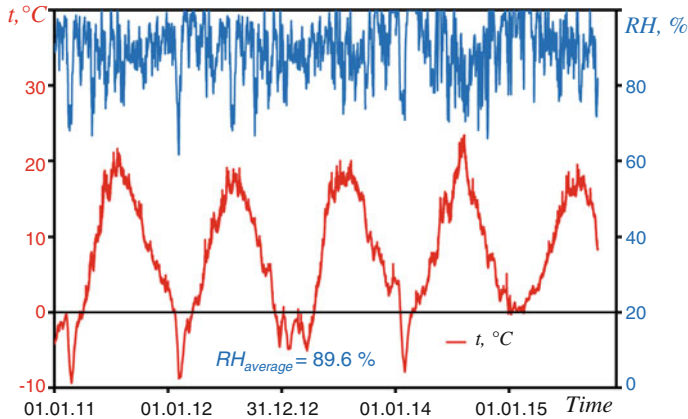
Fig. 11 Indoor climate in 5 year period of Muhu St. Catherine’s Church, typical for all unheated dolostone churches in Saaremaa—very high relative humidity, long time negative temperatures at winter period (excl. year 2015)

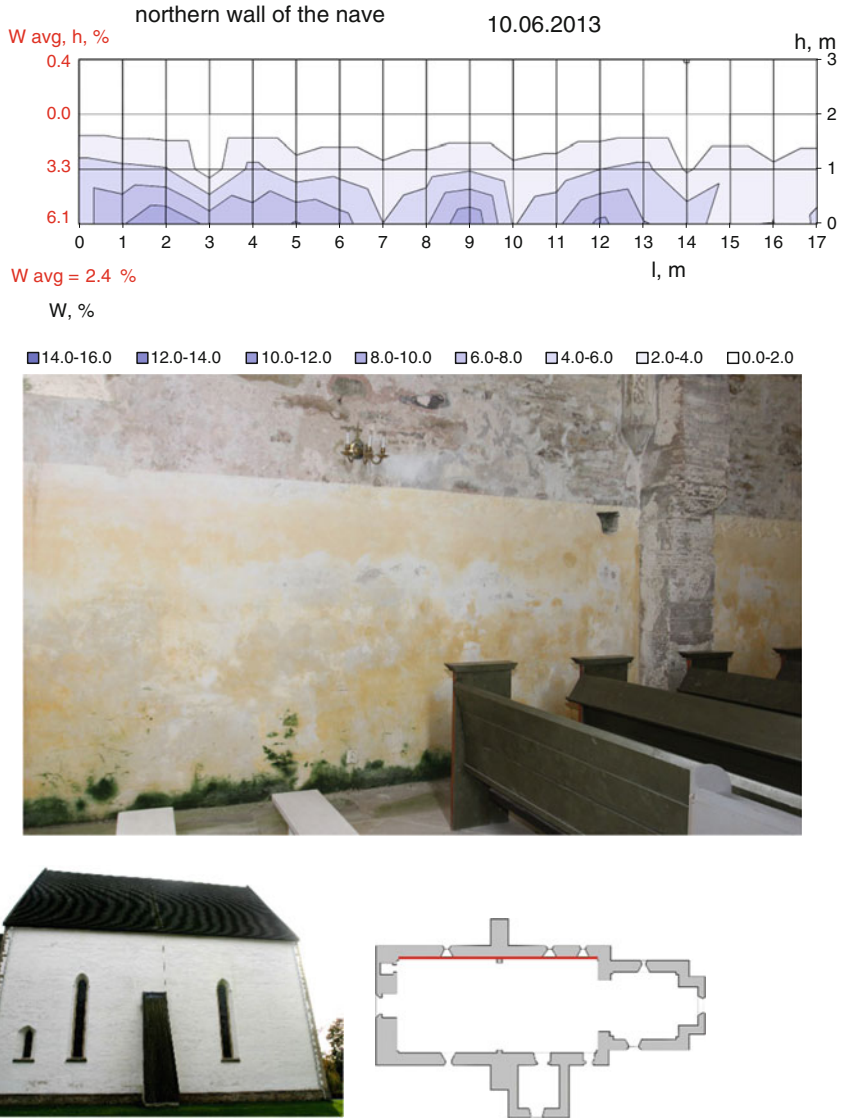
Fig. 12 Typical picture of rising damp, Muhu Church, measuring depth up to 30 cm (*up*). Picture of the part of the wall what moisture content was measured (*middle*). Outside of the same wall and measured wall location on the church plan (*down*)

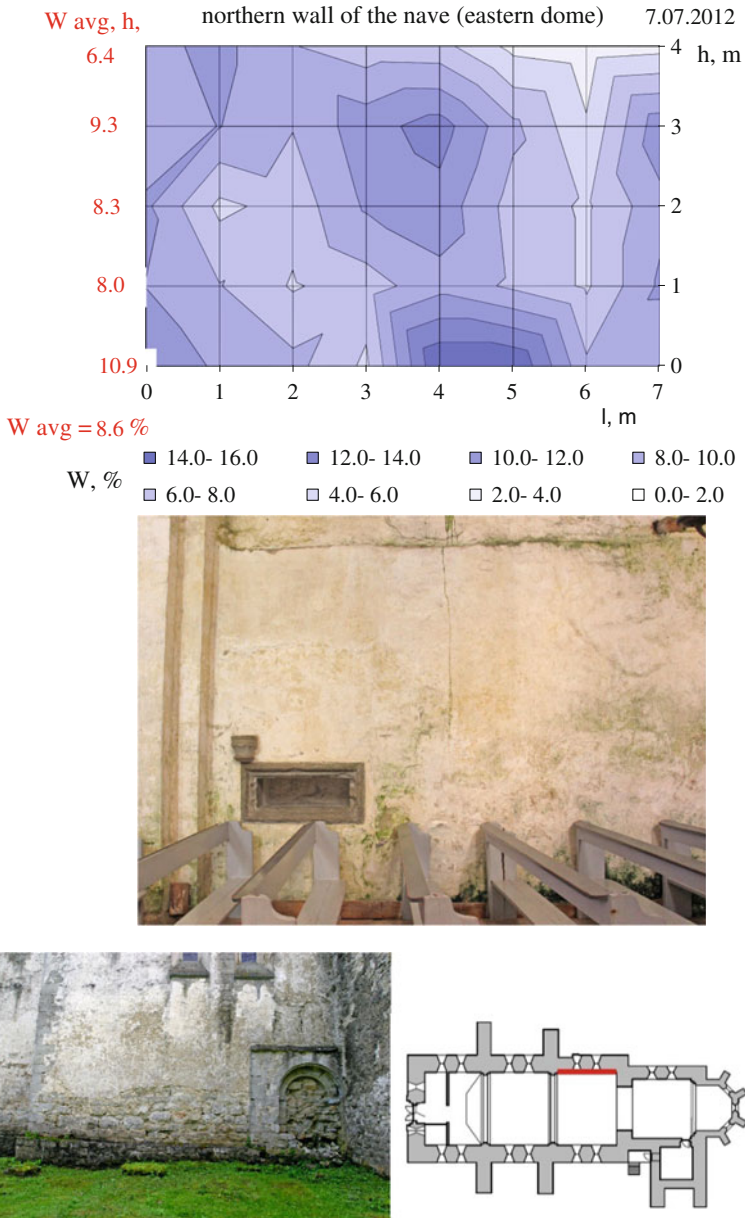
Fig. 13 Multiple water sources in this case: rising dump, condensed water, leakage through the wall and windows, Valjala Church. Measuring depth up to 30 cm. Pictures of wall from the inside and outside; wall location on church plan

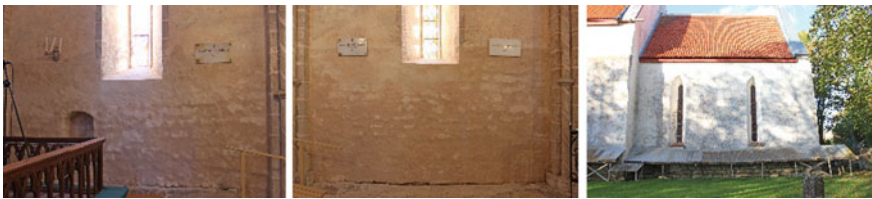
Fig. 14 Southern wall of Kihelkonna Church from inside and outside (on the right side covered ditch is visible)

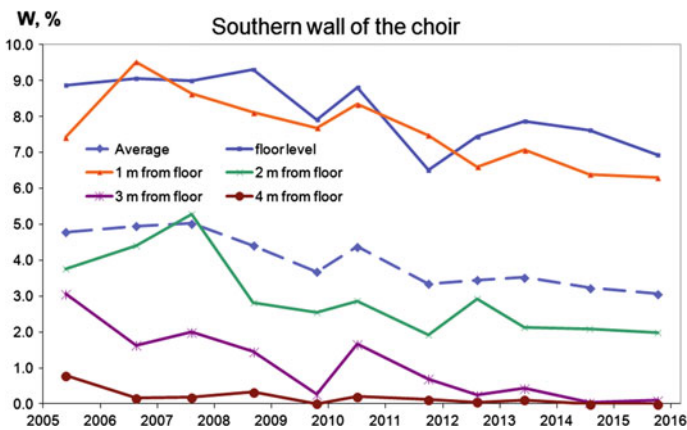
Fig. 15 Timelines of average moisture content of the southern wall of the choir at different levels from the ground

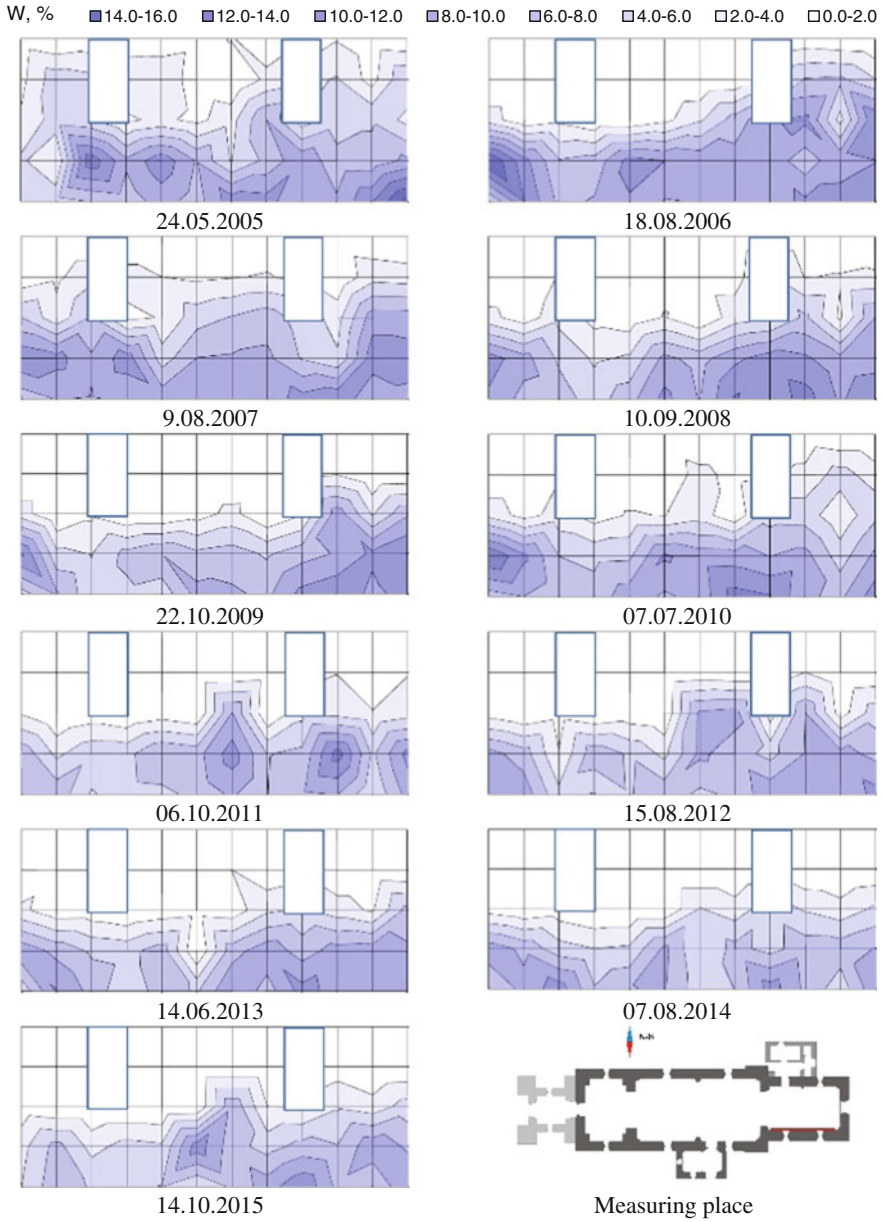
Fig. 16 Moisture maps of the southern wall of choir in Kihelkonna Church, measuring depth up to 30 cm

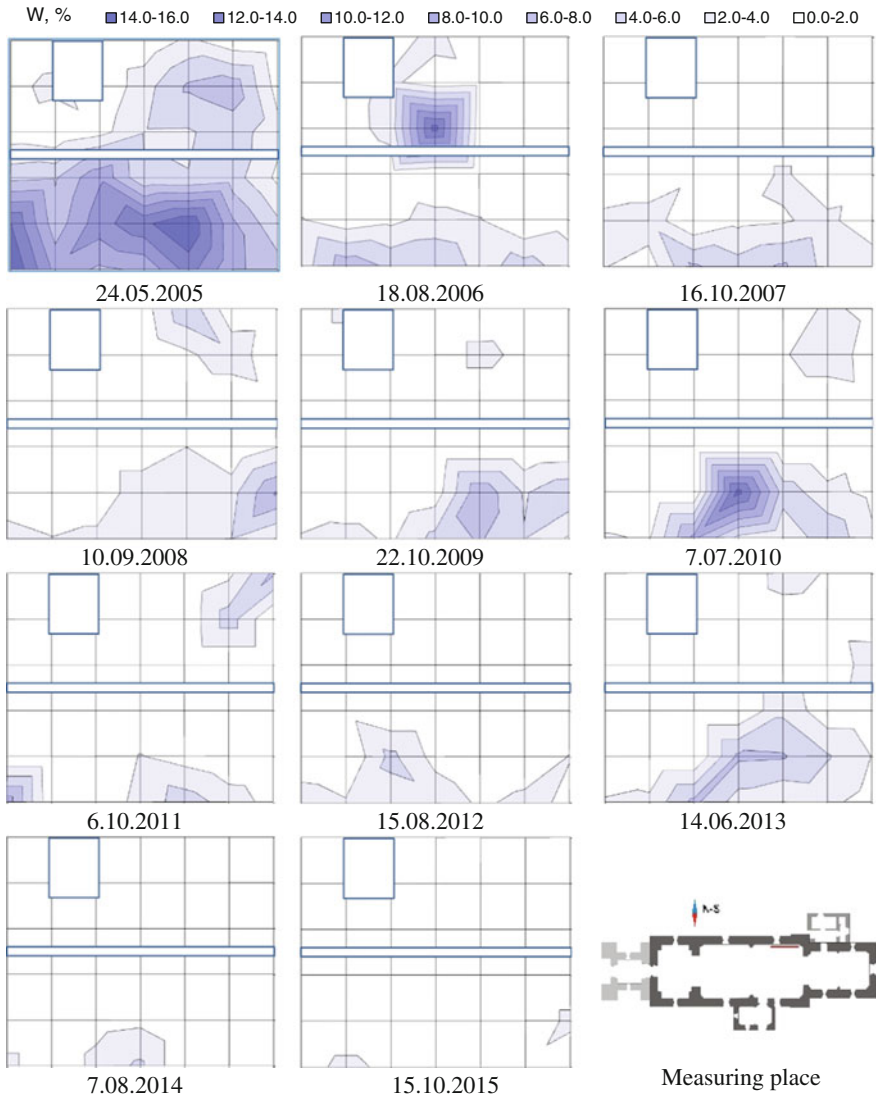
Fig. 17 Moisture distribution changes in northern wall of the nave in the Kihelkonna Church (moisture content measuring depth up to 30 cm)

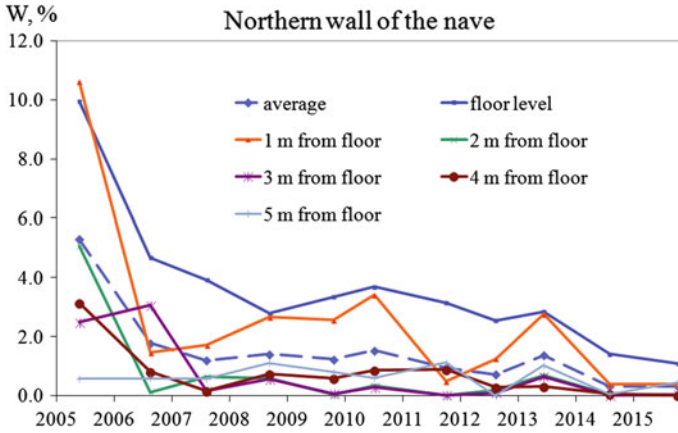
Fig. 18 Decrease in moisture content in wall on the levels up to 5 m from the floor level after conservation works in 2005 in Kihelkonna church

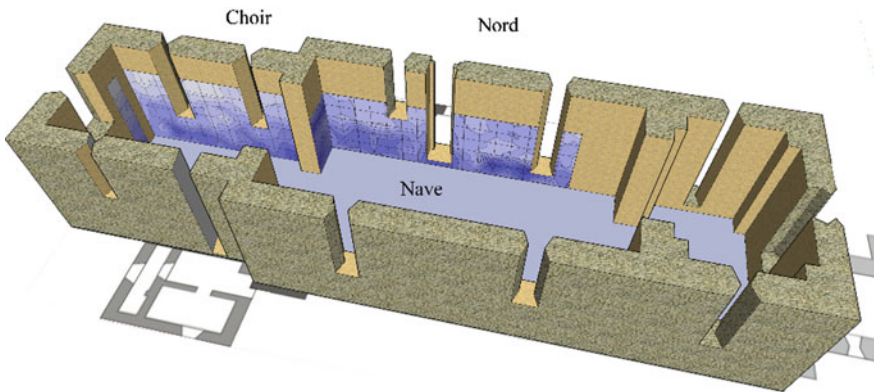
Fig. 19 Moisture content maps of the Kihelkonna Church presented on 3D model of the church

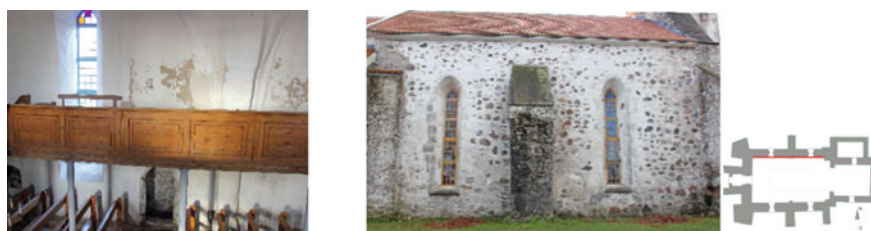
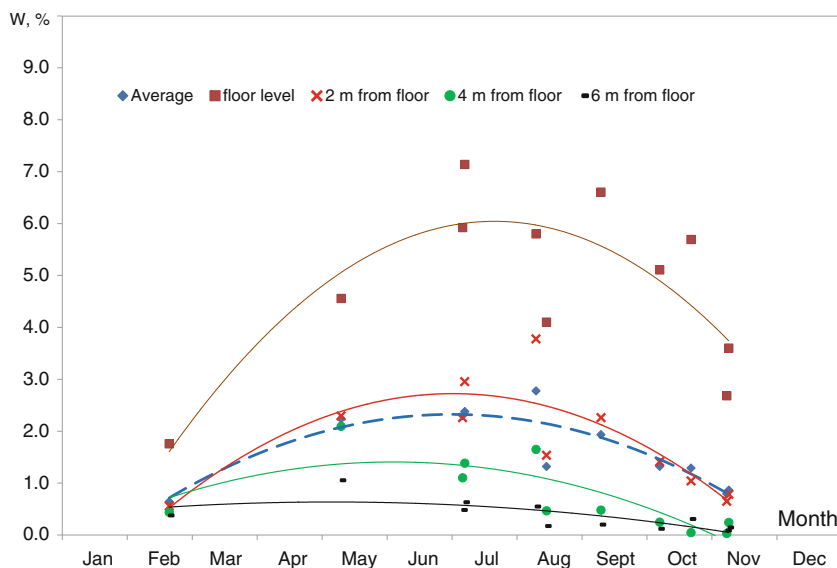
Fig. 20 Seasonal moisture content changes in the wall on the different levels from the floor

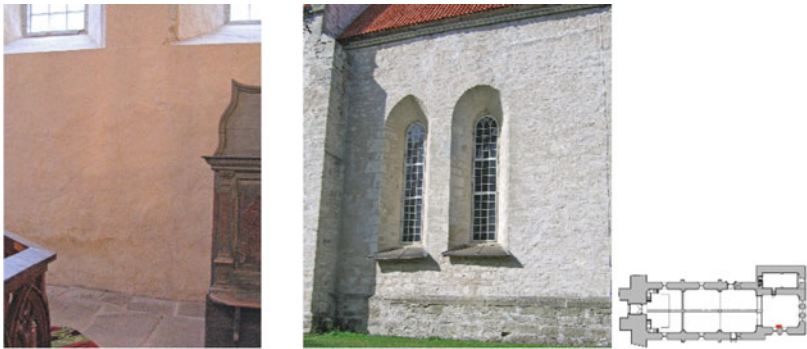
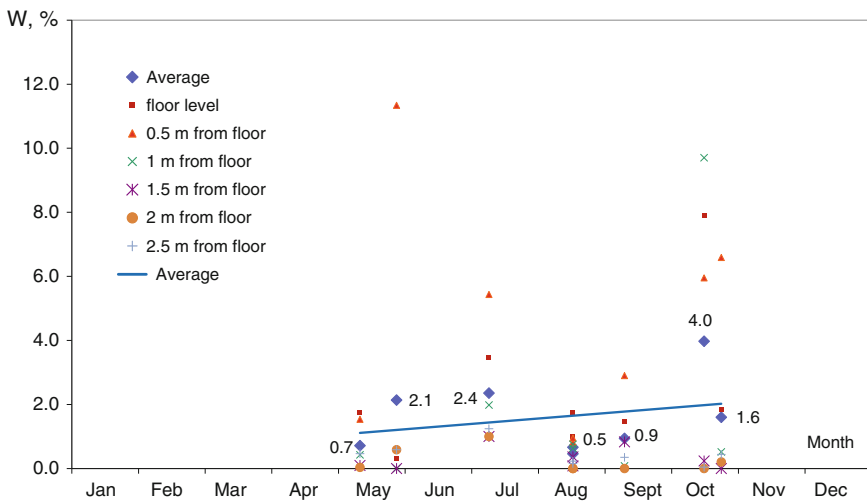
Fig. 21 Average moisture content of the southern wall in choir of the Kaarma Church is low (~2 %), but sometimes peaks up

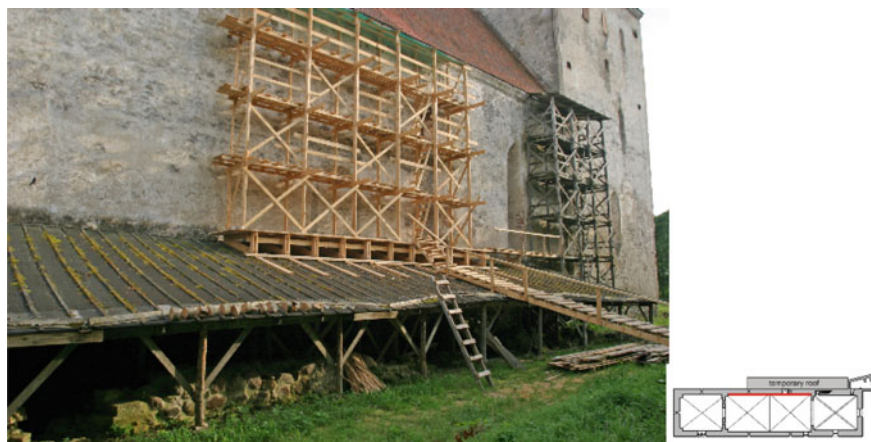
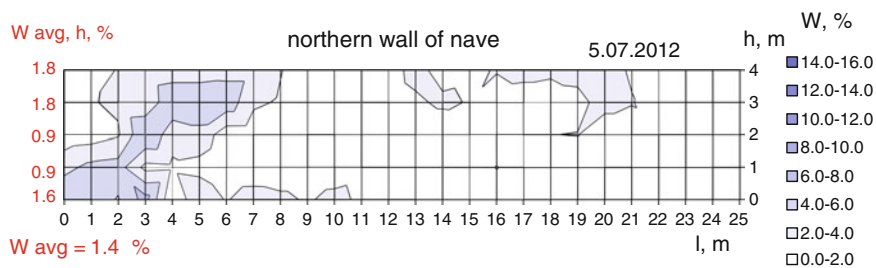
Fig. 22 Moisture content is low under the temporary awning (from the year 2000) covering the ongoing archeological excavations

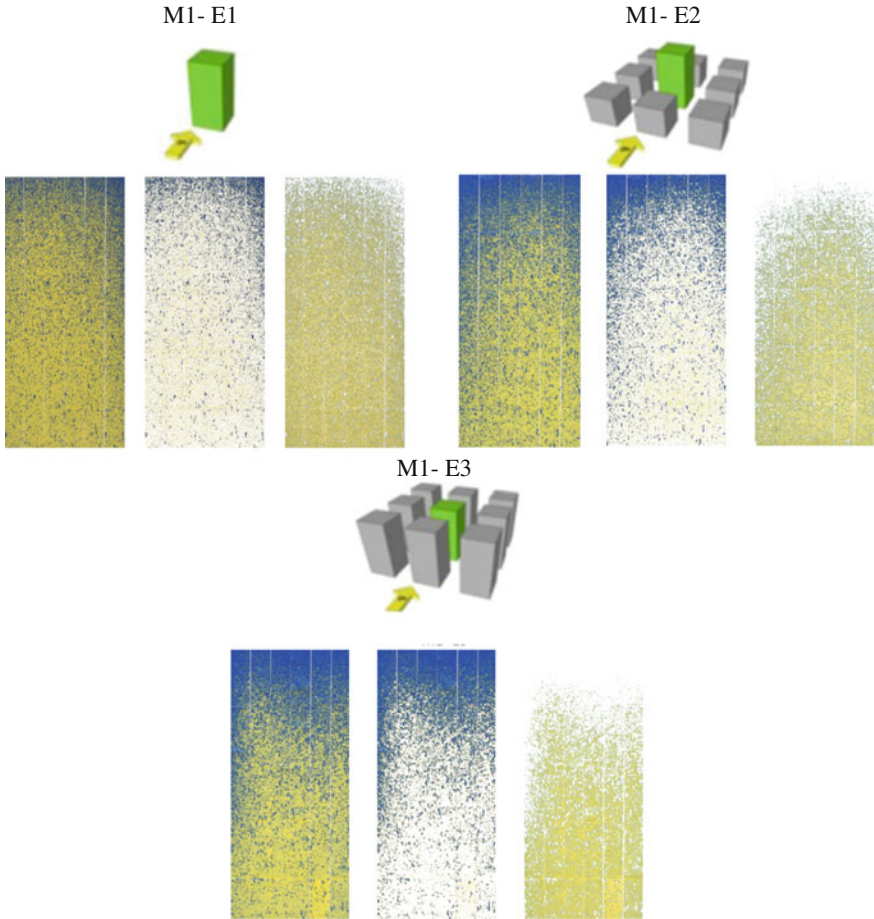
Fig. 5 Proposed methodology application for the model with square base (M1) and different surroundings

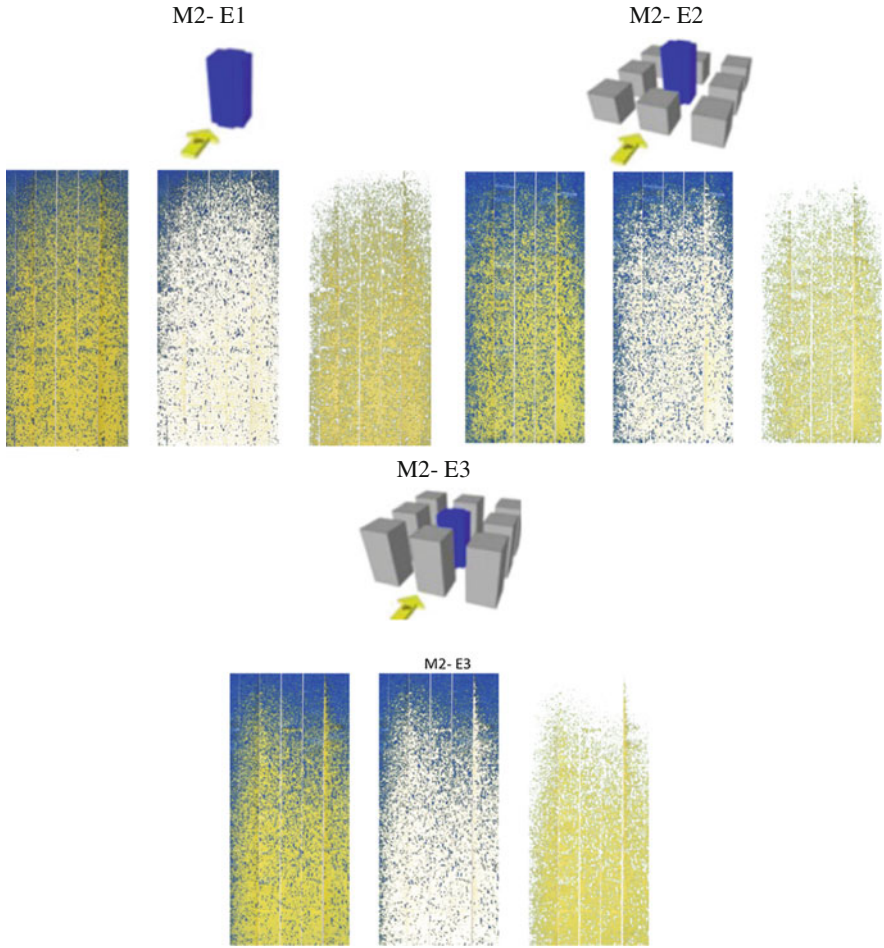
Fig. 6 Proposed methodology application for the model with cross base (M2) and different surrounds

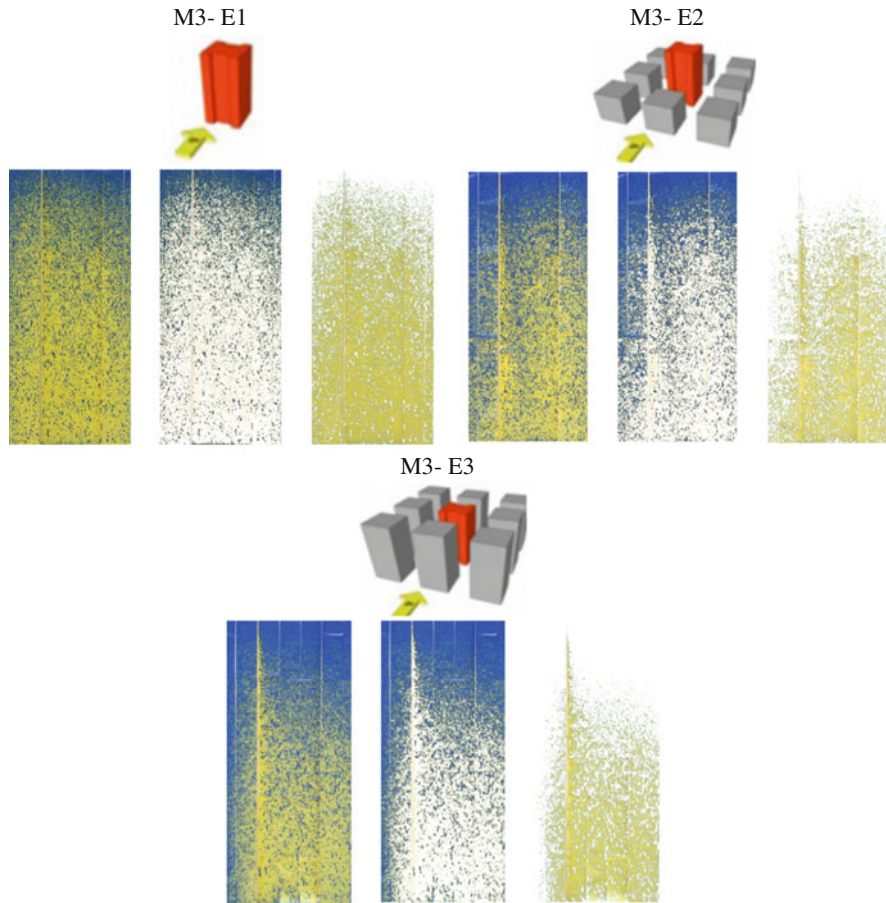
Fig. 7 Proposed methodology application for the model with H format base (M3) and different surrounds

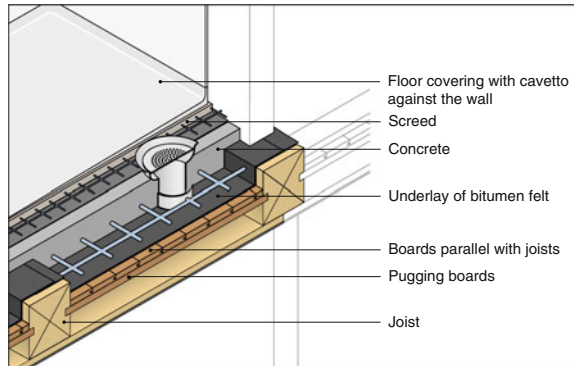
At that time, the guideline approved by the Danish Ministry of Housing was SBI Direction 109, “*Floors on wooden floor joists and linings on stud walls in wet rooms*” (three editions the last one valid until 1991) (Kjerulf et al. 1984). A prerequisite for the use of lightweight constructions was that the constructions were accessible from beneath so that any leaks could be detected as soon as possible.

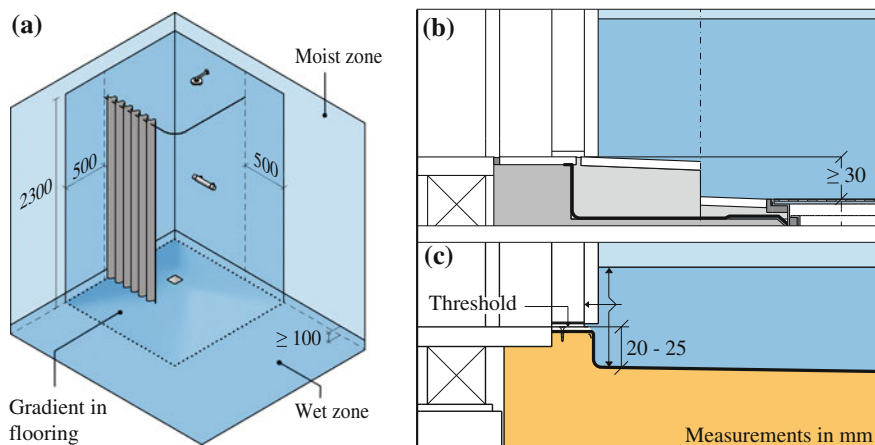
Fig. 3 a Moist and wet zones in a bathroom with a shower unit, where the wet zone encompasses the entire floor and walls around the shower unit until 500 mm from its demarcation. Wet zone on walls are from floor to ceiling, however, in tall rooms the area above normal room height can be considered as a moist zone. No penetration of pipes in the floor is allowed in the most water-exposed area—marked with a *dotted line*. This is normally also the area with the largest slope of the floor towards the floor gully. The room is designed as a “basin”, i.e. either as shown in b 30 mm height difference between the top of the drain and the floor at the door or alternatively c 20–25 mm between floor surface and lower edge of threshold (Brandt and Morelli 2015)

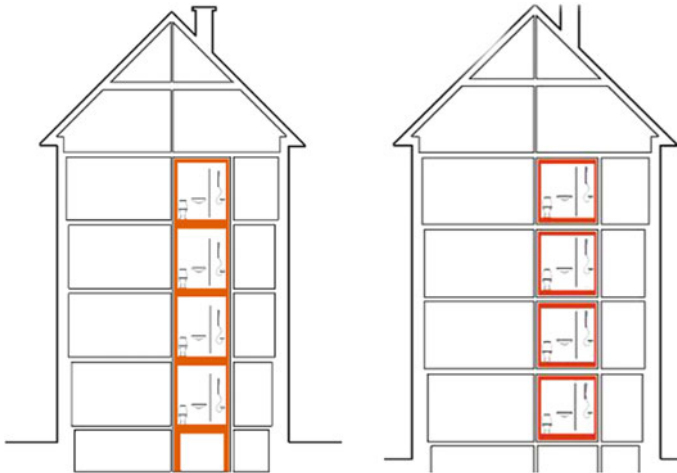
Fig. 4 *Left* Self-supporting cabins with foundation in basement, and *right* Bathrooms installed as cells in each apartment on existing floor division of wooden beams

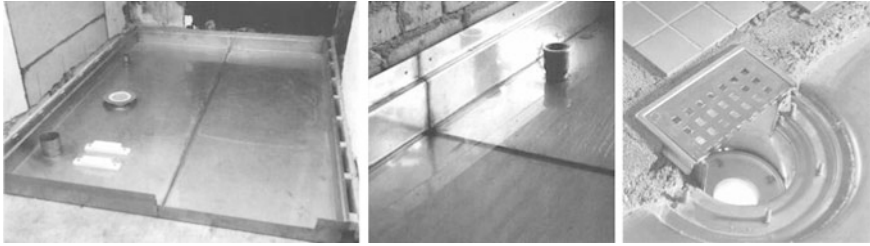
Fig. 5 *Left* Steel surface on entire floor with a reduced height of the edge in the *front right* for a door. The *two white parts* are for the toilet and behind it is the floor gully. *Middle* The folded edge at the assembly between steel floor and wall and the assembly of two steel plates. *Right* Structure of floor with tiles and screed around the floor gully. Pictures from Danish Ministry of Housing (1994)

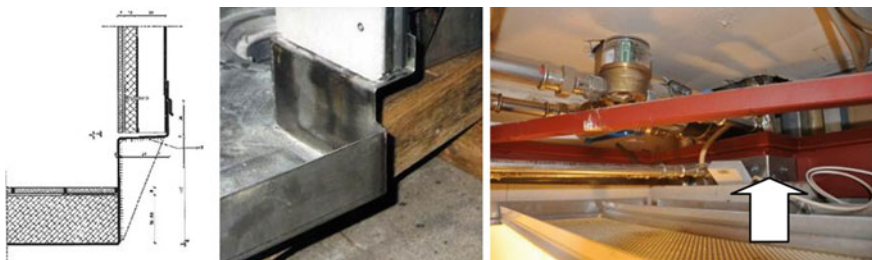
Fig. 6 *Left* Section in floor and wall showing where the steel membranes are overlapping. *Middle* Assembly of wall and floor at the door, where the steel height is reduced. *Right* Red painted steel frame above ceiling for fastening the walls steel plates, see marking. Pictures from Danish Business and Housing Authority (2004b)

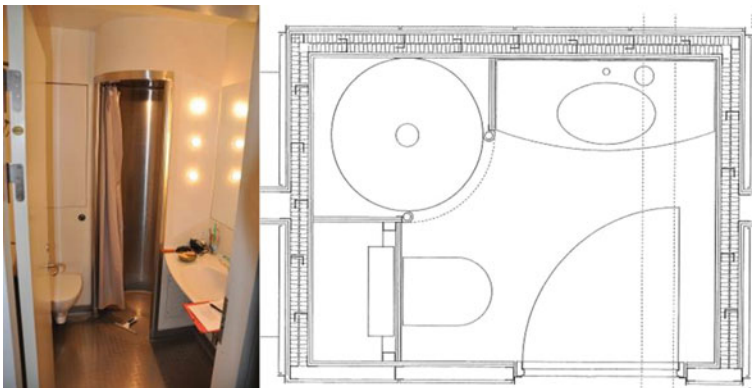
Fig. 9 *Left* Picture of the bathroom after approximately 20 years of use. *Right* Horizontal section of the bathroom. Pictures from Danish Ministry of Housing, Urban and Rural Affairs (1999b)
