Building Pathology and Rehabilitation

João M.P.Q. Delgado *Editor*

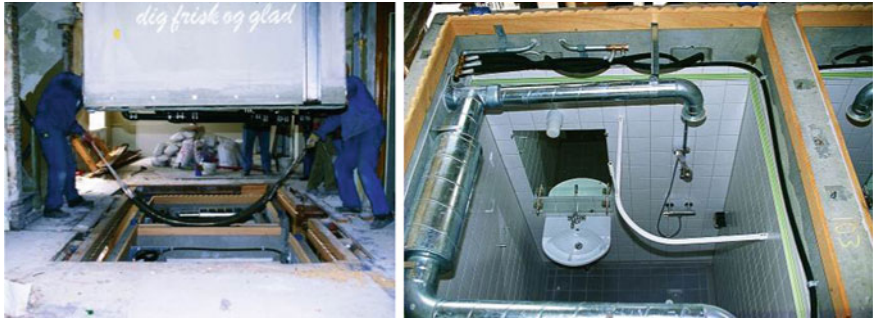
Fig. 13 *Left* Installation of two cabins as Bathroom #15 with placing of apartment boundary in the middle. *Right* Installed Bathroom #15 cabin seen from above. Pictures from Danish Ministry of Housings (1997)

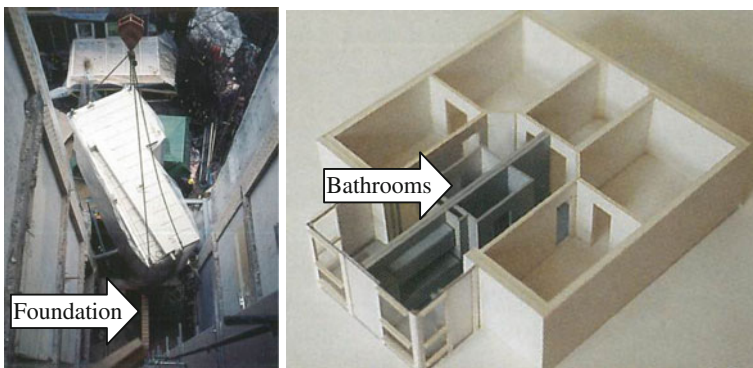
Fig. 14 *Left* Installation of a kitchen and bathroom. At the ground, a brick foundation can be seen. *Right* Principal sketch of the kitchen placed in a bay and the bathroom inside the apartment after renovation. Pictures from Danish Ministry of Housing and Urban Affairs (1998b)

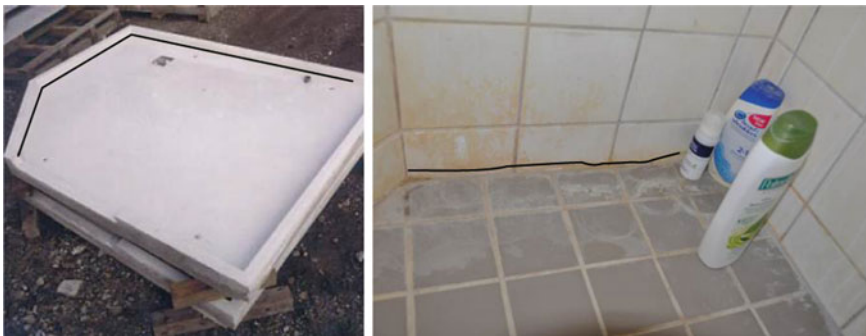
Fig. 15 *Left* Fibre reinforced bottom plate with a plinth marked with a *black line*. *Right* The *black line* indicates the crack, which was found on different walls in the bathroom above and below the apartment on the picture. *Left* Picture from Danish Ministry of Housing, Urban and Rural Affairs (1999b)

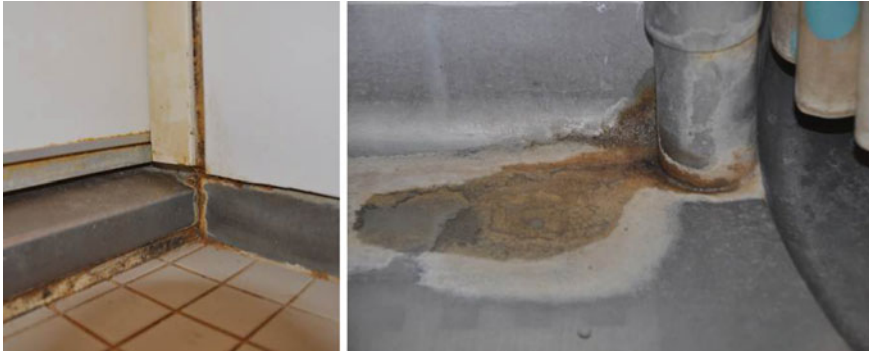
Fig. 16 *Left* Bathroom #4, the corner of the door, wall and floor assembly where the rusty *red* colour is anticipated to be mould growth as it is the same colour as seen on the silicone sealant. *Right* Rusty *red* colour at each corner at the interface of the shower unit and floor, see also Fig. 9

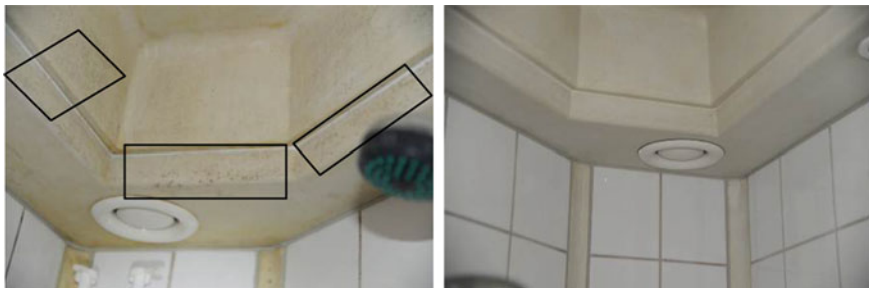
Fig. 17 Two bathrooms connected to the same ventilation exhaust, but where the one (*left*) has a *low rate of extraction* and *dark stains* in the ceiling, whereas the other (*right*) has a *high rate of extraction* and *no dark stains* in the ceiling

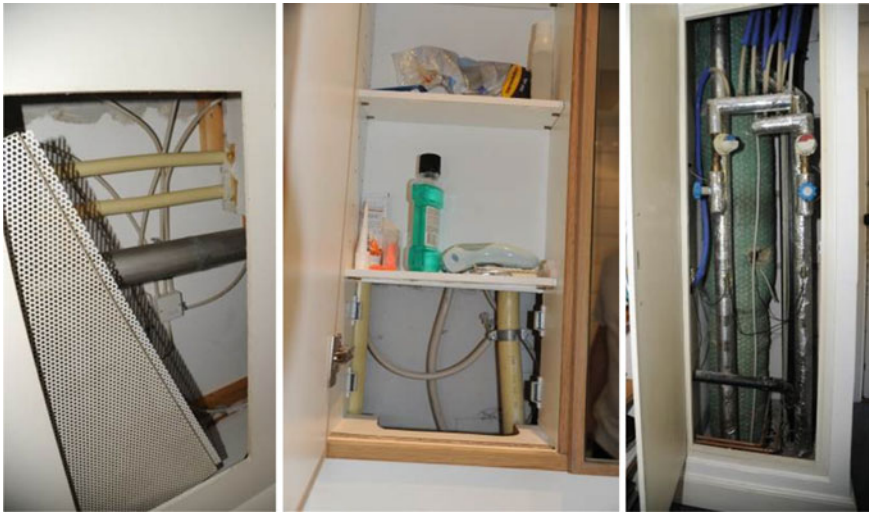
Fig. 18 *Left* Access to installations through a hatch in the ceiling. *Middle* A small cabinet gives access to the installations. *Right* Access to the installations through a door in the bedroom

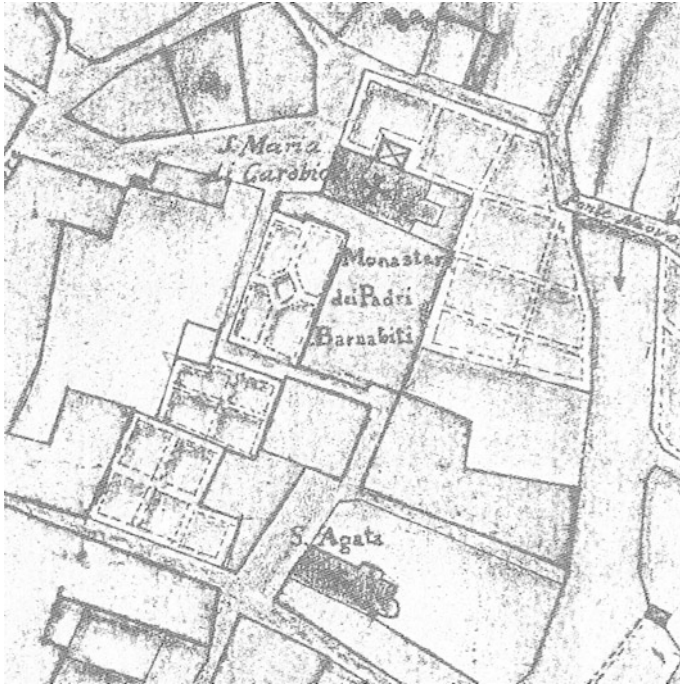
Fig. 3 Historical map of the complex of Carrobiolo. One of the files uploaded in the platform of the Carta del Rischio, Historical section. It is part of a map of 1721 from Giovanni Filippini, then redrawn in 1738 by Carlo Porta (Filippini 1722)

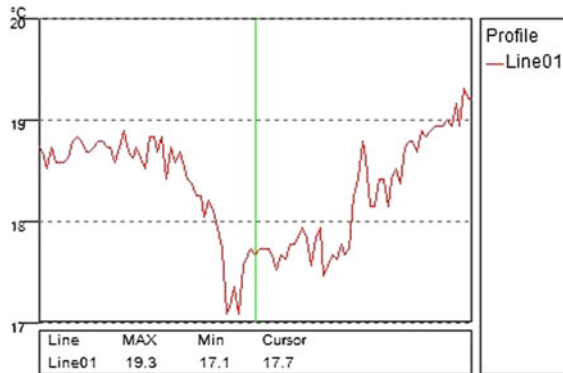
Fig. 5 The graph shows the thermal linear trend in temperature between the surface in good state of preservation and the area with the presence of moisture, with a thermal gradient of about 2 °C

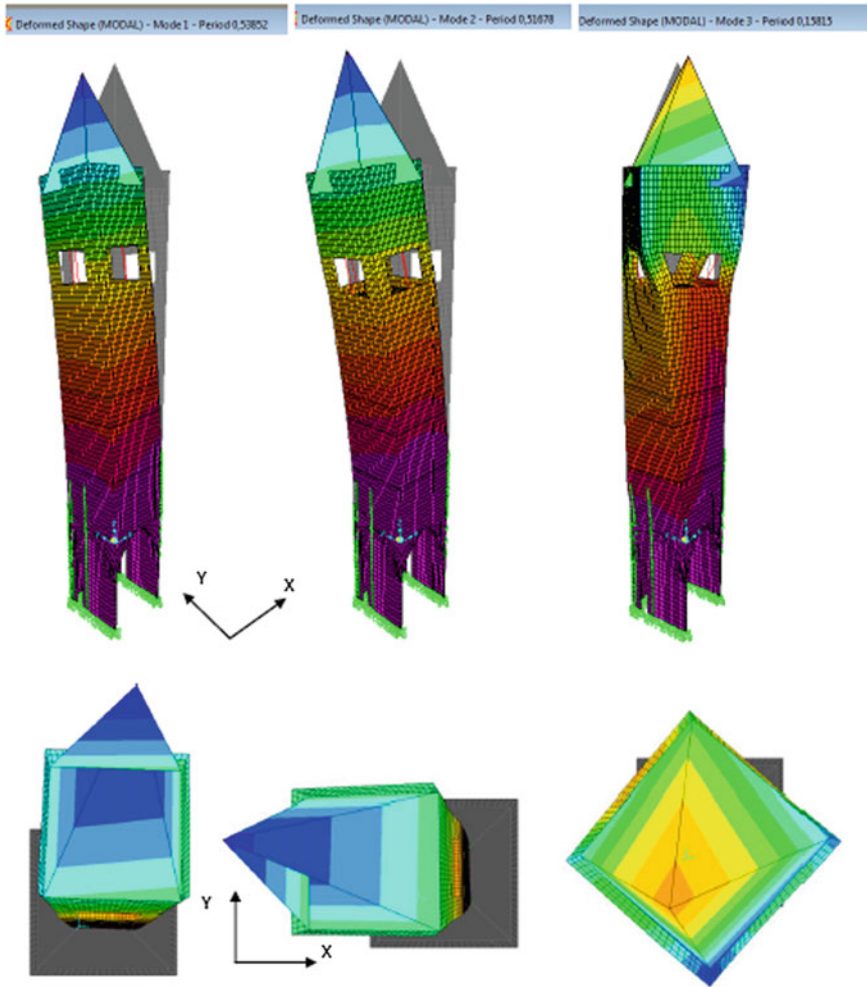
Fig. 6 This image comes from the exam of the static and seismic bell tower played by the group of L. Jurina. The *picture* shows the first three modes of vibration, in the Y-direction (MODE 1), i.e. along the axis of the church, in the X-direction (SO₂), which is perpendicular to the axis of the church, and torsional (MODE 3)

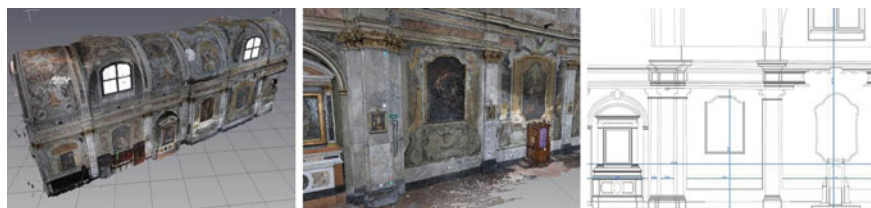
Fig. 12 North elevation

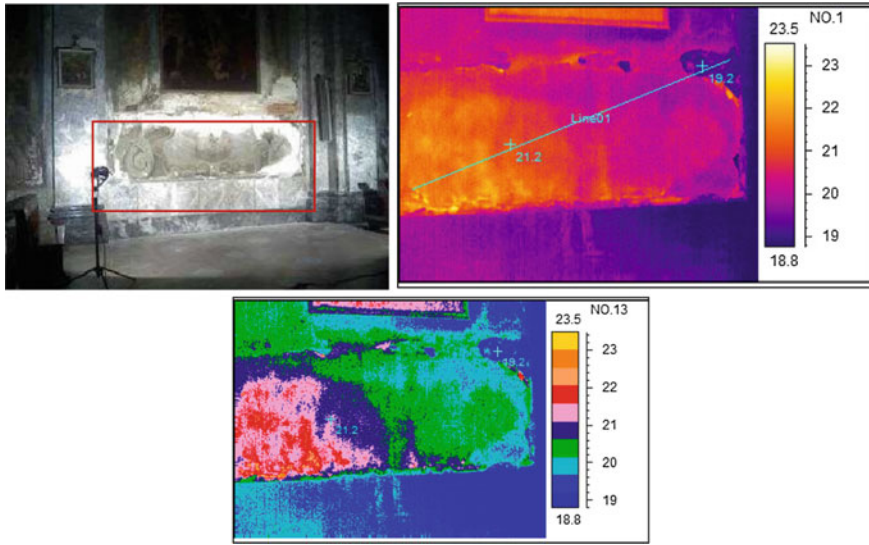
Fig. 13 North elevation, third span. The thermographic investigation was carried out in active thermography to highlight the different behaviours of the surfaces with respect to the induced heating and subsequent cooling

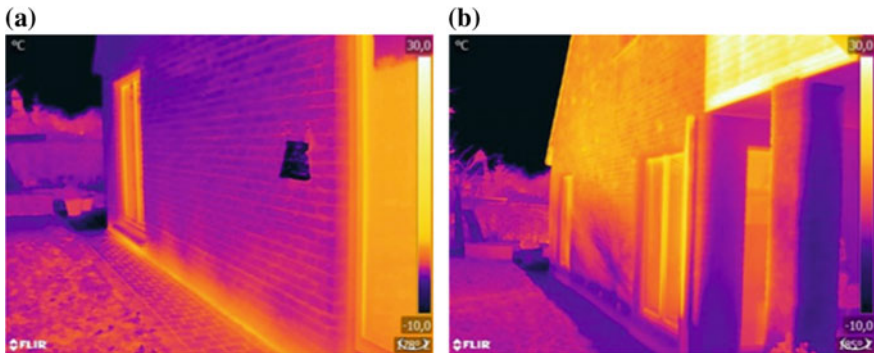
Fig. 2 *Left* A thermal bridge at the foundation–wall interface of the East façade, clearly visible before sunrise. At the moment of the measurement, a temperature difference of 19 °C was present. *Right* IR picture of the same façade, at 10 a.m. After sunrise, the façade was exposed to radiant heat from the sun. Because of the heat capacity of the bricks, the outside surface temperature of the construction remains influenced by the sun radiance by which thermal bridges can become invisible

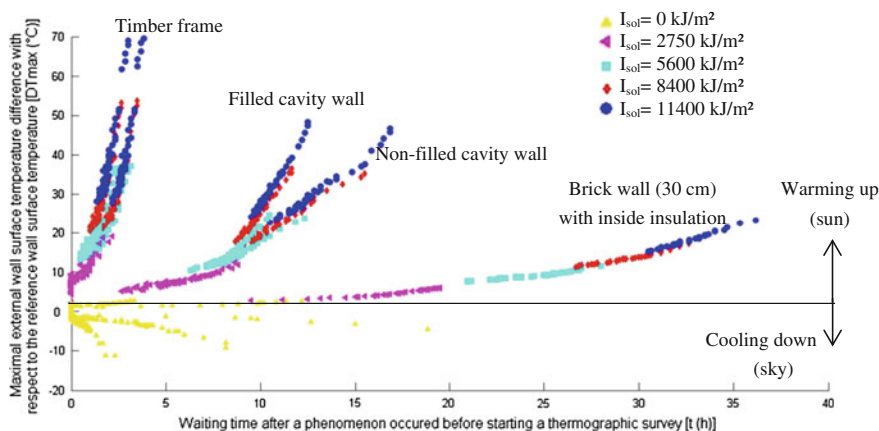
Fig. 3 Maximal external wall surface temperature deviation from the steady state and waiting time for 6 types of building components. The *horizontal axis* shows the period of time in which heavy clouded weather should occur before it is possible to measure surface temperatures closer than 0.5 °C to the steady state

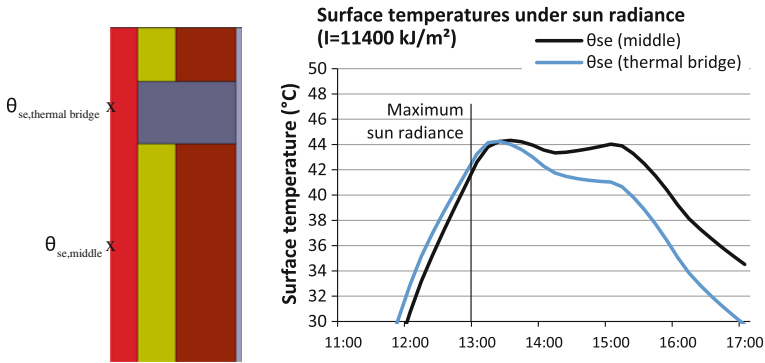
Fig. 4 Simulation model of a thermal bridge in a filled cavity wall, exposed to sun radiance. The graph shows the current of the outside surface temperatures

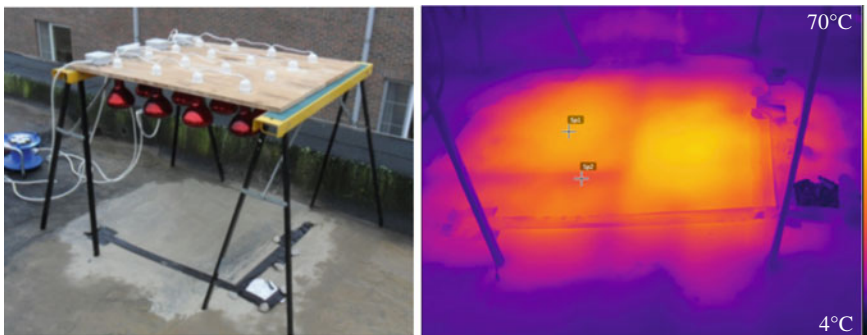
Fig. 5 *Left* IR light bulbs can be used to create a radiant heat source for the inspection of a membrane on a flat roof. *Right* After heating up the surface with the IR light bulbs, a colder area becomes visible under the surface. This indicates that there is possibly water between the insulation panels under the roof membrane

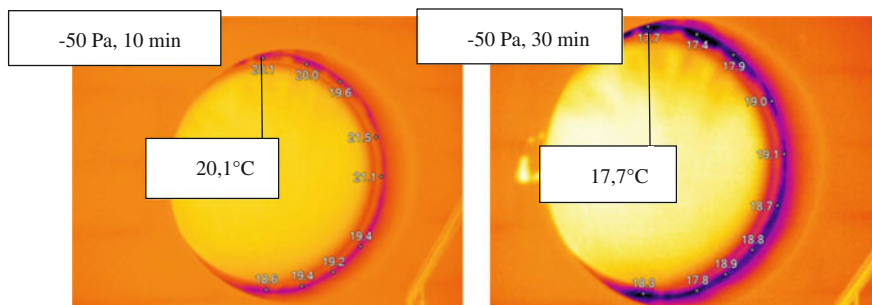
Fig. 6 IRT-survey at the inside of a window–wall intersection under a pressure difference of -50 Pa. The image on the *left* is taken after 10 min, while the image on the *right* displays the surface temperatures after 30 min. *Blue spots* are the coldest and *white spots* are the warmest zones on the image. Due to the change in surface temperature, it is clear that this is an air leakage spot and not a thermal bridge

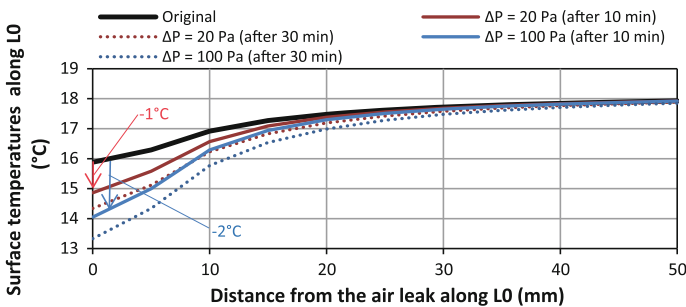
Fig. 8 The pressure difference has a limited influence on the surface temperatures near the joint. At the air leakage spot, the resulting surface temperature difference between 20 and 100 Pa was $1 \text{ }^\circ\text{C}$ throughout the whole period of depressurization in the models

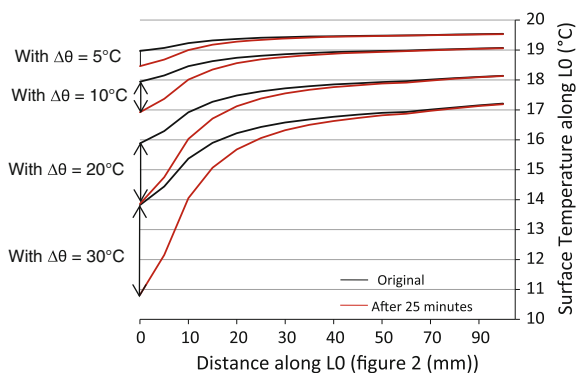
Fig. 9 Effect of the temperature difference on the change in surface temperature. A minimum temperature difference of 10 °C is advised when using IRT to assess air infiltration spots. With this difference, a change in surface temperature of 1 °C after 25 min is obtained

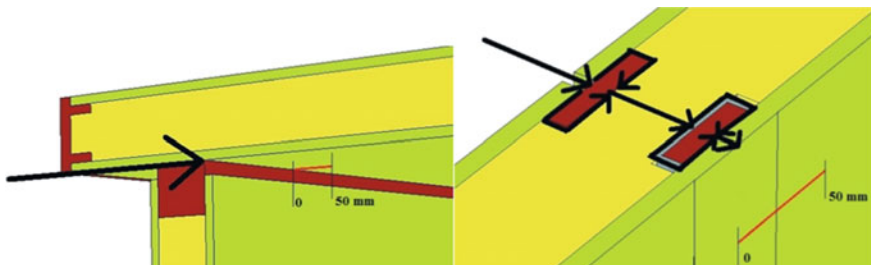
Fig. 10 *Left* Roof–wall junction. *Right* Wall–wall junction. The air flow was a fixed value in the simulations. Along the *red lines* on the figures, the simulated temperature profile was plotted

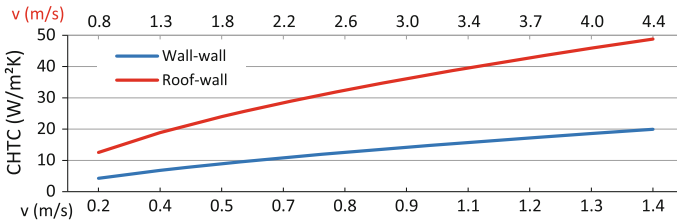
Fig. 11 CHTC ($\text{W/m}^2 \text{ K}$) correlated to the speed of the air flow, calculated with a leak width of 0.5 mm

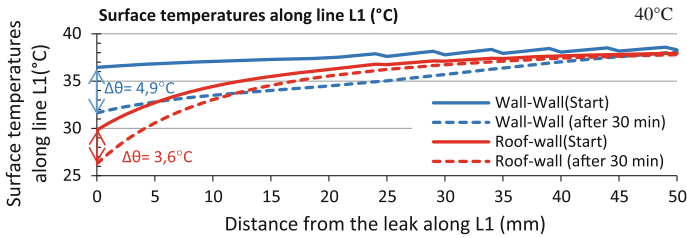
Fig. 12 Simulated surface temperatures (°C) at 50 Pa pressure difference, simulated with a width (w) of 0.5 mm (full line). These profiles are taken along the black line shown in Fig. 6

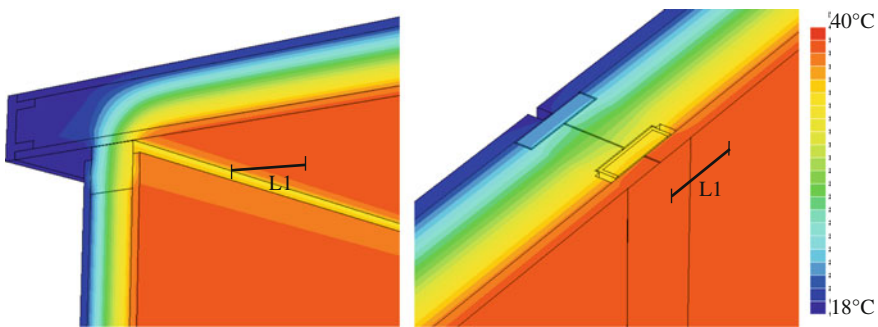
Fig. 13 Temperature distribution inside the simulation models, before depressurization. The surface temperature in the roof–wall junction is already lower due to the high conductivity of the wooden beam between the roof and wall panel

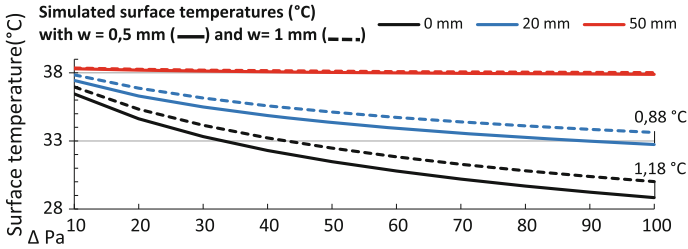
Fig. 14 Simulated surface temperatures of wall–wall junction. The *horizontal axis* shows the different pressure differences, and the *vertical axis* shows the surface temperatures at 0, 20 and 50 mm distance of the air leak. The maximum difference between the simulated results with both widths is 1.18 °C, at 0 mm from the leak with pressure difference 100 Pa

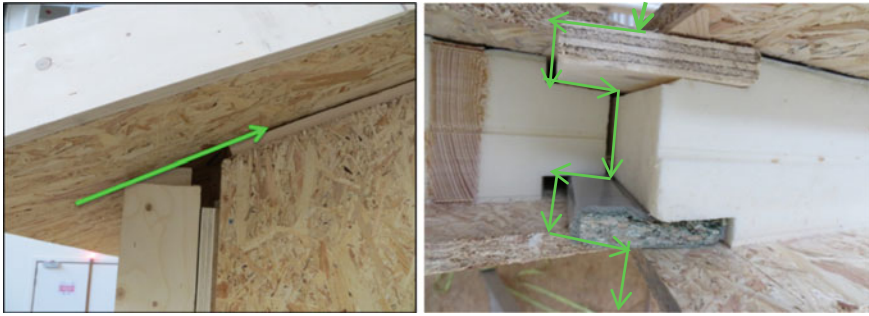
Fig. 15 *Left* Section of the roof–wall junction. *Right* Picture of the wall–wall junction with grey PVC foam brace at the inside. The expected air infiltration path from outside to inside is indicated with a *green arrow*

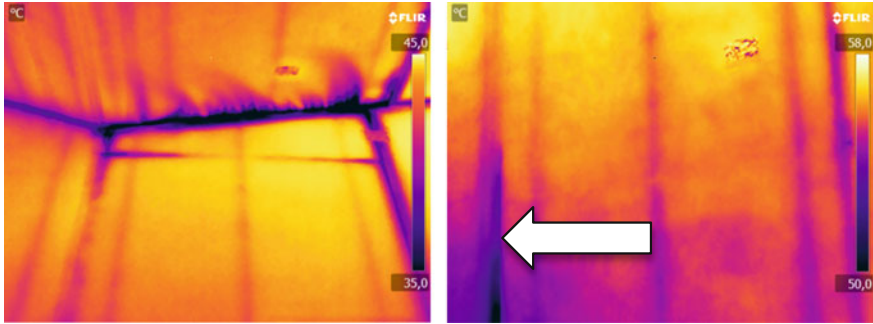
Fig. 16 *Left* Roof–wall junction thermogram. *Right* Wall–wall junction (indicated with an *arrow*). Images taken at 30 min with –50 Pa pressure difference

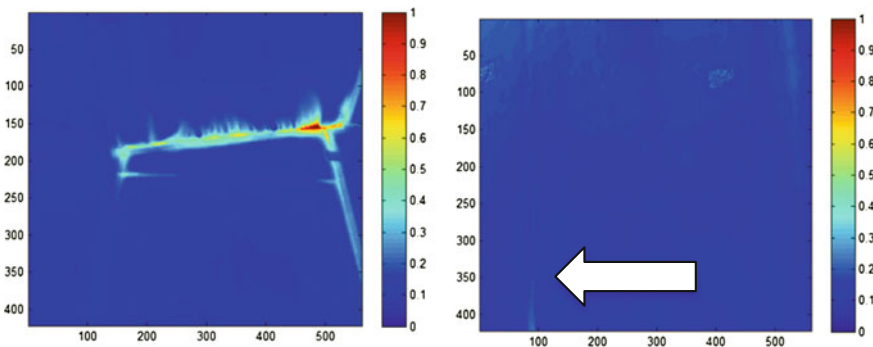
Fig. 17 Change in temperature factor relative to the first image after 30 min. *Left* Roof–wall junction. *Right* Wall–wall junction

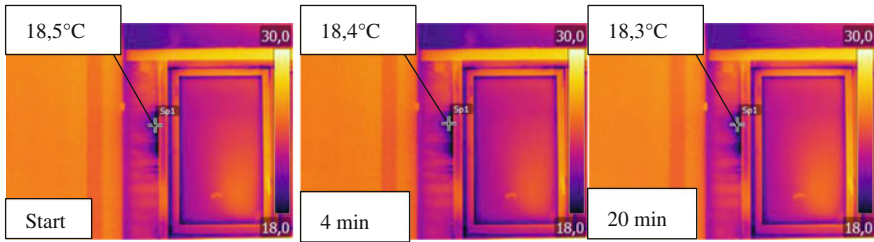
Fig. 18 All pictures were taken with $\epsilon = 0.90$ and reflected environment temperature of $19\text{ }^{\circ}\text{C}$. There was no change in the pattern visible, but due to the irregular shape, this was clearly an air leakage spot

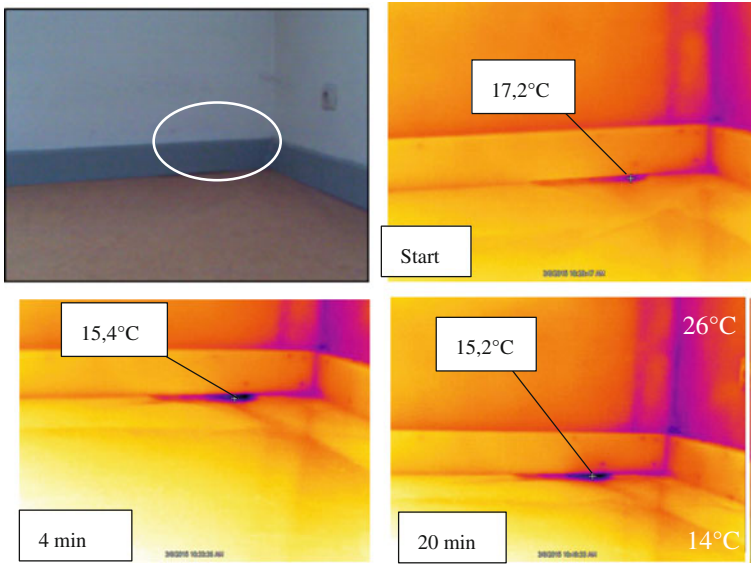
Fig. 19 Infrared images under -20 Pa pressure difference of a large air leak, visible with the eye. After 4 min of depressurization, the surface temperatures remained nonetheless constant. All pictures were taken with an emissivity of 0.90 and reflected temperature of 20.0 °C

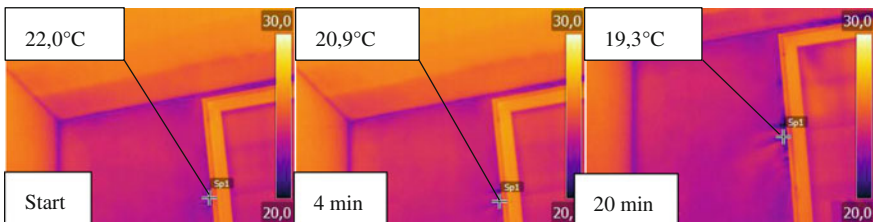
Fig. 20 Infrared images under -20 Pa pressure difference. All pictures are taken with $\varepsilon = 0.90$ and reflected environment temperature of 19 °C. The surface temperatures kept decreasing until the end of the test

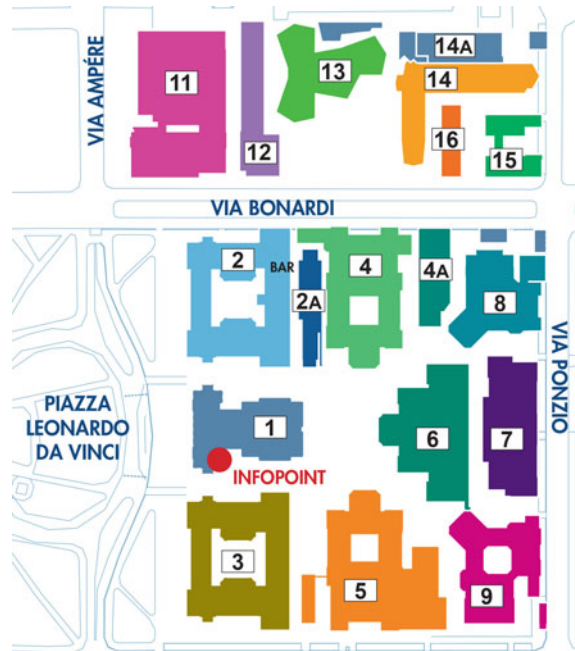
Fig. 1 Map of Leonardo Campus

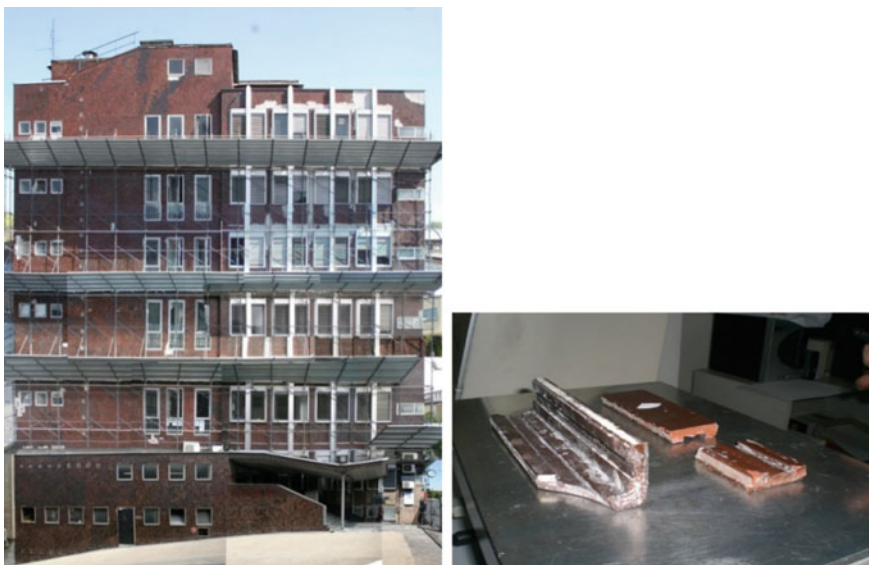
Fig. 3 Building 12 in Campus Leonardo (*left*); details of the tiles of building 12 (*right*)

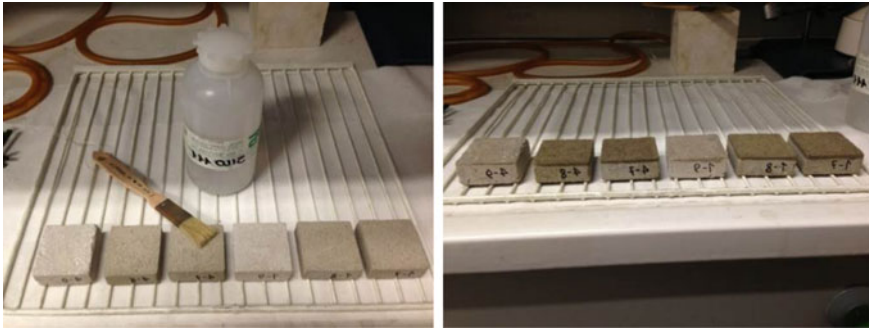
Fig. 4 Application of the water-repellent siloxane treatment on the outer surface of cement mortar samples (CEM I and IV)

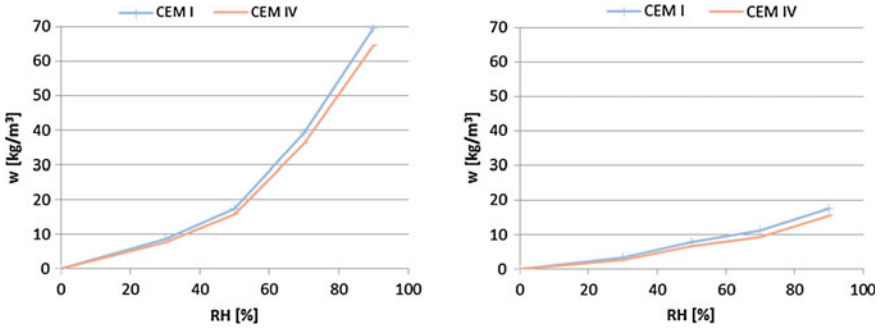
Fig. 5 Relative humidity–moisture content mass by volume (untreated specimens: *left*; treated specimens: *right*)

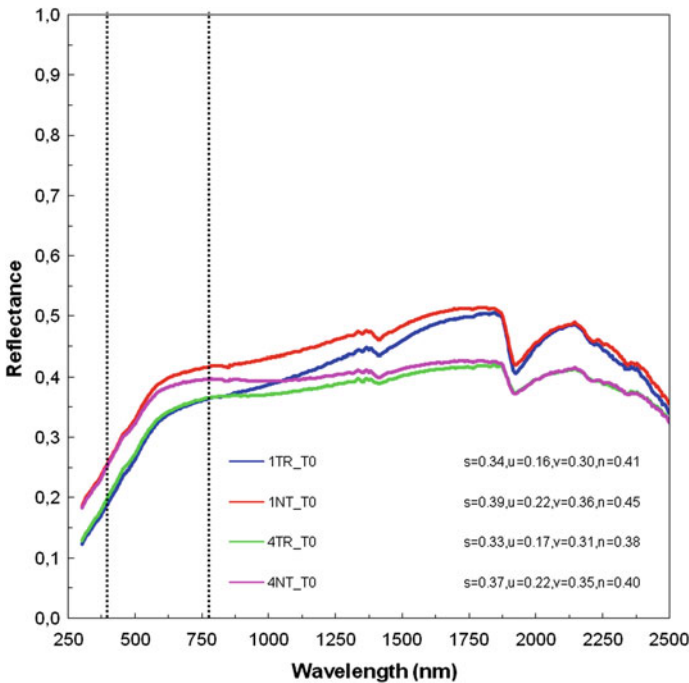
Fig. 13 Spectral and computed solar (*s*), UV (*u*), visible (*v*), and near infrared (*n*) reflectance performed before exposure; the curves of the specimens with siloxane treatment are TR, whereas the untreated are NT

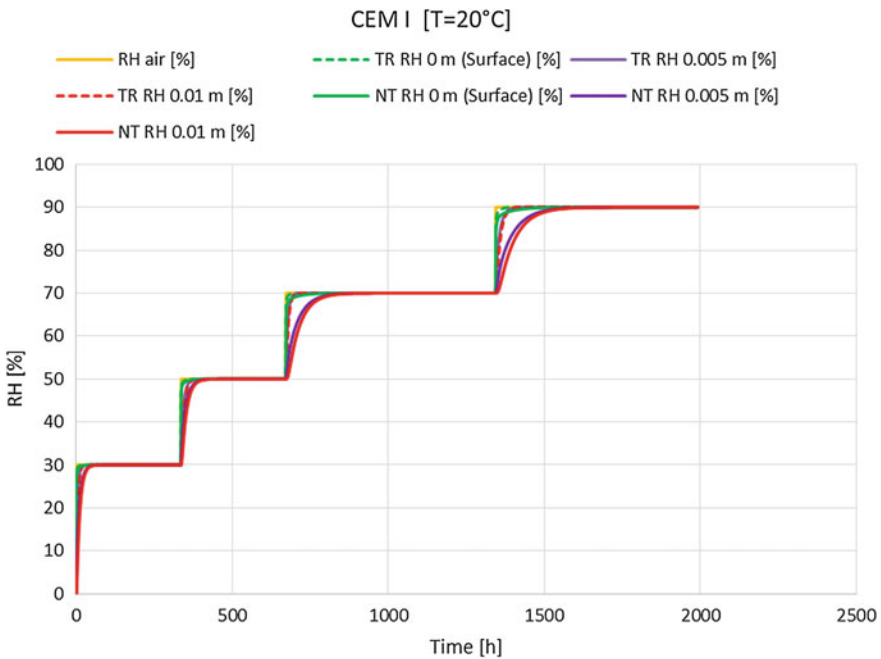
Fig. 14 Comparison of the RH trends for untreated/treated cement (CEM I) specimens

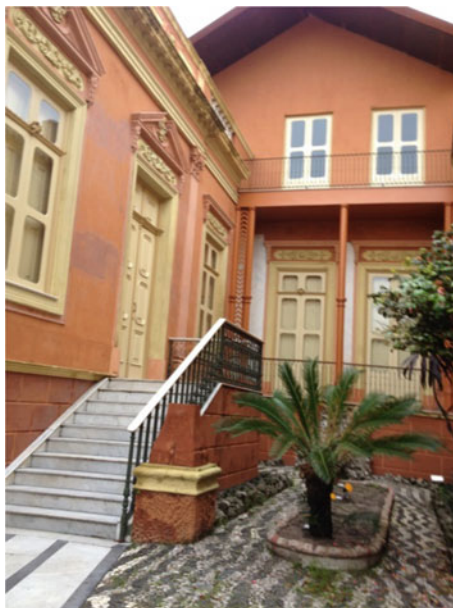
Fig. 1 Pelotas Candy Museum

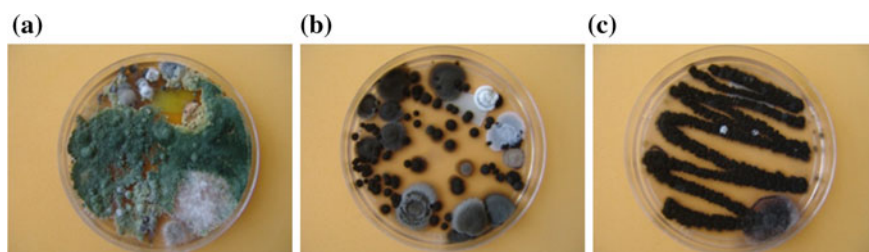
Fig. 3 a, b, c Fungal growth example in Petri dishes from the building indoor surfaces collection

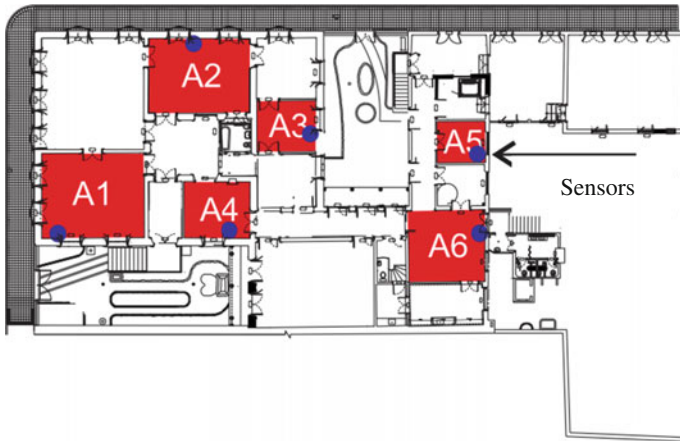
Fig. 4 Environments monitored on the ground floor

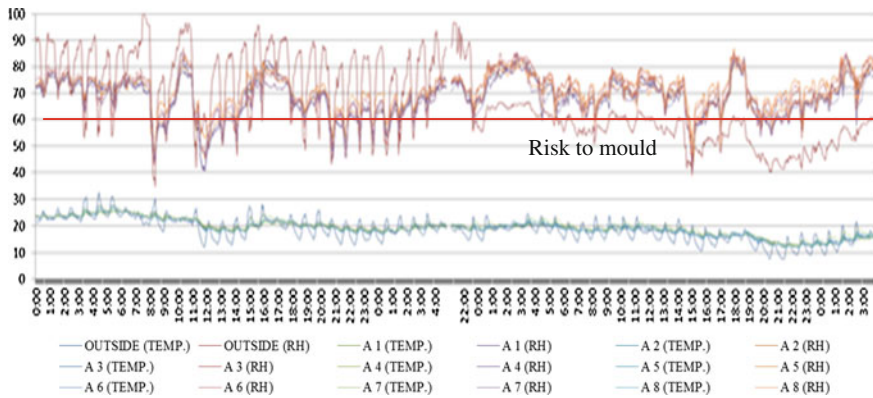
Fig. 7 RH and temperature sensors for indoor and outside from April to May

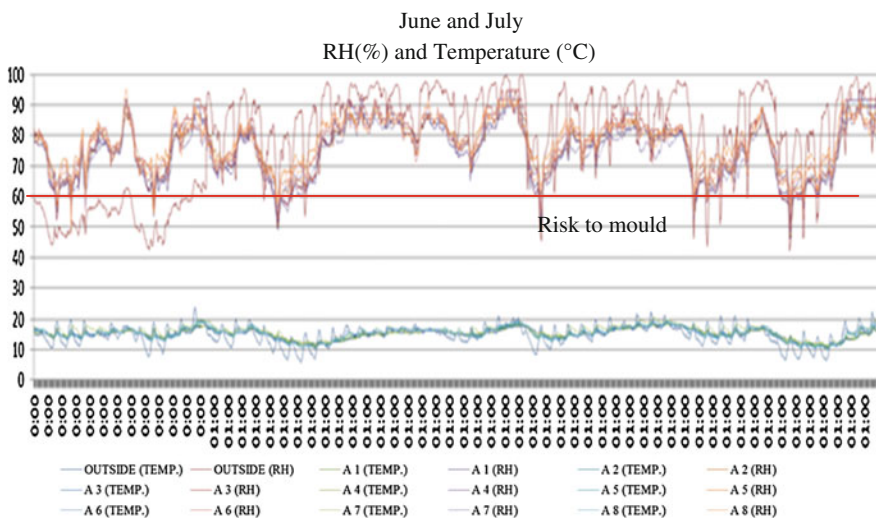
Fig. 8 RH and temperature sensors for indoor and outside from June to July

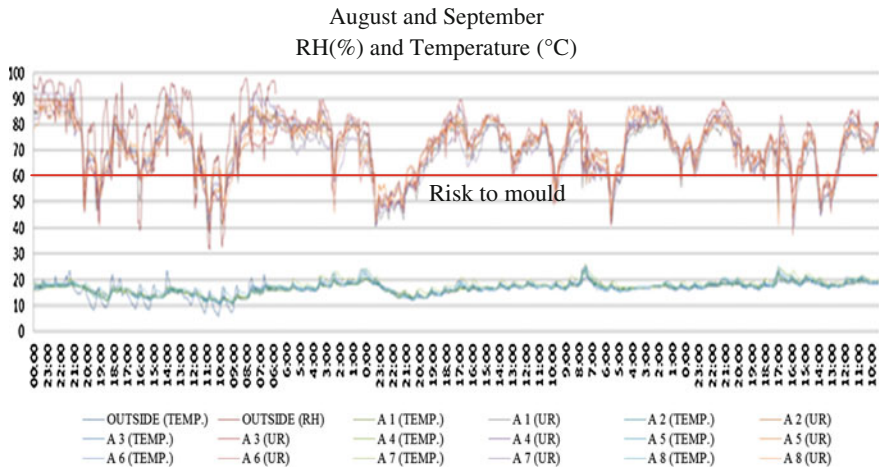
Fig. 9 RH and temperature sensors for indoor and outside from June to July

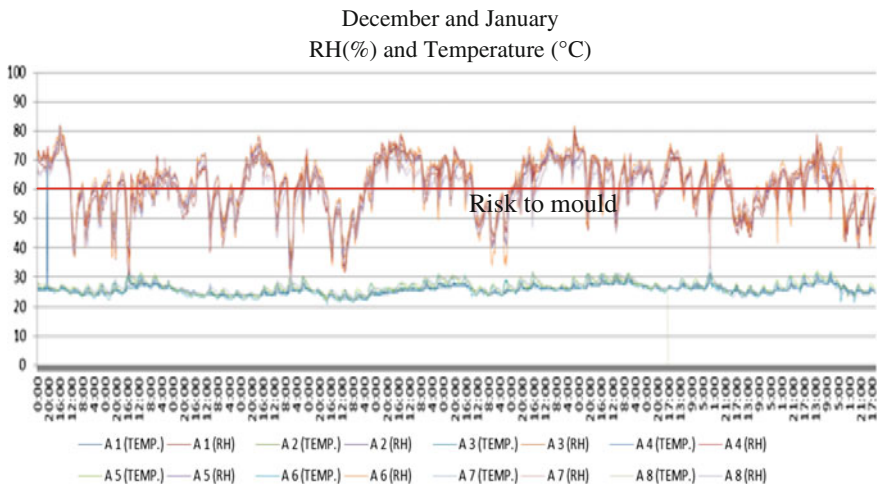
Fig. 11 RH and temperature sensors for indoor and outside from December to January
