Structural Integrity Study for Additional Piles on an Existing Jacket Structure in Western Indian Offshore

Praveen Bhat and Bakul Master

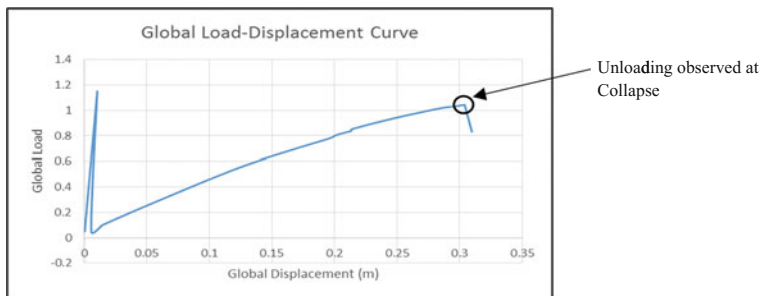
Fig. 2 Jacket structural collapse around a load level of 1.05

The results of the ultimate strength analysis revealed that the structure is not able to withstand the environmental forces up to the target RSR [4] level of 1.323 for all the considered directions, primarily due to failure of Row-2 piles (refer Fig. 3) and X-brace joints present on Row-A and Row-B of the jacket structure, around a load level of 1.05 (refer Fig. 2).

The analysis results (both design-level and ultimate strength) revealed that the structure was having overstressed piles (predominantly Row-2 piles) and X-brace joints. The main reason for that is the change in the design regime (design hydrodynamic coefficients, hydrodynamic marine growth thickness, etc.) and installation of additional facilities on the platform over a period of time. All these factors have contributed to an increase in the hydrodynamic loading by more than 45%.

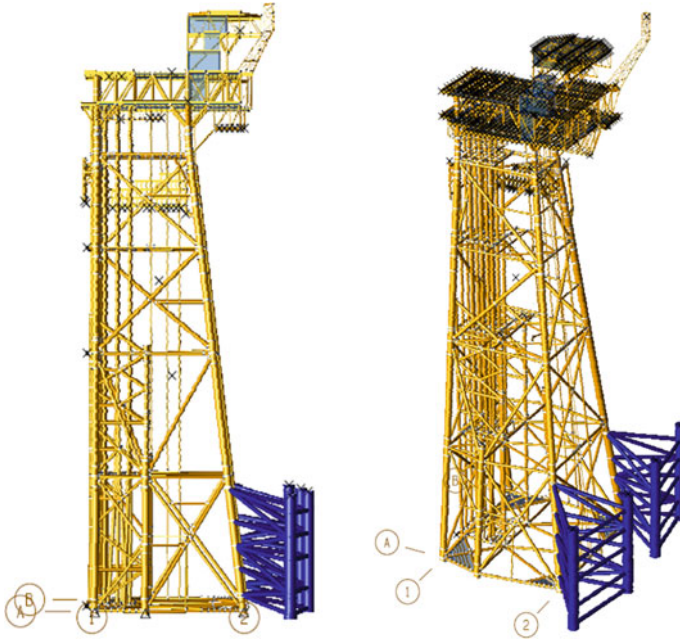
Fig. 4 Structural model with additional piles

Additionally, the exact new pile intra-spacing and distance from existing piles on Row-2 (refer Fig. 4) will have to be ascertained for assessing the load distribution and pile group effects. The proximity to which the installation barge could approach the platform and the obstruction posed due to the structure deck needs to be duly considered.

Number: 4

Size: 2.134 m (84 in. outer diameter) \times 0.065 m (Thickness)

Vertical Penetration below mud line: 45.5 m

It is to be noted that after carrying out the strengthening of the jacket structure with additional four piles on Row-2 of the structure, the load redistribution has effectively resulted in the reduction of stresses in some of the adjacent members and joints, e.g., the Row-A and Row-B primary X-brace joints (b/w EL (-) 52.76 m and EL (-) 77.455 m) were now found to be stressed within permissible limits.

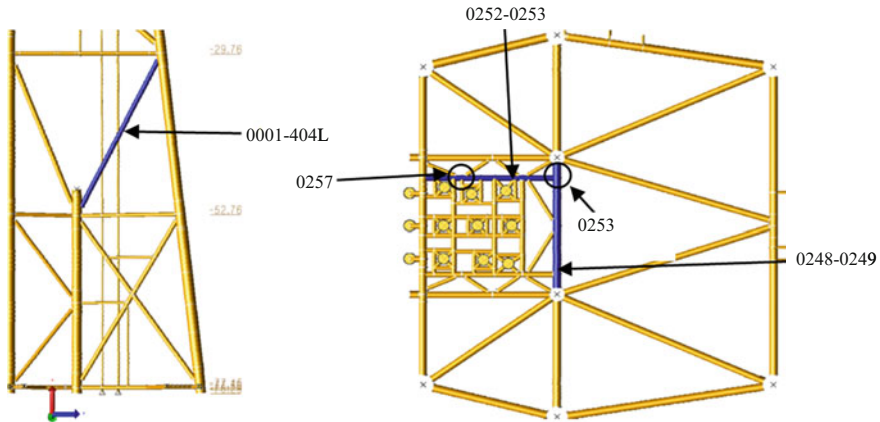
Fig. 5 Structural components proposed for grouting (as highlighted)

One of the primary structural members and two primary structural joints were found to be overstressed after carrying out the analysis with additional piles; so, strengthening of these components has been proposed. The analysis has been carried out after considering the strengthening of the member 0001-404L with adequate strength grout [6] (Fig. 5), the results of which reveal that the member is stressed within the permissible limits. The results of the re-analysis performed after

considering the strengthening of the respective chords for joints 0253 and 0257 with adequate strength grout (Fig. 5) reveal that the structural joints 0253 and 0257 are stressed within the permissible limits.

1. Removal of sump and pump casing,
2. Non-consideration of future riser protector on Row-2 of the structure,
3. Installation of additional four 84" (2.134 m) piles on row-2 of the platform (two each at A2 and B2), and
4. Grouting of primary structural member 0001-404L and primary joints 0253 (Joint Chord member 0248-0249 to be grouted) and 0257 (Joint Chord member 0252-0253 to be grouted)
