# Cracking Failure Analysis of X70 Pipeline Steel Weld

**Abstract** The weld defects were detected by Nondestructive Testing Technology (NTT). The microstructure and microhardness were examined by optical microscope(OM), scanning electron microscopy (SEM) equipped with EDS and Vicker microhardness tester to identify the reasons of cracking failure in X70 pipeline steel weldment. As a result, the microstructure in the root layer and filling layer of the weld presents ferrite and pearlite while it is ferrite and bainite in the covering layer, but the morphology and distribution as well as the content of ferrite and pearlite in the root layer are different from which in the filling layer; the cracks initiate at the root of the weld and propagate towards filling layer, and the C, O, S segregation is serious, which contribute to the initiation and propagation of the crack in the weld; the hardness decreases sharply around the crack tip, which exhibits lower strength.

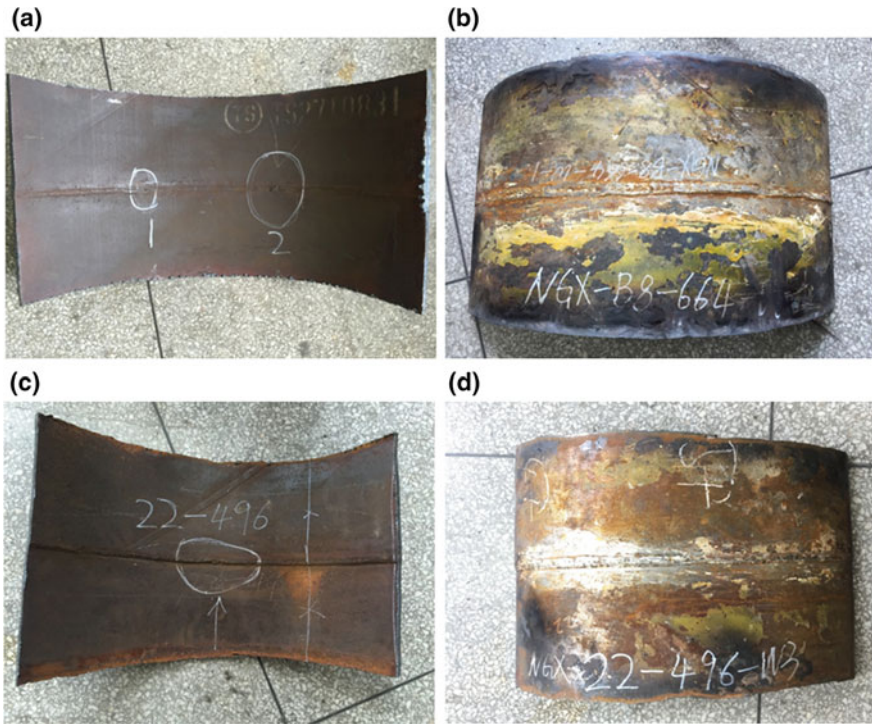
The failed two segments of the X70 weld were shown in Fig. 1 containing inner pipe (a, c); and outer pipe (b, d). The cracking failed girth weld in X70 pipeline was firstly detected by X-ray detectoscope, and the results were shown in Fig. 2. It was found from Fig. 2 that three places of crack points appeared in the weld, and the three places of crack points were circled out in Fig. 1.

**Fig. 1** Profile of failed segments; **a** two defects in the weld of one inner pipe; **b** outer profile of **a**; **c** one defect in the weld of the other inner pipe; **d** outer profile of **c**

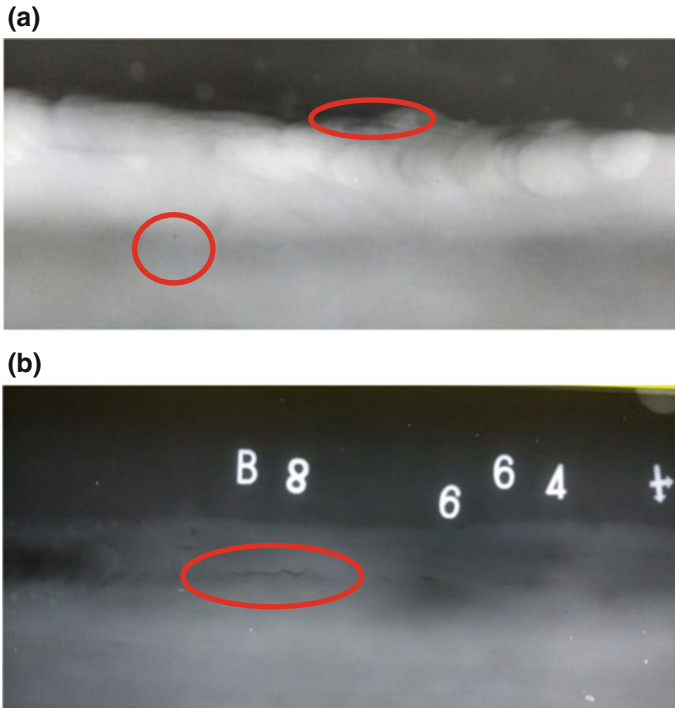
**Fig. 2** Defects detected by X-ray detectoscope near failed girth weld; **a** detected result of Fig. 1a; **b** detected result of Fig. 1c

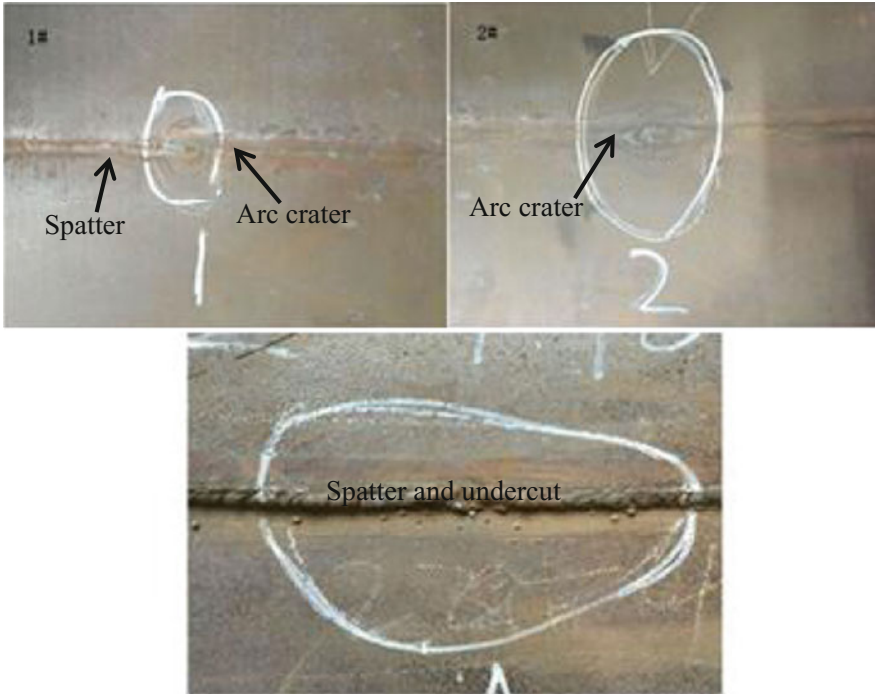
Morphology characterization of three defects in the weld of X70 pipeline steel was shown in Fig. 3. It was obvious that arc crater, excessive grind and a lower thickness of weld which compared to base metal all existed in 1# and 2#; lots of spatter on the back of the weld appeared in 1#, and also, serious undercut as well as spatter existed in 3#. These defects in the weld surface will introduce stress concentration, and induce crack initiation in the defects places [6]. The three specimen were cut by Wire cut Electrical Discharge Machining (WEDM) according to the

**Fig. 3** Morphology characterization of the weld surface

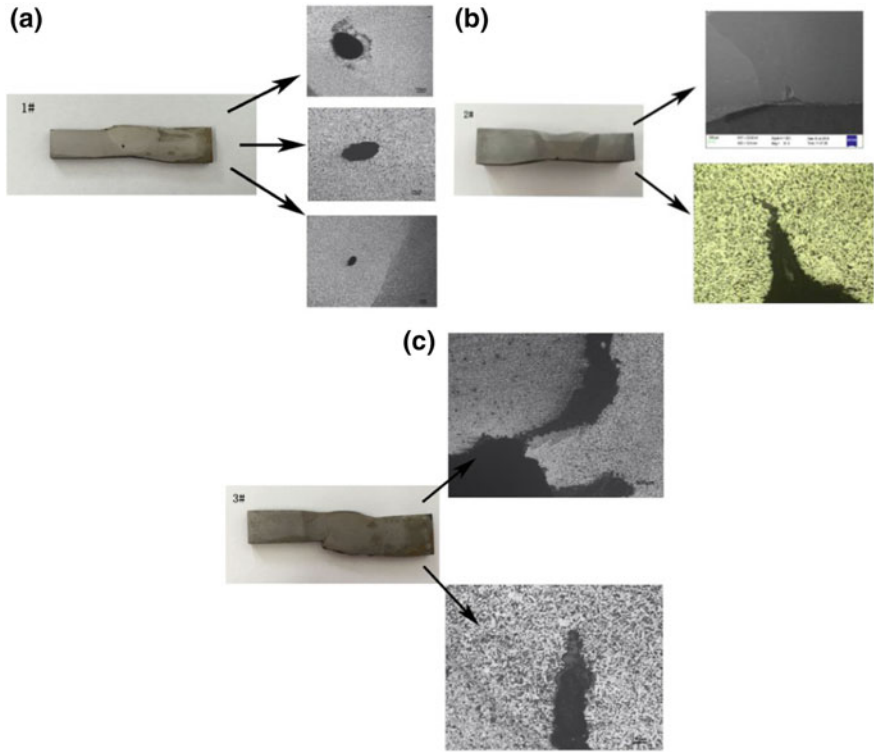
Multi-function Ultrasonic Phased-array Detection System and prepared by grinding using 150, 240, 600, 1000, 2000, 3000 and 5000 grits of SiC paper and polished, then etched by nitric acid alcohol solution(4%). The microstructure features were studied using optical microscope (OM), and the results were shown in Fig. 4. It is obvious that there are three porosities locating in the filling layer in 1#, while it is a crack in the weld in 2#, and the crack initiates from central position of the weld root, extends towards filling layer and ends at the filling layer. When it comes to 3#, however, the crack initiates from undercut position of the weld root, circuitously extends towards filling layer and ends at the filling layer.

To sum up, the cracks all initiate from the weld root, and extend towards filling layer, which may relate to the different microstructure, composition of the weld. So microstructure investigations, EDS analysis as well as microhardness test were conducted in order to better understand the reasons of the weld cracking in X70 pipeline.

Fig. 4 OM observation results of 1#, 2#, 3#

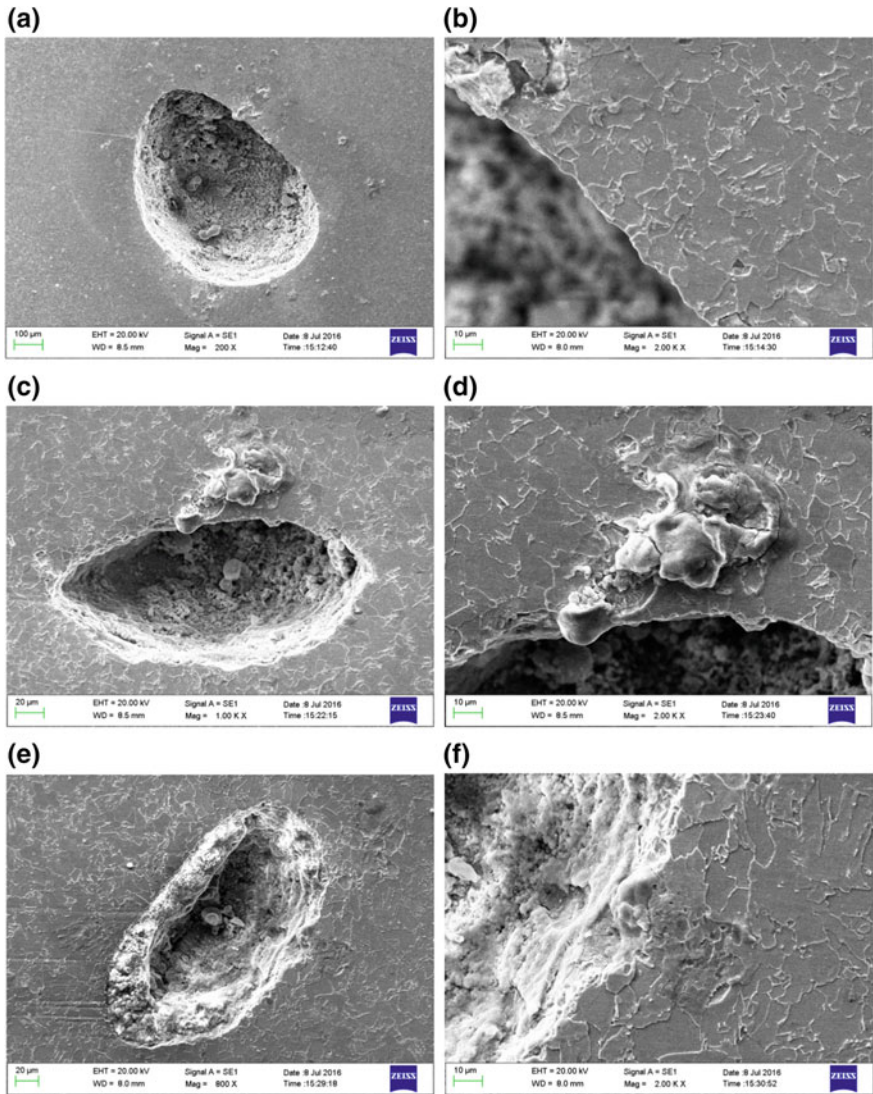
**Microstructure Observation.** It is observed that there are three porosities locating in the filling layer in 1# and the enlarged morphology is shown in Fig. 5. The microstructure of the layer where porosities are located in is shown in Fig. 6. It can be confirmed from Fig. 6a that the irregular porosity which may result from the incomplete cleaning of the weld, is located in the filling layer and is adjacent to the root layer. The existence of irregular porosity will reduce force bearing area, contribute to stress concentration and then promote the formation and extension of crack [6, 7]. Figure 6b–d are microstructure of root layer, filling layer, and covering layer; respectively; it is a mixture of ferrite and pearlite in root layer and filling layer while some bainite structure formed in the covering layer; however, as the root welding process has a similarly effect with preheat on the filling welding, it formed more pro-eutectoid ferrite and less pearlite in filling layer compared with the root layer.

**Fig. 5** a, c, e are three porosities locating in the filling layer in 1#, while b, d, f are enlarged one, respectively

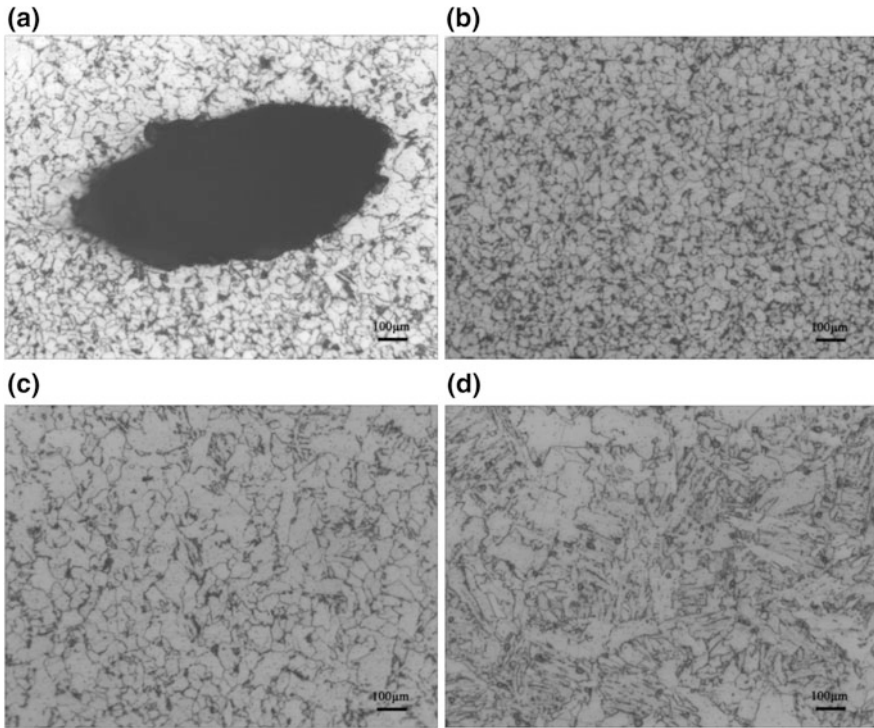
**Fig. 6** Microstructure in the weld of 1# **a** morphology of porosity; **b–d** are microstructure of root layer, filling layer, and covering layer, respectively

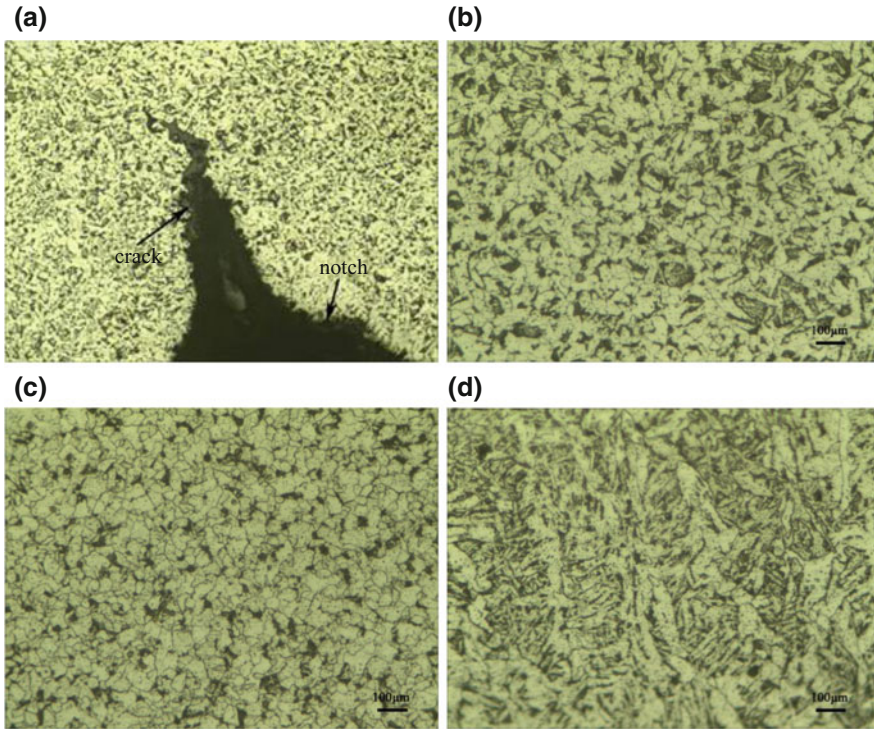
The observed result of 2# is crack formed in weld. Figure 7 shows the microstructure of the weld where the crack is located in. The microstructure of each layer in 2# is similar to 1# because of the same welding process. There is an obvious notch in the root weld according to Fig. 7a, which may be the result of excessive grind to the weld reinforcements after welding process. This notch destroyed integrity and consistency of the weld, leaving a local damage on the

surface and resulting in stress concentration [8], thus it will promote the original crack beside the notch extend to the weld with the comprehensive effect of flowing petroleum and natural gas in the pipeline, corrosion, etc. The crack originated from the weld root, then propagated irregularly and tortuously towards filling layer. In order to further investigate the crack propagation, a SEM observation was conducted. The result is shown in Fig. 8. It can be seen from Fig. 8a that the crack is located in the root layer and propagate irregularly and tortuously along a path shown in Fig. 8b. From Fig. 8c, there formed inclusion in the crack tip, and the inclusion has an effect on the crack propagation that the crack is arrested here. It can be speculated as the following views: firstly, ferrite can sustain some deformation [9] because of its excellent plasticity, then some stress can be released; secondly, as the inclusion has higher strength, the crack propagation can be effectively restrained.

**Fig. 7** Microstructure of the weld in 2#; **a** morphology of crack; **b, c, d** are microstructure of root layer, filling layer, and covering layer, respectively

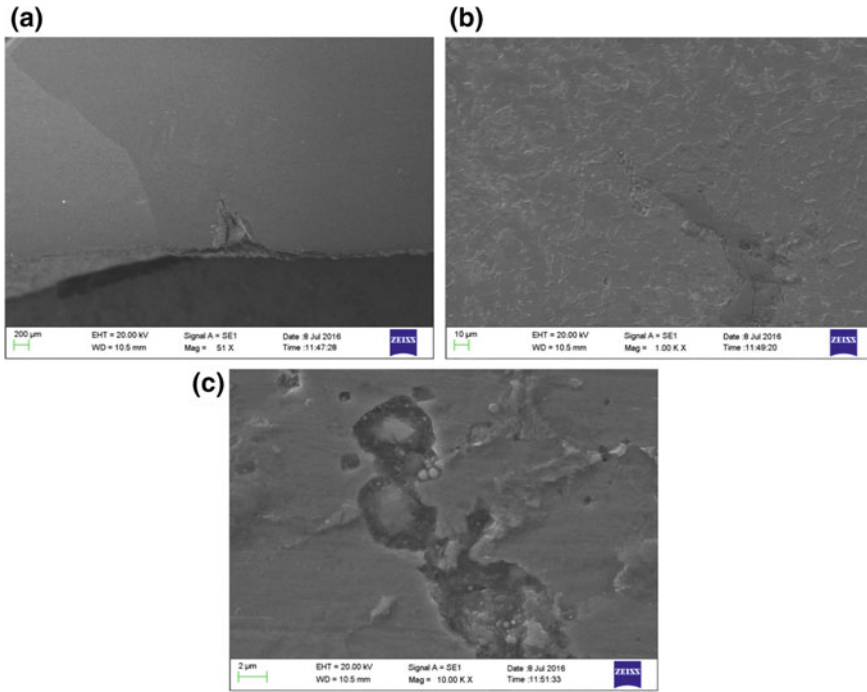
**Fig. 8** SEM observation results of 2#; **a** macroscopic characteristic of notch and crack; **b** crack propagation path; **c** crack tip in (b) with red circle

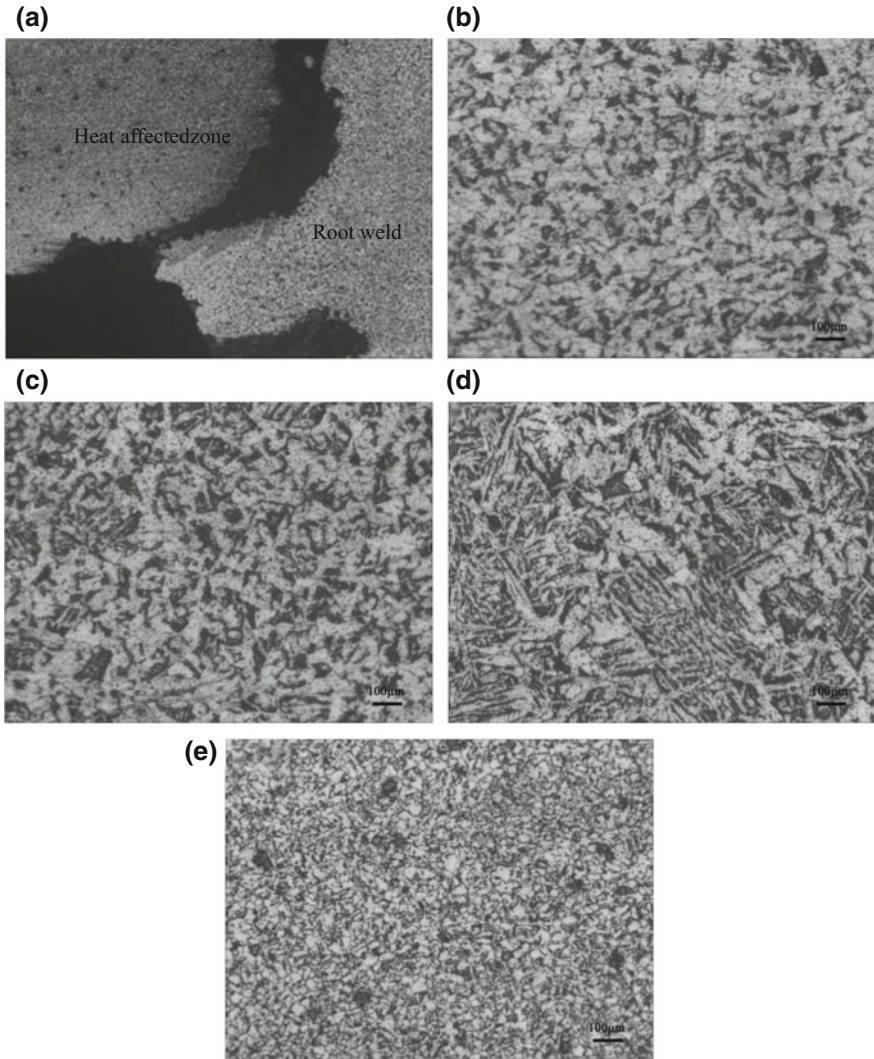
The microstructure of each layer of 3# is shown in Fig. 9. The observation results indicate that the microstructure is mainly ferrite and pearlite. Figure 9a shows that crack originates from the undercut area and propagate towards weld center along the fusion line. The main reason is that edge offset exceed the technological procedure, which increased stress concentration and prompted the crack initiation. Besides, the heat affected zone experienced most serious edge offset, contained most serious stress concentration, resulted in crack initiation and propagation under service environment. The crack width increased during propagation from fusion line to root weld center, and stopped at the filling layer. For one thing, the microstructure in heat affected zone refined a lot compared with root layer according to Fig. 9b, e; for another, although some stress was released, there were still stress concentration existed in the weld, and this prompted the crack propagated to coarse grain of root welding layer, then stopped with the comprehensive effect of some inclusion and ferrite as well as pearlite.

**Fig. 9** Microstructure of the weld in 3#; **a** crack initiation position and propagation direction; **b**, **c**, **d** are microstructure of root layer, filling layer, and covering layer, respectively; **e** microstructure of crack initiation position

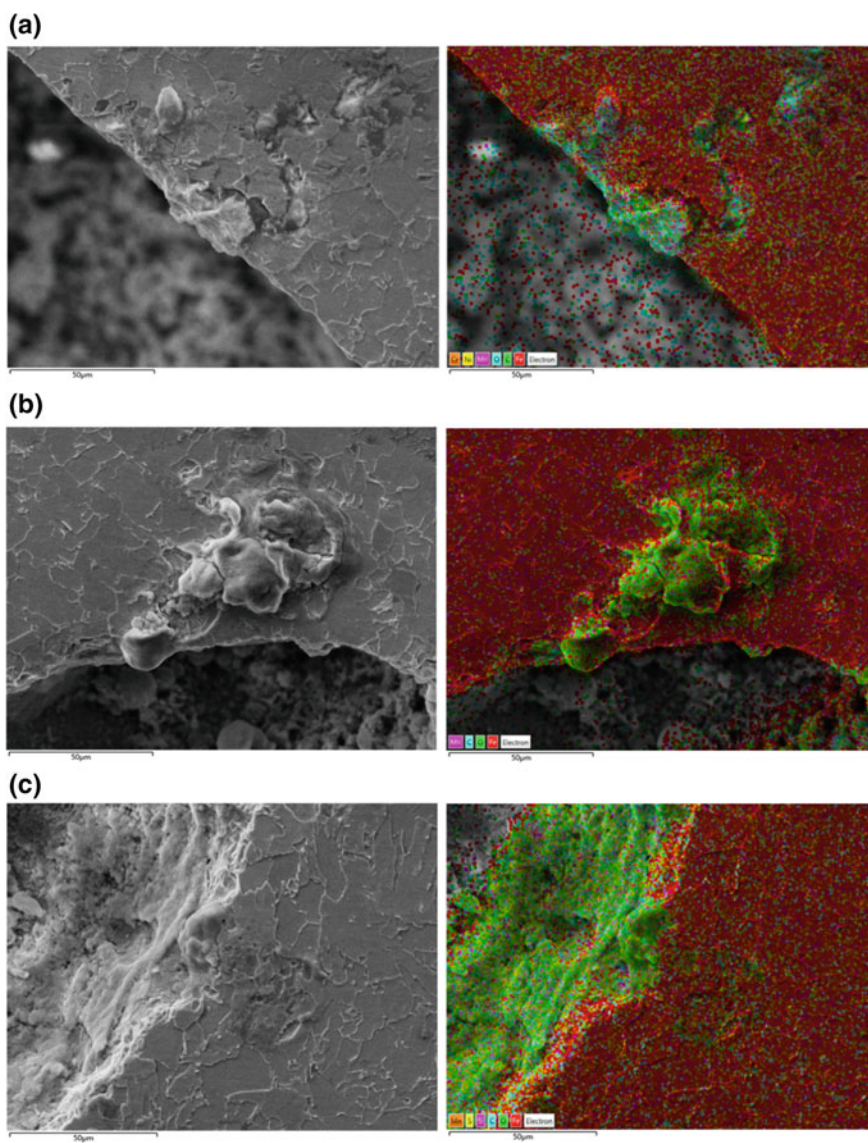
Figure 10 shows the surface scan result of porosity in 1#. The observation results show that there is more O element distributing along the crack edge alongside the porosity, which indicates that the crack may result from the oxide.

**Fig. 10** Surface scan result of porosity in 1#

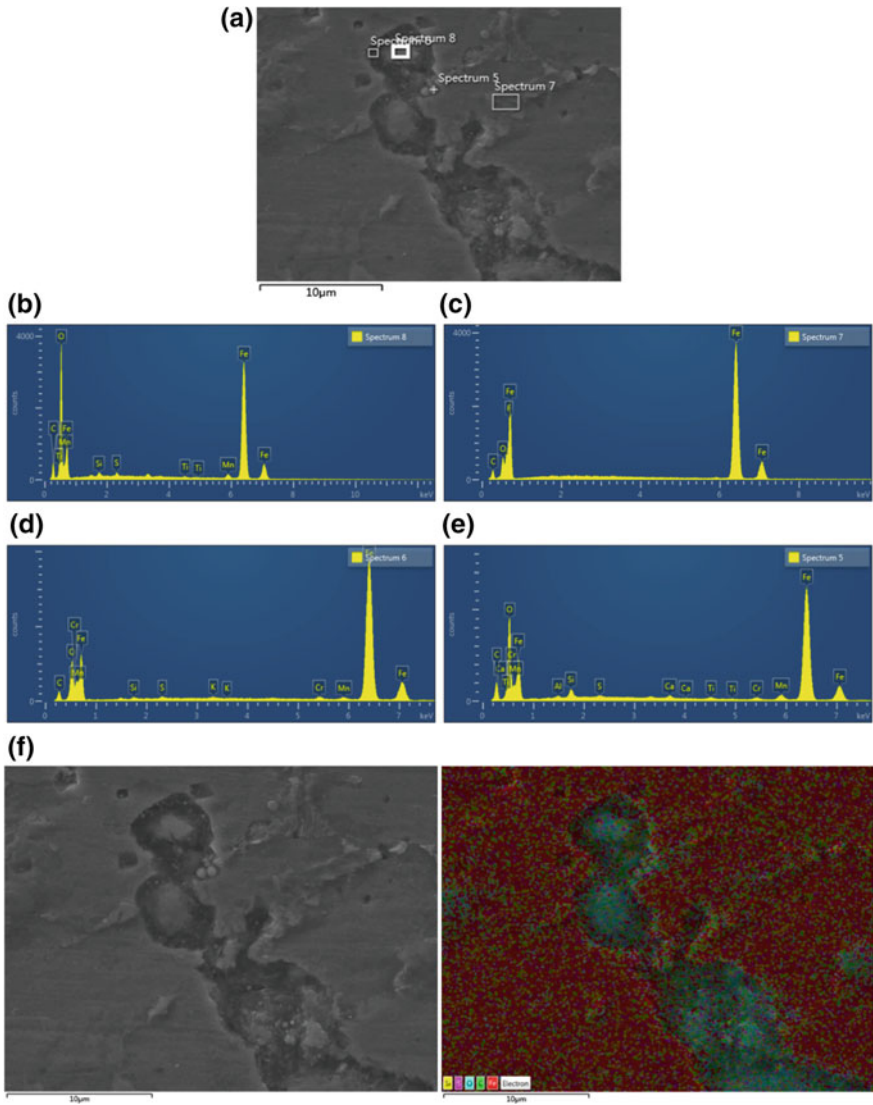
Figure 11 shows the point scan and surface scan results of crack in 2#. It can be concluded that element segregation is serious during welding process, and it is easy to form brittle inclusions [10]. On one hand, these brittle inclusions can not deform effectively to release stress; on another hand, they can also constrain crack propagation. Figure 11f shows the surface scan result of crack tip of 2#. It indicates that the beneficitation of C, S and O is serious.

Fig. 11 EDS analysis of crack tip in 2#

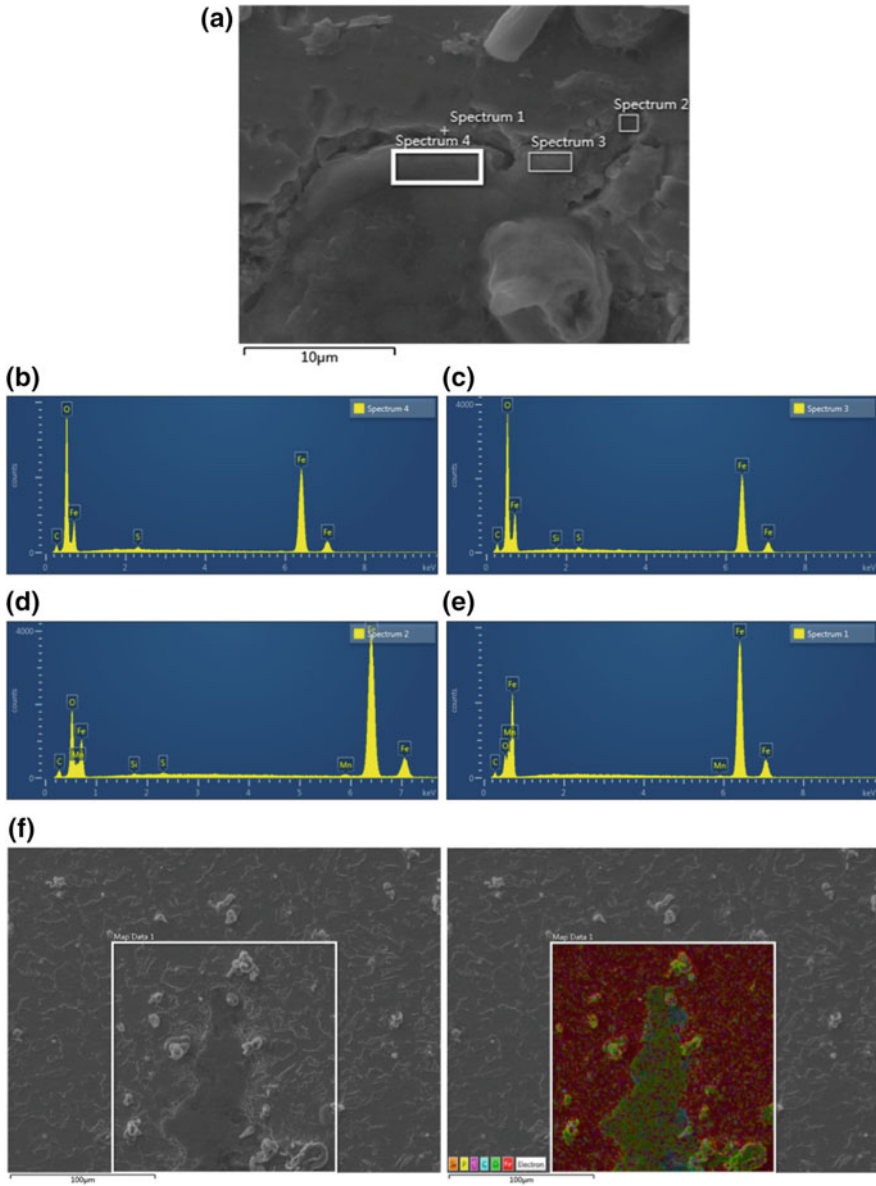
Figure 12 shows the point scan and surface scan results of crack tip in 3#. It is also a beneficitation of C, S and O elements. These two elements can easily form brittle inclusion together with Si, Cr, Mn, Ti. As an oxidation environment can significantly accelerates crack growth rates, rather than temperature alone [11]. So it is important to control those elements like O, S.

Fig. 12 EDS analysis of crack tip in 3#

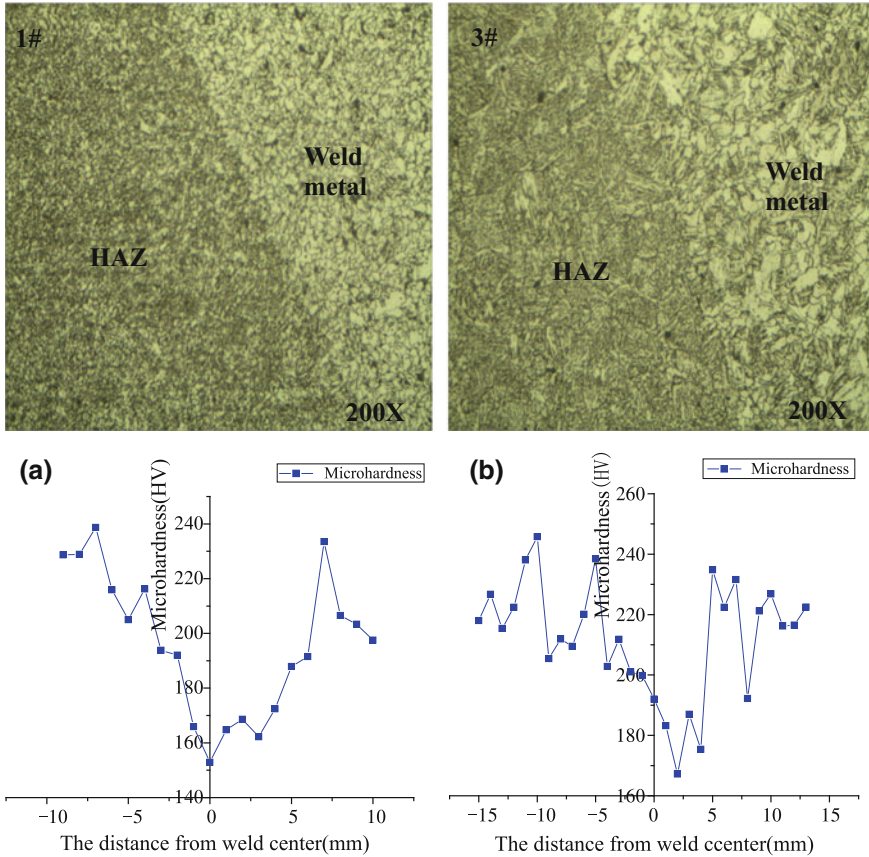
**Microhardness Analysis.** Microhardness test was conducted by tester HVD-2000TM/LCD at room temperature. 1# and 3# are selected for testing. As those defects are mainly distributed at filling layer, so the selected position is filling layer. The results are shown in Fig. 13. It can be clearly seen that the microhardness distribution is almost the same for the weldments with 1# and 3# that the

microhardness values in the weld are all lower than base metal. The grain size in the weld is more coarse than heat affected zone and base metal, leading to a lower microhardness value in the weld. So it is important to control the grain size by controlling heat input and interpass temperature during welding process.

Fig. 13 Microhardness profile; a 1#; b 3#
