# Chapter 12

## Forensic Evaluation of Long-Distance Flow in Gently Sloped Ground During the 2018 Sulawesi Earthquake, Indonesia

Hemanta Hazarika, Divyesh Rohit, Takashi Kiyota, Mitsu Okamura, Siavash Manafi Khajeh Pasha, and Sukiman Nurdin

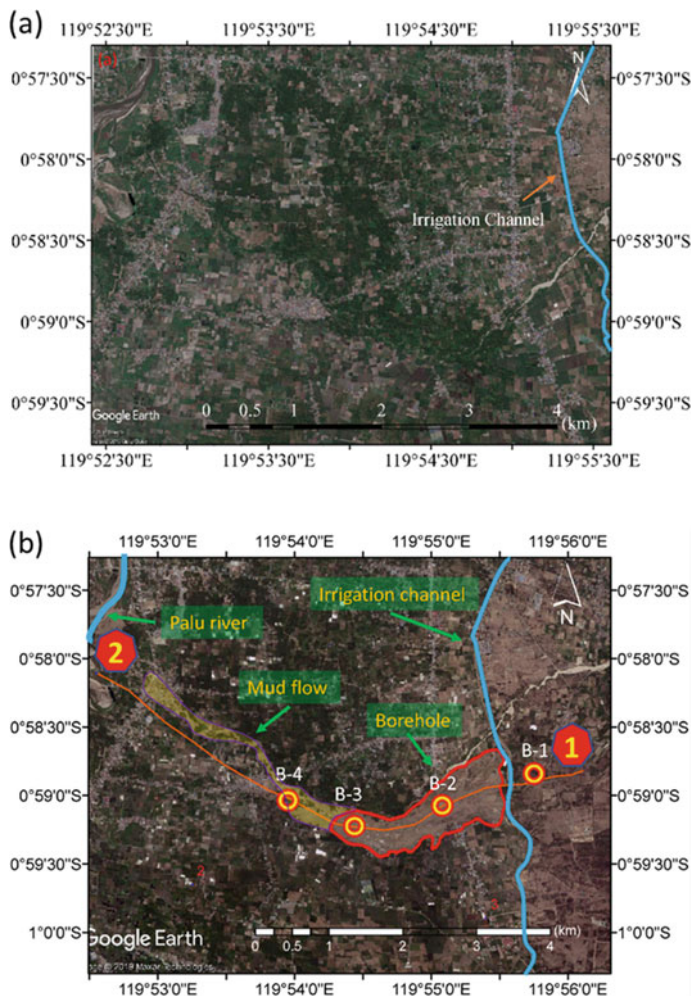
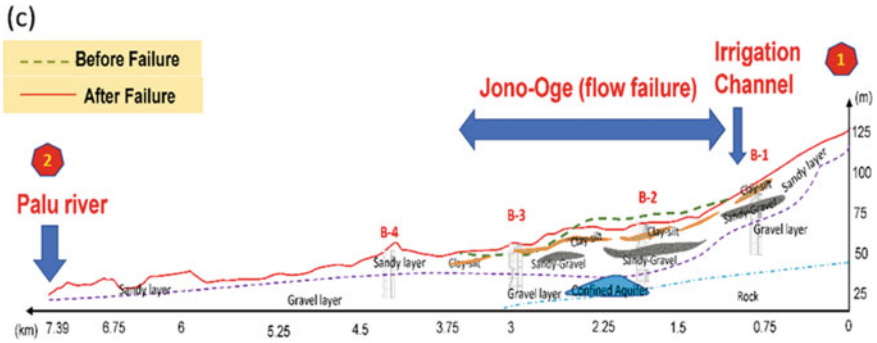
The flow-slide at Jono Oge was the longest with respect to the debris flow and ground movement among all the flow-slides, which were triggered due to the 2018 Sulawesi earthquake. The origin of the flow-slide was observed at the crown, just besides the irrigation channel in eastern edge of Palu Valley (Fig. 12.5). The flow-slide was spread over an area of 1.5 km<sup>2</sup> of area with maximum displacement of 2 km. (Hazarika et al. 2020). The location of flow-slide was at the bottom of alluvial fan created at the valley mouth in the space between old alluvial fans with gentle gradient, low elevation and shallow groundwater table (Kiyota et al. 2020). The flow-slide damaged approximately 500 units of houses in the area with many being swept away or buried under the soil. It should be noted that 90% of the flow-slide area was utilized for agricultural activities. Shallow groundwater table and subsurface water in the overlying sandy layers, due to the presence of irrigation channel, probably would have aggravated the weak ground conditions and contributed significantly to the extensive flow-slides stretching over a few kilometers.

**Fig. 12.5** Satellite imagery and ground profile of Jono Oge area **a** before earthquake, **b** after earthquake and **c** cross section at profile 1–2 (Hazarika et al. 2020)

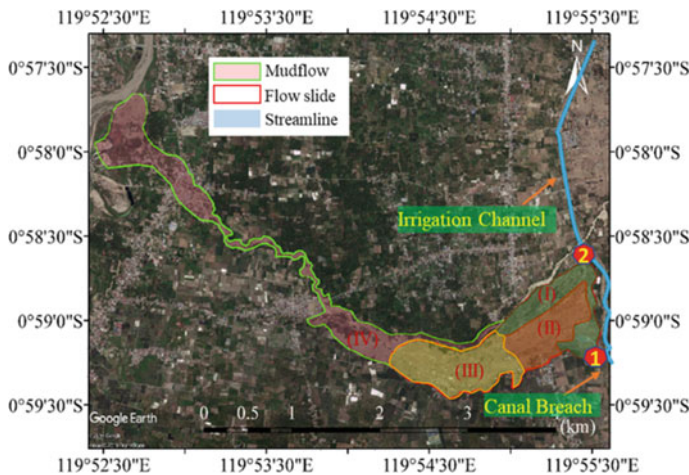
Based on the observations made by Hazarika et al. (2020), the flow-slide profile in Jono Oge is categorized into four zones (I, II, III and IV) according to ground movement mechanism, surface features and maximum displacement (Fig. 12.6).

Zone I includes the crown or head scarp, which extends from northeast side of failure zone (parallel to the western boundary of irrigation channel) to the south-eastern side of failure zone where it meets the channel. The overlying soil strata of the main scarp were highly stratified with an alternating layer of sand, silt and organic soil as seen in Fig. 12.7a which implies the area was a wetland at the lower end of the old fan (Kiyota et al. 2020). This zone also is characterized by scouring and erosion of surface sediments due to the breach of irrigation channel which discharged large volume of the water (Fig. 12.7b). The maximum displacement of soils in this zone ranges from 2 to 50 m.

Fig. 12.6 Flow-slide area categorized into zones based on ground displacement in flow-slide area (Hazarika et al. 2020)

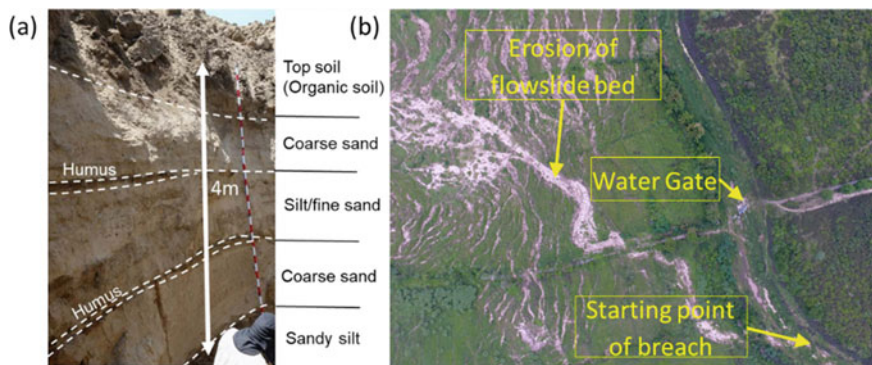
**Fig. 12.7** **a** Soil stratification observed at the crown (Kiyota et al. 2020) and **b** UAV imagery of channel breaching and water gate destruction in Zone I (Hazarika et al. 2020)

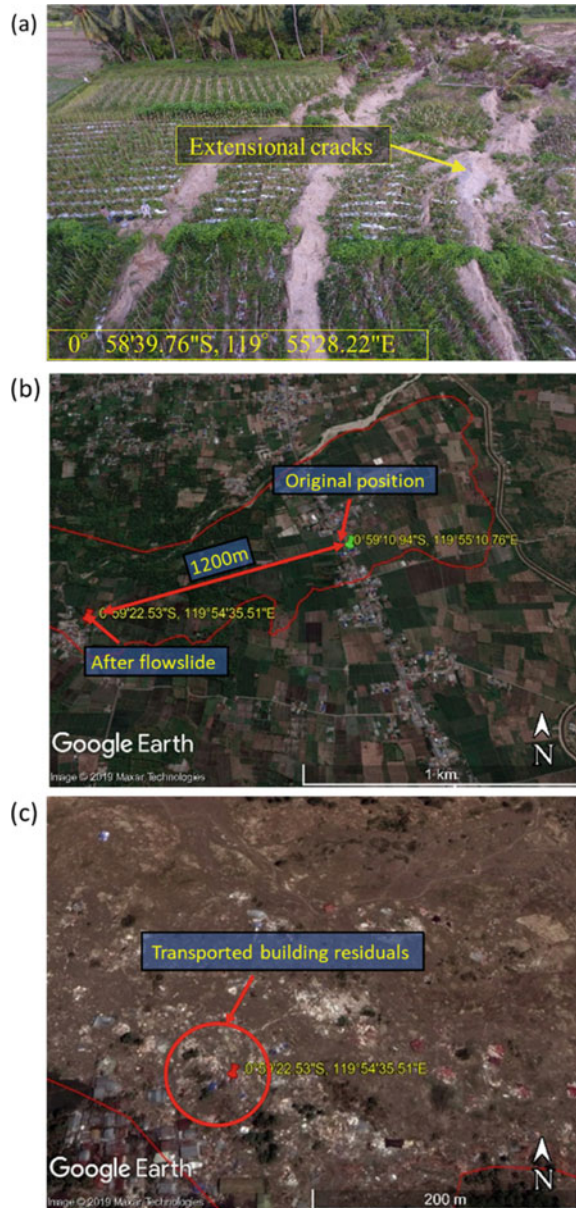
Zone II, where the flow-slide initiated after the onset of possible liquefaction in the sandy and sandy-silty layers below the ground surface, was the surface soil layers started moving toward the southwest direction of failure zone. The surface features show large extensional cracks with drastic change in soil morphology (Fig. 12.8a). Figure 12.8b shows the displacement of a house which moved approximately 1200 m due to the flow-slide. The maximum displacement in this region varies from 300 to 1300 m. The residuals of the displaced house after the cease of flow-slide can be seen in Fig. 12.8c.

Zone III is the region, where most of the disaster debris, including house rubbles and uprooted trees, got deposited. As shown in Fig. 12.8b, the debris of the structures and mudflow from Zone II piled up in the Zone III.

**Fig. 12.8** Zone II **a** surface deformation with extensional cracks, **b** displacement of house structure from Zone II to Zone III due to the flow-slide and **c** residues of the displaced house after the flow-slide (Hazarika et al. 2020)

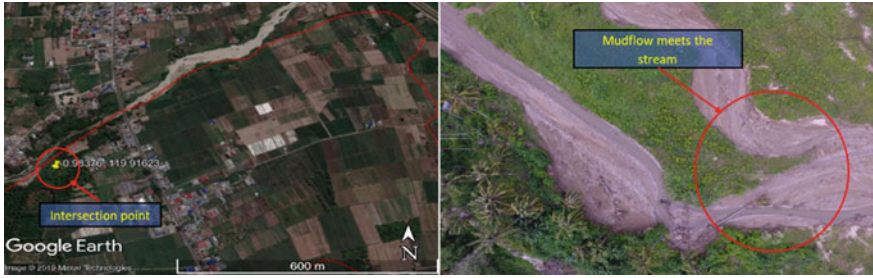
Zone IV is located at the toe of the flow-slide and close to Palu River. The breached irrigation channel in Zone I discharged huge amount of water, which then flowed into Zone IV along with the debris. This debris flow which then confluence the stream flowing on the west bank of the flow-slide and finally ended up flowing into the Palu river (Fig. 12.9).

**Fig. 12.9** Intersection of mudflow and stream (Hazarika et al. 2020)

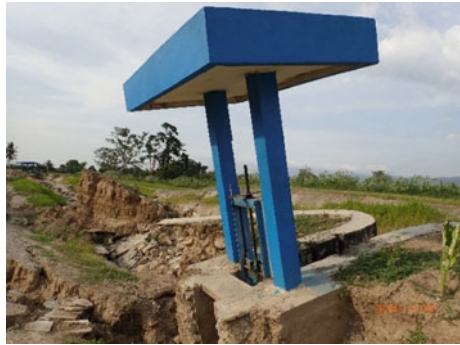
The ground motion caused damage to housing, transportation and irrigation structures. The damage due to flow-slide in Jono Oge was further aggravated due to the breach of irrigation channel, as shown in Fig. 12.10, which shows the completely dry state of the channel. According to eyewitness, the embankment of the irrigation channel breached 2 min after the earthquake, which implies that the damage to the embankment of irrigation channel was not caused by the earthquake motion, but it might have been caused by the dragging force due to flow-slide.

**Fig. 12.10** Damage to irrigation channel and control gate in Jono Oge

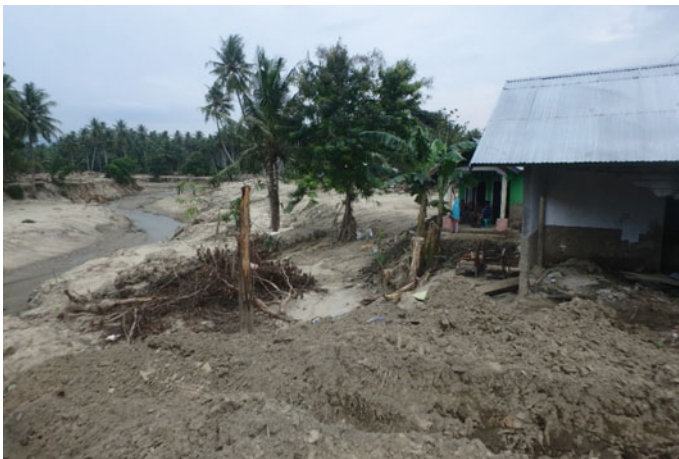
According to another eyewitness, living near the downstream of the flow-slide, after the ground motion ceased, the thick mud water flowed down for approximately an hour, and the houses along the river bank were inundated with the mud and debris, as shown in Fig. 12.11. From the mud inundation mark on the houses, it could be deduced that the height of mudflow at the downstream area was about 7 m above the current river water level. It is to be noted that such mud slide was not observed in other areas, such as Petobo and Sibalaya, where similar damage occurred in the irrigation channels. The origin of the water that caused the flood in Jono Oge could be attributed to a confined aquifer beneath the affected area of flow-slide (Kiyota et al. 2020).

**Fig. 12.11** Mud inundation mark on the house depicting the height of mud flow passing the area (Kiyota et al. 2020)

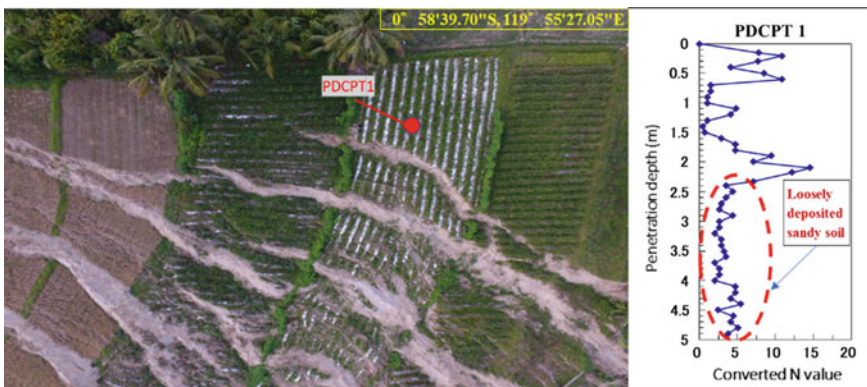
Figure 12.13 represents the plot for converted  $N_{SPT}$  value versus depth for PDCPT1 at the location, which is outside the failure zone, far from extensional cracks. As observed in Fig. 12.13, there is a decrease in the  $N$  value for the soil layers below 2.5 m, indicating the presence of loose liquefiable layers. The risk of liquefaction is also high due to the presence of groundwater table at a shallow depth (water level at the time of testing G.W.L = 2.3 m). Furthermore, to correlate the soil lithology at location PDCPT1, a pictorial image of the cliff nearest to the extensional crack is shown in Fig. 12.14. As shown in Fig. 12.14, the overlying layer consists of 10–20 cm of organic soil, followed by 30–40 cm of clay and silty clay layer, while the underlying 10–20-cm-thick silty sand layer is sandwiched between the upper clayey layer and lower 10–20-cm-thick clayey silt layer.

Fig. 12.13 PDCPT conducted near the crown of flow-slide and the test result (modified from Hazarika et al. 2020)

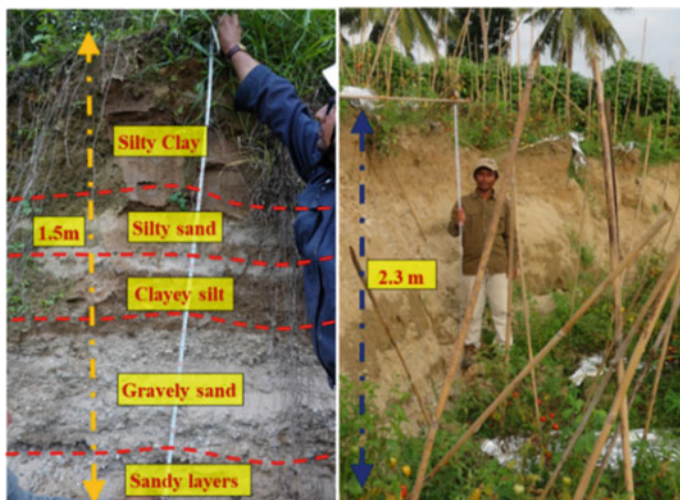
**Fig. 12.14** Profile of exposed soil layer due to the extensional cracks near PDCPT1 (Hazarika et al. 2020)

Furthermore, beneath the silty layer, there were several layers of sandy and gravelly sand, which appeared to be influenced by probable liquefaction in the underlying layers (Hazarika et al. 2020).

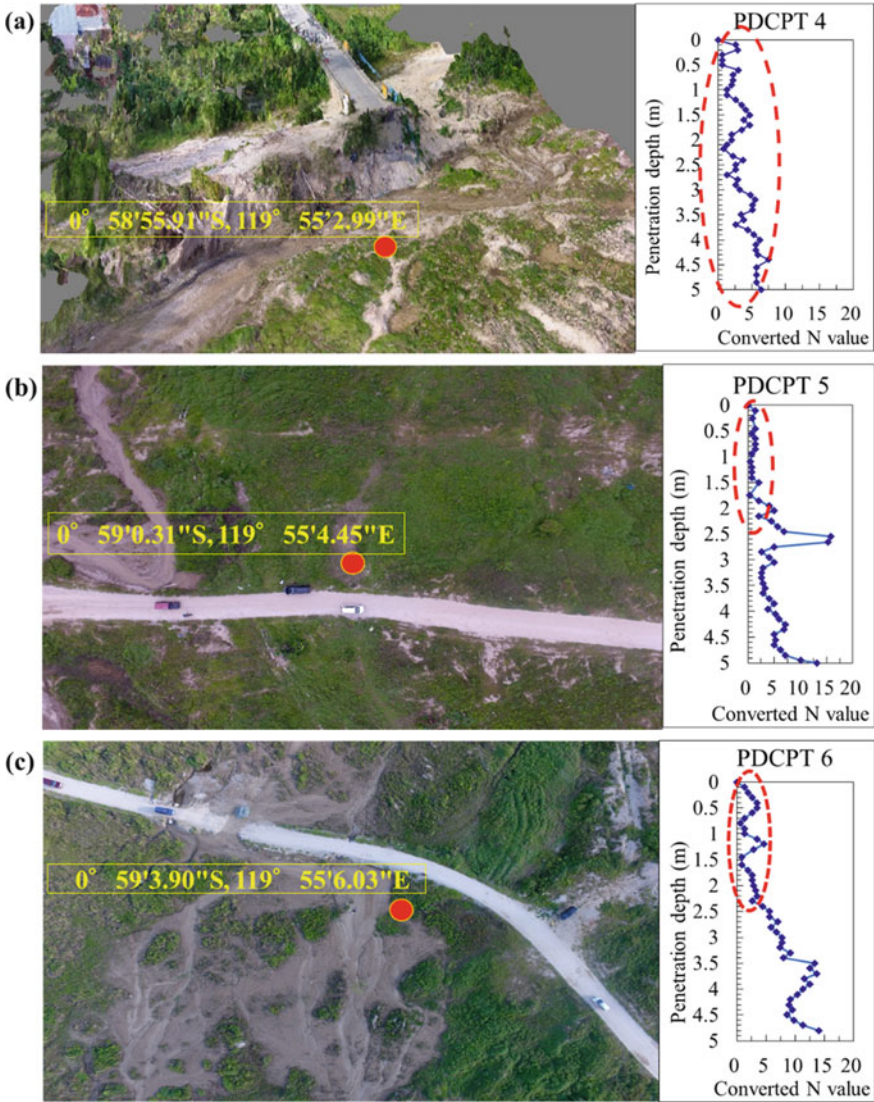
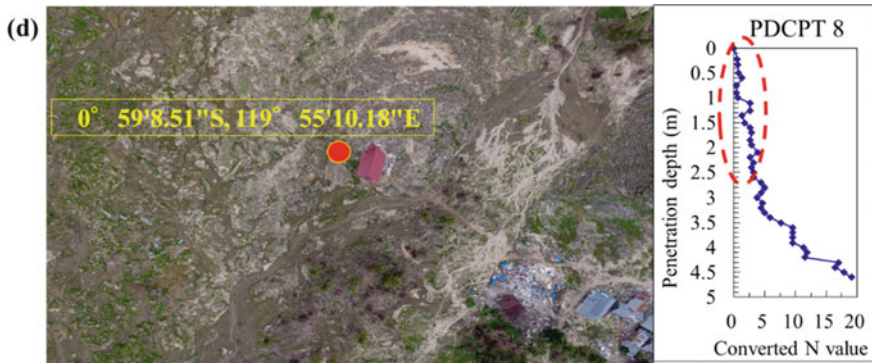
The PDCPTs 4, 5, 6 and 8 were conducted alongside the damaged road as discussed before in Fig. 12.13. PDCPT4 was conducted beside the collapsed bridge near the stream (Fig. 12.15a). PDCPT5 was conducted within the flow-slide Zone (I) near the reconstructed road as shown in Fig. 12.15b. PDCPT6 was conducted in the Zone (II) alongside the reconstructed road as depicted in Fig. 12.15c. PDCPT8 was conducted few meters away from the red house which experienced no displacement during the flow-slide (Fig. 12.15d). The results of the PDCPTs conducted are converted in terms of SPT N values and are plotted alongside the locations of the tests (Fig. 12.15a–d). Here, in Fig. 12.13a, the overall soil profile up to the depth of 5 m shows weak soil, and this was due to its presence near the river, where the bridge collapsed during the earthquake. As seen from the test results, the N values for all the locations are less than 10 up to a depth of 2.5 m which signifies very loose to loose soil below the ground surface. It can be observed in PDCPT 8 that the soil below 4 m is of medium strength as against those observed in PDCPTs 4, 5 and 6. The deposits at the PDCPT locations are believed to be loosely deposited sand and silty sand layers which were carried over from the upstream of flow-slide region (Hazarika et al. 2020).

The red house shown in Fig. 12.15d was the only structure that did not move from its original location, as compared to all other structures in the flow-slide region. This could be attributed to the massive mat foundation over which the house was built. The self-weight of the mat foundation along with the house restrained its

**Fig. 12.15** Aerial imagery of PDCPT locations and converted SPT N value versus depth (modified from Hazarika et al. 2020)

lateral displacement even though some structural elements of the house were partially damaged due to the impact of debris. Figure 12.16 displays the aerial view of the unmoved red house along with other houses, which moved from few meters to few hundred meters.

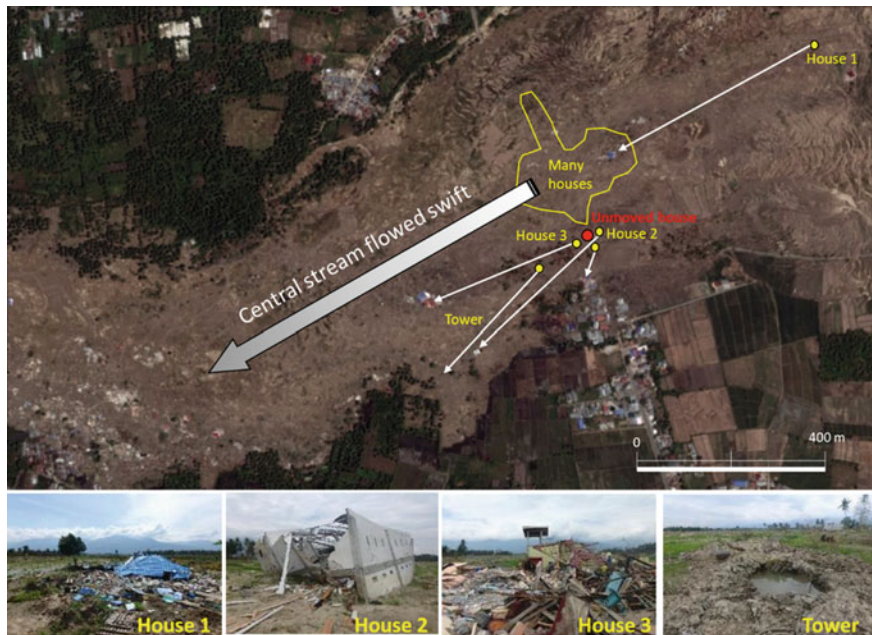
Fig. 12.16 Displacement of housing structures in the flow-slide zone in Jono Oge (Kiyota et al. 2020)

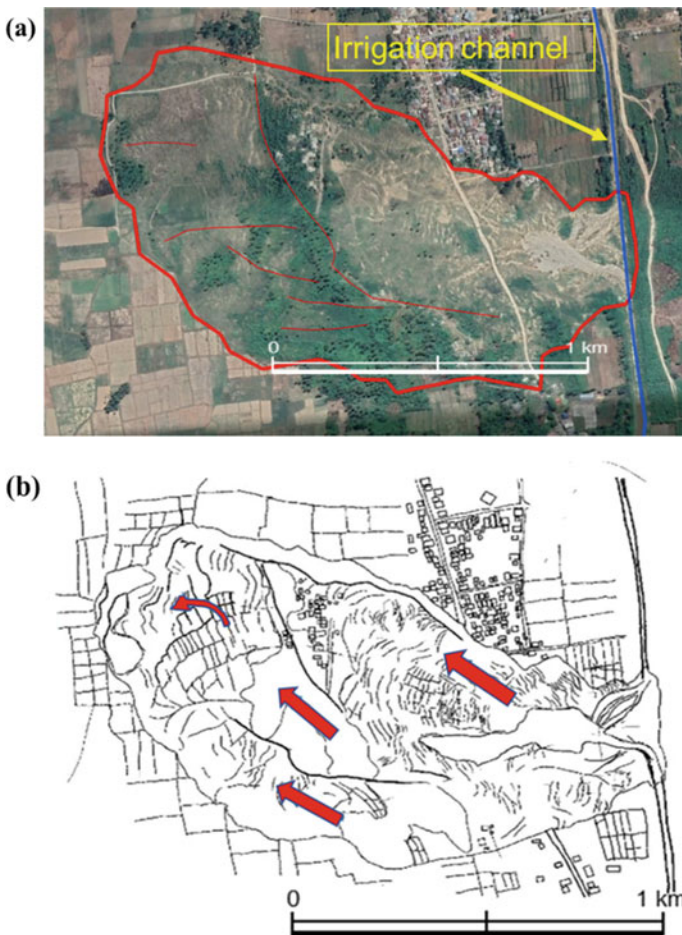
**Fig. 12.17** Flow-slide at Sibalaya, **a** area after the earthquake as captured by the UAV and **b** ground movement during the flow-slide in different zones (Kiyota et al. 2020)

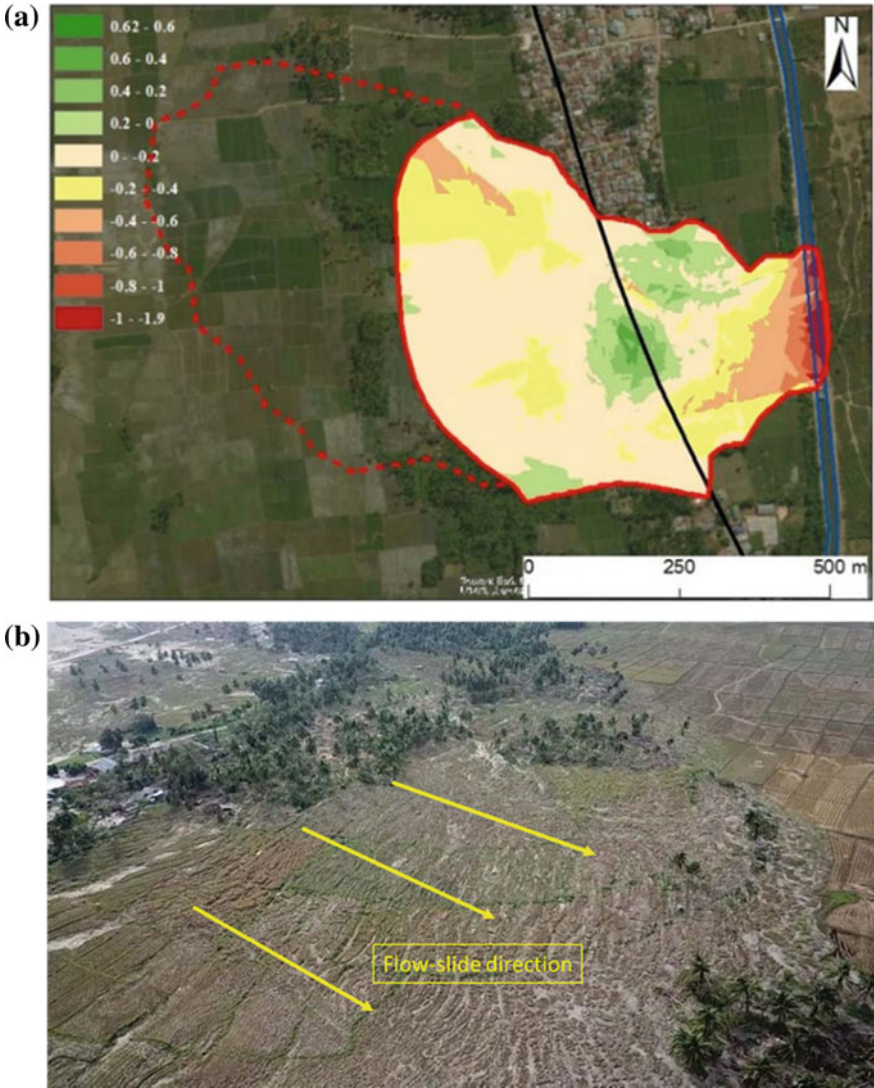
The normal strain contour map of the ground movement shown in Fig. 12.18a provides a quantitative description of overall ground displacement characteristic. As

**Fig. 12.18** Sibalaya flow-slide region: **a** normal strain in east–west direction,  $\epsilon_{x'}$ , and **b** flow-slide direction and extensional cracks in downstream zone (Okamura et al. 2020)

observed from the figure, extremely large tensile strain is generated in the narrow zone of the upstream region. Similarly, in the upstream region (paddy fields), which is just below the crown or main scarp, the tensile strain ranges from 20% to 60%. In this zone, all the houses and roads, along with paddy fields and trees, were displaced by about 350 m. In contrast, the tensile strain is relatively small in the area between the upstream and downstream paddy fields, including the original road that

was passing through this area, and compressive strain was observed (Okamura et al. 2020). Here, the negative tensile strain implies that the ground moved downstream from its original position causing extensional cracks, while the positive tensile strain relates to the compression of existing soil surface due to thrust from accumulating or depositing soil mass from upstream. The aerial view of flow-slide direction showing the extensional cracks in the downslope region of the flow-slide is shown in Fig. 12.18b.

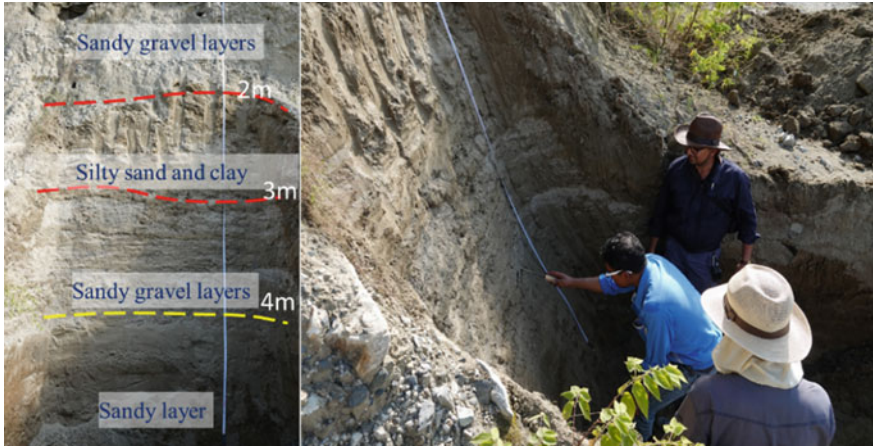
To understand the geological profile of the failure zone, multiple trenches were excavated in Sibalaya to examine the soil lithology and arrive at probable cause of the failure. Figure 12.20 shows the soil profile from one such trench located within the failure zone (refer Fig. 12.17a). As shown in Fig. 12.20, the subsurface soil lithology is highly stratified with layers of sandy gravel, silty sand and clay, sandy gravel and sandy soil. The silty sand and clay layer, which is sandwiched between

sandy gravel layers, is assumed to be the cause of failure by trapping the excess pore water pressure developed during the ground motion and thereby destabilizing the underlying sandy layers.

Fig. 12.20 Soil profile observed near the main scarp of failure in Sibalaya

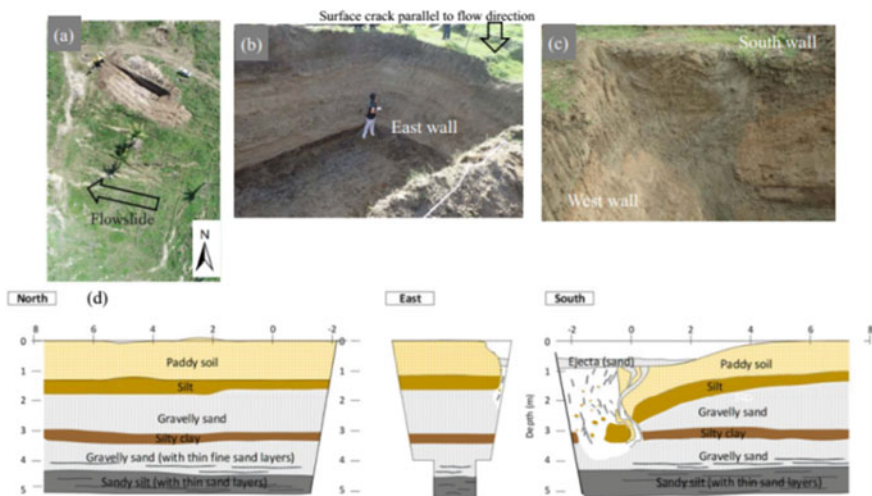
Figure 12.22a–d shows the images of the excavated Trench #1 as well as soil stratification. Figure 12.22a shows the aerial view of the excavated trench, while

**Fig. 12.22** Details of Trench #1 at Sibalaya. **a** Aerial photograph, **b** north and west walls in the trench, **c** southeast corner in the trench and **d** sketch indicating stratification of soil layer exposed on the walls (Okamura et al. 2020)

Fig. 12.22b, c shows the faces of east wall and west wall of the trench. The sketch of the north, east and west walls of the trench, depicting the soil profile, is shown in Fig. 12.22d. The trench was located upstream, about 150 m downslope of the irrigation channel. The longitudinal axis of the trench was oriented parallel to the flow-slide direction. In Fig. 12.22d, the gravelly sand layer underlying the surface layers is confined by multiple sand and sandy gravel layers of 10–30 cm thick, with some sandwiched silty sand layers, whose thicknesses are of the order of 10 cm. In the south wall, the surface of gravelly sandy layer sinking toward the southeast corner implies the potential liquefaction of this layer during the earthquake. Beneath the gravelly sand layer, there exists a thin stiff silty clay layer that separates the two gravelly sand layers, which seemed to be intact except at the corners. The underlying gravelly sand layer was mostly uniform, with only a few thin interlayers near its bottom. It has been observed that, in all the exposed walls, the typical configuration of non-liquefied gravelly sand layer was a stack of sand and sandy gravel layers in every 10–30 cm, with thin silty sand layers having thicknesses of the order of 10 cm sandwiched in between. This implies the potential liquefaction of both the upper and lower gravelly sand layers, resulting in shearing, which was observed in the lower gravelly sand layer.

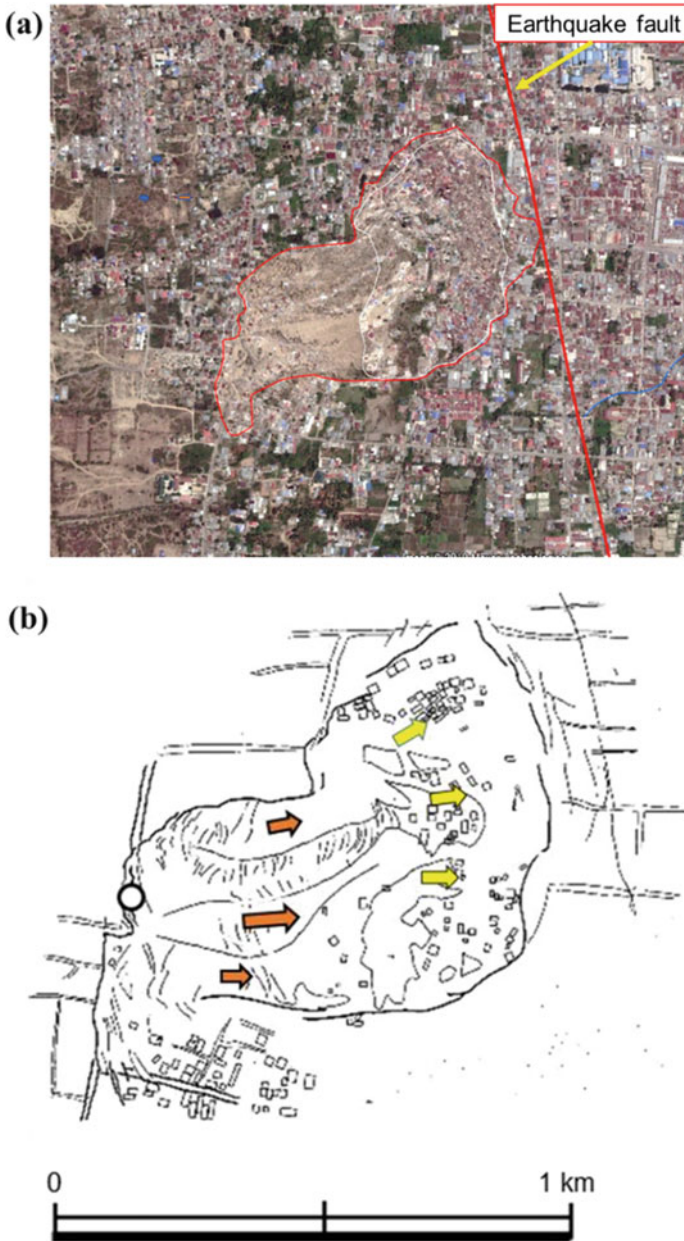
A satellite image of Balaroa flow-slide area after the earthquake is shown in Fig. 12.24a, while the ground movement direction denoted by arrows is shown in Fig. 12.24b. The soil profile at the crown was found to be coarse sand deposit of thickness 3–4 m which was covered under debris of granite boulders. Sand ejecta from the lower layers were found in the surface layer which was covered from the upstream debris. A significant amount of ground subsidence was found near the crown of the flow-slide, while most of the overlying soil and structures moved in the east direction forming large tensile cracks. The ground subsided by an average depth of 3–4 m in the upper region of the flow-slide, while in the lower region, the ground was uplifted by 5 m, which could have been due to the accumulation of soil blocks and structural debris. Unlike Jono Oge and Sibalaya, Balaroa was a densely populated area, where around 1300 units of houses were destroyed. The presence of

**Fig. 12.24** Flow-slide in Balaroa area: **a** satellite image and **b** the direction of ground movement (Kiyota et al. 2020)

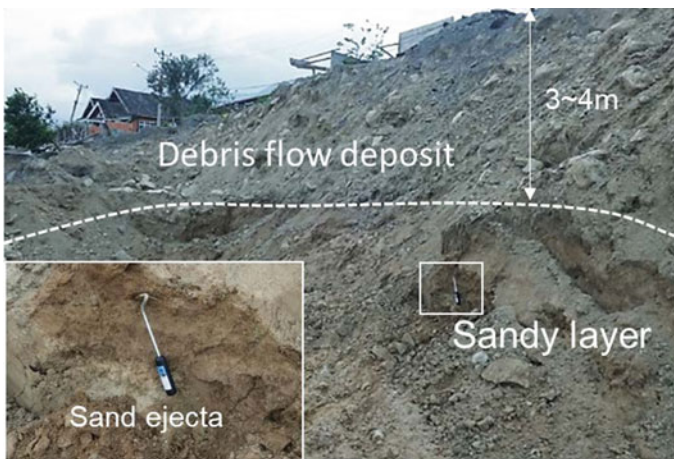
**Fig. 12.25** Soil profile observed at the crown (Kiyota et al. 2020)

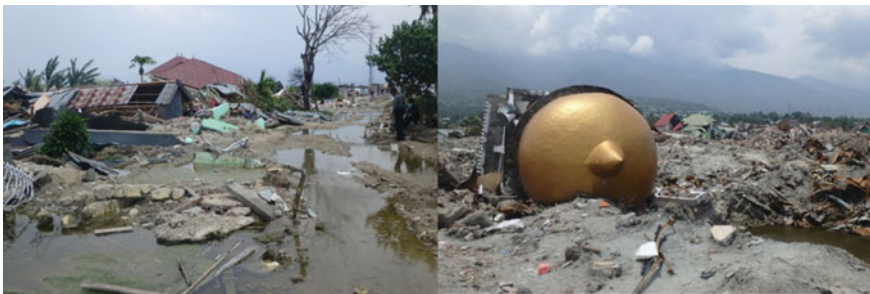
Multiple eyewitness accounts describe the movement of ground in the form of fluidized flow downhill, carrying along the houses and mosques (Fig. 12.26) with it. Also, a clear evidence of sand ejecta on the ground surface was found during the survey, and that confirmed the authors' hypothesis that liquefaction took place in the underlying soil layers (Fig. 12.27).

**Fig. 12.26** Inundation of water after the earthquake and destroyed mosque structure due to the flow-slide (Kiyota et al. 2020)

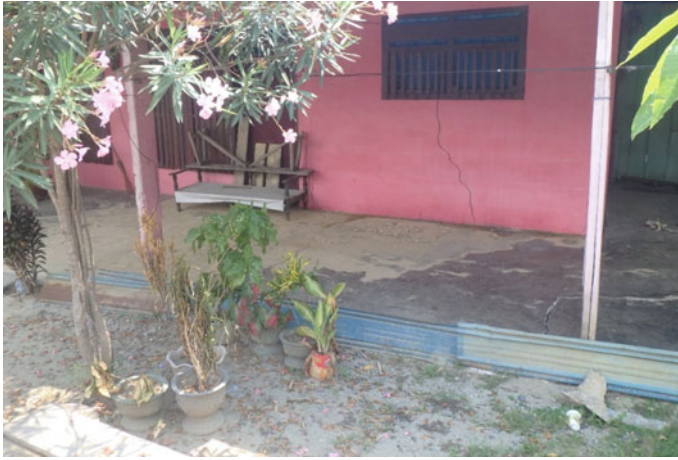
**Fig. 12.27** Sand ejecta observed in the upper part of the flow-slide (Kiyota et al. 2020)

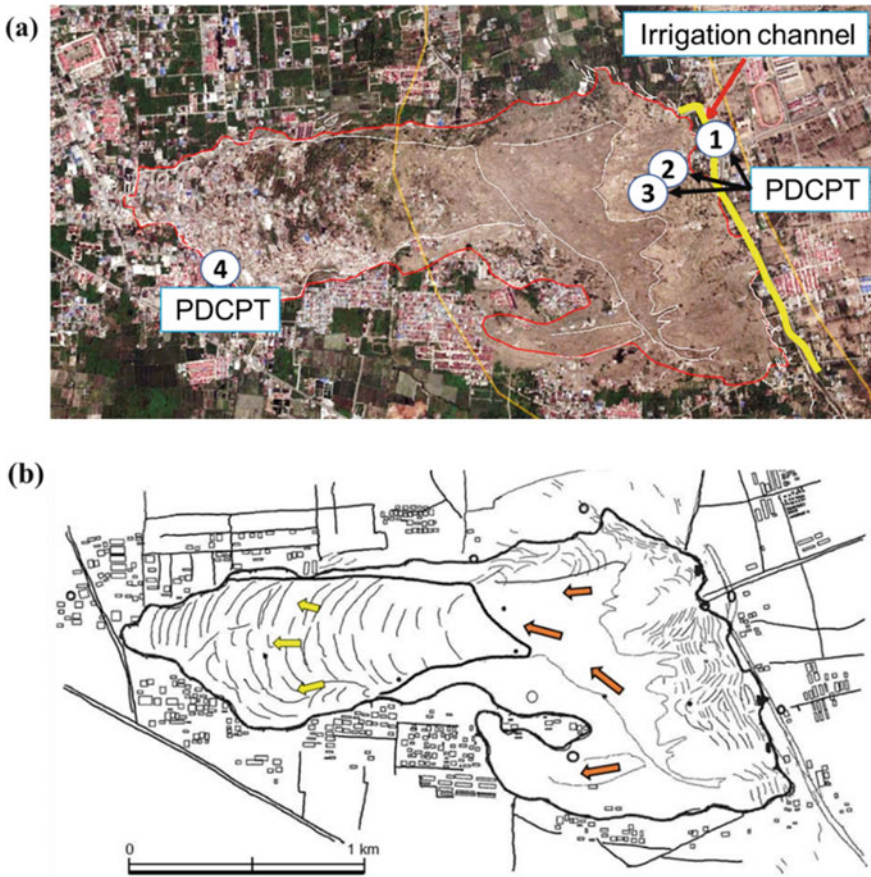
**Fig. 12.28** Petobo area after the earthquake: **a** satellite imagery after the earthquake along with the location of PDCPTs ①~④ (Google Earth, 2018) and **b** ground displacement during the flow-slide shown by arrows (Kiyota et al. 2020)

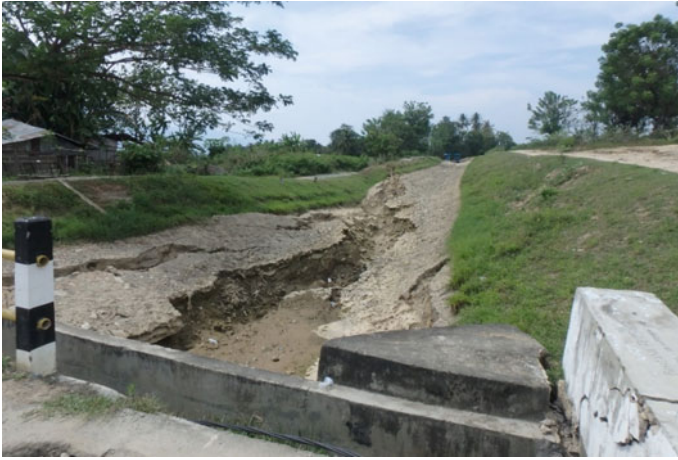
In this subsection, assessment of the damage, based on the survey conducted by the research team of the University of Tokyo, is described. Petobo is located on the west side of Palu Valley. It had a flow-slide area of about 180 ha. The watershed area of the failed region is approximately 14 km<sup>2</sup>. The ground failed at the bottom of alluvial fan formed near the valley mouth. Figure 12.28a depicts an aerial image of the post-earthquake flow-slide zone in Petobo, using Google Earth along with the locations of the PDCPTs ①~④ conducted in the area. The ground displacement vectors during the flow-slide can be seen in Fig. 12.28b. The ground inclination of the failed site was very gentle (2–3%). Similar to Jono Oge and Sibalaya, Petobo also had an irrigation channel passing directly above the flow-slide area, which was damaged (Fig. 12.29). The water from irrigation channel disappeared after the earthquake. The ground movement in this area occurred mainly in two directions, as evident from Fig. 12.29.

**Fig. 12.29** Damage to the embankment of irrigation channel (Kiyota et al. 2020)

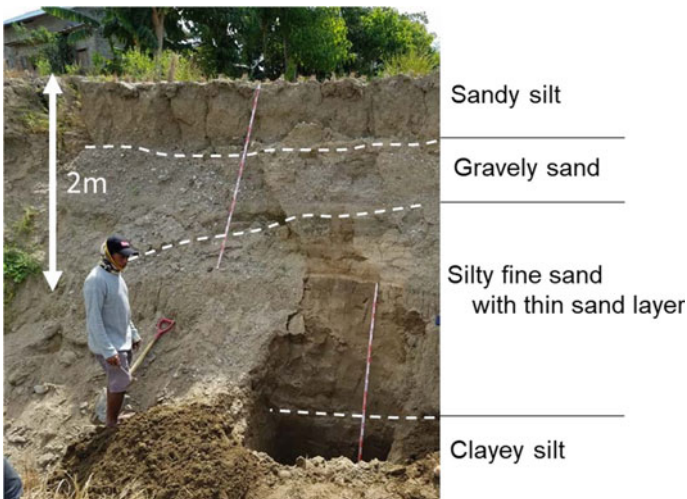
The surface soil profile at the crown shown in Fig. 12.30 depicts the presence of alternating layer of silty sand and gravelly soil, which runs parallel to the ground surface. The soil deposits shown in Fig. 12.30 are assumed to be from the deposits caused by flow-slide. Similar to other flow-slide sites, many tensile cracks were observed in upstream slope of the flow-slide in Petobo. The ground elevation was found to be lowered by an average of 5 m.

**Fig. 12.30** Soil profile observed at the main scarp of flow-slide in Petobo (Kiyota et al. 2020)

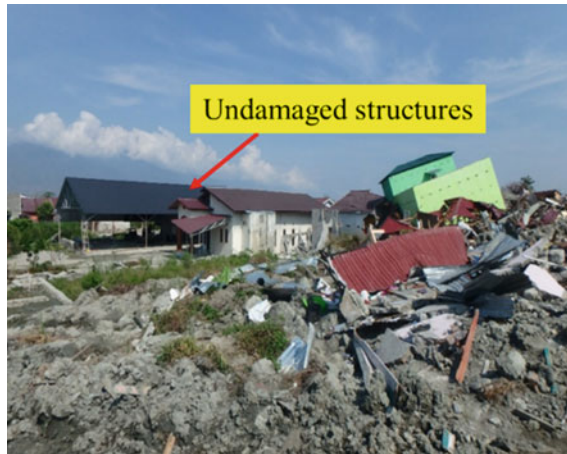
not damaged, as shown in Fig. 12.31, where undamaged structure stands near the damaged structure. Housing structures which moved downstream were buried by thick soil mass and other debris (Fig. 12.32). As observed in Balaroa, the presence of surface flow of water due to formation of small springs was seen in Petobo too. Additionally, similar springs were found in the downstream sedimentation zone, which experienced about 5 m increase in its elevation, probably due to compressive strain from surrounding soil. The presence of springs at the site implies the presence of a confined aquifer (artesian water) below the ground surface. Similar to Balaroa, in Petobo too sand ejecta were observed.

**Fig. 12.31** Damaged and undamaged structures (Kiyota et al. 2020)

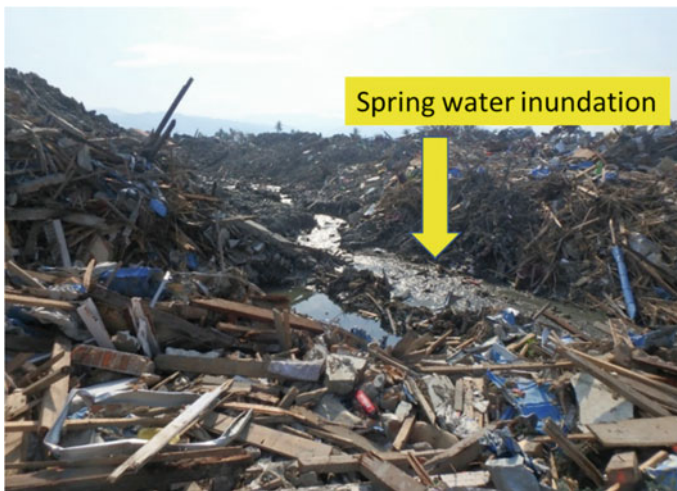
**Fig. 12.32** Spring water inundation on the ground surface (Kiyota et al. 2020)

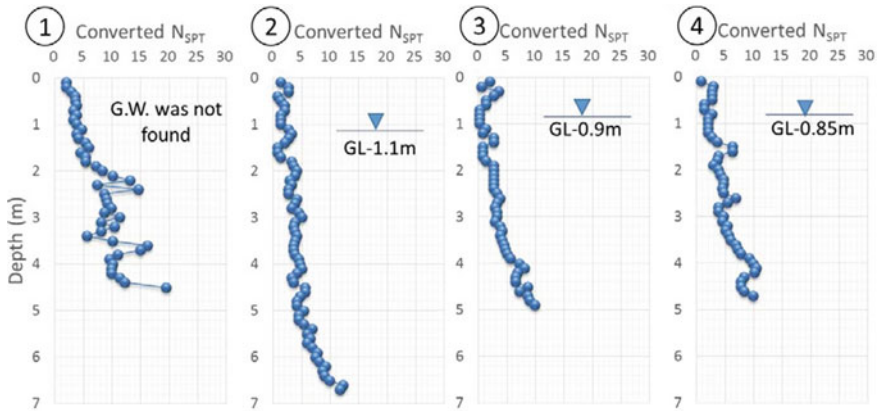
As described before in Fig. 12.28a, PDCPTs ①~④ were performed in and around the flow-slide zone to evaluate the subsoil strength and condition. It is to be noted that the sand ejecta were found near PDCPT nos. ②, ③ and ④. As shown in Fig. 12.33, the subsoil condition was weak with  $N_{SPT}$  values for the PDCPT that are small which implies very weak soil deposits. It can be inferred that a combination of weak soil and shallow groundwater with artisan pressure led to the occurrence of liquefaction due to the earthquake.

**Fig. 12.33** Converted  $N_{SPT}$  values from PDCPT performed at Petobo (Kiyota et al. 2020)
