Assessment and Retrofitting Augmentation Methods of Seismic Performance on Existing RC Buildings Across India

Ankeeta Karmakar

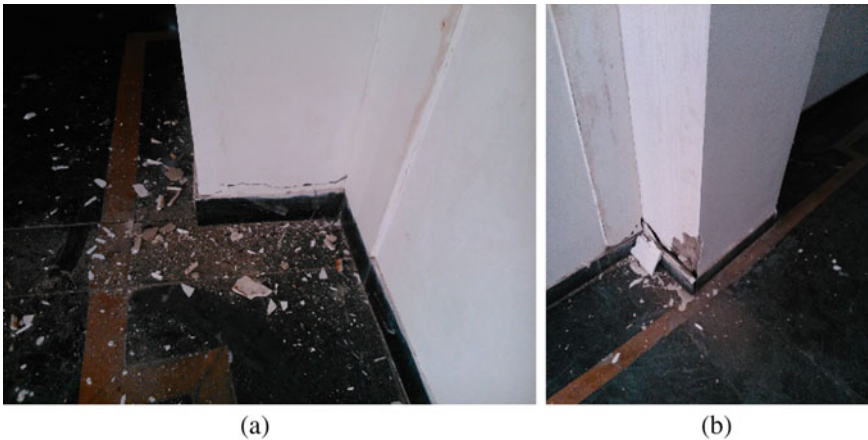
Fig. 1 Columns (fourth level) of Royal Group of Institution in Guwahati that faced damages due to the Imphal earthquake 2016

The land of Manipur was shaken by an earthquake of 6.7 magnitude in January 2016, which hits the capital city of Imphal, destroying more than 2000 three-story and four-story offices and residential buildings [11]. Due to the sparse population in the region, the reported fatalities were very minimal [12]. Newly built RC structures were damaged, a majority of publicly funded, and government buildings were affected badly due to failure to complying with the Indian standard code of Practice for seismic design, IS 1893 [13]. The earthquake was felt in few cities of Assam, which caused few damages to the RC buildings in the region of Silchar (260 km away) and Guwahati (490 km away). Figure 1 shows columns of the five-story Royal Group of Institution building located in the region of Guwahati, which experienced damage due to the severe ground motions of the Imphal earthquake.

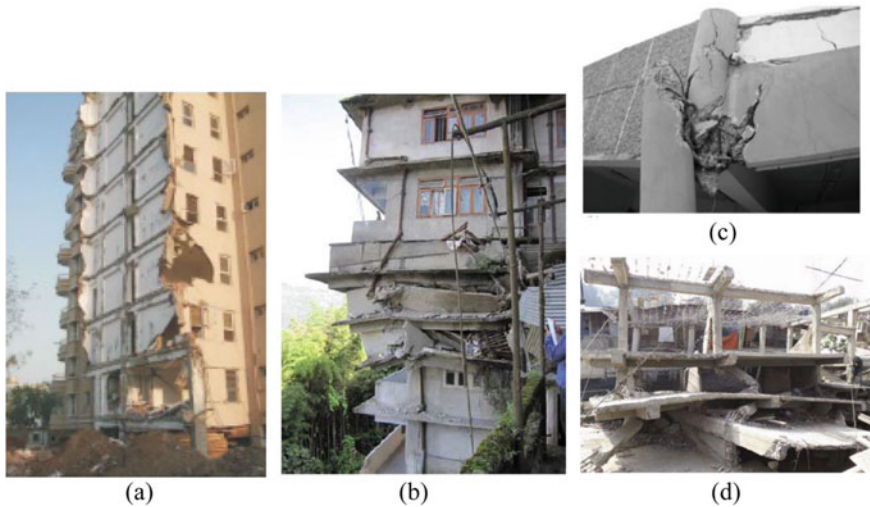
Fig. 2 **a** Collapse of an H-shaped 10-story newly constructed apartment building in the region of Sikhara, Ahmedabad [18], **b** Collapse of middle stories due to the 6.9 magnitude Sikkim earthquake (2011) in the region of Balwakhani, Gangtok [9], **c** Failure due to short column mechanism in few columns of New Passenger Terminal, Port Blair [19], **d** Complete collapse of a four-story building in the region of Dewlahland, Imphal [13]

of an entire wing of one of the open arms, which caused the lives of 89 persons, as shown in Fig. 2a. The open first story with no infill wall created a soft story mechanism where the lateral load resistance was significantly lesser than the upper stories. The presence of infill wall on the above-ground stories made the levels stiffer and resulted in attracting a huge amount of earthquake forces compared with the open ground story that caused large-scale destruction in the entire city of Ahmedabad.

This type of construction practice has given rise to irregular and unsymmetrical plans both vertically and horizontally [21]. Figure 2c shows the gravity load failure of a nine-story building in the region of Balwakhani, Gangtok during the Sikkim earthquake (2011). Various failures occurred due to lapping of longitudinal reinforcement at inappropriate locations, no adequate confining reinforcement, extensive extension of upper story over cantilever beam, inferior material quality, and poor workmanship.

One of the northeastern states, Manipur, lies on the seismic zone V. During the earthquake of 2016, huge destructions were seen. The three-story RC building of Sports Authority of India experienced severe damages, which led to its demolition at a few months of its life. Figure 2d shows a four-story building that collapsed completely during the earthquake. The Asia's largest all women's market "New Market building" (Ima Keithel) experienced major damages [13]. In the building, PVC pipes of 150 mm were concealed inside the circular columns, which jeopardized the confinement of exterior columns causing the reduction in strength and spalling of concrete. Failures in RC buildings were seen majorly due to no ductile detailing, inadequate spacing of transverse reinforcement, unequal clear cover, lack of confining reinforcement, inferior material quality, and failure to complying with IS code of practices. On the other hand, the old traditional wooden buildings showed better performance as compared with the RC buildings.

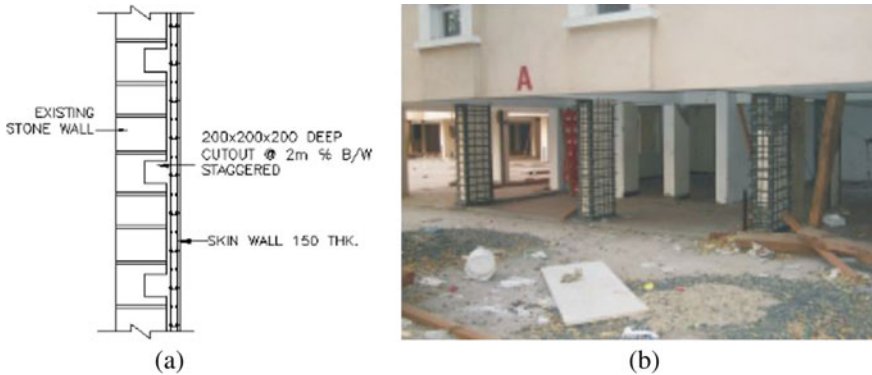
Fig. 3 Different retrofitting measures adopted to strengthen—**a** Mani Mandir, Morbi [23], **b** H-shaped 10-story apartment building, Sikhara [18]

During the Bhuj earthquake (Gujarat) 2001, the Mani Mandir complex located at Morbi at 125 km away from the epicenter experienced severe damages. The building was constructed during 1930s. Dynamic analysis was carried out to observe the seismic performance, and retrofitting technique was implemented. The building was constructed using yellow sandstone, but after carrying out the dynamic analysis, few members like wall, bastion were retrofitted using reinforced concrete skin walls of 150 mm thickness, as shown in Fig. 3a [26]. As mentioned in Sect. 2, an entire wing of a 10-storied H-shaped building in Sikhara collapsed. The columns at the open ground story of the other wing of the building have been strengthened using concrete jacketing as shown in Fig. 3b.

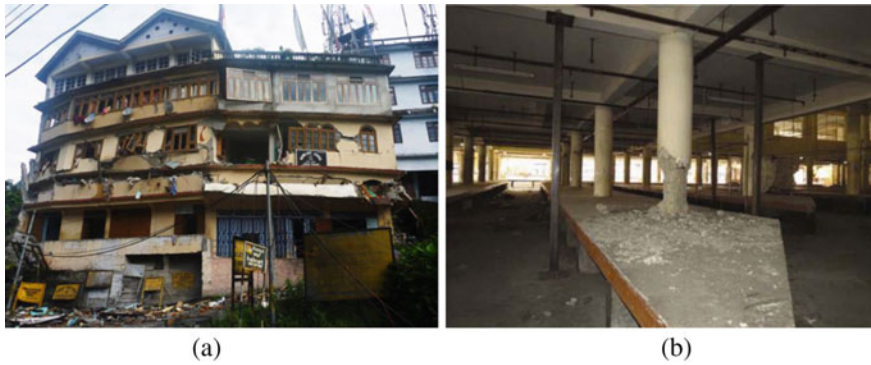
During the Sikkim earthquake 2011, the Moonlight School of Chungthang region, constructed in the year 1985, encountered collapse of the second story, which propagated to the upper story, as shown in Fig. 4a. During the non-linear static pushover analysis, two forms of design analysis were applied—Design Basis Earthquake (DBE) bearing PGA of 0.18 g and Maximum Considered Earthquake (MCE) bearing PGA of 0.36 g. Using the guidelines of ATC-40, the performance point was found out and was compared with FEMA-365 guidelines. The analysis resulted in hinges at the region of immediate occupancy and life safety for the maximum considered earthquake at 22 columns of the corridor of the school building. Glass Fiber-Reinforced Polymer (GFRP) was used to strengthen the columns of the structure, which generated hinges during the non-linear static pushover analysis [25].

During the Imphal earthquake 2016, the New Market building (Keithel 3) constructed in the year 2006 encountered severe damages in various structural components due to poor workmanship, substandard quality of material, and failure

Fig. 4 **a** Total collapse at the second story leading to extensive damage at the third story of Moonlight School building at Chungthang, Sikkim [25], **b** Damages in the columns due to short column effect in the New Market building, Imphal [24]

to compliance with Indian Standard guidelines as shown in Fig. 4b. For the non-linear analysis with PGA of 0.36 g, the non-linear flexural hinges were assigned to the beams and columns using the definition generated by Paulay and Priestley [27]. The shear hinges were assigned to the model using the shear force—shear deformation ($V-\Delta$) models explained in IS 456. As the region of Imphal is located at the remotely hilly terrain, to have an easy, convenient, and quicker solution with implementation of local resources, concrete jacketing was adopted to strengthen the column that failed in flexure and shear. The pushover curves generated before and after retrofitting showed that the stiffness and lateral strength increased remarkably as shown in Fig. 5. The load and moment curve for the most critical column (C6-GR) showed an increasing capacity by three times as shown in Fig. 6. The capacity of all the columns increased sufficiently and the demand pairs were laid inside the interaction curve [24].

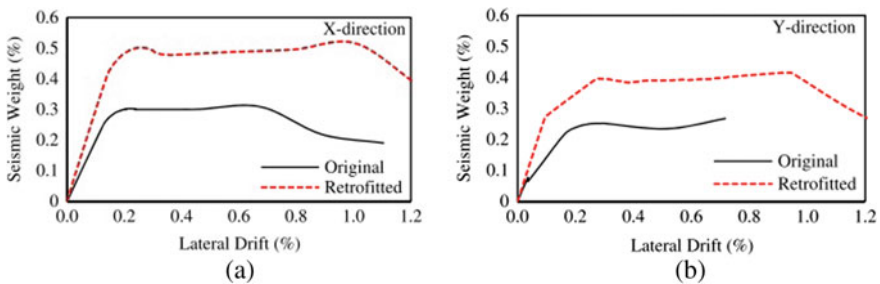
Fig. 5 Pushover curve obtained for the original and retrofitted building after the analysis in the direction of **a** X axis, **b** Y axis [24]

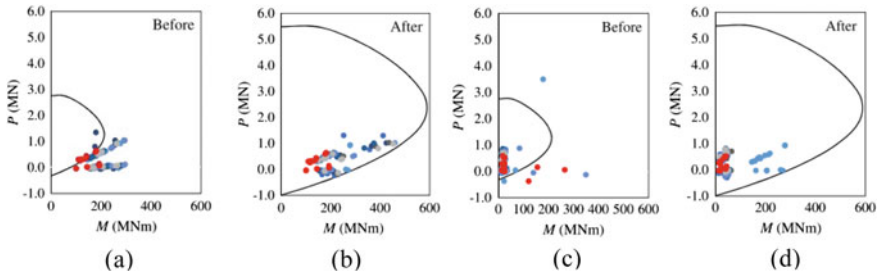
Fig. 6 P–M interaction curves for all the columns of New Market building in comparison to C6-GR in the direction **a** X-axis (before strengthening), **b** X-axis (after strengthening), **c** Y-axis (before strengthening), and **d** Y-axis (after strengthening) [24]

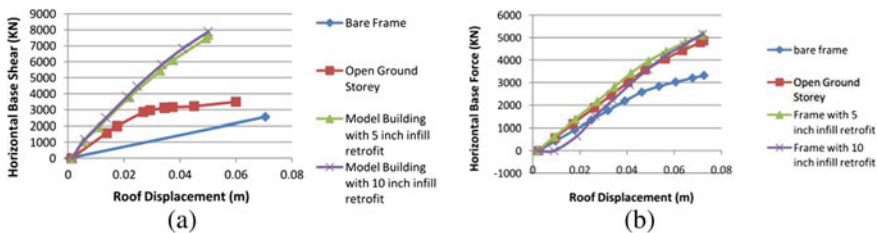
Fig. 7 The static pushover curve for all the three considerations of—**a** sample building, **b** existing building [28]

locations further increased the horizontal base shear, but a significant difference was observed for 5 inches and 10 inches of thickness infill wall [28].

An evaluation was made to reduce the seismic vulnerability by introducing infill masonry walls to the reinforced concrete frame at certain locations of the ground story [28]. Two buildings were chosen for the analysis—(a) Sample building of five stories and (b) an irregular existing building. For each of the buildings, three different scenarios of modeling were considered—(i) Bare frame, (ii) Open ground story, and (iii) Masonry retrofitted building. For the retrofitting technique, 5 inches and 10 inches infill masonry walls were considered in the study. Plastic hinges were assigned as per the guidelines of FEMA 356 (inbuilt in SAP2000), and a pushover analysis was carried out. The pushover curve for the sample building as shown in Fig. 7a resulted that a considerable increase in horizontal base shear is observed when infill masonry walls of 5 inches and 10 inches are considered as a structural element. On the other hand, Fig. 7b shows that for the existing building, the horizontal shear for bare frame increased considerably as compared with the sample building but the horizontal shear for open ground story increased. The masonry infill wall at strategic
