Investigation and Design of Remedial Measures for Landslide in Hunthar Veng, Mizoram—A Case Study

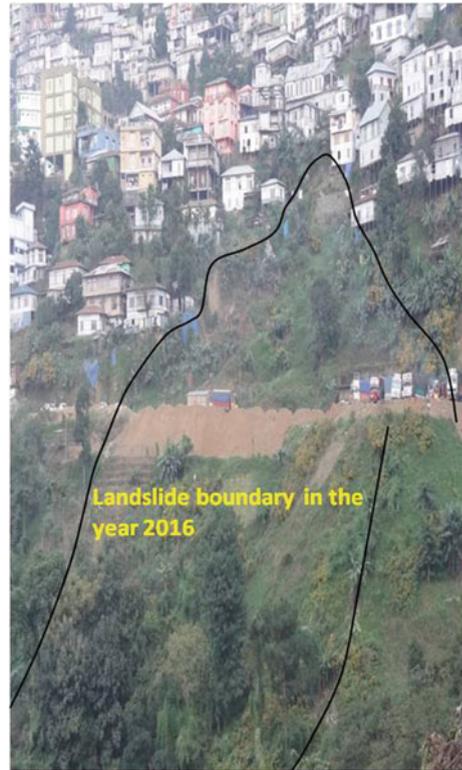
Fig. 1 Hunthar landslide and sinking area (Ch: 179/500 km on NH-54)

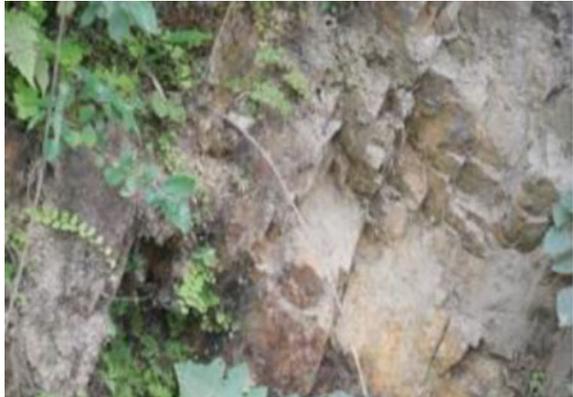
The soil formation in the Hunthar Veng area, in general, is of loose sedimentary type with high porosity and permeability. The top of hills being capped by sandstone having sufficient porosity, rainwater infiltrates down to interface with impervious clayey shale layers (Fig. 2) and exit to the surface due to gravity. While coming out through the shale/silty soil layers, the water carries with it the slope forming material from down below. It results into the subsidence of the area. It was also indicated that there are lot of water channels in the landslide affected area, out of which some are visible and some of them are required to be unearthed.

Fig. 2 Shale and interbedded siltstone–shale at the road section of NH-54

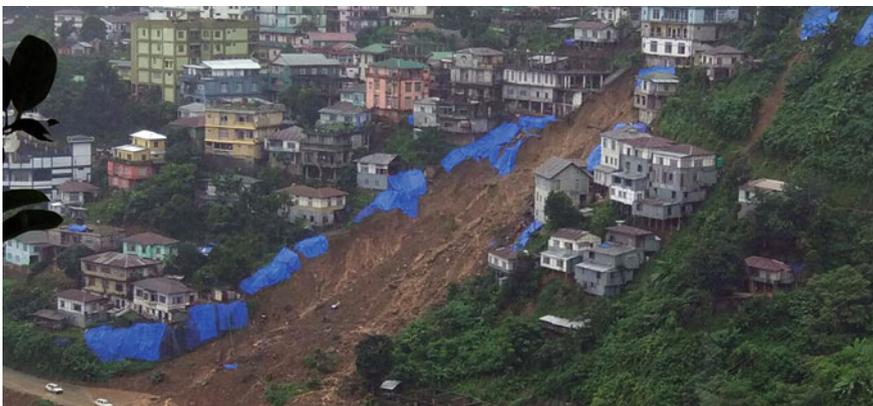
Fig. 3 Affected area above national highway

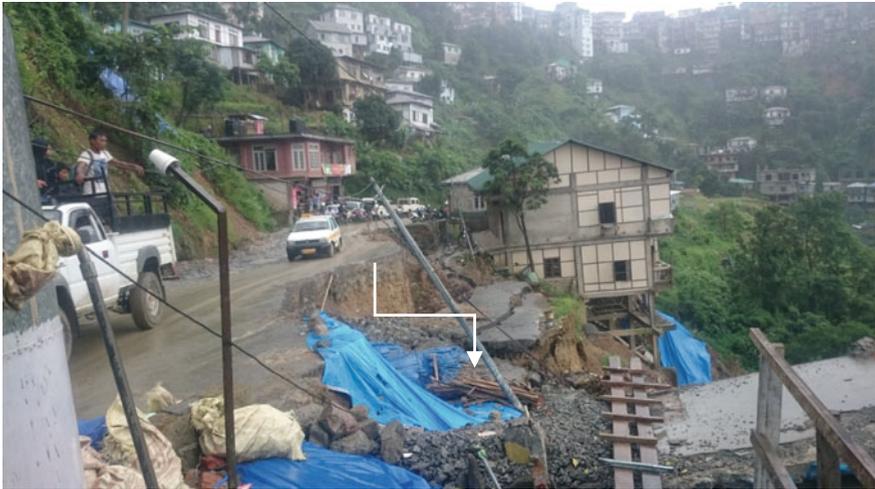
Fig. 4 Sinking/sliding of national highway

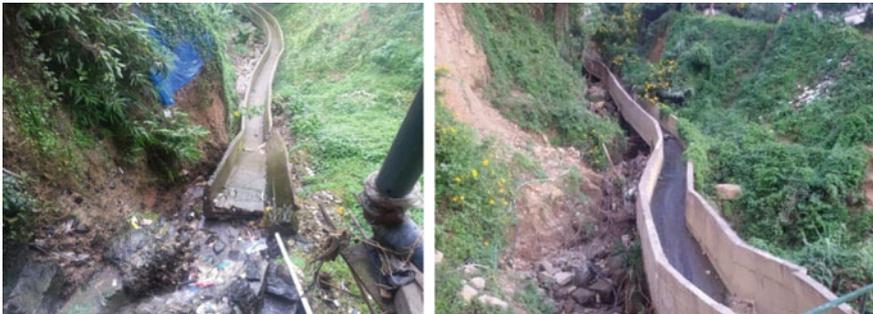
runoff water from the uphill side of the slope, two water channels as shown in Fig. 5 were provided but it was observed that it was choked and broken and therefore not very effective in draining out surface runoff.

Fig. 5 Condition (eroded and broken) of side drains adjacent to affected slide

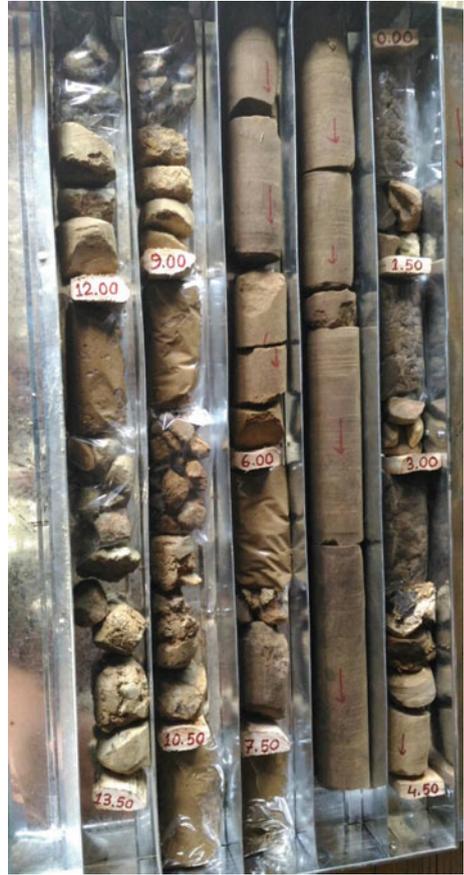
Fig. 7 Rock showing poor core recovery

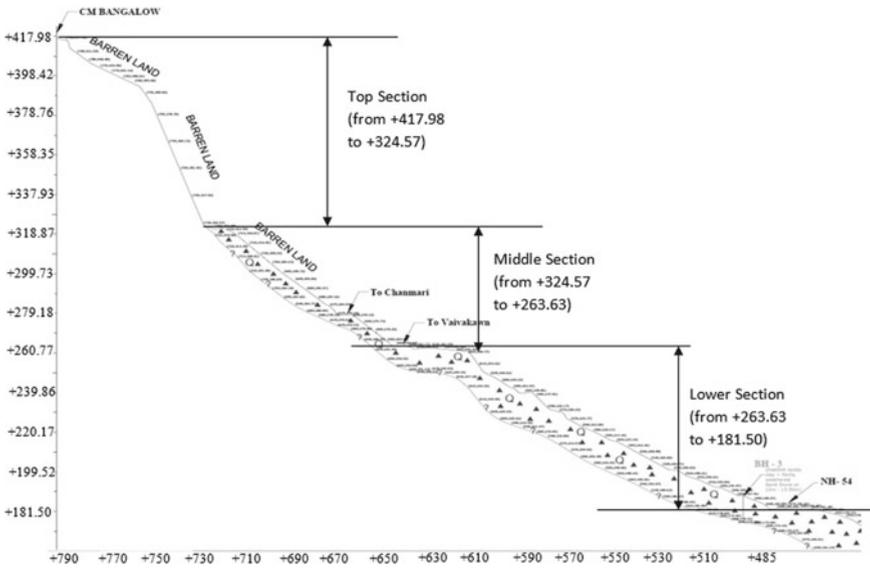
Fig. 8 C/s of affected landslide area

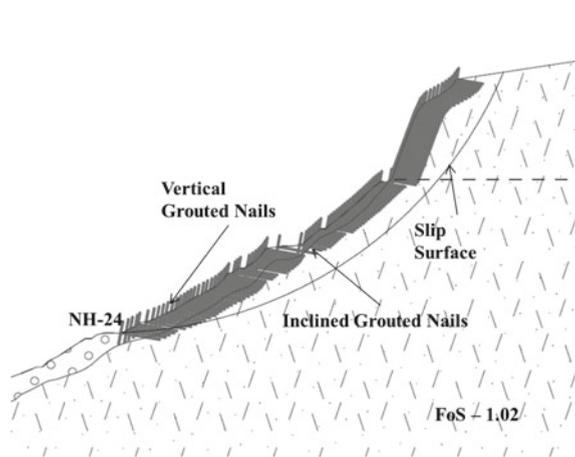
Fig. 9 Slip surface for option 1

Figure 9 presents the stabilisation measures in option 1 (Inclined and Vertical Grouted Nails) with grouted nails. It can be seen that the Factor of Safety (FoS) is still less than the required limit set by the standards (1.25 [6]). Slip surface passes well below the reinforced region and it starts from the crown of the affected area and ends at the toe of the affected area; they still lead to a translational failure.

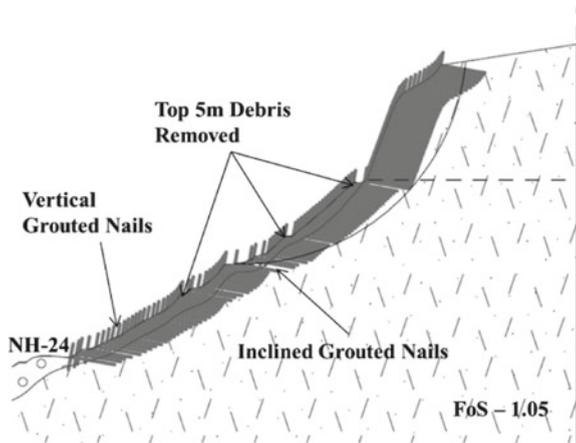
Fig. 10 Slip surface for option 2

In order to improve the stability of the slope, in option 2 (Removal of Debris and Installation of Grouted Nails), it was further thought to remove the debris by 5m in vertical direction from bottom to top and making berms of suitable width, and nails were installed on the slopes created in such a manner. The results of the analysis are shown in Fig. 10. It may please be noted that even with such an arrangement, the factor of safety was found to be less than 1 as face failure occurs.

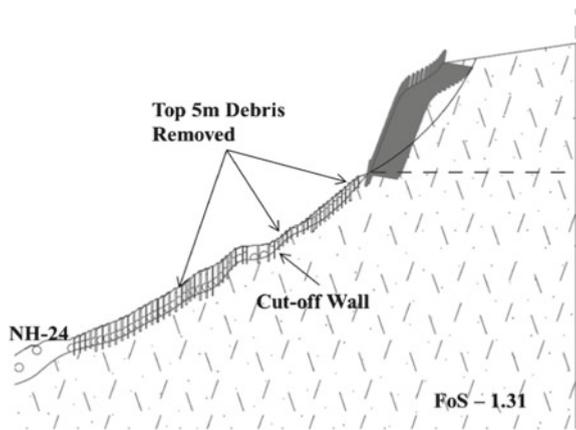
Fig. 11 Slip surface for option 3

other horizontally so that it forms a wall). They were provided from middle portion to lower portion at a vertical distance of 3m and up to a depth, where the piles are embedded into HWR at least up to a depth of 3D to 5D. Only with this arrangement a factor of safety greater than 1.2 could be obtained. All the above slope stability analysis results are indicated in Table 5.

Figure 11 presents the final option 3 (Stepped Slope with Cut-off Wall). In option 3, cut-off walls were provided in the form of continuous piles (very close to each
