A Case Study of Las Palmas Tailings Dam Failure

T. S. Aswathi, Ravi S. Jakka, and David Frost

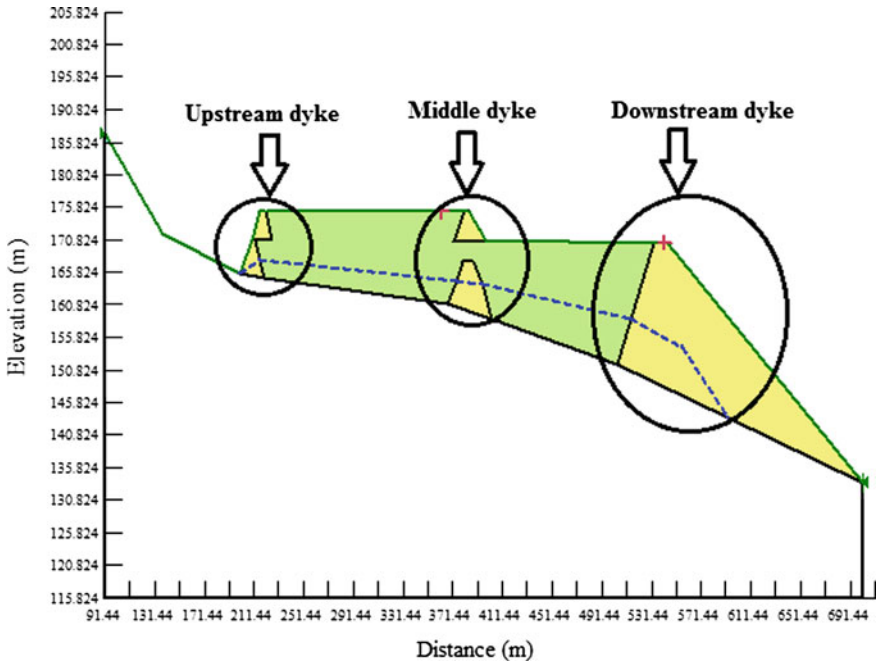
Fig. 1 Cross-sectional view of Las Palmas tailings dam (Note: The horizontal and vertical scales are different)

in the left-hand side of the cross-section are referred to as upstream dykes. Likewise, on the right-hand side, the dykes constructed using the downstream method of construction are referred to as downstream dykes. Similarly, in the middle of the cross-section, the dykes constructed similar to the centerline method of construction (but there were tailings between the two dykes) are referred to as middle dykes (Fig. 1).

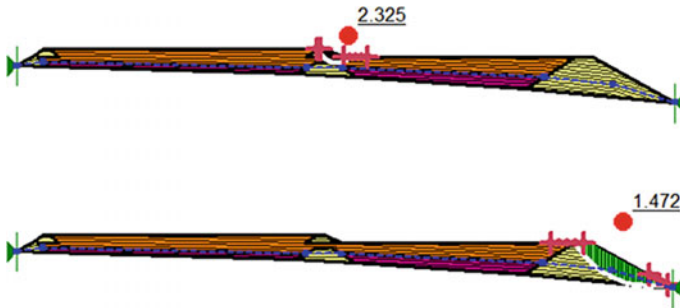
Fig. 5 The static slope analysis of Las Palmas tailings dam before an earthquake

The following conclusions are drawn from the study. The tailings dam is stable under static conditions. However, the pseudo-static analysis representative of stability under earthquake indicates that the dam is unstable under the Chile earthquake. The slope stability of the middle dyke is more in the case of both the static as well as pseudo-static cases when compared to the downstream slope. This proposes the

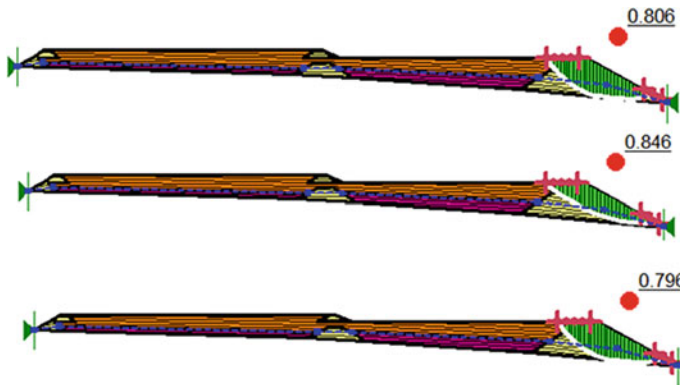
From Table 3, it is seen that there is a decrease in stability under earthquake loading. Further, the pseudo-static factor of safety is less than one in all the cases for the downstream dyke, i.e., it is unstable during earthquakes, whereas the middle

Fig. 6 The Pseudo-static factor of safety of downstream dyke corresponding to horizontal seismic coefficients of 0.47, 0.39 and 0.48

Condition	Middle dyke	Downstream dyke
Static	2.325	1.472
Pseudo-static for k_h 0.47	0.935	0.806
Pseudo-static for k_h 0.39	1.061	0.846
Pseudo-static for k_h 0.48	0.922	0.796

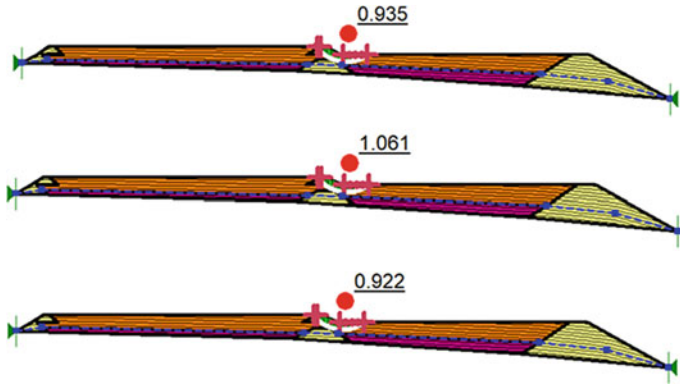
Fig. 7 The Pseudo-static factor of safety of middle dyke corresponding to horizontal seismic coefficients of 0.47, 0.39 and 0.48

dyke is more stable in the static as well as pseudo-static cases when compared to that of downstream dyke. However, the factor of safety is around one (slightly more or less than one) indicating that a slight increase in seismic force is enough to make the middle dyke unstable.

mechanism that the downstream dyke failed first and then the middle dyke during the earthquake. Upon the failure of the downstream dyke, the contained tailings flowed down which further triggered the failure of the middle dyke, that is, the flow failure occurred.
