# Experimental Investigations and Numerical Simulations for the Seismic Assessment of a Masonry Building

Mariella Diaferio

, Marilena Venerito, and Michele Vitti

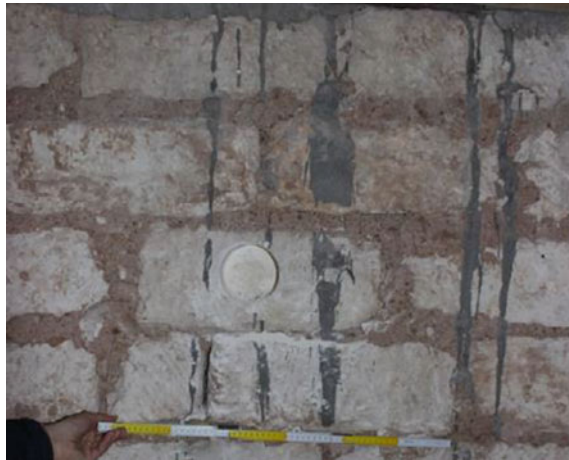
**Fig. 5** Detail of a masonry panel for the evaluation of MQI

The masonry walls of the San Marco Church have been classified as shown in Table 1, where NF stands for Not Fulfilled, PF for Partially Fulfilled, and F for Fulfilled (see Fig. 5), while the mechanical properties have been evaluated in accordance with the prescription of the Italian Codes for the squared softstone masonry.

Vertical loading (V)	Horizontal in-plane Loading (I)	Horizontal out-plane Loading (O)
MM	NF	0	0	0
WC	PF	1	1	1.5
SS	F	3	2	2
SD	F	1	1	1
VJ	PF	0.5	1	0.5
HJ	F	2	1	2
SM	PF	0.7	0.7	0.7
	QMI	5.25	4.2	4.9
Masonry category		A	B	B

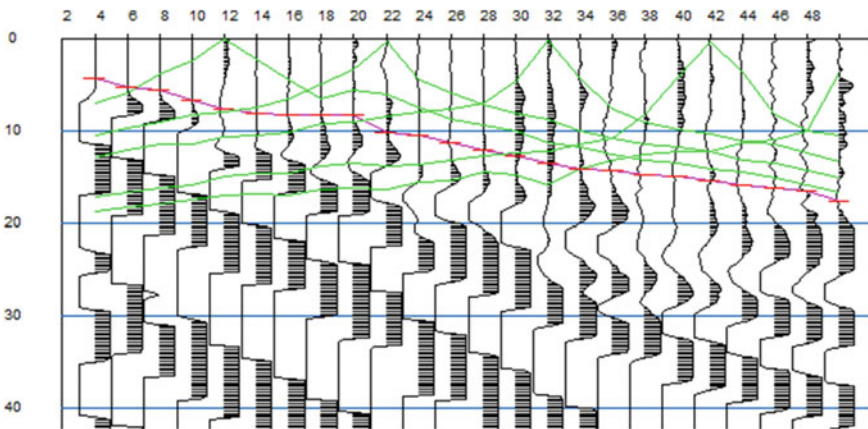
Fig. 6 Seismogram for the shot point at the beginning of the survey line

In Fig. 6 the acquired seismogram for the case in which the shot point is at the start point of the survey line is shown, while in Table 2 the first arrival times of P-waves at the surface of the earth for each geophone are presented.

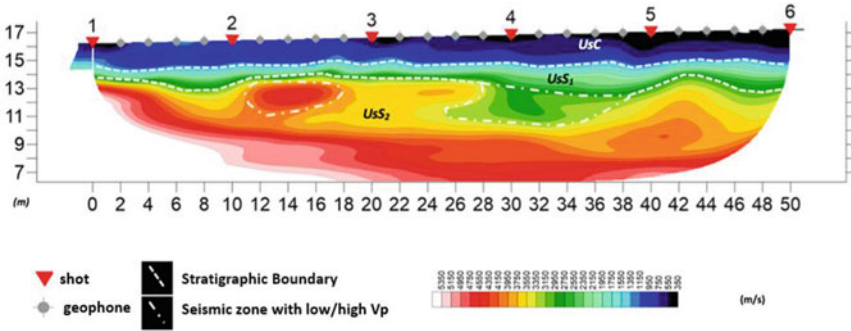
Fig. 7 Seismic stratigraphy: x axis distance [m] along the survey direction and y axis distance along the vertical direction [m]

The results of the soil inspection are shown in Fig. 7 where a contour plot shows the acquired wave velocity profile at varying depth from the ground level (y axis) and along the survey direction (x axis). The plot shows that the subsoil consists of 2 basic seismic stratigraphic units from the ground level:

- The first seismic stratigraphic unit UsC (see Fig. 7) extends up to an average depth between 1.3 ÷ 2.8 m from the ground level with an almost stratiform structure. This seismic layer is characterized by  $V_p$  values ranging between 500 ÷ 900 m/s, with minimum values recorded at a distance along the survey direction greater than 22 m, while the minimum values are reached beyond the cited distance. The boundary, which divided this unit from the underlying seismic layer, appears clearly marked as it is characterized by very high gradient values.

- The second seismic stratigraphic unit UsS (see Fig. 7) shows a clear increase in the detected speeds and an uneven distribution of the values. This unit can be further divided into 2 subunits: the first unit UsS<sub>1</sub>, characterized by a variable thickness ranging between 1.0 ÷ 2.0 m, reached the maximum values in the range of distance along the survey direction equal to 28–40 m. This zone manifests V<sub>p</sub> values ranging between 1450 m/s and 2400 m/s with values increasing with depth. The second seismic stratigraphic unit UsS<sub>2</sub> is characterized by V<sub>p</sub> values greater than 3300 m/s with an uneven distribution, moreover, at a depth of 7 m from the ground level, the V<sub>p</sub> values increase ranging between 4500 m/s and 5700 m/s.

In accordance with the experimental results and with the Italian Codes prescriptions [9, 10], the category A (Rock or other rock-like geological formation, including at most 3 m of weaker material at the surface) was assumed for the soil, while the topographic category was assumed equal to T1.

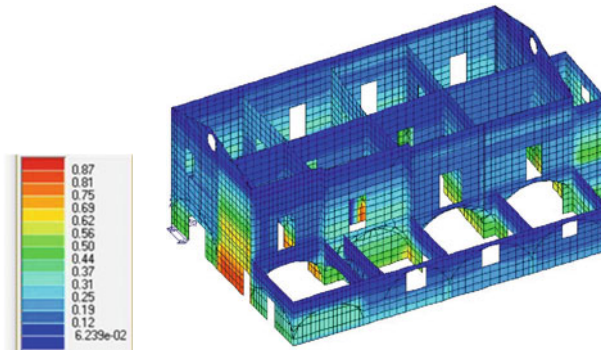
**Fig. 9** Results of the safety checks related to the axial forces and out-of-plane bending moment induced by static loading condition

In the first step of the analysis, a static analysis has been carried out to estimate the safety level of the Church in the usual loading conditions. In Fig. 9 the plot of safety checks related to the axial forces and out-of-plane bending moment is shown.

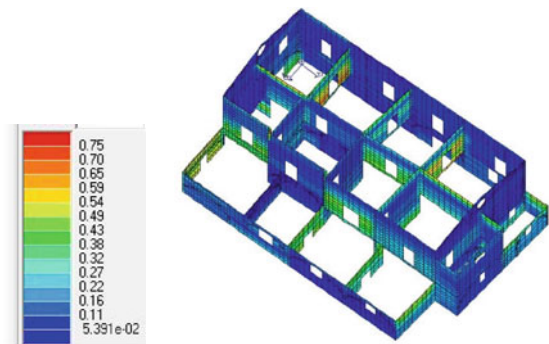
**Fig. 10** Results of the safety checks related to the axial forces and in-plane bending moment induced by the worst seismic load condition

The response spectrum analysis has been carried out to evaluate the seismic vulnerability of the church. In Fig. 10 the plot of the safety checks related to the axial forces and in-plane bending moment due to the worst load conditions is shown, in this case the load combination considers the seismic action too.

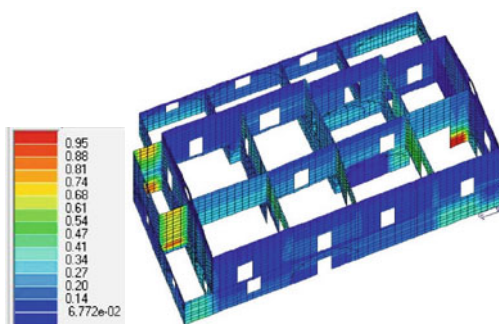
**Fig. 11** Results of the safety checks related to the shear forces induced by the worst seismic load condition

For the same load combination, in Fig. 11 is plotted the results of the safety checks related to the shear action. It is worth noting that the structure is subjected to shear forces not compatible with its resisting capacities.

The experimental analysis and the definition of an accurate numerical model highlighted that the San Marco Evangelista Church capacity may be lower than the demand when it is subjected to seismic actions, and that has an average vulnerability degree.
