Preliminary Stage OpenSEES Simulation of the Collapse of Plasco Tower in Fire

Ramakanth Domada, Tejeswar Yarlagadda, Liming Jiang, and Asif Usmani

© Springer Nature Singapore Pte Ltd. 2024
M. Madhavan et al. (eds.), *Proceedings of the Indian Structural Steel Conference 2020 (Vol. 1)*, Lecture Notes in Civil Engineering 318,
https://doi.org/10.1007/978-981-19-9390-9_11

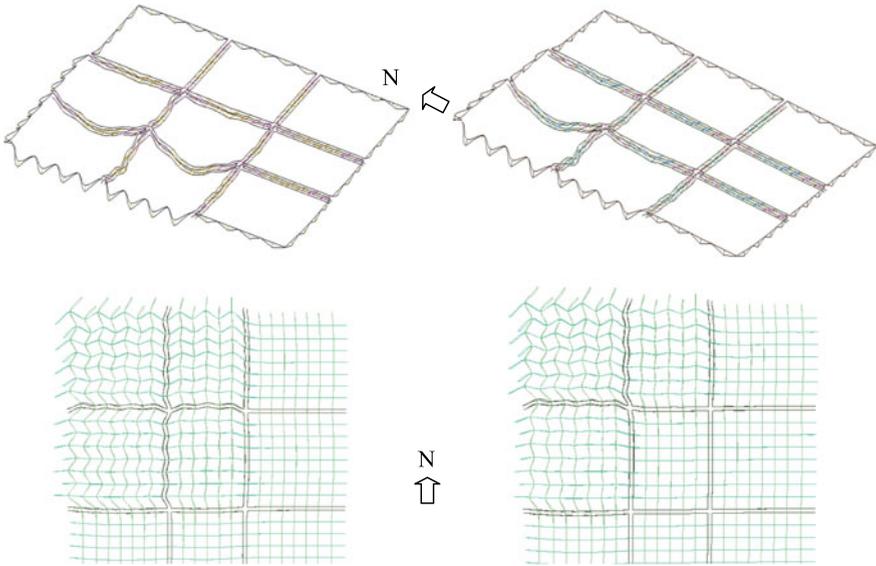
Figure 5 shows the floor deformations under the fire load scenarios b and c (see Fig. 1).

In the EW direction, the lengths of primary beams longer in comparison with the NS direction, hence the deflections in beams along the EW direction are higher.

In the blocks under fire, the in-plane deformation near the edge is not uniform because of presence of alternate perimeter columns. Because of that, the grid of secondary beams in the top view appeared like waves passing in both the directions.

Fig. 5 Floor deflections under the 3-block and 4-block fire scenarios in perspective (secondary beams hides) and in the plan view

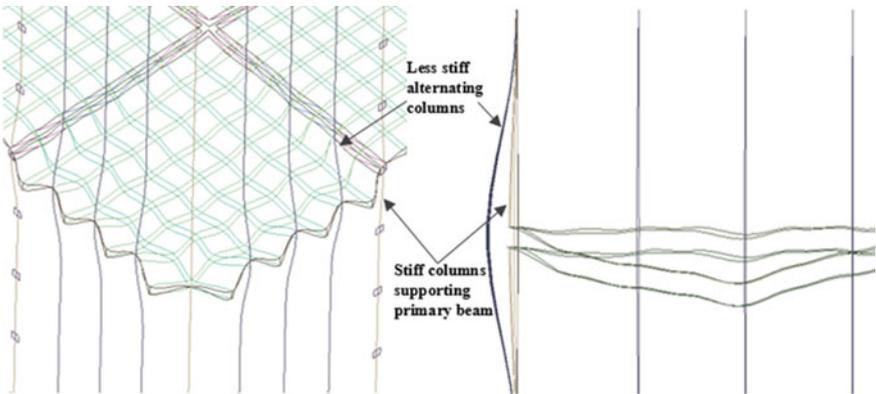
Figure 6 depicts the interaction of expanding floor with stiff columns and less stiff perimeter columns.

Fig. 6 Visualization of columns getting pushed by the expanding floor

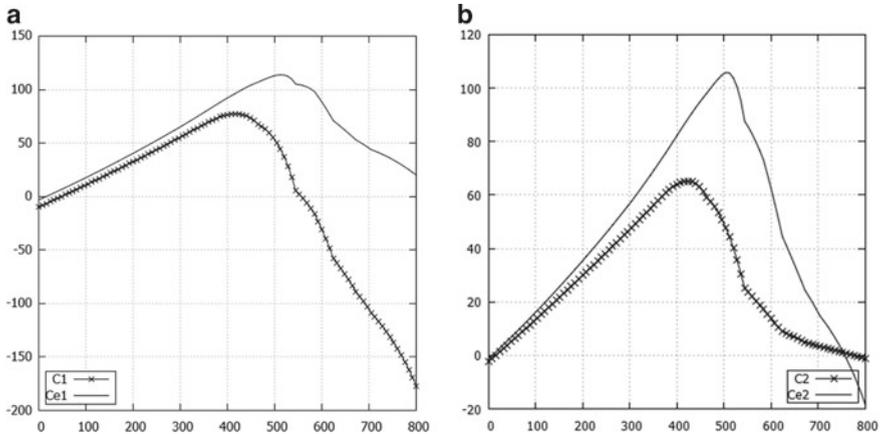
The results in Fig. 7 show push-out deformations of columns C1, Ce1, C2 and Ce2 on 11th under the four considered fire scenarios.

Fig. 7 Temperature versus horizontal displacement plot for column **a** C1, Ce1 and **b** C2, Ce2

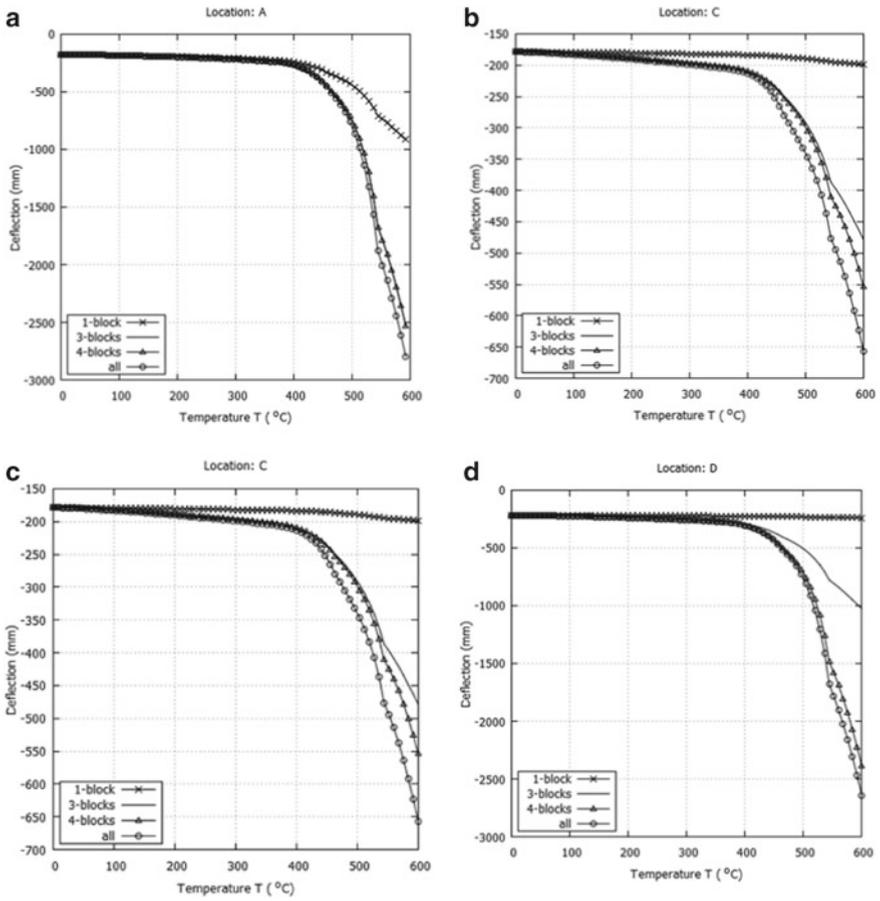
The results in Fig. 8 show the beam deflections in primary beams at locations A, B, C, D under the four considered fire scenarios.

Fig. 8 Comparison of mid-point displacements in beams A, B, C and D under the four fire zone extents

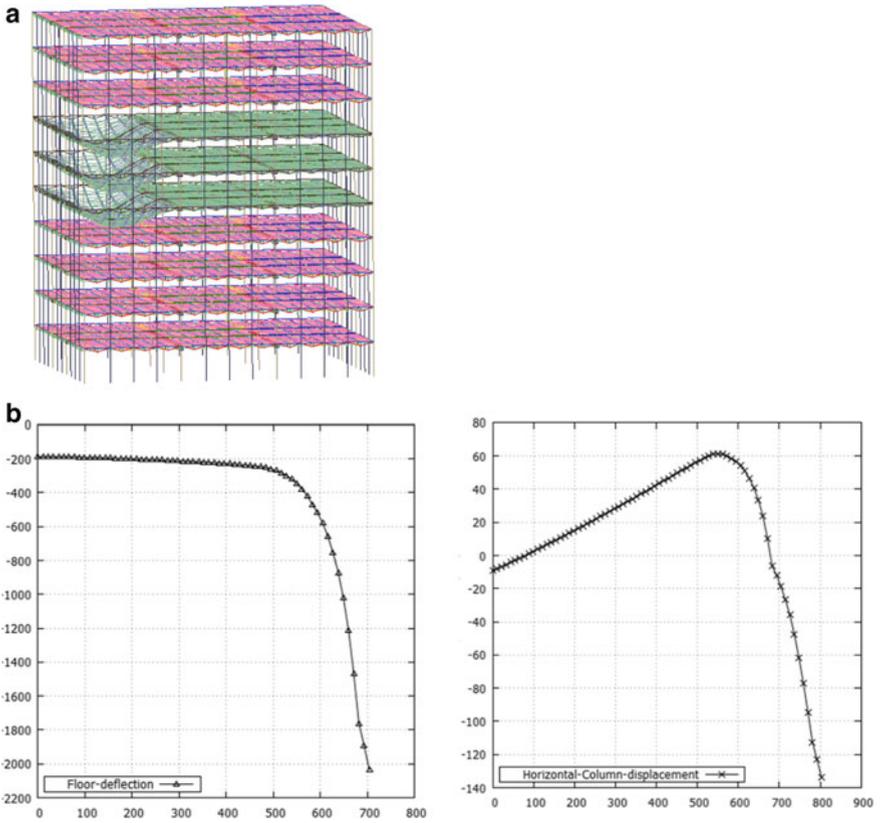
The plot in Fig. 9 highlights results of the analysis carried out assuming three floor fire on north side of the structure. The two graphs show (a) the in-floor deformations in case of three floor fire (b) column outwards deformations.

Fig. 9 a Horizontal displacements in and b Difference in deflection between Ce2 and C2 columns under critical 4-block fire loading

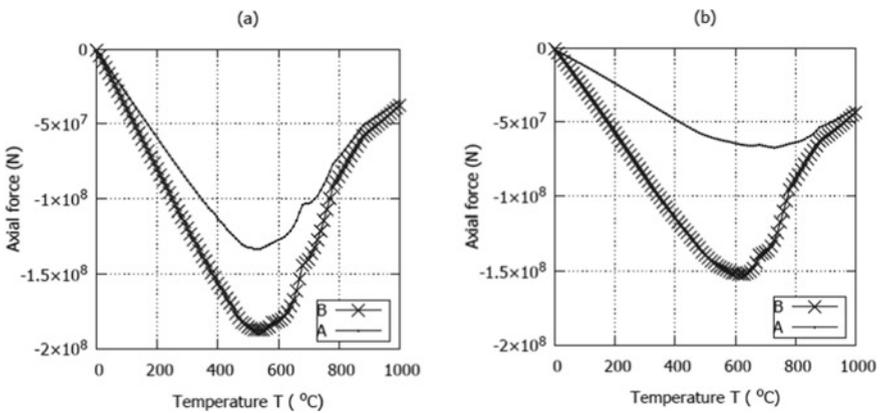
The development of compressive forces in the top chord members of primary beam trusses at locations A and B during the 1-block fire and 4-block fire scenarios are shown in Fig. 10. As location 'B' is on the beam whose supporting column is relatively stiffer, higher compressive forces are observed in the beam because of the higher lateral restraint. The extent of fire is also a factor influencing the forces, because lateral displacement restraints are higher in the 1-block fire than the 4-block fire.

- When three blocks are under fire, the relative lateral column deflections are highest along the EW direction. See Fig. 10a. After 700 °C, the difference between C2 and Ce2 plots is greater in comparison with C1 and Ce1.

Fig. 10 Comparison of top chord axial forces at the mid-sections of primary beam at locations A and B during a 1-block fire and b 4-block fire
