Analysis of the Hydraulic Characteristics of the Debris Flow Disaster Chain in Baozhuping Gully and Analysis of the Conditions for Debris Flow Initiation

Abstract. Taking the Baozhuping gully landslide-debris flow disaster chain in Ya'an City as an example, through field investigation and on-site measurement, this study analyzed the characteristics of the collapse and breakthrough during the "7.16" debris flow outbreak, and provided the types of dam break and its hydraulic characteristics after the landslide slide. The results show that the instability of the dam body of the pond is mainly due to the damage caused by the overflow of the top, and the maximum flow rate of the dam break reaches 30.12 m³/s, which triggers the initiation of debris flow downstream, providing reference for the prevention and control of similar debris flows.

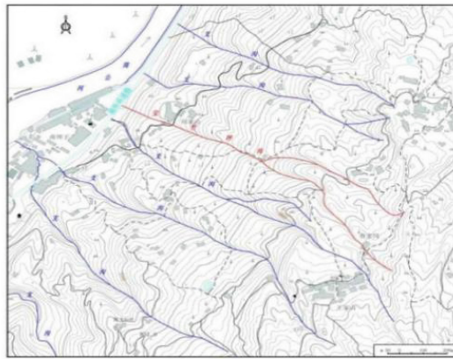
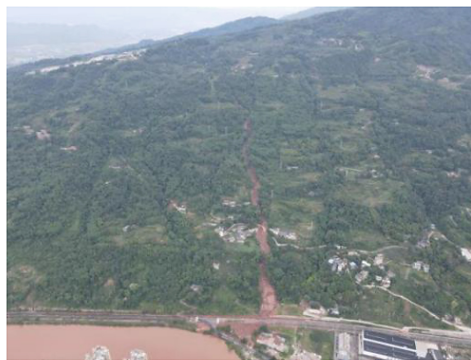
Considering the surrounding environment, there are several tributaries with similar geological conditions to Baizhuping Gully (see Figs. 1 and 2). These tributaries share similarities in terms of basin area, main gully length, terrain slope, and lithology. No debris flows were reported in any of these tributaries on July 16, 2022. From the video footage taken by Chuan Guan News after the debris flow event in Baizhuping Gully, it can be seen that there was still a large amount of floodwater in the gully, while the left tributary remained clear (see Figs. 3 and 4). This indicates that the debris flow in Baizhuping Gully was likely caused by rapid sliding of slope soil and rock from the upstream slope into the foot pond, resulting in a significant change in hydraulic conditions due to the rapid influx of water [10–12].

Fig. 1. Distribution map of Baozhuping gully and surrounding branch gully

Fig. 2. Image of Baozhuping gully and surrounding branch gully

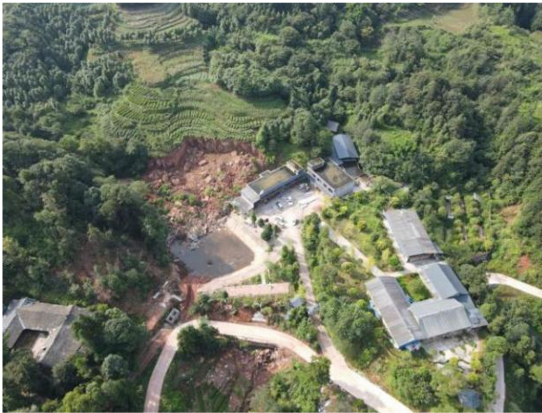
According to the investigation and analysis of pre-and post-failure images (Fig. 3), the reservoir was excavated by local residents as a slope foot, with a front section built as a dam primarily for aquaculture. It has an elongated rectangular shape, with a length of about 85m and a width of 50—20 m. The depth of the reservoir is approximately 4m, with a storage capacity of about 11,900 m³.

Due to the heavy rainfall over several days, the slope formed by excavating and constructing the fish pond at the front edge became saturated. The strength and stability of the soil and rock decreased continuously, eventually resulting in a rapid sliding along the mudstone layer towards the reservoir. The sliding distance was approximately 30 m, with a volume of 9,600 m³. The soil and rock mass squeezed the water in the reservoir, causing it to rapidly overflow into Baizhuping Gully.

Fig. 3. Aerial images on August 11, 2022
