Fatigue crack initiation in hot isostatically pressed Ti-6Al-4V castings

D. EYLON

Precision castings of the Ti-6Al-4V alloy containing pore defects were hot isostatically pressed (HIP) in an attempt to improve the high cycle fatigue strength. Although all defects were healed, the fatigue strength was still low when compared to β -processed wrought material with a similar microstructure. Fatigue-crack initiation analysis, which included precision sectioning, indicated that early fatigue-crack initiation sites were related to relatively large α -platelet colonies and massive grain-boundary α (GB α) phase. Shear across the large colonies or along the GB α interfaces provided large initial cracks which resulted in the fatigue-life degradation. Large colonies and massive GB α developed in the HIP healed zones of the casting pores. In spite of the total HIP pore closure, the fatigue-strength improvement was small when compared to wrought material due to the coarse microstructure that developed in some locations during the HIP cycle. Large planar-shear initiation facets across several colonies were also observed. The multi-colony faceted shear is the result of the Burgers relation betwe

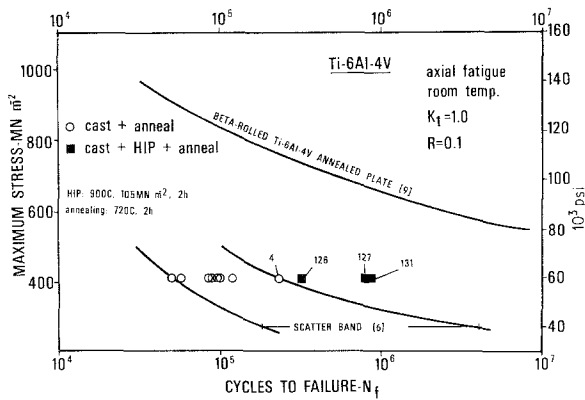
Figure 1 $S-N$ curve for Ti-6Al-4V castings with a wide scatter band and the data points of cast and HIP material without porosity. The $S-N$ curve of β -processed wrought Ti-6Al-4V with similar microstructure is shown for reference.

In an attempt to improve the fatigue life, the cast components were hot isostatically pressed (HIP) to close the casting porosity [8]. Although the porosity was healed by the HIP process, the fatigue strength was only marginally improved when compared to typical wrought material (Fig. 1).

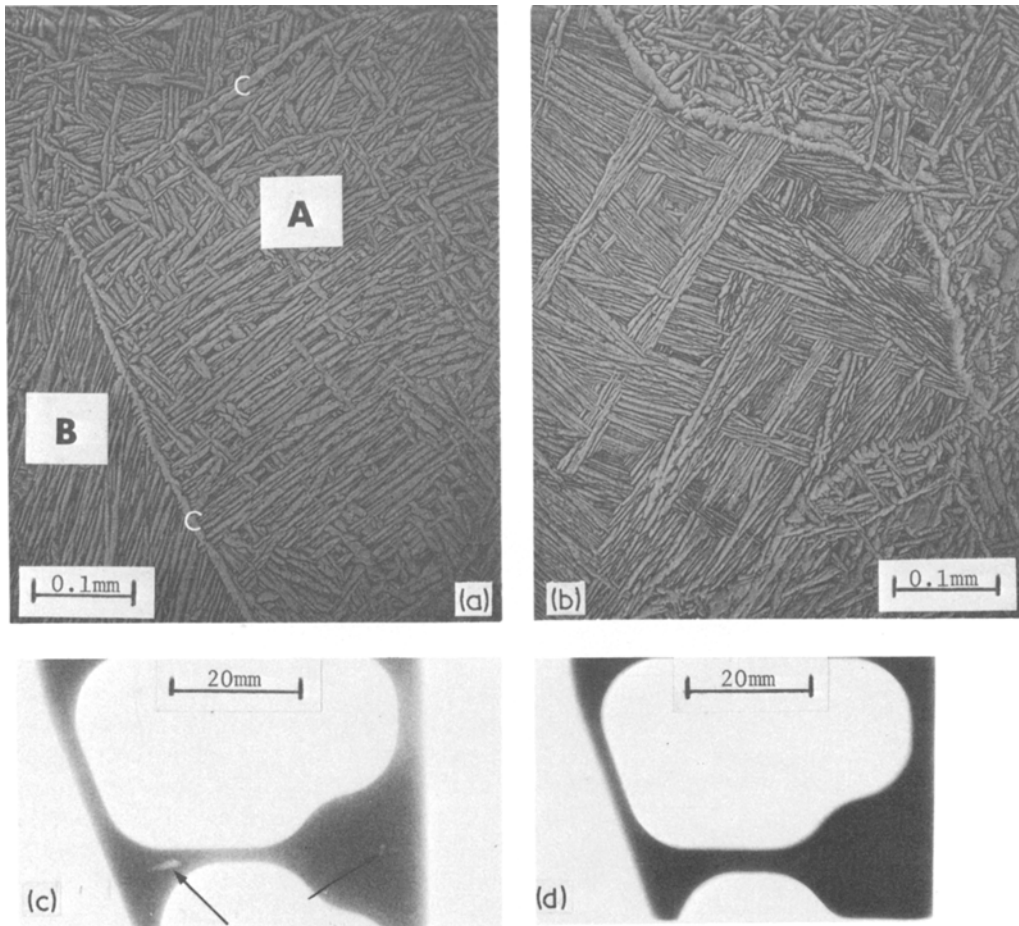
The cast, HIP and annealed microstructure is shown in Fig. 2a. At the optical microscopy level, it appears that the HIP cycle did very little to change the cast structure of the non-porous areas [12], and the mixture of basketweave structure (A), colony structure (B), and prior beta grain-boundary α (C) remained the same. However, in those locations where large dendritic pores were identified by radiography (Fig. 2c) prior to the HIP cycle, relatively large packet-type colonies (0.3 mm average diameter) and massive grain-boundary α (GB α) which outlines the pre-existing pore, were observed in the post HIP structure (Fig. 2b). The HIP healed zone microstructures were observed by sectioning through the previously identified void locations (Fig. 2c). The extent of the healed zone was determined by low magnification polarized light observation. Fig. 2d is the radiograph of the same porous location in Fig 2c after the HIP cycle and it shows a complete porosity closure. No residual porosity was detected by either radiographic or metallographic techniques in any of the examined HIP specimens. Although HIP was performed below the 995°C transition temperature, the β -annealed structure in the healed zones (Fig. 2b) indicate that these localized areas were cooled from the β -region. This could be the result of either local porosity closure adiabatic heating or local chemical composition changes in the dendritically solidified large pore surfaces [12], which lowered the β -transition temperature.

Figure 2 (a) The microstructure of the cast material photographed at a defect-free location, A: basketweave structure; B: colony structure; C: grain-boundary α ($GB\alpha$). (b) The microstructure of cast and HIP material in a healed pore zone showing colony structure and $GB\alpha$ with the healed zone. The basketweave microstructure is part of the original structure. (c) A radiograph of casting pores in an as cast component segment. (d) A radiograph of the HIP healed segment shown in (c). (b) is taken from the healed zone of the left-hand side pore shown in (c).

Since the HIP operation healed the subsurface porosity, all examined failure initiations were related to microstructural elements rather than to defects. However, the average smooth fatigue life was only marginally improved over that of the porous cast material (Fig. 1). The reason for this minimal improvement is the development of large colonies and massive GB α in the porous locations

Shear fracture on common plane through more than one colony increases the chance of having shear-initiation facets larger than the colony size and, therefore, lower fatigue life. The probability of multi-colony faceted fracture increases as the PBG size increases [17]. The healed pore areas in the cast and HIP material (Fig. 2b) thus constitute potentially dangerous zones for this type of larger facet initiation.

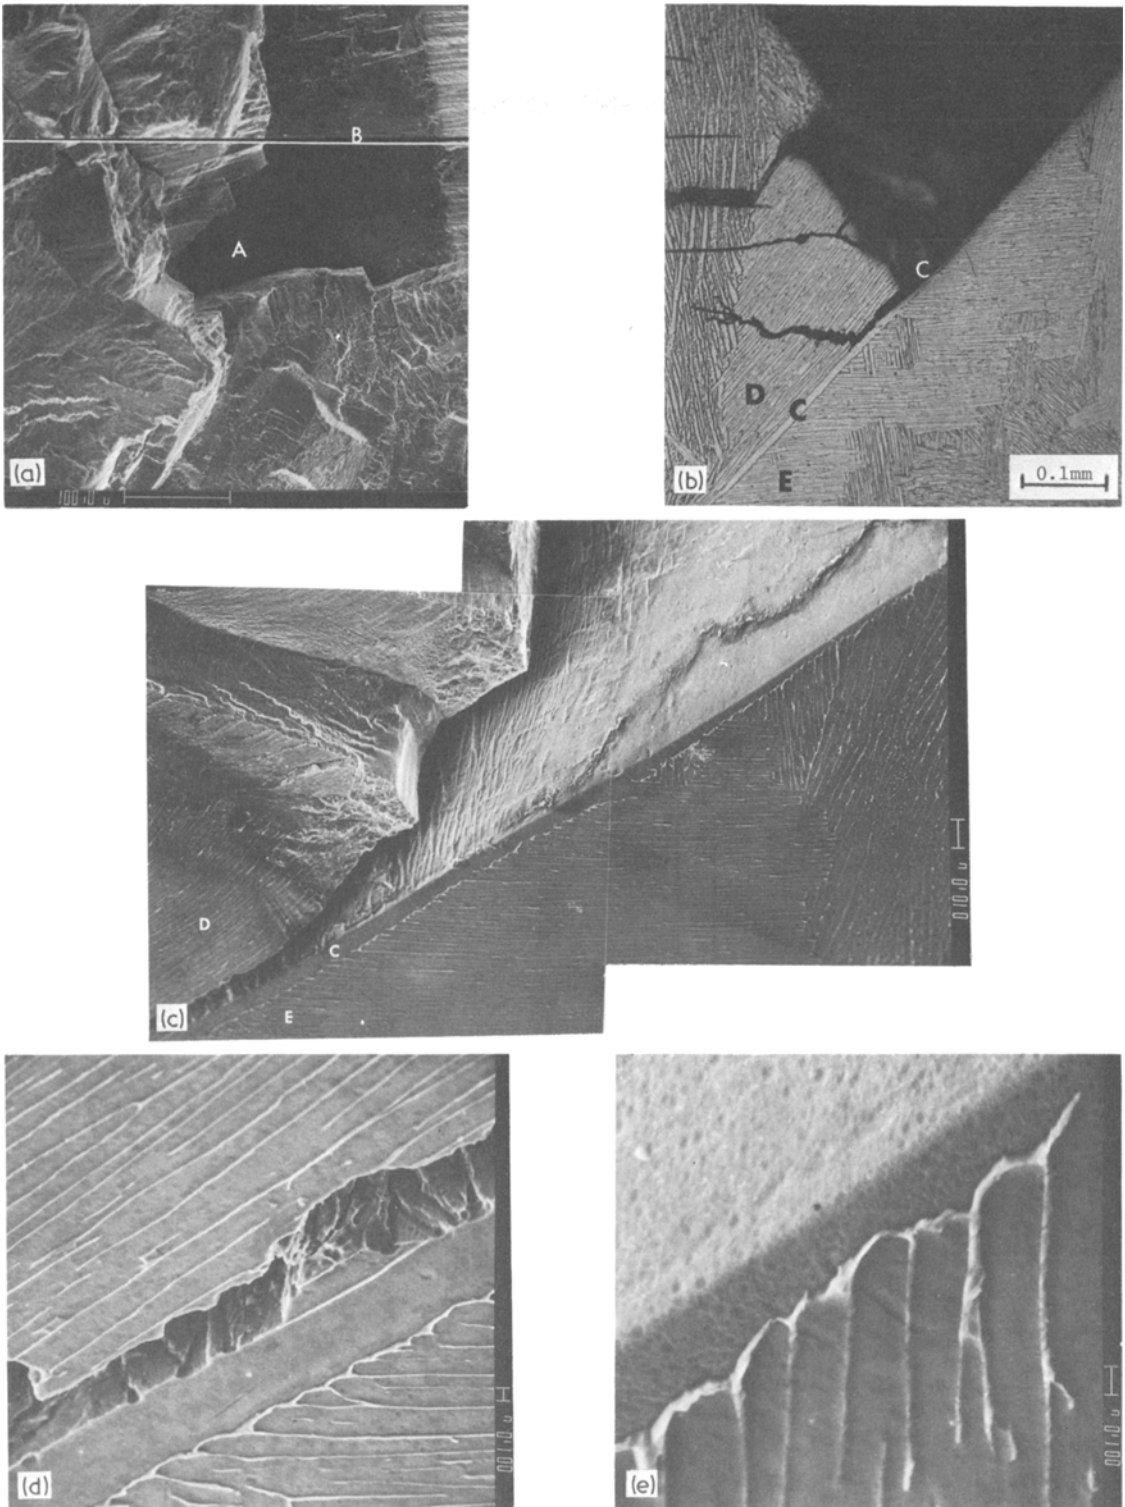
Figure 3 Grain-boundary α fatigue-crack initiation of specimen 127. (a) Fracture initiation facet (A) and section line (B). (b) The section plane and the microstructure under the GB α facet (C) separating colonies D and E. (c) Micrographic/fractographic SEM image of the initiation site at the section plane showing GB α (C) and colonies D and E. (d) High magnification image of the separation zone between the GB α and colony D. (e) High magnification image of the GB α shear zone.

The subsurface $GB\alpha$ crack initiation (127) is shown in Fig. 3a and marked A. The specimen was sectioned parallel to line B and the underlying microstructure is shown in Fig. 3b. It can be seen that the initial crack (C) was on the same plane as the $GB\alpha$, which separates colonies D and E. The tensile axis is in the vertical direction of the photomicrograph. The 45° inclination of the $GB\alpha$ made it a favourable location for crack initiation since it parallels the maximum shear

direction. Unlike most $GB\alpha$ in the structure (Fig. 2a and b), this $GB\alpha$ is planar, which also aids crack formation. An angled SEM image which exhibits both the fracture surface and the underlying microstructures in the initiation region is shown in Fig. 3c. The higher magnification image in Fig. 3e shows that the $GB\alpha$ was left intact and that the initial crack occurred along the boundary between the $GB\alpha$ and colony D. Examination of colony D orientation in Fig. 3b and the high magnification image in Fig. 3d shows that the α -platelets were parallel to the $GB\alpha$ plane resulting in the separation on the D side of the $GB\alpha$. The conditions which made this a favourable initiation site are, therefore:

- (a) the GB α is planar,
- (b) it is inclined at 45° to the tensile direction, and
- (c) the α -platelet long axis of the adjacent colony is parallel to the GB α .

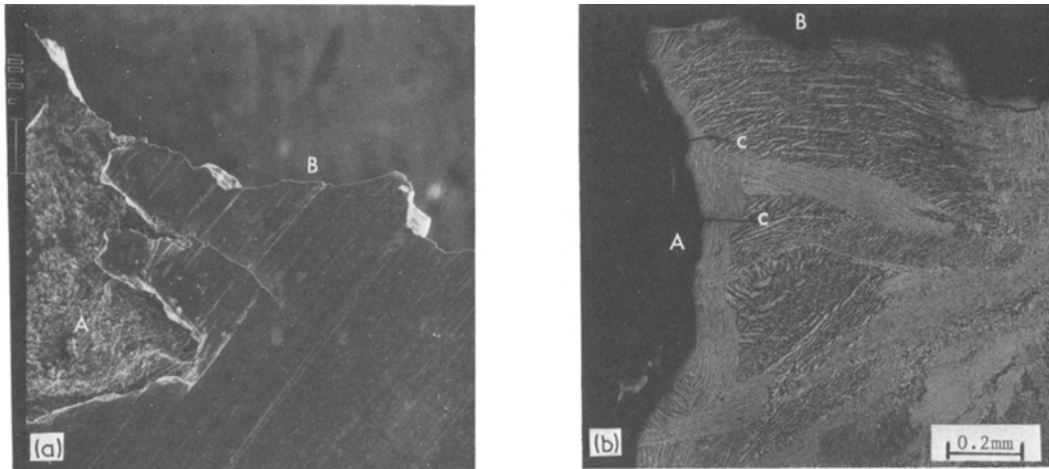
Figure 4 Specimen 127. (a) Large unhealed casting pore (A) on the surface of the specimen, which in spite of its size (1 mm) and its location near the fracture zone, did not initiate the final fracture (B). (b) A section through pore A showing the final fracture B which initiated from the GB α in Fig. 3b. The microcracks C which developed in this region did not grow fast enough to cause the final failure.

Because of the nature of the metal flow in the HIP process, surface porosity cannot be filled and healed. Fig. 4a shows a large surface defect (A) close to the fracture surface (B). In spite of its large size, it did not initiate the terminal crack in specimen 127. A section through this defect (Fig. 4b) reveals a few microcracks (C), none of which matured to final fracture.

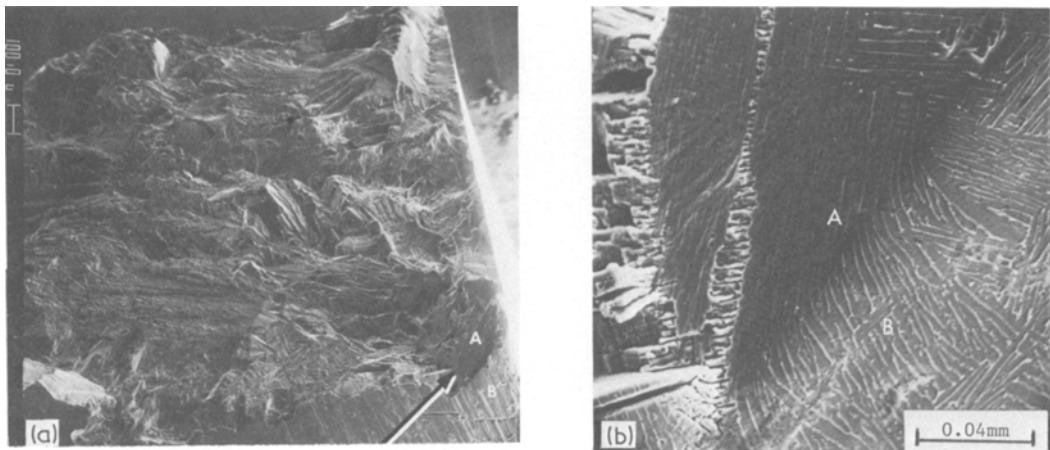
Figure 5 Specimen 131. (a) Shear initiation facet (A) close to the specimen surface (B). The location is marked with an arrow. (b) Section through facet A on plane B shows the microstructure on the etched shear facet A and the underlying microstructure on the section plane B.

The fatigue failure of specimen 131 initiated from a 0.1 mm shear facet close to the surface and is marked with an arrow in Fig. 5a. A section through the initiation site (Fig. 5b) shows that the shear plane A is inclined to the tensile axis and is almost perpendicular to the long axis of the α -platelets on the section plane (B). The fracture surface was slightly etched with Kroll's reagent to reveal the colony platelet structure.

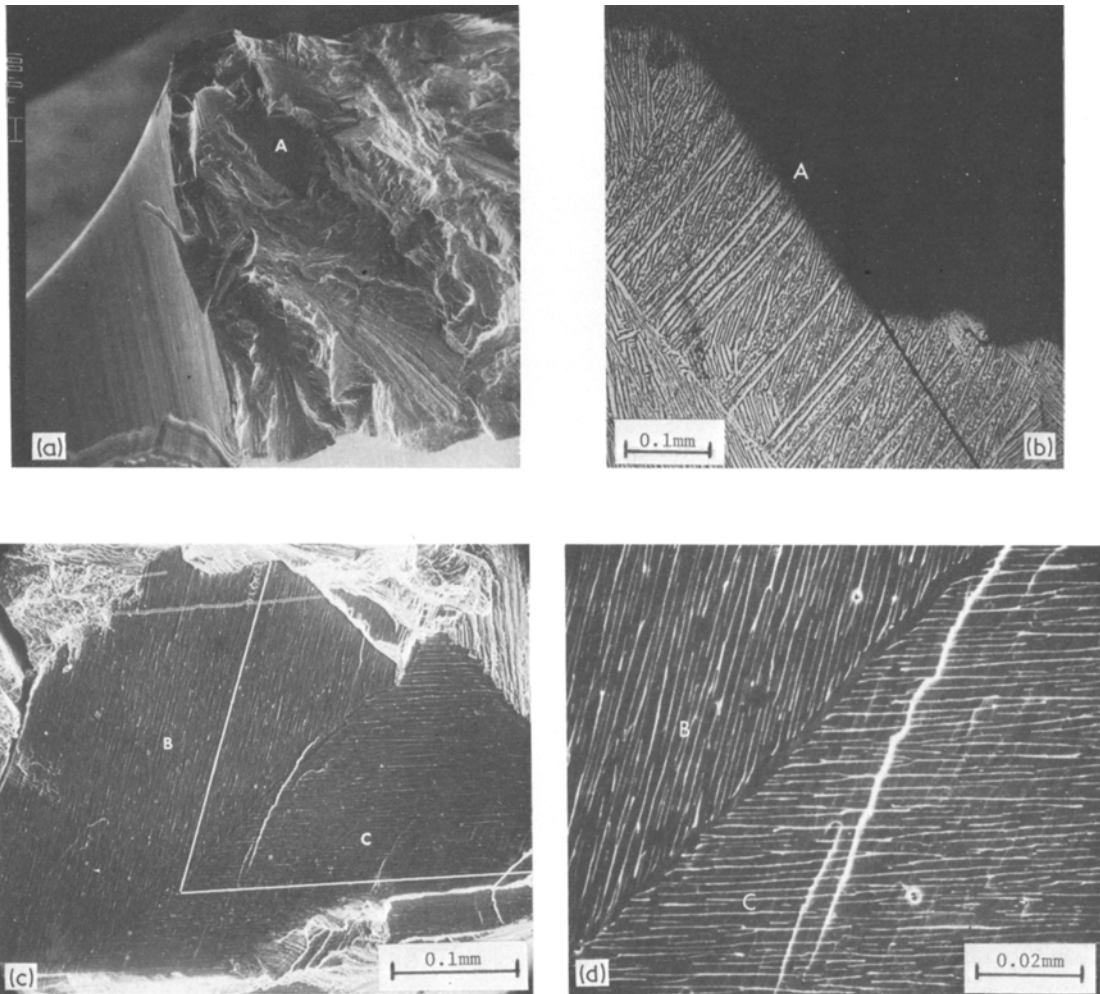
Figure 6 Specimen 126. (a) Large shear initiation facet (A) close to the specimen surface. (b) A section through the facet A showing shear-across-colony initiation. (c) SEM image of the etched facet A showing two colony orientations B and C at a 70.5° angle. (d) High magnification SEM image showing the α/β interface details of colonies B and C along their boundary.

The initiation site of specimen 126 (Fig. 6a) is similar to 131 (Fig. 5a); however, the shear facet is larger (0.5 mm) and is inclined at 30° to the tensile axis (Fig. 6b). Examination of the mating fracture surfaces showed that there are two colony orientations (B and C) on the facet plane (Fig. 6c). This and the high magnification image in Fig. 6d were photographed from the etched surface of facet A. The facet was accurately placed in the SEM specimen stage so that it was parallel to the image plane, thus enabling the measurement of the angle between the α/β interfaces of the two colonies. The angle is shown in Fig. 6c and was measured to be 70.5°. The surface preparation and the image recording are described in more detail elsewhere [17].

The shear facet of specimen 126 (Fig. 6a) is larger than the average colony size of the healed pore zones (Fig. 2b). The etched surface in Fig. 6c reveals that the shear is across two colonies with a 70.5° trace orientation relationship on the fracture plane. The α -platelet orientation of each colony is related to the prior beta grain (PBG) orientation through one of the 12 possible variants of the Burgers relation [21, 22]:
