Flight Service Environmental Effects on Composite Materials and Structures

H. BENSON DEXTER

DONALD J. BAKER

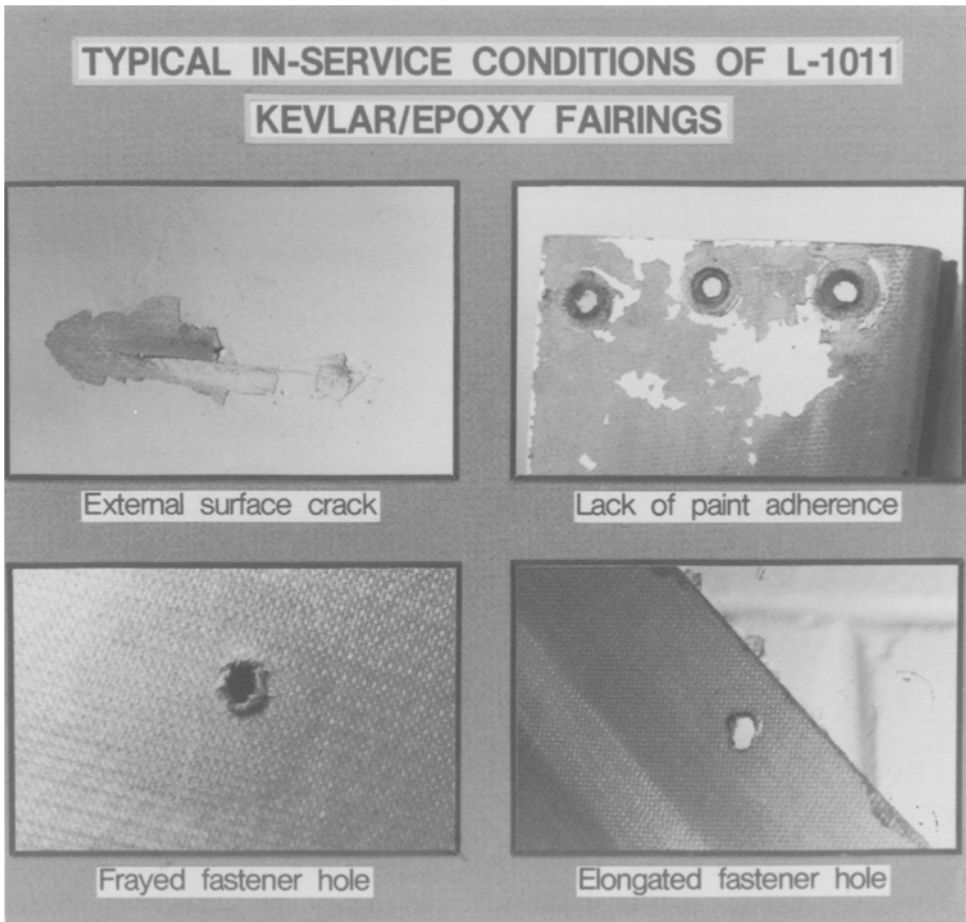
Figure 6. Typical in-service conditions on L-1011 kevlar/epoxy fairings.

The photographs shown in figure 6 indicate various types of damage incurred by the L-1011 Kevlar-49/epoxy fairings in service. Minor impact damage from equipment and foreign objects has been noted on several fairings, primarily the honeycomb sandwich wing-to-body fairings. Surface cracks and indentations have been repaired with filler epoxy and, in general, the cracks have not propagated with continued service. Paint adherence has been a minor problem, particularly for parts that have been in contact with hydraulic fluid. Frayed fastener holes have been noted in several fairings, primarily due to nonoptimum drilling procedures and improper fit. Elongated holes have been noted, primarily due to improper fit and nonuniform fastener load distribution. There have been no moisture intrusion problems with the Kevlar-49/epoxy fairings, and they have performed similar to production fiberglass/epoxy fairings. The fairings are still in service, and the three participating airlines are monitoring their performance during normal maintenance inspections.

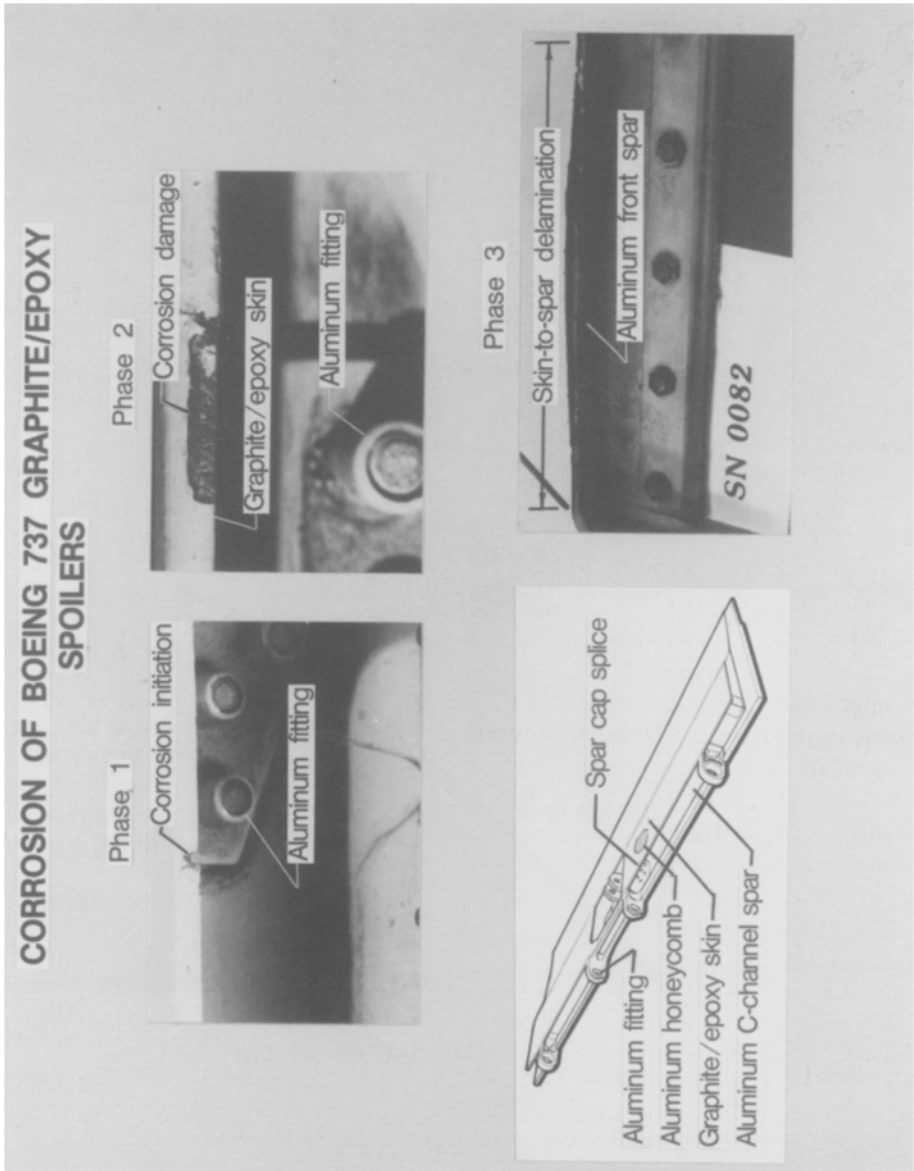
Figure 7. Corrosion of Boeing 737 graphite/epoxy spoilers.

A typical corrosion damage scenario for a splice between the center hinge fitting and spar is shown in figure 7. The corrosion damage can be characterized by three phases of development. Phase 1 involves corrosion initiation at an aluminum fitting or at the aluminum spar splice. The corrosion initiates due to moisture intrusion through cracked paint and sealant material. If the corrosion products are not removed and new sealant applied, the damage progresses to phase 2 where moisture penetrates under the graphite/epoxy skin along the aluminum C-channel front spar. Normal service loads combined with moisture contribute to crack growth and subsequent corrosion. If the phase 2 corrosion is not repaired, the damage progresses to phase 3 where extensive skin-to-spar separation takes place. Phase 3 corrosion can result in significant strength and stiffness loss. It takes about 2 years for the corrosion to progress from phase 1 to phase 3. Design changes and improved sealing methods could prevent corrosion damage in composite-metal interfaces.

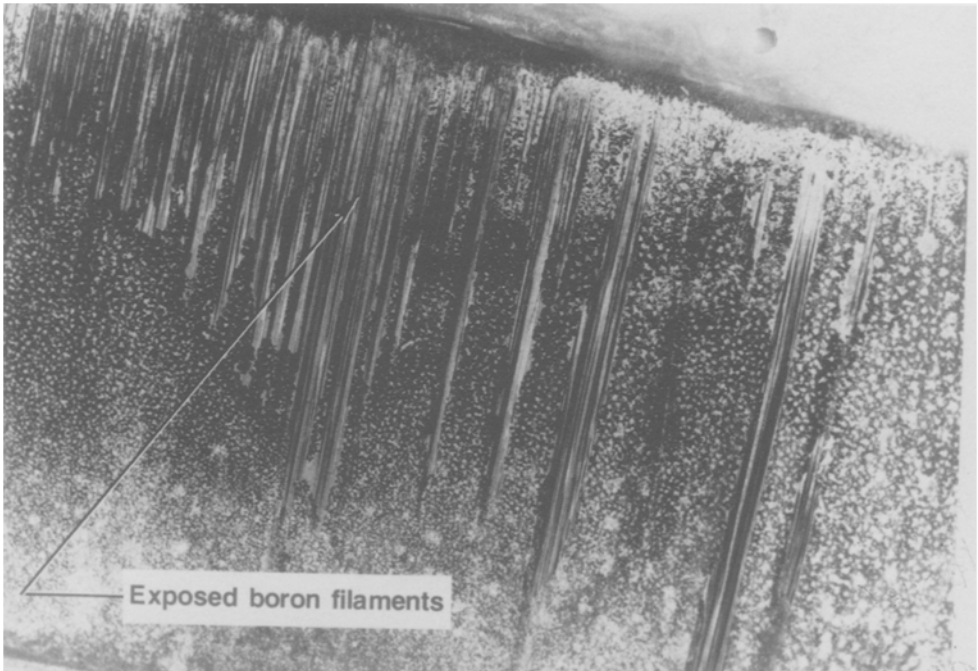
Figure 10. Corrosion damage to DC-10 boron/aluminum aft pylon skin panel.

One of the three boron/aluminum skin panels on the DC-10 aircraft was removed from service after 7 years because of corrosion damage. The photograph shown in figure 10

indicates that the outer layer of boron filaments on the inside of the panel was almost completely exposed. The panel contained a light residue of ester oil similar to engine oil; however the specific corrodent was not identified. A second panel also had some corrosion damage and a small crack, but the panel is still in service and is being monitored closely to check for crack growth and further corrosion damage. The crack in the panel was probably caused by exterior mechanical damage during removal and reinstallation of the panel during inspection. It has been concluded that the method of corrosion protection used was inadequate. In general, the boron/aluminum panels have not performed as well as similar production titanium panels. Additional details on the DC-10 boron/aluminum skin panels are presented in [8].

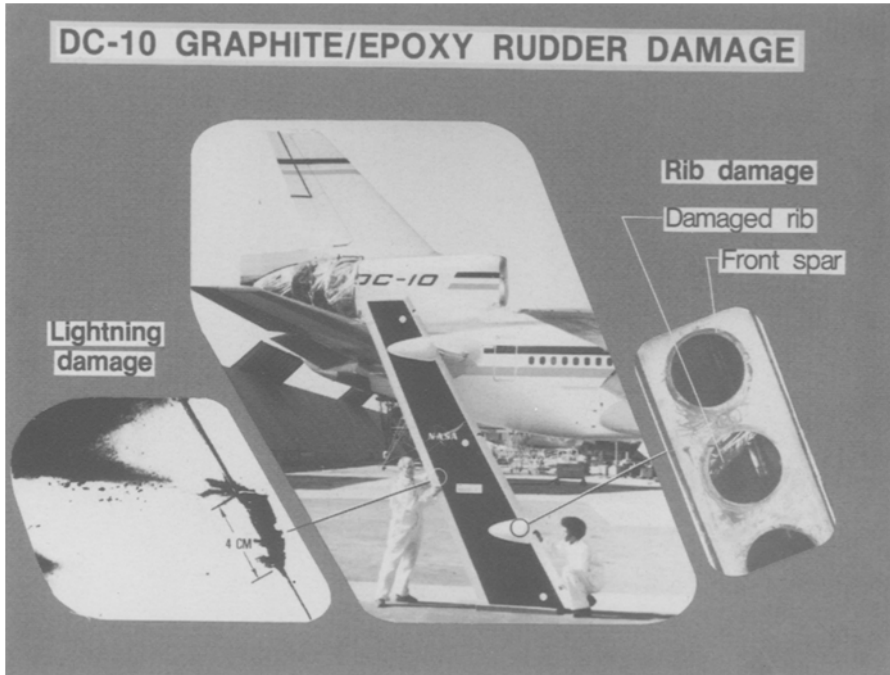
Figure 11. DC-10 graphite/epoxy rudder damage.

There have been several incidents which required rudder repairs. The damage sustained by the rudders included minor disbonds, rib damage due to ground handling, and skin damage due to lightning strike. Figure 11 shows minor in-service lightning strike damage to the trailing edge of a rudder and rib damage that occurred while a rudder was off the

aircraft for other maintenance. The lightning strike damage was limited to the outer four layers of graphite/epoxy and a room temperature repair was performed in accordance with procedures established at the time the rudders were certified by the FAA. The rib damage was more extensive and a portion of a rib was removed and rebuilt. A detailed discussion of the repair procedure is given in [9].

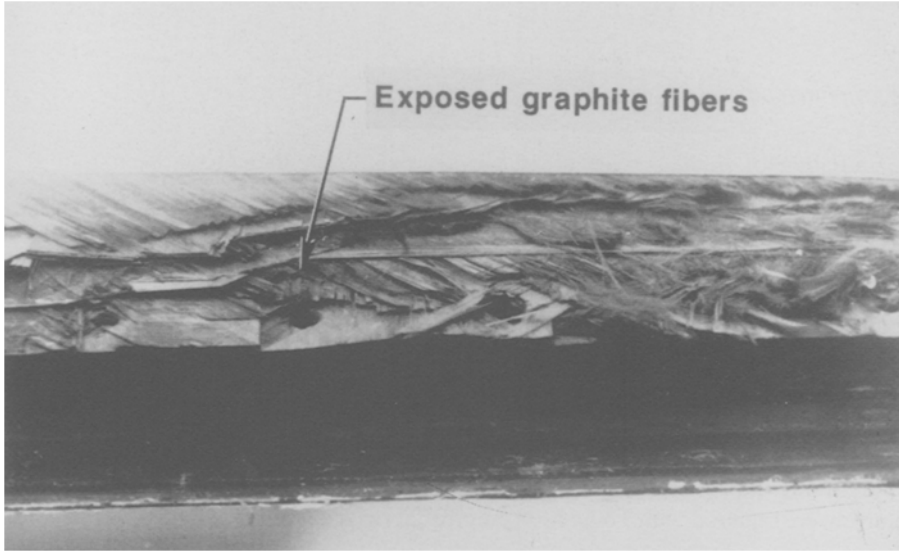
Figure 12. Lightning strike damage to DC-10 graphite/epoxy upper aft rudder trailing edge.

More extensive lightning damage was sustained on another graphite/epoxy rudder as shown in figure 12. Upon inspection of the rudder, it was discovered that the lightning protection strap was inadvertently left off after the previous maintenance check. The skin in the damaged area is eight plies thick over an 8-ply spar cap. Fiber damage and resin vaporization extended through the skin forward of the spar, and the skin and spar cap aft of the rear spar were completely destroyed. Details of the repair procedures are given in [10].

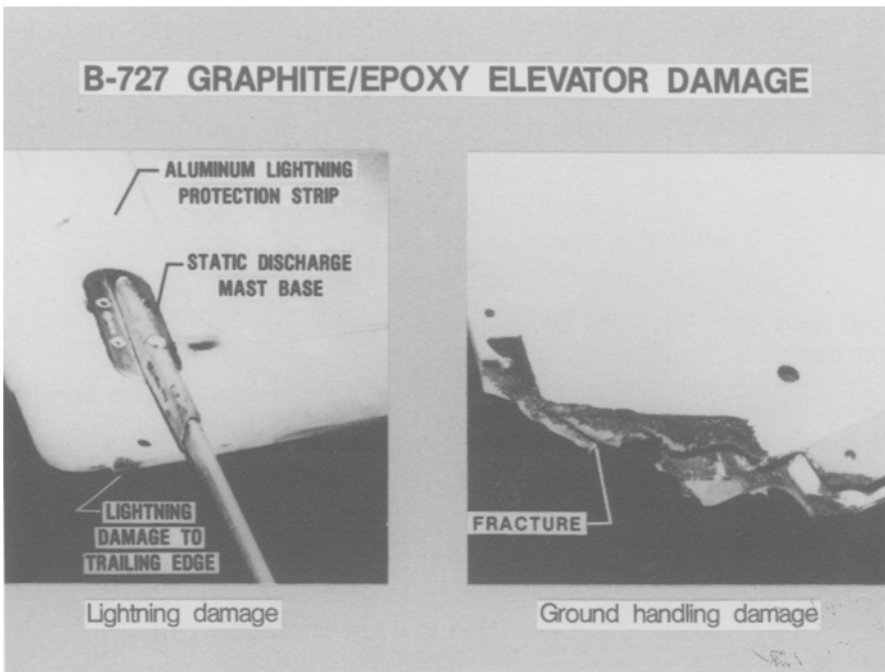
Figure 14. B-727 graphite/epoxy elevator damage.

Since initiation of flight service of 10 elevators in 1980, there have been four B727 graphite/epoxy elevators damaged by minor lightning strikes and two elevators damaged during ground handling. Damage from lightning strikes ranged in severity from scorched paint to skin delamination. Figure 14 shows typical lightning damage to the trailing edge of an elevator and trailing edge fracture of another elevator caused by impact from a deicing apparatus. The most severe damage to an elevator occurred when the static discharge probe of one B727 penetrated the elevator of another B727 during ground handling. Skin panels were punctured, four holes in the lower surface and one hole in the upper surface, and the lower horizontal flange at the front spar was cut inboard of the outboard hinge. All the elevator repairs were performed by airline maintenance personnel.

The lightning damage was repaired with epoxy filler and milled glass fibers. The skin punctures were repaired with T300/5208 prepreg fabric and Nomex honeycomb core plugs.

The front spar was repaired with a machined titanium doubler, which was mechanically fastened to the lower skin flange of the spar chord. The repaired graphite/epoxy elevators are in storage and can be reinstalled for continued service. Details of the design and fabrication of the graphite/epoxy elevators are given in [11].

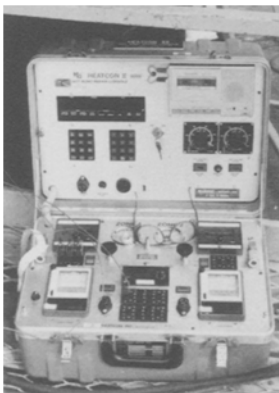
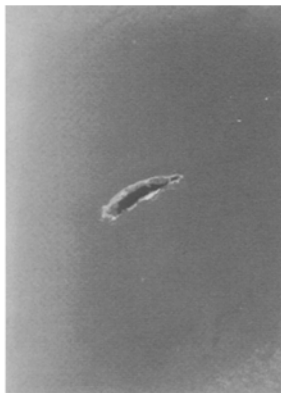
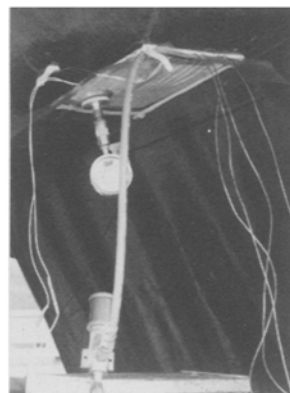
Figure 15. In service repair of B-737 graphite/epoxy horizontal stabilizer lower skin.

There have been three reported damage incidents on the B737 horizontal stabilizers. De-icer impact damage was induced on the upper surface panel of both stabilizers on one aircraft. These impacts were minor and damage was limited to the skin, not affecting the stiffener elements. The third stabilizer was damaged when a broken fan blade penetrated the lower surface of the stabilizer. The penetration missed the stiffener elements and damage was limited to a small area of the skin panel. All three of the stabilizers were repaired on the aircraft using wet lay-up cure techniques per specifications developed by Boeing. Figure 15 shows details of the in-service repair process.

Lower skin puncture

Repair console

Elevated temperature vacuum cure

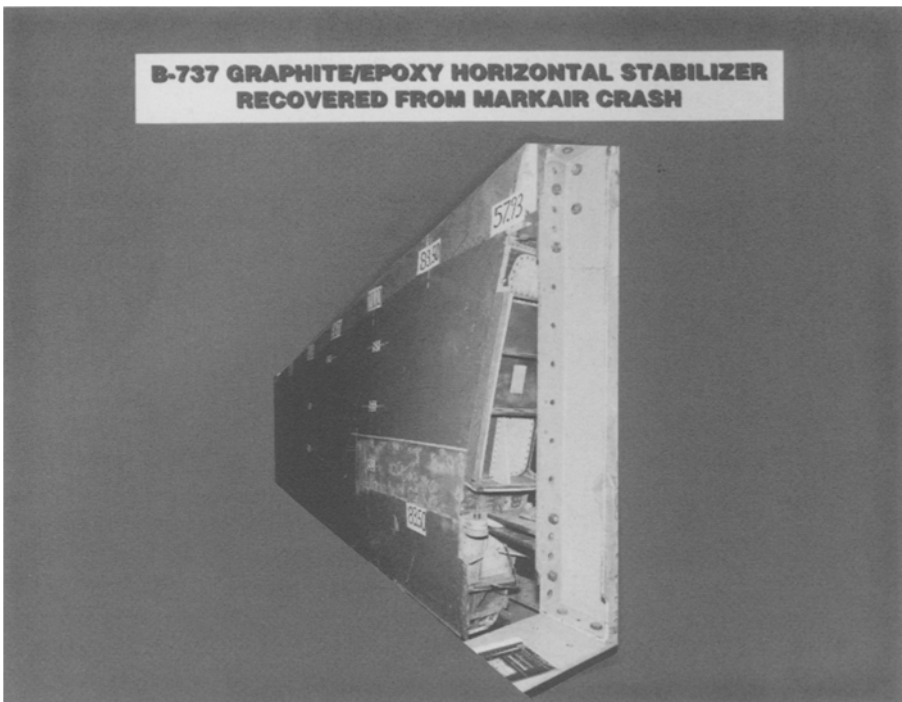
Figure 16. B-737 graphite/epoxy horizontal stabilizer recovered from Markair crash.

Figure 16 shows a photograph of one of the stabilizers. No “non-crash” induced delaminations were found and there was no corrosion of metal-composite interfaces. These results indicate the effectiveness of the fiberglass isolation system that was used to prevent galvanic corrosion between graphite and metal parts. Boeing plans to conduct residual strength tests on material coupons machined from skin panels and compare results with baseline tests. Details on the development of the graphite/epoxy horizontal stabilizers are reported in [13].
