Continuous Strain Monitoring in the Rock Foundation of a Large Gravity Dam

K. Kovári

Federal Institute of Technology, Zurich, Switzerland

Summary

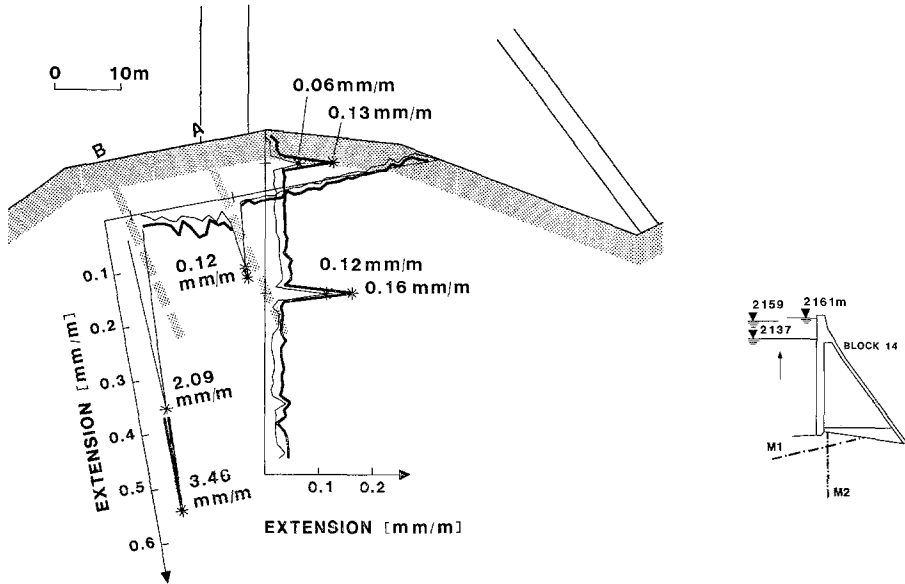
be manifested as singularities in the measured strain distribution curves. Indeed along all six measuring lines such peak values occurred occasionally which doubtlessly point to the presence of active joints. In Figs. 8 to 11 they are marked by a star and provided with a figure indicating the amount of the observed deformation. Before going into details of the interpretation of measurement results, it should be emphasized that the most important finding of the measuring campaign was the detection of the peaks in the strain distribution. Very soon it became clear that only a few active joints requiring special attention were present in the foundation rock of the Albigna dam. Thus, the rock mass below behaves mainly as a homogeneous monolithic body. The active joints designated by A and B in Figs. 8 to 10 belong to the principal joint set 3 in Fig. 4. The joint A intersects both the sub-horizontal measuring lines (M1 and M3) and the vertical ones (M2 and M4). In the area of block 14 the borehole M2 is obviously too short to be intersected by the active joint B. The joint A is identical with the longitudinal crack discovered at an early stage of the investigations and mentioned in

Fig. 8. Distribution of strain along the boreholes M1 and M2 due to increase of water level

The question of whether only one single joint or more of them opened and closed within the 1 m base length of the measurements causing a deformation of 3.67 mm/m (Fig. 10) is of no practical relevance. Let us now consider more closely the observed strain distributions in Fig. 8. The striking feature of this figure is the great sensitivity of the strain developments to the increase of the water level at this final stage of reservoir filling. The strains brought about by the last 2 m in water level increase are about the same as the strains caused by the preceding 22 m in the filling sequence.

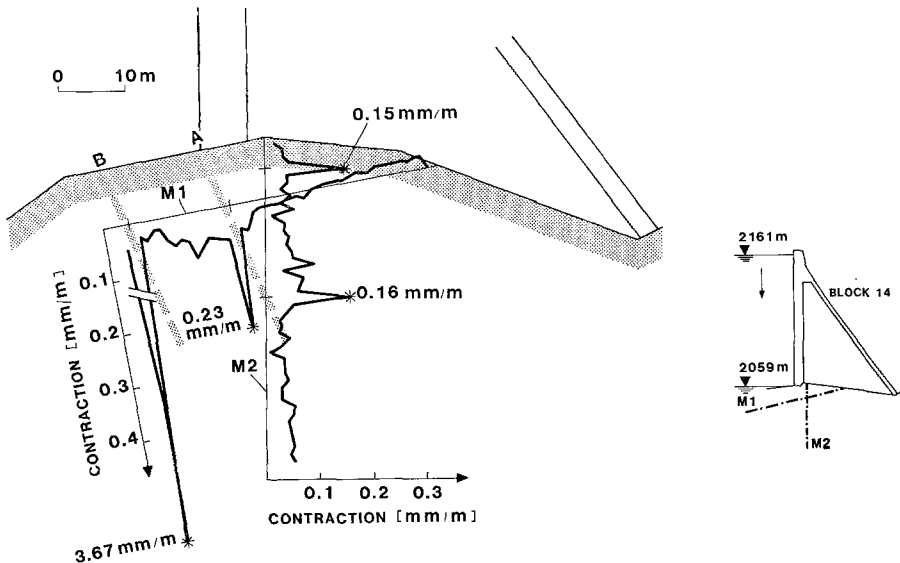
Fig. 9. Distribution of strain along the boreholes M1 and M2 due to complete fall in water level

From the observations of the crest deflection and also from previous borehole extensometer measurements, it was noticed that large deformation of the structure starts only at a water level of approx. 2140 m. It is, therefore, not surprising to see from Fig. 9 that the emptying of the reservoir causes a complete rebound of these strains shown in Fig. 8. The three installed boreholes M3, M4 and M5 at block 16 (Fig. 10) permits a rather complete picture of the deformational behaviour of the bedrock to be obtained. Apart

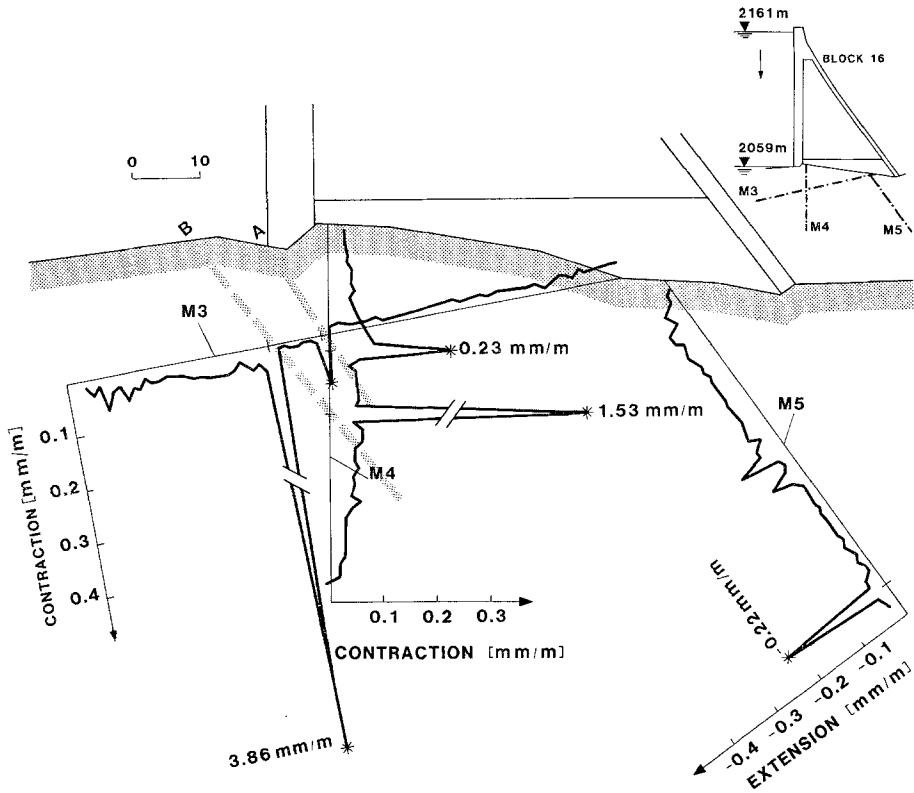
Fig. 10. Distribution of strain along the boreholes M3, M4 and M5 due to complete fall in water level

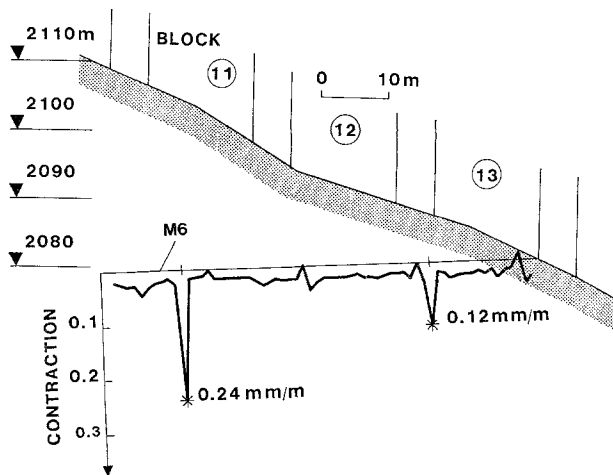
Fig. 11. Distribution of strain along the borehole M6 due to complete fall in water level

principal joint sets 1 and 2 at a steep angle. The remarkable peak in the strain distribution may be an indication for the active joint which was most probably one of the causes for the difficulties arising during the first reservoir filling in 1960.

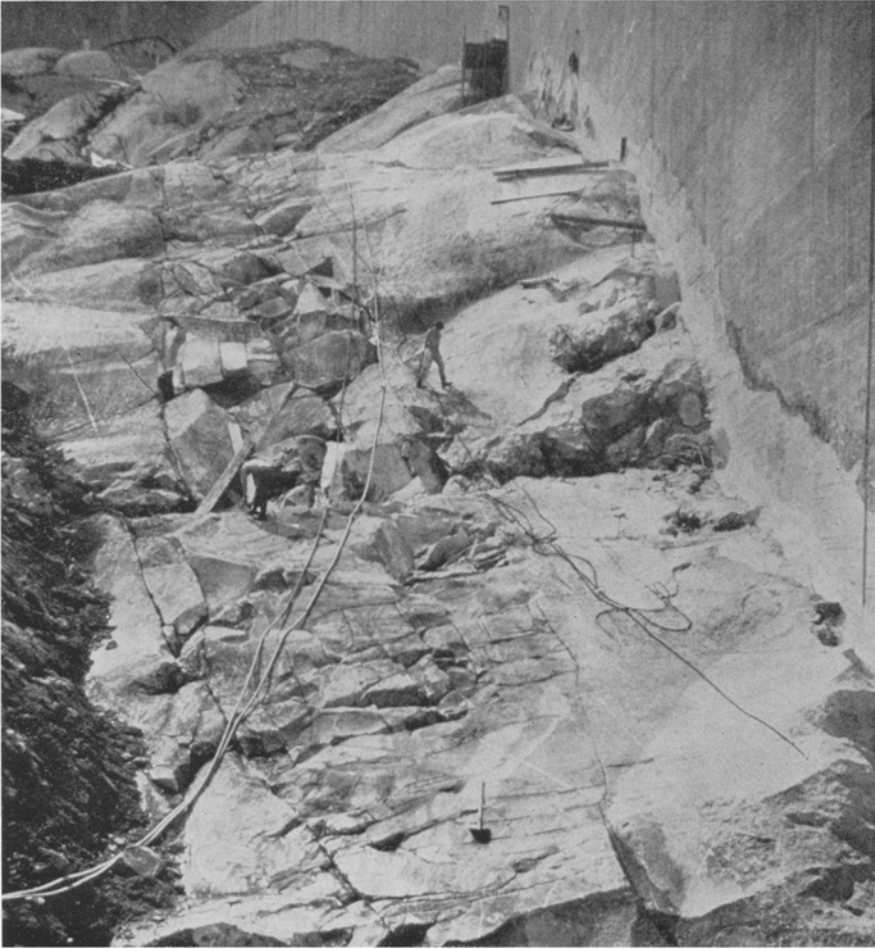
of a mud layer from the reservoir bottom adjacent to the toe of the dam, a set of longitudinal cracks on the rock surface could be observed which were obviously associated with the above-mentioned open joint B (Fig. 12).

Fig. 12. Longitudinal cracks on the rock surface at the upstream toe of the dam seen after removal of mud

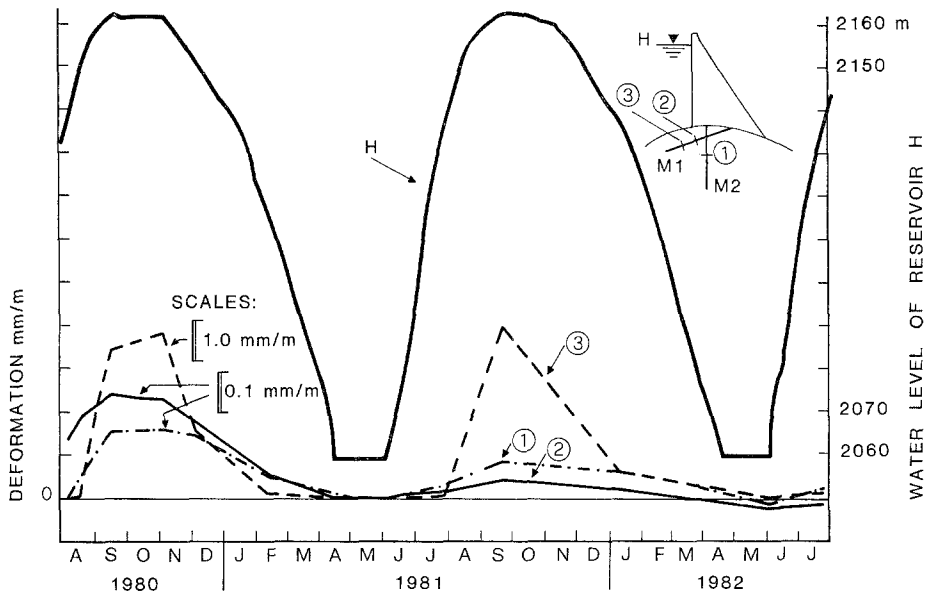
Fig. 13. Relation between reservoir water level elevation, time, and the opening of the particular joints 1, 2 and 3 at block 14

In Fig. 13 the opening and closing of some selected active joints at block 16 are related to the reservoir water level and time. It can be seen that the first readings with the Sliding Micrometer were performed in the period August 1980 and they continued up to the end of 1982. The frequency of the readings decreased with time because later the measurements only served for control purposes. The remedial measures to stop the underseepage of the dam were also carried out in the summer of 1980. They resulted in a sharp decrease of water loss (Fig. 5). The primary purpose of the measures taken was to prevent the water from direct access to the longitudinal open joints. Therefore, a neoprene water sealing was installed reaching about 4 m high on the dam heel and extending to a maximum of 8 m on the cleaned rock surface thus forming an L shape. The width of the neoprene strip varied along the dam heel according to the distance of the B joints from the dam. The total length of this water sealing carpet amounted to 240 m, which accounted for about 60% of the crest length. To ensure a tight sealing of this extraordinary size different technological problems had to be solved. Preliminary investigations concentrated on the question of adhesion between neoprene and concrete and neoprene and rock. The prevention of squeezing of the neoprene into open fissures acted upon by the 100 m reservoir head was a major concern. Special attention was paid to allow for large local strains in the vicinity of the active joints A and B exhibiting opening and closure.

The loss of water measured on the left bank valley side north of the block 11 could be decreased by these measures from 11 l/s to max. 1.5 l/s. The joint deformations (Fig. 13) also decreased except from the active joint B as indicated by the curve 3 which means that the water must have found its way to this joint. Fortunately, due to its sufficient distance from the heel of the dam, this joint has no influence on the underseepage of the dam. It obviously does not reach the injection curtain.
