The potential for catastrophic dam failure at Lake Nyos maar, Cameroon

JP Lockwood¹, JE Costa², ML Tuttle³, J Nni⁴, and SG Tebor⁵

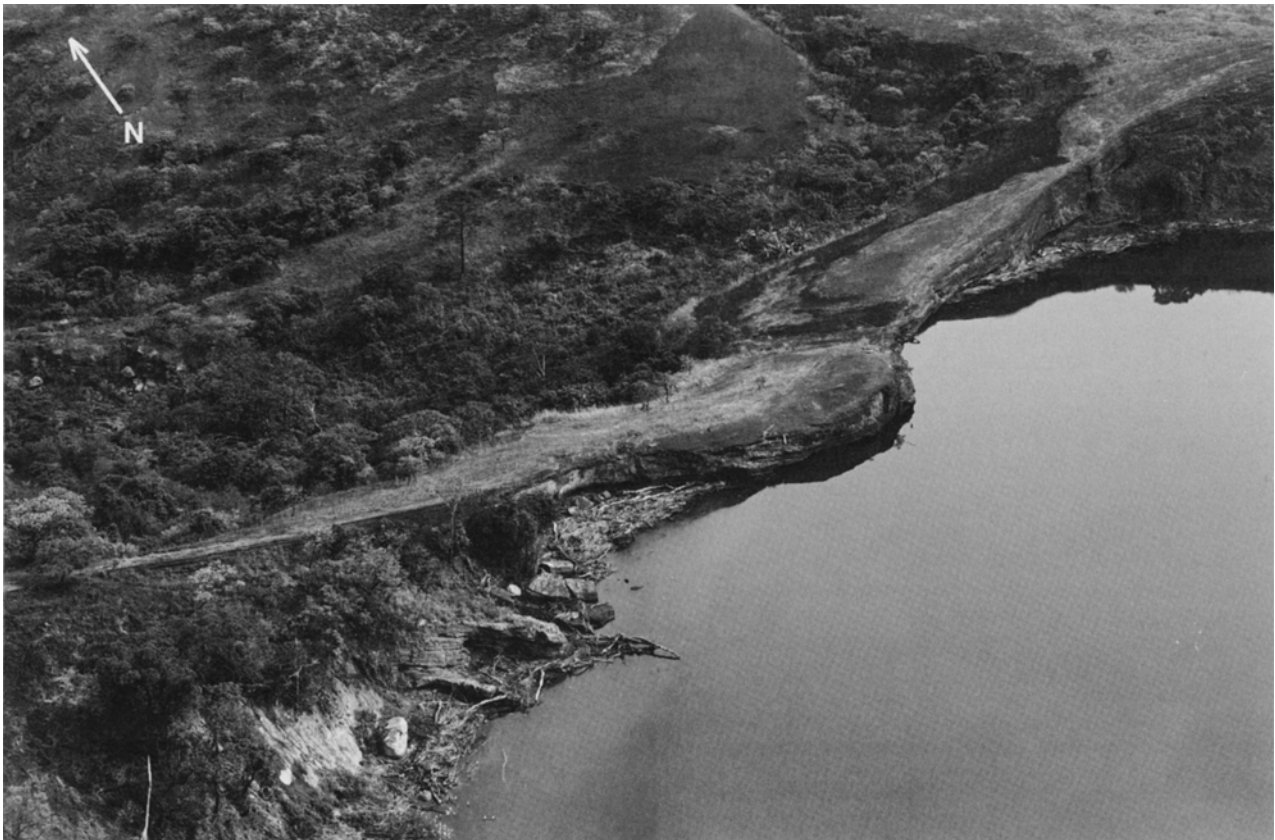
Lake Nyos has an area of 1.49 km², is 208 m deep, and has a water volume of about 132 million m³. The lake waters are dominantly impounded by granitic bedrock to the east, south, and west (Kling et al. 1987, Fig. 2), but to the north the upper 40 m of the lake is bounded by a narrow natural dam composed of friable pyroclastic deposits. The natural spillway across the dam's crest is the lake's only surface outlet (Fig. 2).

During the rainy season (May–October), lake level rises, and a 15-m-wide stream flows across the 45 m width of the natural dam, then drops over a 25-m-high overhanging cliff. During the dry season (November–April), the lake level drops 1–2 m, and no water flows over the dam. The burst of gas from the lake in August 1986, generated large surface-water waves, and one 6-m-high wave washed over the dam. Remarkably, the dam withstood this wave overtopping without eroding and breaching; many natural dams might have immediately failed (Costa and Schuster 1987).

Fig. 2. Lake Nyos natural dam. View northeastward

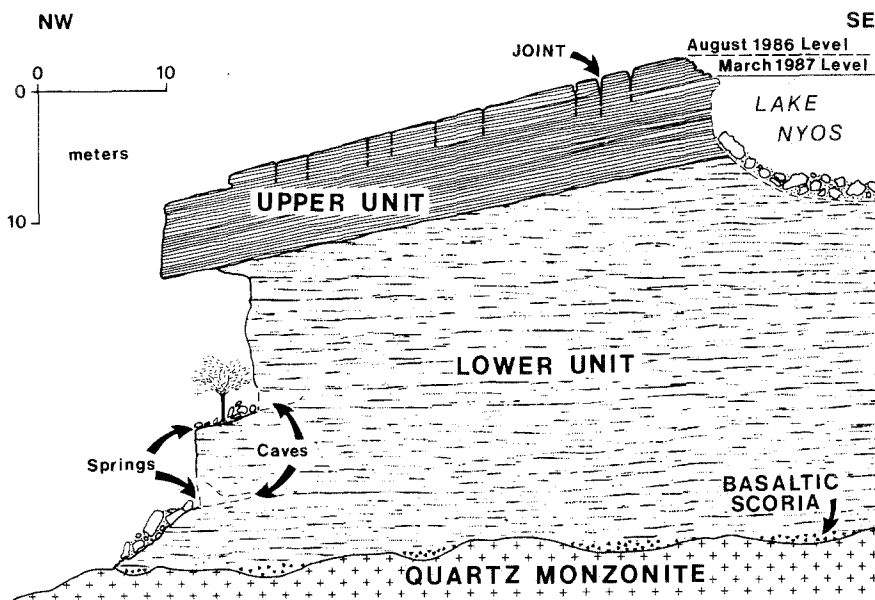
The pyroclastic rocks that form the dam can be divided into upper and lower units (Fig. 3).

Fig. 3. Cross section of the natural dam, showing upper and lower units of pyroclastic deposits as of March, 1987 (bathymetric data unavailable). Physical dimensions of the dam and surface positions of joints are based on a field survey

The lower unit portion of the dam face is a zone of continuous water seepage. Several caves, 1–3 m in diameter, extend at least 10 m into the lower unit face (Fig. 3). These caves are apparently formed by seepage erosion, although no sediment was noted in the spring waters during our investigation. The caves' rate of advance toward the lake is unknown, but they obviously have the potential to cause failure of the dam by "piping" (Costa and Schuster 1987).

The largest springs (estimated flow of a few l/sec) are associated with these caves, and are concentrated at two horizons — one 4 m above the dam base and the other about 12 m above the base (Fig. 3). Waters from the lower springs leave red-orange deposits of iron hydroxides, both as stream precipitates and as centimeter-long "stalactites" where water issues from overhangs. Waters from the upper springs are clear and leave no precipitates along their flow paths. The absence of iron hydroxide in the upper dam spring waters suggests that these springs are derived from above the mesolimnion². The stream that flows from the combined springs is stained red orange for more than 100 m downstream. These iron oxide precipitates demonstrate that the pyroclastic dam is highly permeable and that waters from Lake Nyos are seeping through the dam.

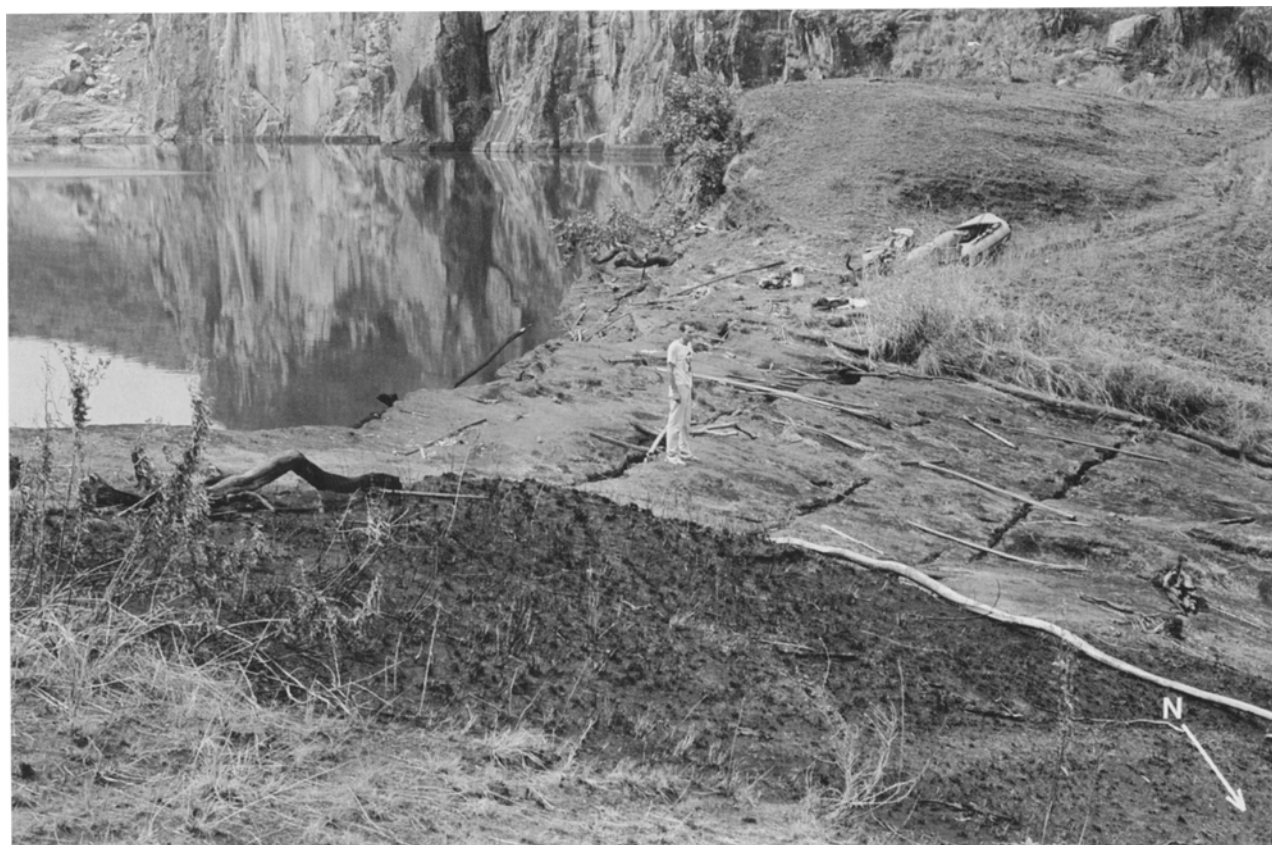
Fig. 4. Upper surface of dam, showing well-developed joints. View southwestward

The downstream face of the dam, hidden by a waterfall during the rainy season, was examined in March 1987, when dry-season weather and seepage had lowered the lake level to 1.7 m below the dam lip (Fig. 3). The resistant upper unit caprock of the natural dam is undermined wherever its margins are exposed. In response to this undermining, the upper unit fails as large blocks controlled by the N. 40° E.-trending joint system (Fig. 4). The base of the waterfall is littered with giant blocks of upper unit ash.

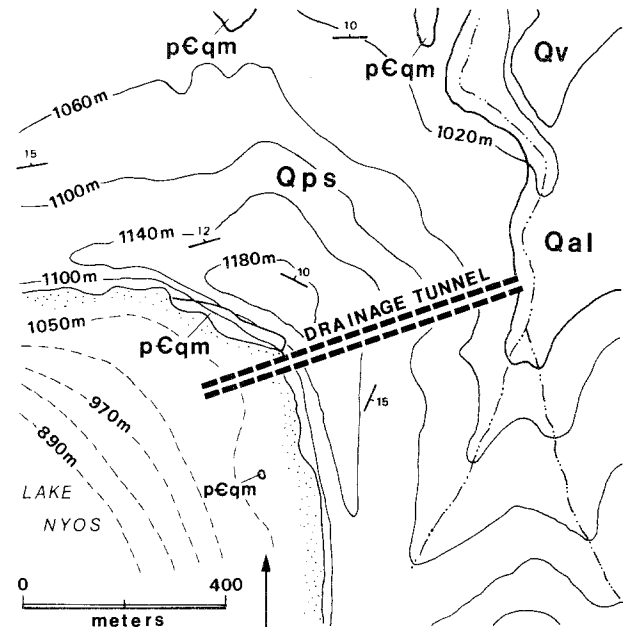
Fig. 10. Geologic map of northeast corner of Lake Nyos, showing location of possible drainage tunnel. Qv, pre-maar effusive volcanic rocks, other Symbols as in Fig. 7

In the case of Lake Nyos, a 680-m-long drainage tunnel appears to be feasible through the northeast crater wall (Figs. 6, 10). Such a tunnel could be driven almost entirely in the granitic rock that underlies the weak crater rim pyroclastic deposits (Fig. 11), and thus avoid the perils of soft-rock tunneling and the need for extensive support and lining. The tunnel could intercept the lake about 65 m below its current surface.

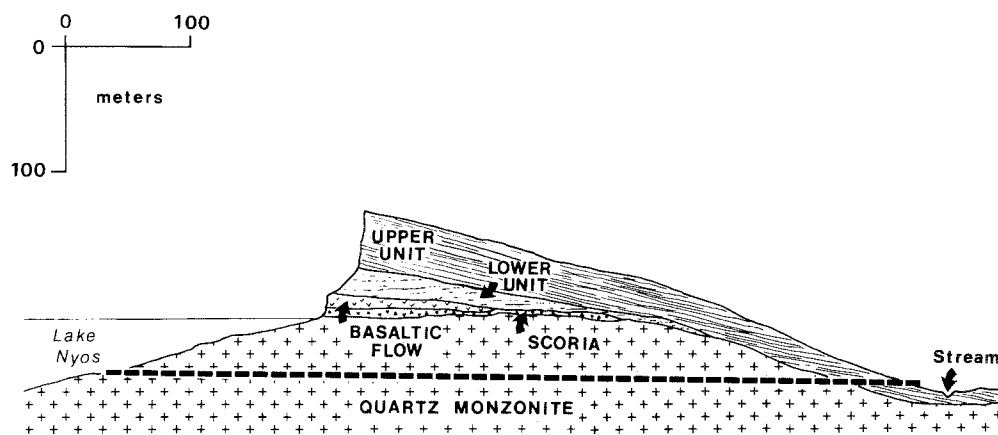
Fig. 11. Geologic cross section through the east rim of Lake Nyos crater, showing location of possible drainage tunnel
