# Failure of a Mine Waste Dump in Zimbabwe: Causes and Consequences

**ABSTRACT** / A combination of factors are considered important in causing the failure and subsequent development of a flowslide of a gold mine waste dump (or tailings dam) at Arcturus, near Harare, Zimbabwe. These factors comprise poor basal drainage, steep perimeter walls, saturation of the walls and basal sediments through continued spigoting of slurry during a period of heavy rainfall, and the effect of this saturation on the tailings. Properties of the tailings, eyewitness accounts, documentary evidence, and site characteristics are discussed. The failure and subsequent development of a fatal 300-m flowslide are reconstructed in a five-phase developmental model. The general applicability of the results is discussed.

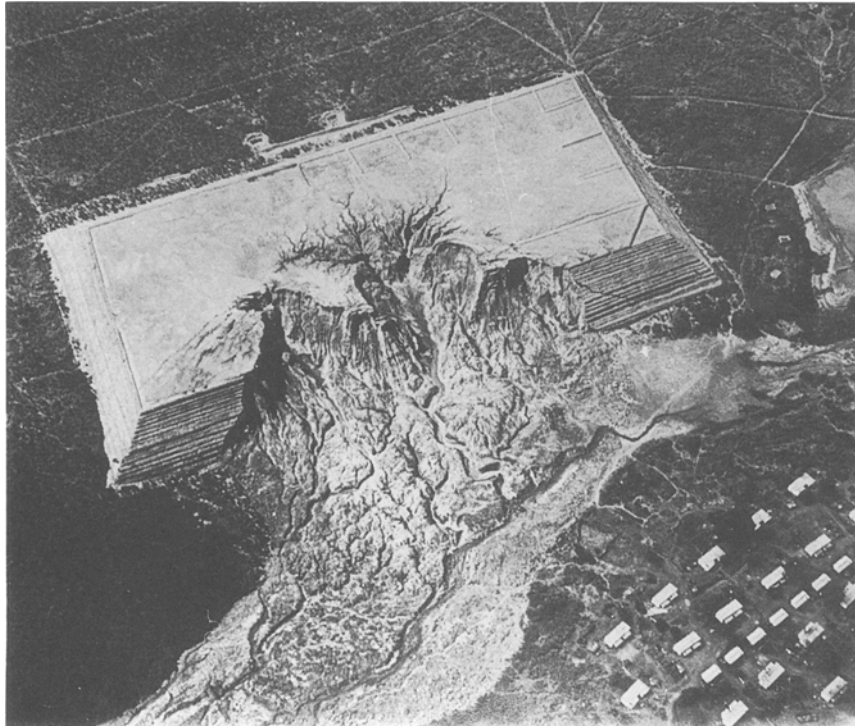
At about 1930 h on 31 January 1978, a breach approximately 55 m wide suddenly developed in the west wall of a large waste dump at Arcturus mine. An estimated 30,000 tons of debris was evacuated from this breach, forming a flowslide about 300 m in length (Fig. 2); This demolished two pole-and-mud huts, killing one child and injuring another. The official inquiry (Ministry of Mines unpublished data) on the failure of the waste dump focused primarily on the issue of the heavy rainfall preceding the collapse and the ability of the penstocks (vertical drains) to cope with the abnormal accumulation of water on top of the dump. The inquiry instigated by the then Rhodesia Department of Mines concluded that provided the penstocks had remained intact, they could have siphoned off the excess water from both the slurry and the rainfall, thus ruling out the development of a large pond on the surface of the dump. Failure was blamed on the steep perimeter walls of the dump and, as a result, it was recommended that

**Figure 2.** Oblique air photograph taken in 1978 shortly after collapse of the waste dump. The main complex and wash apron of the flow-slide are clearly shown. Small paddocks to direct slurry towards the central pond can be seen together with a short retaining wall across the southwestern corner (right-hand side) of the dump and remnants of the retaining wall built parallel to the west wall a few days prior to failure (see Table 1 and Fig. 8). Mine workers' dwellings in the lower right of the photograph indicate scale.

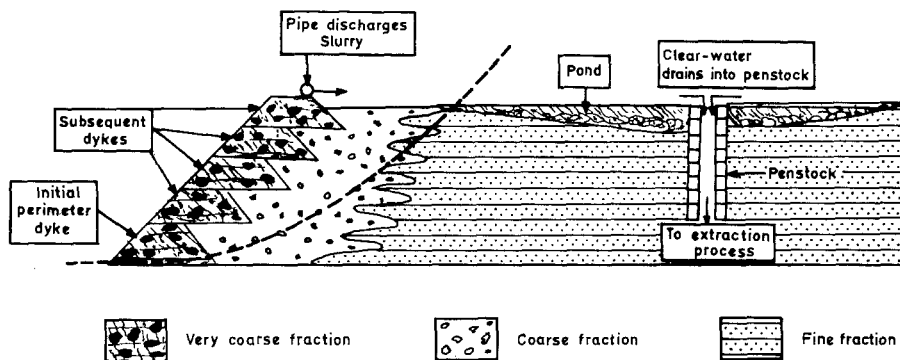
**Figure 3.** Method of waste dump (tailings dam) construction (modified after MacKechnie 1975). Note position of hypothetical failure arc passing through fine fraction.

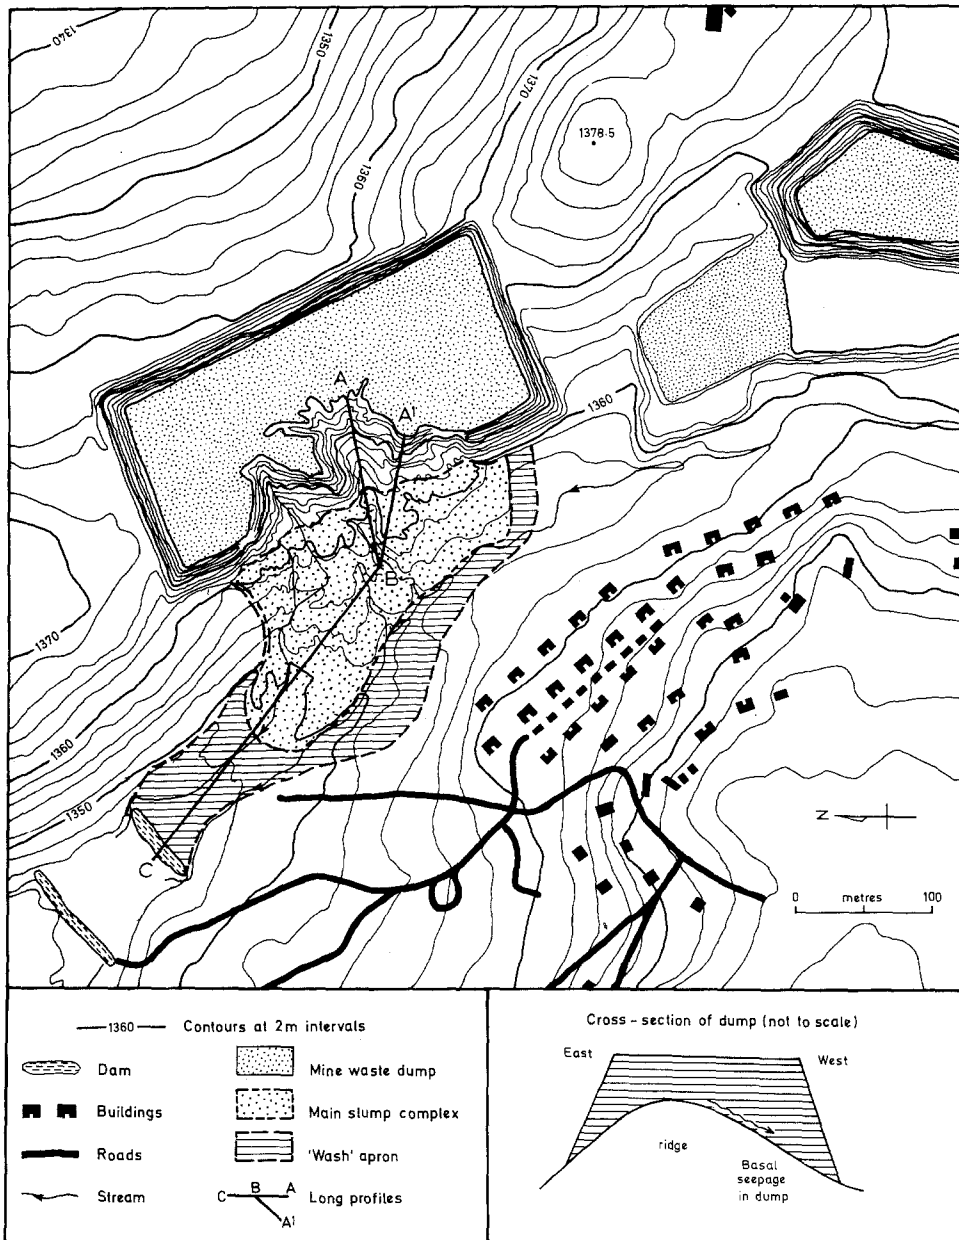
The dump is located on a low saddle-shaped ridge between two small hills (Fig. 4); this ground slopes eastward and westward of the long axis of the dump at angles of 5–6°. The basal drainage beneath the dump as well as the internal seepage, however, are predominantly towards the central part of the western perimeter wall that eventually collapsed (Fig. 4, inset).

**Figure 4.** Waste dump, flowslide, and surroundings, Arcturus Mine. Inset shows likely basal seepage routes in the dump.

drainage during the initial stages of construction of the dump. Basal seepage would have been concentrated towards the central parts of the two longer sides of the dump, particularly the west wall (Fig. 4, inset). The inadequacy of basal drainage is indicated by the reported common practice of periodically easing internal drainage by driving steel pipes into the dump walls, especially in the two to three years prior to failure.

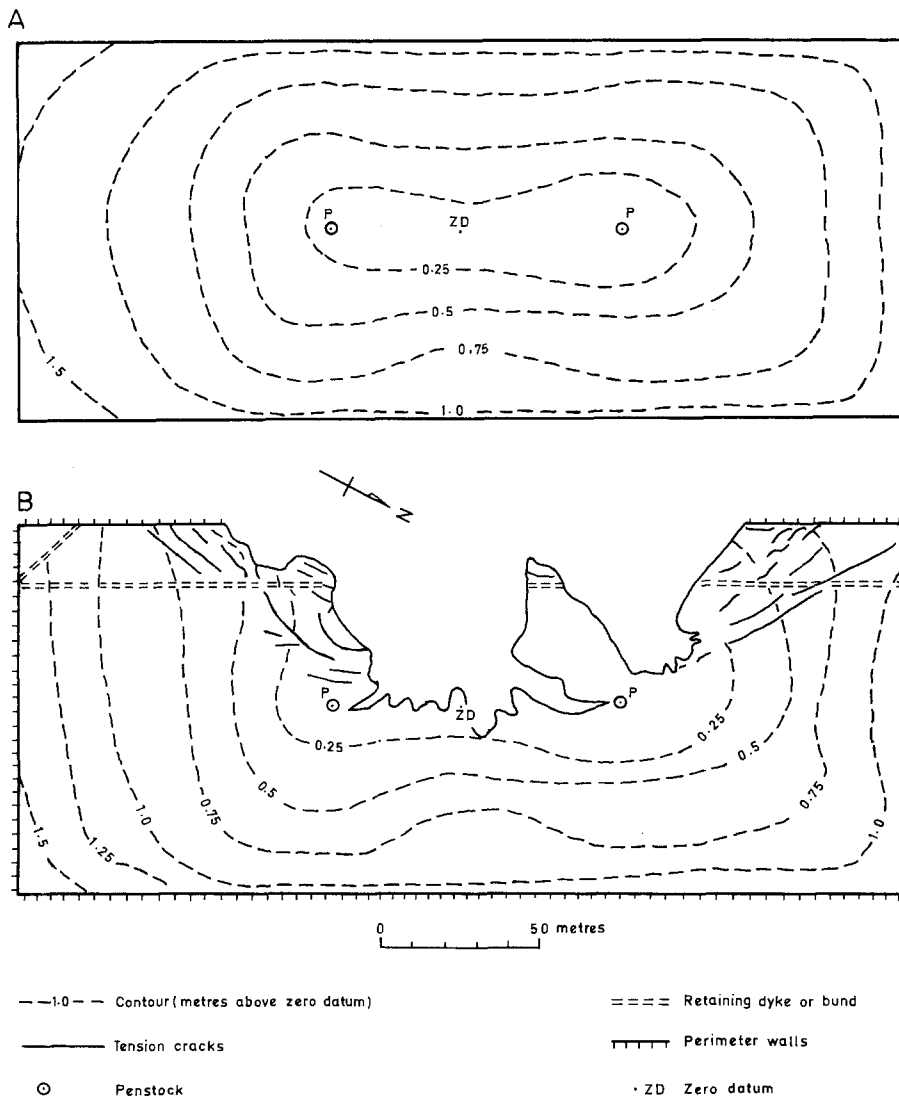
Figure 5A shows how the microtopography of the dump surface might have appeared prior to failure. Its elongated, shallow, dishlike form, with a maximum relief of just over 1.5 m, would have facilitated free drainage of slurry from the perimeter walls towards the central pond. This idealized surface was reconstructed from measurements of the postfailure surface of the dump (Fig. 5B) by replacing the western half with a mirror-image of the eastern half, which was virtually unaffected by the dump collapse. Clearly, during and following failure, there was considerable deformation of the western half of the dump as shown by the configuration of the contours in Figure 5B, indicating tilting of the surface towards the breached wall. Tension cracks curve along concentric arcs that pass around and through the collapsed area of the dump.

**Figure 5.** (A) Idealized reconstruction of the pre-failure waste dump surface. (B) Post-failure form of waste dump surface.

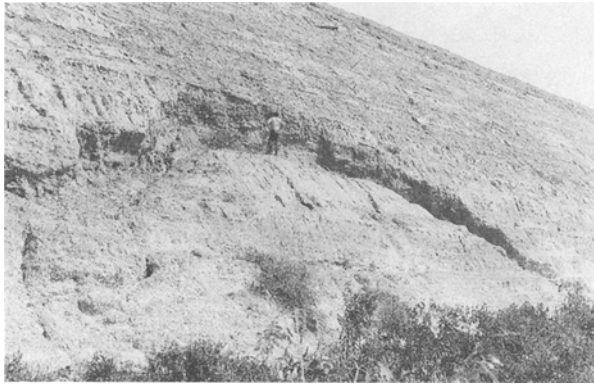
The earliest signs of instability of the dump and weakness in the western wall were reported in 1972, with the development of a large cavity similar to that present in the east wall today (Fig. 6). The remedial measures taken to fill this cavity and stabilize the perimeter wall are summarized in Table 1, along with subsequent events leading up to and just after the failure of the dump. The arcuate scar in the central western wall (Fig. 7) was clearly indicative of a major instability problem, as demonstrated by the largely unsuccessful efforts to plug the cavity in the days prior to collapse.

**Figure 6.** Arcuate scar developed in east wall of waste dump.

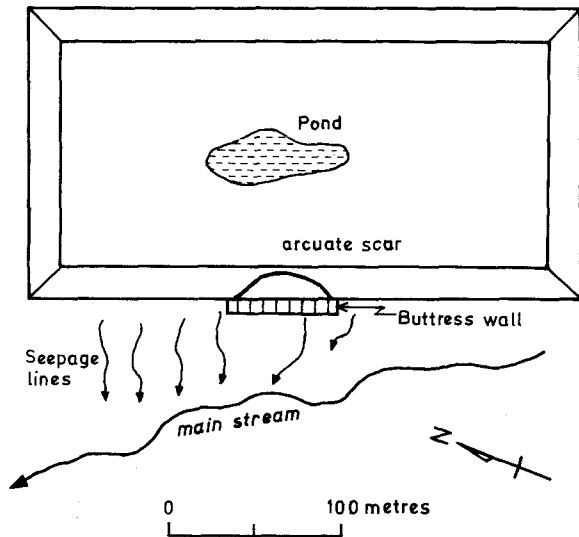
Date	Event	Remedial action
Early 1972	An arcuate scar 60 m wide, 1.5 m across and ca. 10 m deep develops in the west wall.	Scar is filled with 1040 tons of dry rock waste over four days; a buttress wall is built at the base of the scar (Fig. 7).
Week prior to failure	Cavities reappear in west wall and also more localized cavities appear in east wall.	Cavities in west wall are filled with rock waste.
Four days prior to failure	Continued redevelopment of cavities within west wall.	Slurry, discharge pipes are moved "approximately 30 m away" <sup>a</sup> from the west wall and a new retaining bund is built just west of the pipes (Fig. 8).
1930 h on 31 January 1978	Collapse of central part of west wall with a "loud bang" according to mine residents; resulting flowslide engulfs two huts killing one child and injuring another.	Emergency operations to rescue children; construction of series of bunds on intact dump surface to reduce further runoff draining into breached wall and the extension of a surface gully system (Fig. 2).

**Figure 7.** Location of buttress wall and arcuate scar in west wall, based on 1972 air photography.

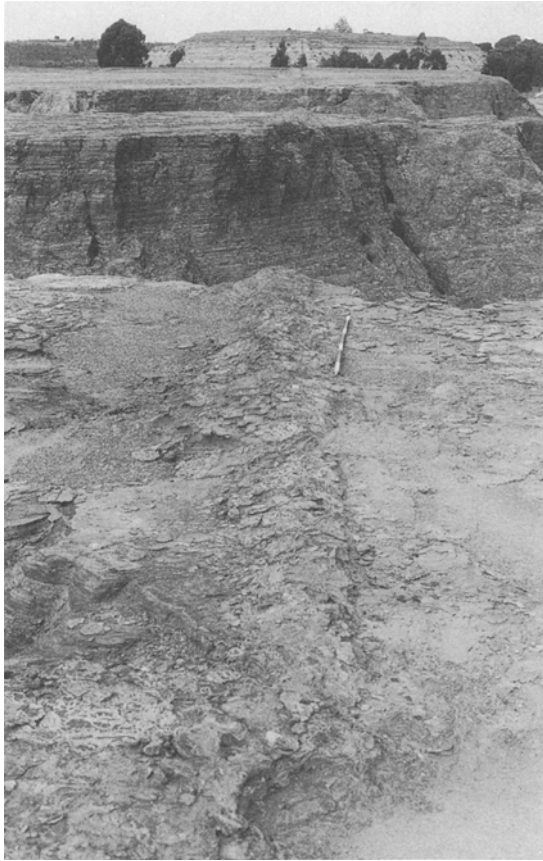
days prior to the collapse. In fact, calculations were based on the incorrect assumption that this bund was 30 m and not the measured 17 m from the west wall. Moreover, there was no way of draining water between this bund and the perimeter wall so ponding undoubtedly occurred in this area, a point noted in the official inquiry.

Furthermore, development of large cavities in the days leading up to failure could have led to sagging of the dump surface near the west wall. In this event, the surface pond would have extended somewhat farther towards this wall. The bund constructed to retain the water in the central part of the dump was in fact made of very wet material (Fig. 8), which collapsed easily, forming a barrier barely 10–15 cm in height. With prolonged heavy rains, it is a strong possibility that the

bund was overtopped as the surface water level rose and the pond shifted towards the west wall. An additional problem arising from poor drainage might have been the rise of the phreatic line within the dump towards the surface of the outer wall.

**Figure 8.** Retaining bund (foreground) built 17 m away from the west wall four days prior to failure in an attempt to reduce the degree of saturation of the area subject to tension crack formation near the west wall (see Table 1).

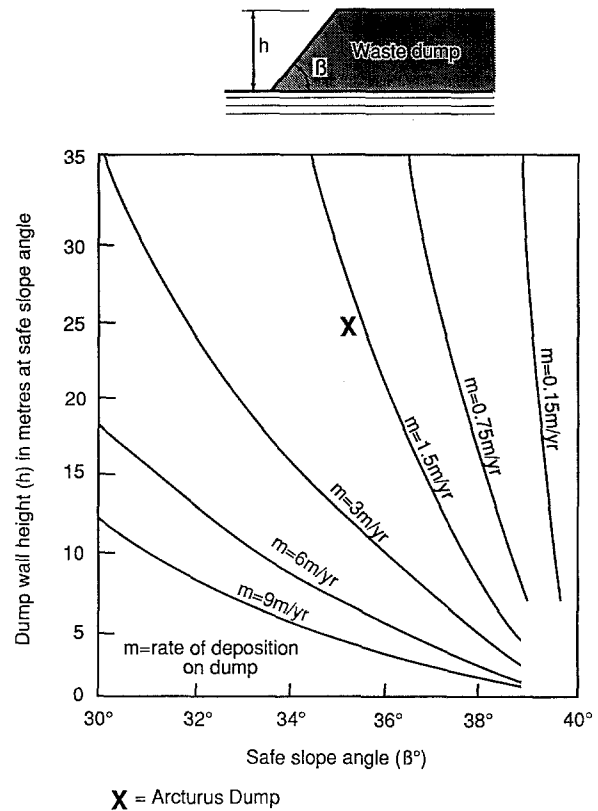
Excessively steep slopes ( $>38^\circ$ ) were regarded as the main cause of failure. This is certainly confirmed by reference to Figure 9, which gives the maximum safe slope angle for the Arcturus dump of  $35^\circ$  based on typical engineering properties of such tailings, the height of the dump, and assuming an impervious base and a start date of deposition of 1960, which yields an annual rate of deposition about 1.6 m/yr. In fact, the official inquiry determined that subsequent tailings dams at Arcturus should not have walls steeper than  $30^\circ$ , and recent regulations state that angles ideally should not exceed  $26^\circ$  (R. Sivotwa personal communication). There can be little doubt that the steepness of the perimeter walls did play an important role in the disaster, but to attach blame almost exclusively to this factor is considered by the authors to be an oversimplification. If perimeter wall steepness had been the overriding factor, then the nearby, now-abandoned dump with equally steep and high walls (Fig. 4) could be expected at least to show signs of collapse, yet this is not the case.

**Figure 9.** Design graph for tailings dam with impervious bases (after Blight 1969). The safe slope angle for the Arcturus dump is indicated.

Postfailure	Official Ministry of Mines inquiry instigated on 1 February and completed by 7 March.	Recommendation that retaining walls on future waste dumps should not exceed angles of $30^\circ$ .

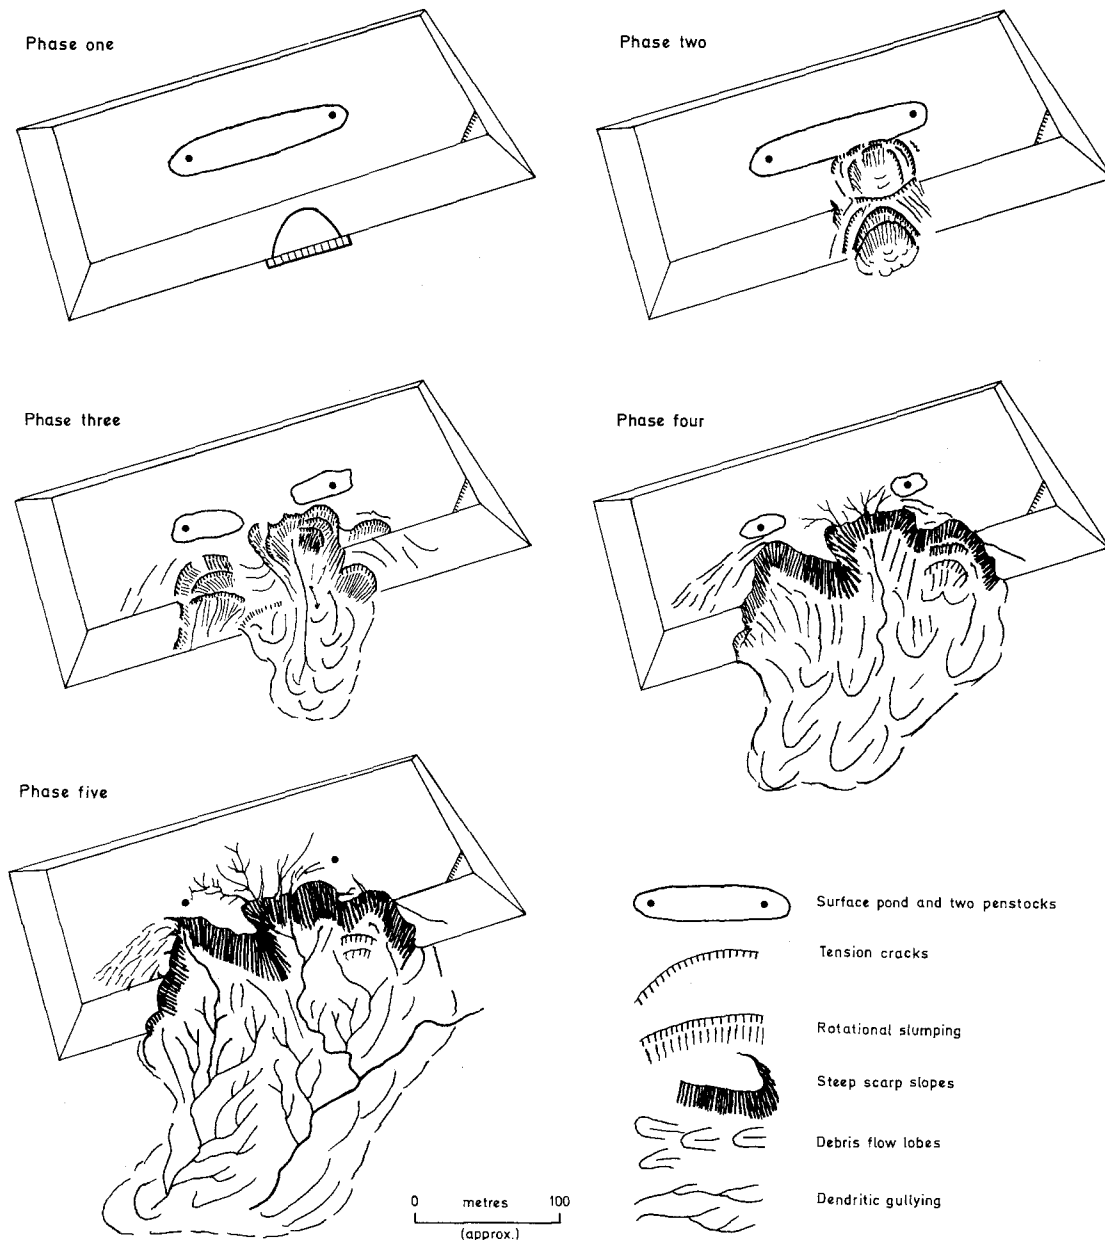
A five-phase sequence in the failure of the west wall and development of the flowslide has been reconstructed on the basis of documentary evidence, fieldwork, and laboratory data (Fig. 10). In view of the development of an arcuate scar some six years prior to the collapse in the central part of the west wall, it is likely that this was the point of greatest weakness in the dump (phase one, Fig. 10). Once failure of the wall had occurred, this would have triggered liquefaction of the saturated tailings in the dam. As movement of this highly mobile sediment began, tension cracks would have formed around the scar zone and extended on to the dump surface (phase two, Fig. 10). Once the breach was opened up, the semifluid sediment would have flowed very rapidly downslope away from the west wall.

**Figure 10.** Five-phase reconstruction of failure of the west wall of the waste dump and subsequent development of the flowslide.

The development of tension cracks and rotational slumping would have extended back rapidly towards the surface pond, thereby commencing drainage of this part of the dump (phase three, Fig. 10). At this time, stresses on areas of the west wall either side of the

breach would have increased to such an extent that they too collapsed. This would have promoted further flowage of basal sediment, enlarging the main breach and two smaller embayments either side of this central cavity as shown in phase four (Fig. 10). In addition, rapid drainage of the surface pond resulted in the formation of a dendritic gully network in the wet tailings (Fig. 12).

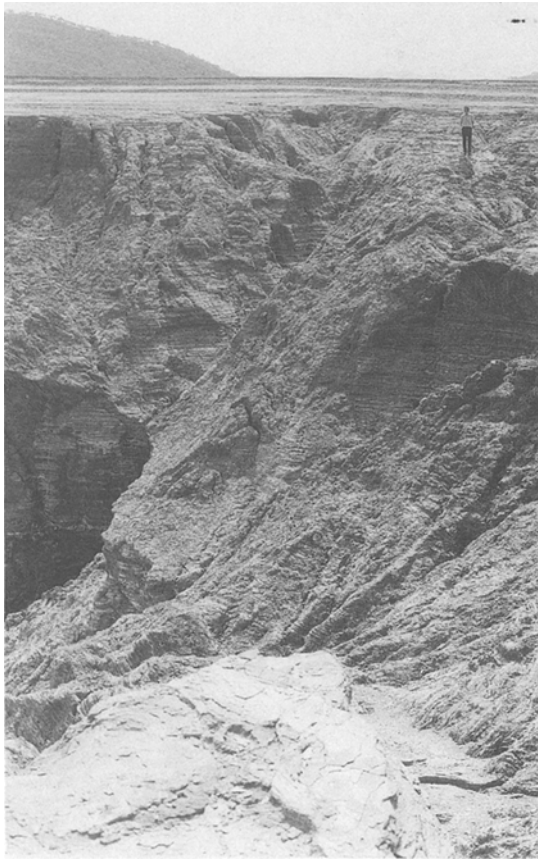
As it did so, it would have undermined the overlying, slightly coarser, more stable tailings, causing further tension cracking and eventual collapse through rotational slipping along these cracks (Fig. 11). Thus, large slabs of sediment would have moved downslope together with the extension of the flowslide at the base.

**Figure 11.** Steep slip faces and slumps in the central part of the collapsed area of the waste dump.

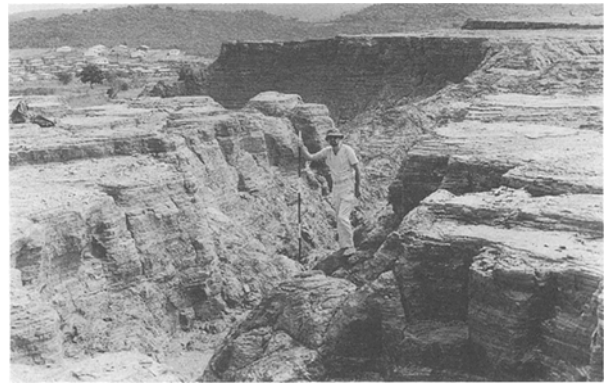
**Figure 12.** Deep gully that formed at the time of failure in wet tailings. The slumping of the originally wet tailings on the margins of the gully can be seen.

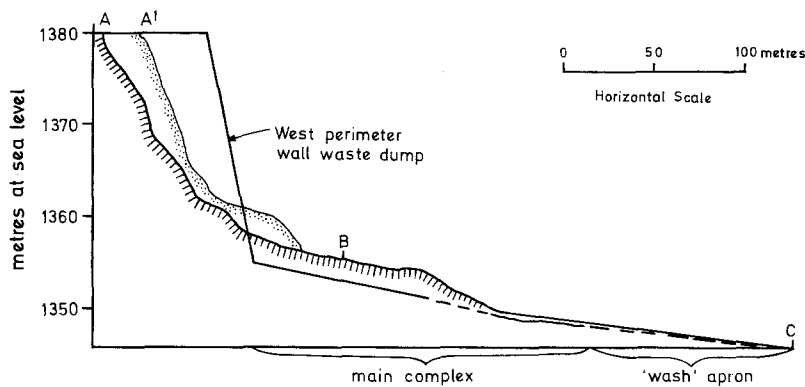
The entire flowslide was approximately 300 m in length with an average slope of  $2^\circ$  (Fig. 13). Its width varied between 60 and 75 m in its lower part. The main complex comprised most of the debris removed from the dump, forming a jumbled mass of debris that stretched across the entire 175-m width of the breach in the west wall and extended some 190 m down valley. Intact lumps of sediment up to 1 ton in weight were found as far as 150 m away from the breach. The fringing wash apron apparently left a thin covering of sediment with occasional larger agglomerations of material. This extended about 35 m on the western edge of the main complex and about 110 m beyond the limit of this complex in a down-valley direction.

Figure 13. Long profile of flowslide.
