## LANDSLIDE DAMAGE TO THE BOAR RIVER WATER SUPPLY PIPELINE, BROMLEY HILL, JAMAICA : CASE STUDY OF A LANDSLIDE CAUSED BY HURRICANE GILBERT (1988)

Rafi AHMAD\*, Aedan H. EARLE\*, Peter HUGUES\*\*, Russell MAHARAJ\* and Edward ROBINSON\*

#### Abstract

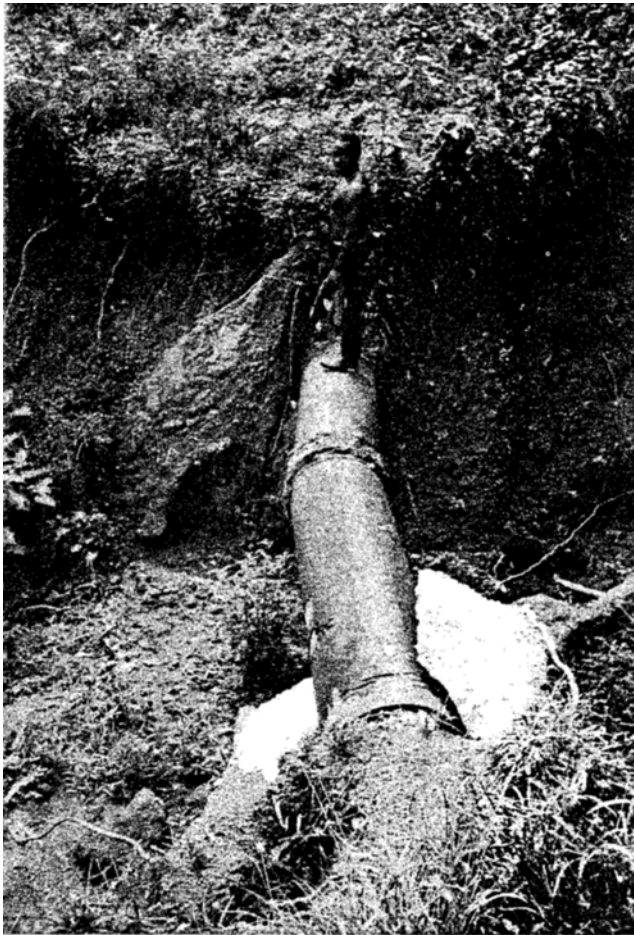
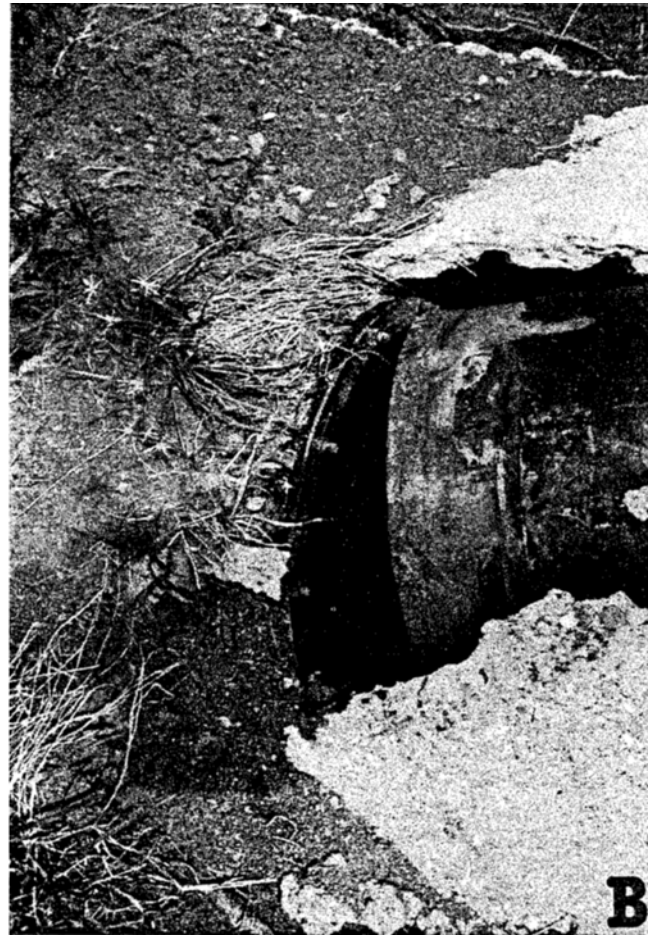
Fig. 2 : A. Northern section of the damaged pipeline at Bromley Hill.

B. A detailed view of the damage in the foreground of the photograph in A. The diameter of the pipe is 24 inches (609.6 mm).

We present here the results of this study and show that the structure was damaged due to a debris flow (*sensu* Ellen *et al.*, 1988) triggered by heavy rainfall associated with the hurricane. The responsibility of writing this paper lies with the senior author (R.A.).

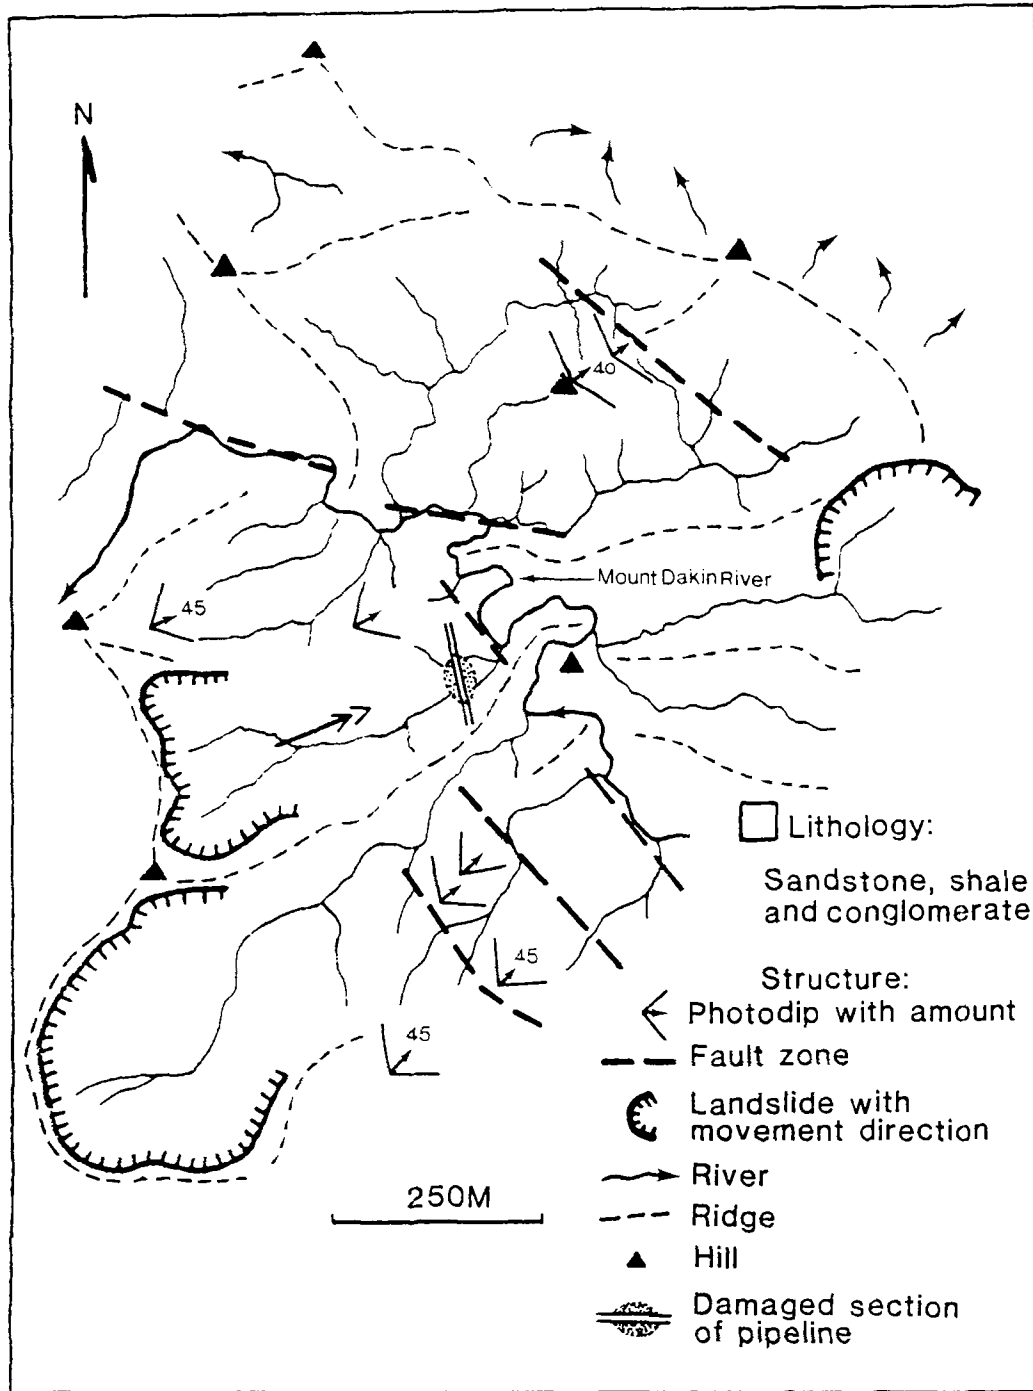
Fig. 3 : Uncontrolled photogeological map of the area around the damaged section of the pipeline, Bromley Hill. See Fig. 1 for location.

**Faults.** – Two major faults have been mapped in the area (Fig. 3). Mount Dakin River flows along a WNW-ESE trending fault. The other NW-SE trending fault is visible on the aerial photographs along the eastern slope of Bromley Hill.

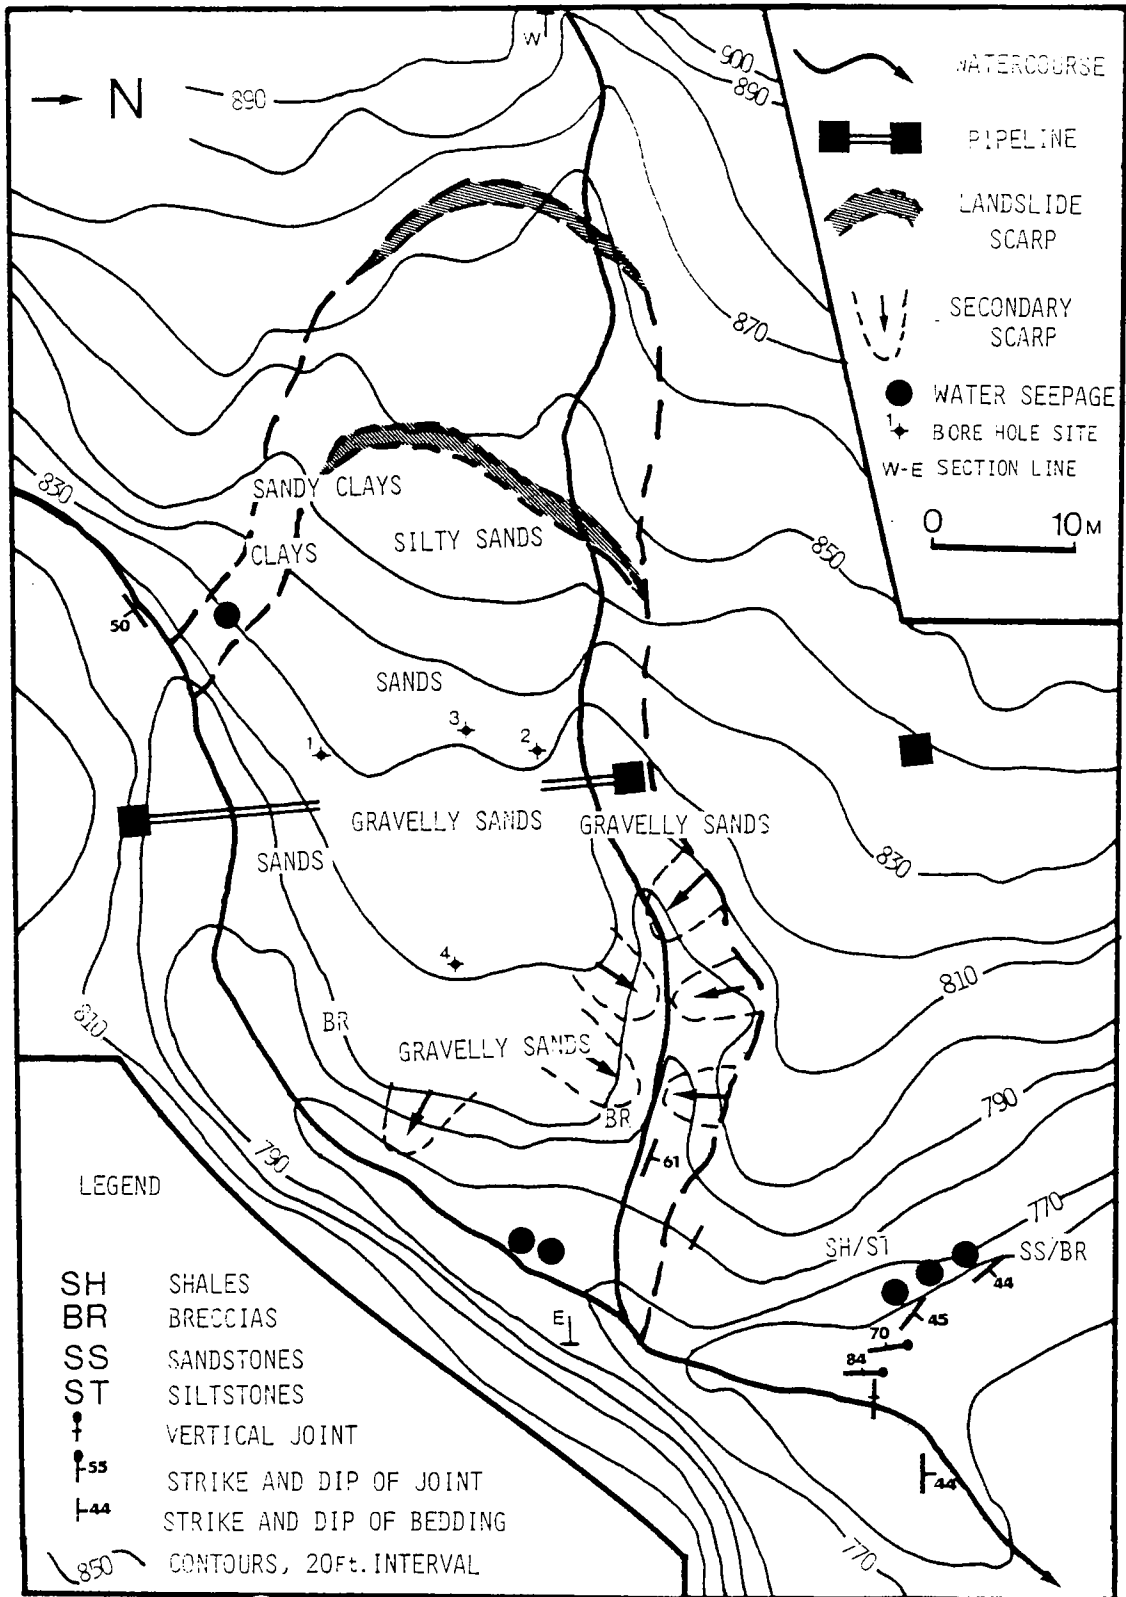
Fig. 4 : Geological map of the debris flow at Bromley Hill. See Fig. 1 for location.

common along the valley slopes. The slopes with landslides are generally sparsely vegetated. The damaged section of the pipeline (Fig. 2) is located on an active landslide (debris flow) on the eastern slope of Bromley Hill. The pipeline is aligned north-south and is located midway along the slope at 246 m. The main scarp of the slide is at 264 m and many minor scarps have been mapped along the length of the slide. The toe of the slide is located at the confluence of two east-flowing streams, which delineate the northern and southern flanks of the slide. Water seepage zones are characteristic of the toe region, and are shown, together with other

b) Fine grained soils – are silty clays, plastic and highly weathered, and stiff; they are inorganic and fissured. They are saturated, and ponding of water in clays is common. Vegetation cover does not allow the preparation of an accurate superficial deposit map for the whole area, but the extent of soils and bedrock within the immediate area of the pipeline is shown in the geological map (Fig. 4).

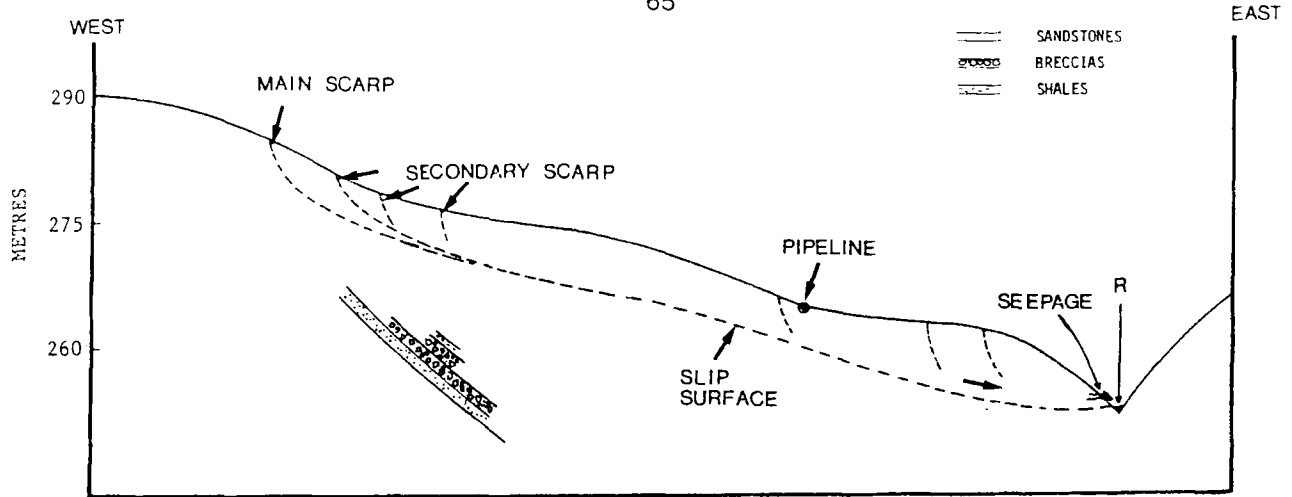
Fig. 5 Geological Cross-Section (W-E) across the damaged section of the pipeline.

Figure 5 is a cross-section through the eastern slope of Bromley Hill at the location of the damaged pipeline. The damage is a consequence of a landslide which developed near the crest of the ridge, upslope of the pipeline. Following Varnes (1978) this landslide would be classified as a complex slide, involving debris flow and avalanching, however, we prefer to describe this slide as a debris flow (*Sensu* Ellen *et al.*, 1988). The main type of displaced material is debris, derived from a thick cover of residual soils, overlying the highly weathered bedrock. The damaged sections of the pipeline suffered considerable displacement because of debris flows and avalanching related to the slide. The toe region is located within the confluence of the two east flowing streams, which define the northern and southern flanks of the slide (Fig. 4). Water seepage was observed in the toe region of the slide and along possible failure planes (Fig. 4 and 5). That the slide is active can be seen from several secondary slides which have developed on the flanks of, and within the main body of the failure.

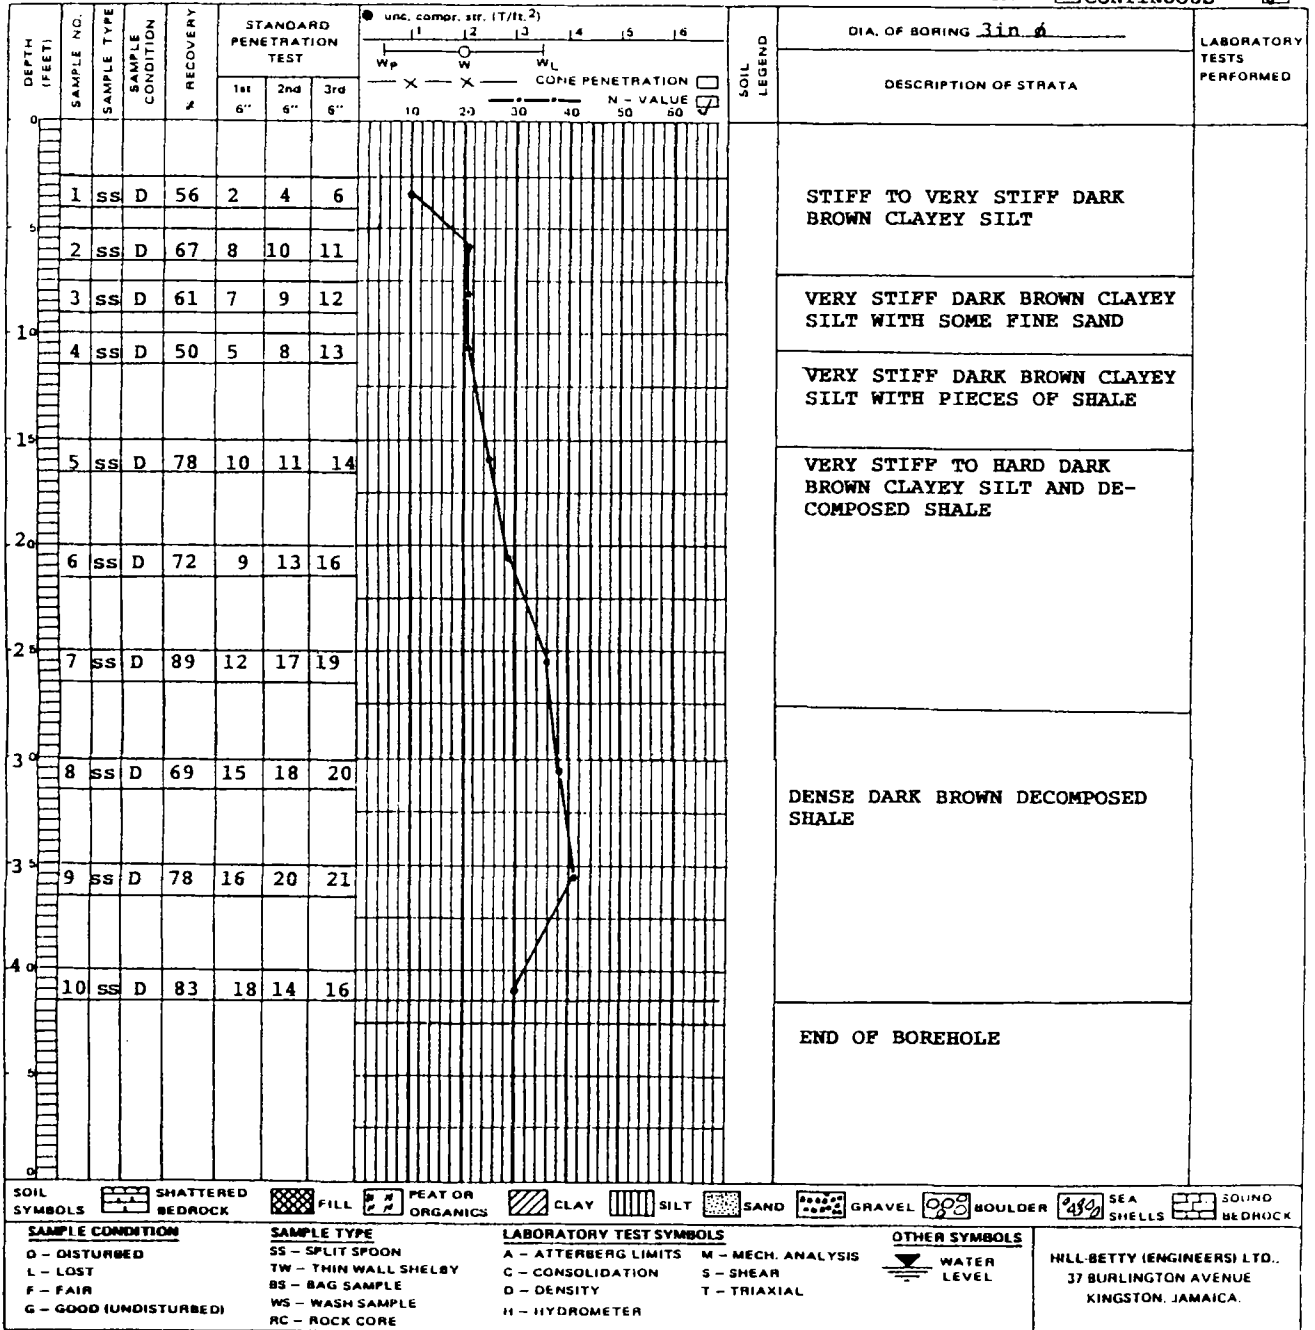
Fig. 8 : Borehole log standard penetration test data and N-value graph for Borehole No. 2.

A significant increase in the drilling pressure was encountered at a depth of 6-7.6 m in boreholes #1 to 3 with the corresponding N-values ranging between 20-46 (Fig. 7 to 9). This suggests the presence of relatively

compact strata (bedrock?) at this depth and is supported by the presence of well indurated sandstone fragments in the core samples. The data from borehole #4 (Fig. 10) show similar material properties at a depth of 5.6 m. Based on above, it is suggested that the slip-surface for the slide is located approximately 6 m below the present level of the pipeline and is in support

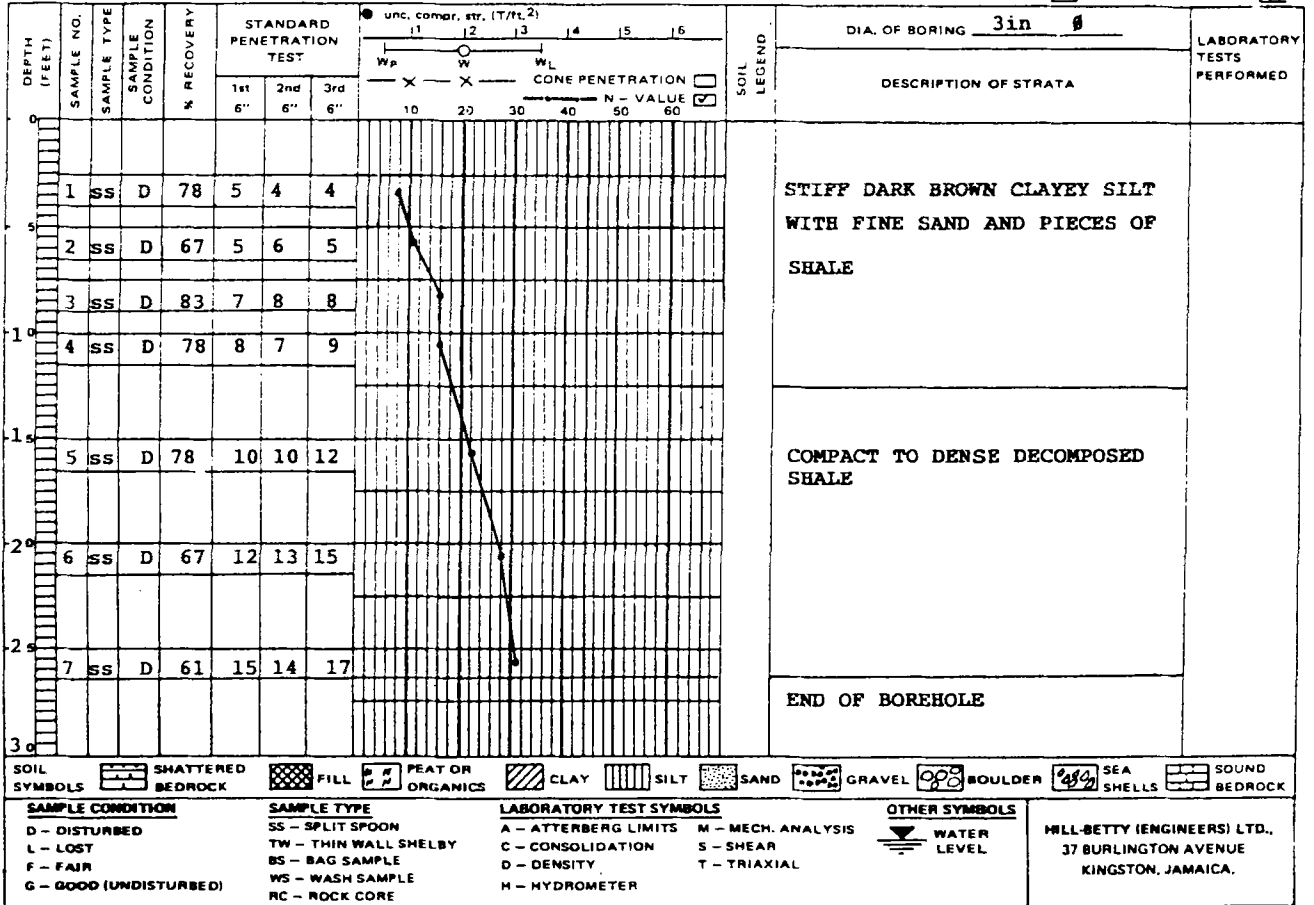
Fig. 10: Borehole log standard penetration test data and N-value graph for Borehole No. 4.

involved flow in clays and drilling results suggest that the slide is shallow with the slip-surface located at a depth of approximately 6 m below the surface. Slope failure at the site appears to be related to drainage conditions along the slope. Soil stratification, mimicking the stratification in the bedrock, is likely, and if present

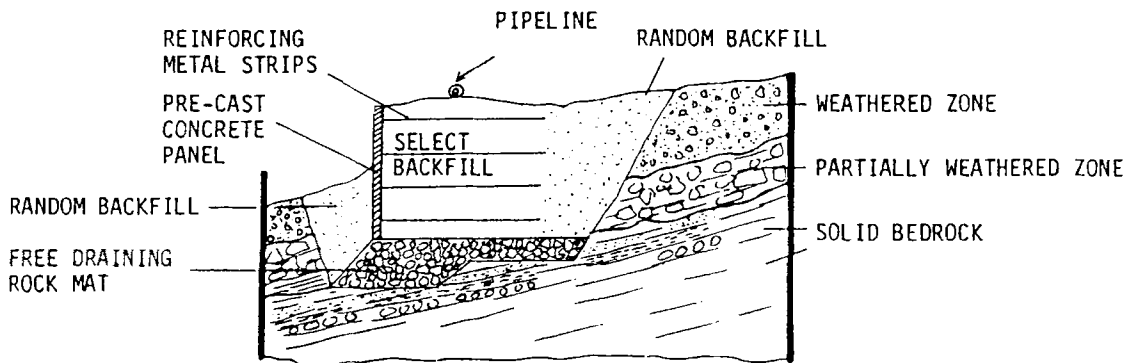
Fig.11: A suggested schematic procedure for the remedy of the landslide using reinforced earth block and select backfill.

movement will only cease if the slope (and slide) materials can be stabilized on the slope itself, or when the unconsolidated material on the slope has all been consumed via erosion of the toe of the slide. However, without stabilization, potentially unstable debris will continue to be generated on the slope. We are of the opinion that the best long term solution to the problem would be to reroute the pipeline altogether. The shortest safe route would be around the toe of the present slide, along the far bank of the stream. Another possibility would be to bridge the slide by suspending the pipeline from stable supports on the flanks of the slide. If the pipeline has to remain in its present position, then it is suggested that a block of the slide surrounding the pipeline supports be taken out and replaced with a compact, granular fill of sharp gravel/sand as suggested in Figure 11. This should be done in conjunction with a scheme to improve the drainage of the entire slope, using contour drains and paying special attention to the crown of the slide and the places where seepage has been observed, and with a programme to plant vegetation on the slope to assist in binding slope materials and controlling runoff.
