## Technical Report

# Electrocardiographic “pacemaker pseudo- spikes” and radio frequency interference

Mark J Cleland BMET,\*  
Edward T Crosby MD FRCPC†

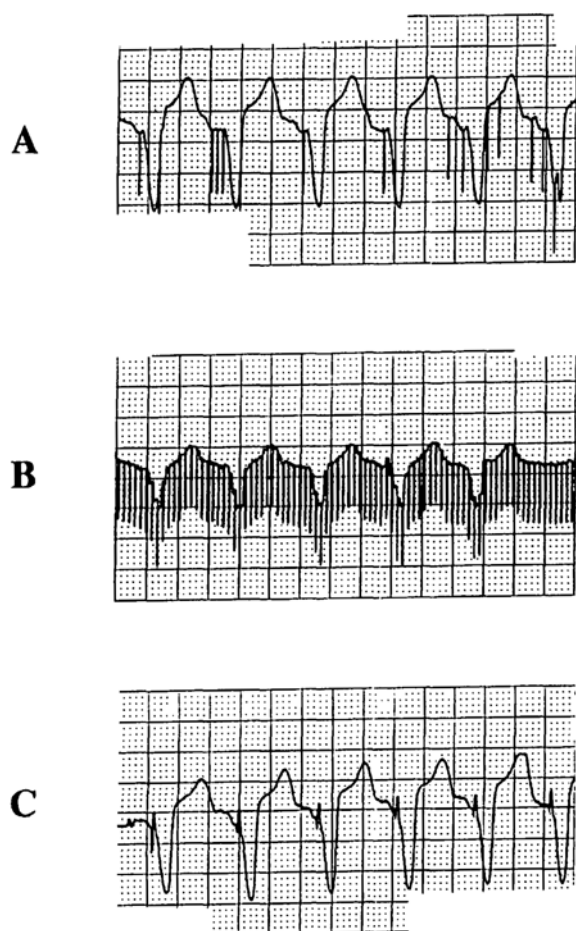
By this time, we were confident that we had eliminated the patient, lead wires, pacemaker and ECG module as factors in the generation of the mystery spikes. Our attention was now directed towards the possibility of radio frequency interference (RFI) or fluctuations on the power line, including ground continuity, as the cause. Using a spectrum analyzer, the

FIGURE 1 Electrocardiogram trace demonstrating occasional artifact spikes (A), near continuous artifact spikes (B) and the trace obtained with Pace Mode disabled (C).

voltage of any magnitude. The ground continuity assessment indicated that the grounds were secure and intact. The pin retention values of the electrical outlets within the PACU were also determined; all measured values were greater than 20 ozs., ensuring the integrity of the electrical receptacles. Finally, we concluded that the origin of the abnormal signals was RFI emitted from a source which was portable and has since been removed from the site.

As part of the evaluation of the phenomena, recordings were forwarded to both the manufacturer of the pacemaker and the PACU monitor. The pacemaker manufacturer, Medtronic™, informed us that there was no circuitry within the pacemaker which would generate a signal similar to the one recorded. The Product Engineering Group at Spacelab™ Medical reviewed the tracing and suggested that the artifact was likely caused by 60 Hz interference in the monitor's environment which was interpreted by the monitor as pacemaker output.<sup>1</sup> They further commented that the interference wouldn't be noticed on the cardiac monitor with the *Pace Mode* off because of a 60 Hz notch filter.
