The quick-mount pipeline connector: failure of a "fail-safe" device

David C. Chung MD FFARCS FRCPC,
Dennis J. Hunter RRT, Franco J. Pavan RRT

This report describes the absence of gas flow despite the apparent proper mounting of a Canadian Liquid Air nitrous oxide quick-mount connector to its wall outlet. A similar but potentially more dangerous malfunction can occur with oxygen quick-mount connectors. The nature and cause of this defect are examined.

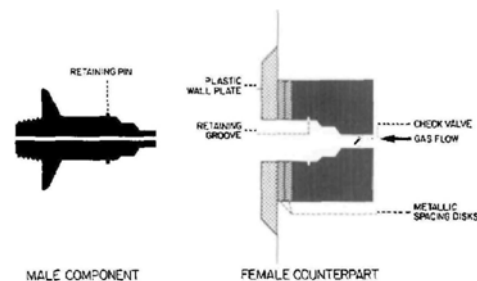
The device in question is a nitrous oxide quick-mount connector (Canadian Liquid Air) illustrated in Figure 1. Coupling of this connector is achieved by plunging the male component into its female counterpart and turning it in a clockwise direction. The plunging manoeuvre will disengage the check-valve to allow free passage of nitrous oxide, and the clockwise turn will secure the two parts together by sliding the retaining pin into the retaining groove. Malfunction of the nitrous oxide quick-mount connector was suspected during a routine inspection

FIGURE 1 A diagram illustrating the male component and the female counterpart of the quick-mount pipeline connector in question.

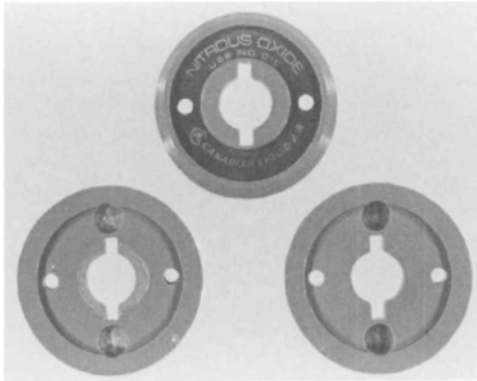
FIGURE 2 The face of the plastic wall plate (top), reverse of the plastic wall plate with the gouged-out defect (bottom left), and reverse of a wall plate without the defect (bottom right).

On dismantling the gas outlet, the cause of malfunction became immediately apparent. There was a defect on the back of the plastic wall plate around its opening (Figure 2) and another on the front of the first metallic spacing disk (Figure 3), thus creating a false retaining groove between the

wall plate and the first metallic spacing disk. Although apparent connection could be achieved with the retaining pin engaging this false retaining groove, the male component was not long enough to open the check-valve. This malfunction was confirmed by the absence of gas flow but could not be detected by the external appearance of the mounted connector alone. The defects on the plastic wall plate and on the spacing disk could only have been gouged out by the retaining pin – created by plunging the male component into its female counterpart and executing a clockwise twist simultaneously before the check-valve was opened.

Like other anaesthetic mishaps, however, the importance of human error as a contributing cause to equipment failure should not be discounted.^{1,2} Proper coupling of this connector should be achieved only by pushing the male component straight into its female counterpart until the check-valve is disengaged (as indicated by a gas leak) before turning this male component clockwise so as to slide the retaining pin into the retaining groove. Earlier rotation of the male component can cause the retaining pin to lodge in the potential space between the wall plate and the first metallic spacing disk or between the spacing disks themselves. Normally the retaining pin is lodged securely in the retaining groove after a 45 degree clockwise turn. If the male component can be rotated more than 45 degrees after engaging its female counterpart, the probability that the retaining pin has entered a false passage should be considered. We wish to

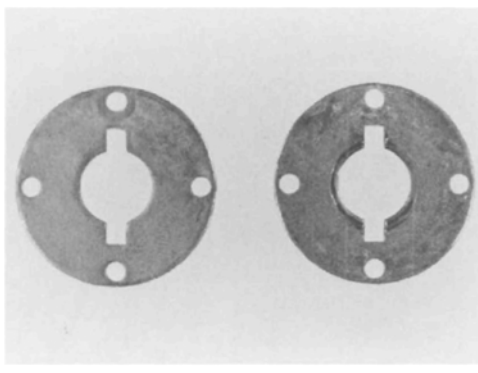
FIGURE 3 Metallic spacing disk with the gouged-out defect (right) and one without defect (left).
