LEAKAGE DEFECTS VIA BUBBLE TRAILS IN GREY IRON CASTINGS

John Campbell

University of Birmingham
Birmingham, United Kingdom

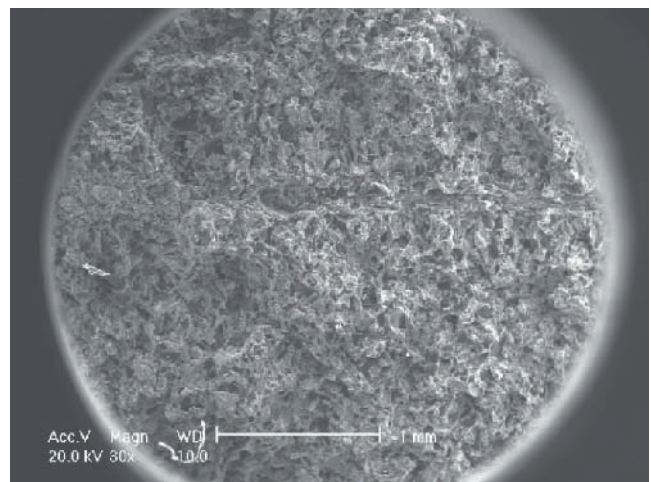
Figure 2a (Type A defect; Casting No 1) Secondary Electron (SE) SEM Image of bubble trail in casting (circular frame is the complete field of view, approximately 3.5 mm in diameter, showing most of the thickness of the 4 mm thick casting wall).

The fracture surfaces were studied by SEM. For the first Type A sample, an overall view of the fracture, showing the defect traversing the whole of the 4 mm thick casting wall is seen in Figures 2 and 3. In Figure 2, the SEM image uses secondary electrons (SE) so that the path of the defect is only just discernible. (It is to be noted that the defects are shown

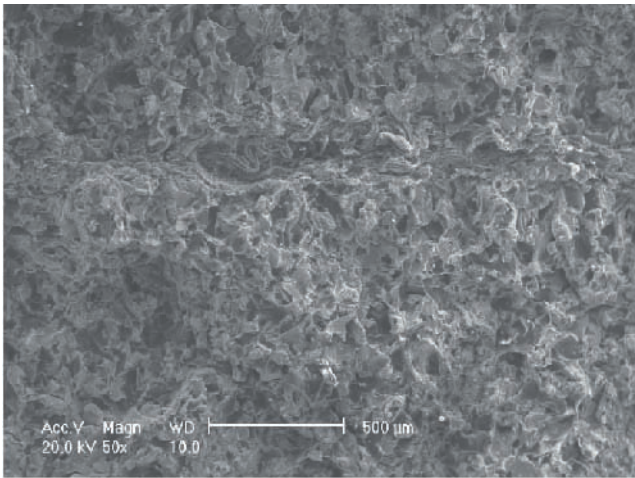
Figure 2b (Type A Defect; Casting No 1) Closer view of figure 2a.

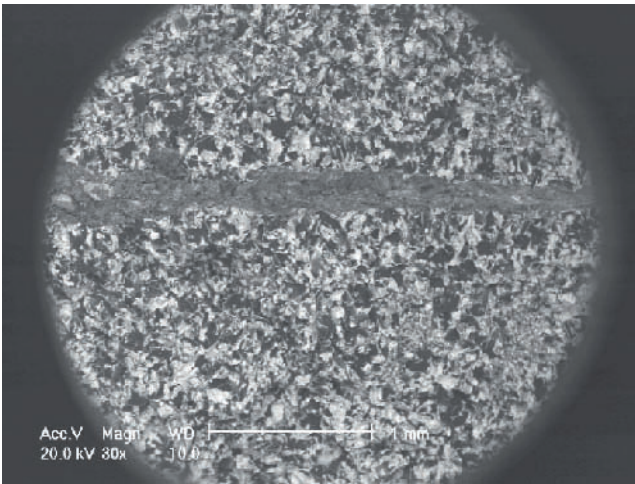
Figure 3a. (Type A Defect; Casting No 1) Back Scattered Electron (BSE) SEM image of Figure 2a illustrating the light element content of the bubble trail.

Figure 3 shows the same fields of view but imaged by back-scattered electrons (BSE), to reveal the defect in its entirety with much greater clarity. Also, of course, the defect is further revealed to consist largely of light elements (lighter elements scatter electrons only weakly, giving a low signal count, and thus appear dark in the image).

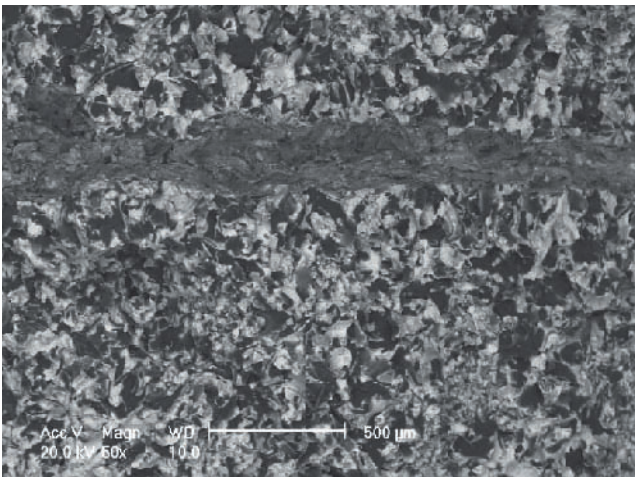
Figure 3b. (Type A Defect; Casting No 1) A closer view in BSE mode corresponding to Figure 2b.

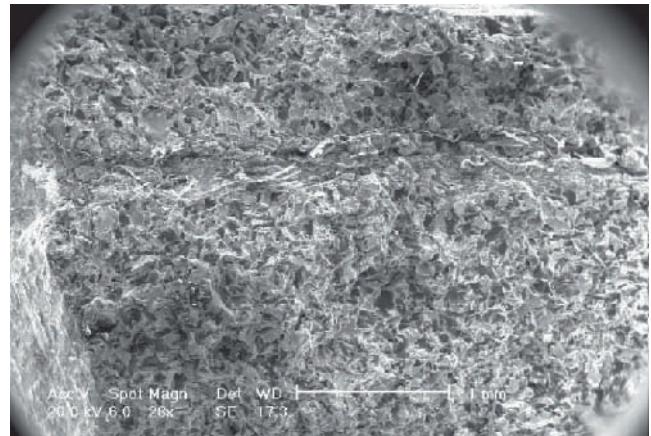
Figure 4a. (Type A Defect; Casting No 2). Secondary electron image of the fracture surface containing the leak defect traversing the complete 4 mm thick casting wall, showing the leakage hole only approximately 300 μm diameter emerging at the casting surface.

Figure 4a shows the complete length of the defect through the 4 mm thick wall of Casting No. 2. The point at which the leak path emerges at the outer face of the casting is clearly seen to be only approximately 300 μm diameter, and so barely visible to the naked eye. Figures 4b to 4f show a series of close-ups of the films that constitute the tubular bubble trails.

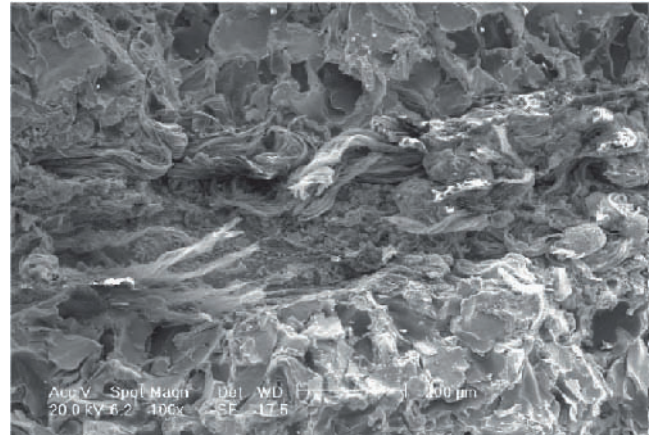
Figure 4b. (Type A Defect; Casting No 2) showing the irregular grouping of bubble trails near the centre of the leak path.

Figures 4b and 4c indicate that the leak path is formed from a cluster of perhaps 10 or 20 separate bubble trails, many of them spiralling, assuming to reflect the often-observed spiralling mode of rise of bubbles in a liquid (an effect foreseen years before in the sketching of Figure 1). The extreme thinness of the films, allowing them to be translucent to electrons, can be noted in Figure 4d. It is estimated that the thinnest films are probably only tens of nanometres thick. The longitudinal tracery of fine folds, or creases representing straightened folds, seems characteristic of the thinnest films.

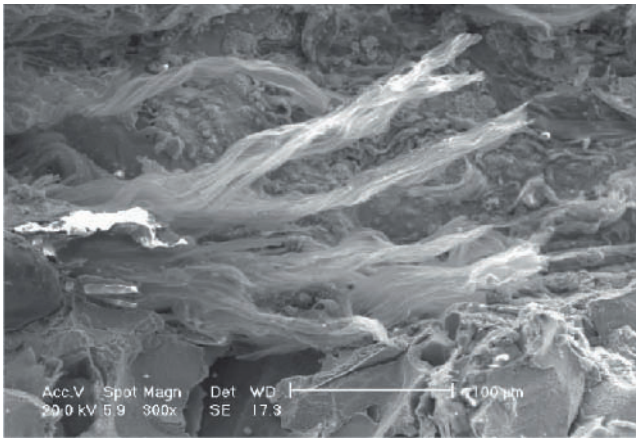
Figure 4c (Type A Defect; Casting No 2) A closer view of sample 1 illustrating the twisted form of some trails.

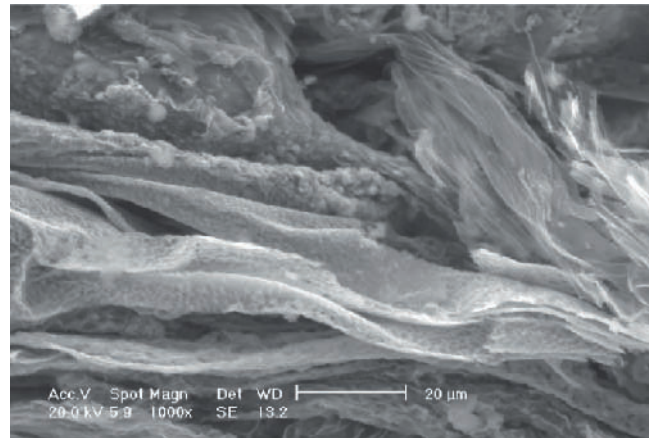
Figure 4e (Type A Defect; Casting No 2) Images of thin translucent and thicker granular films.

A mix of thin and thick films is seen in Figure 4e. The thicker films are opaque when viewed by SEM, and appear significantly more granular. In Figure 4f, the granularity is seen to be of the order of 1 μm, and it seems likely that the films themselves are approximately this same order of thickness. An interesting detail in 4e is a feature suggestive of a small explosive event in the upper part of the image.

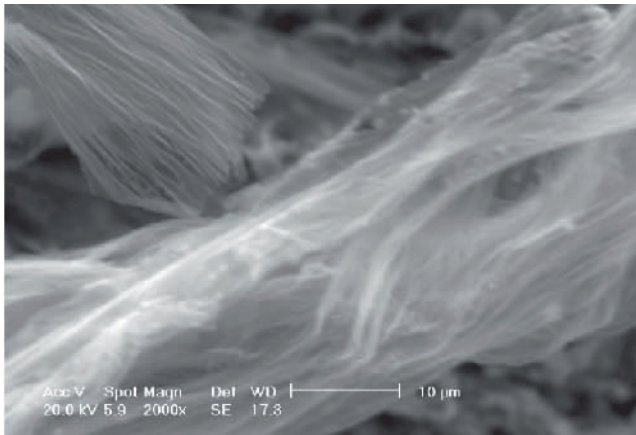
Figure 4d (Type A Defect; Casting No 2) A close-up view of translucent fluted trails (foreground trail is necessarily out of focus).

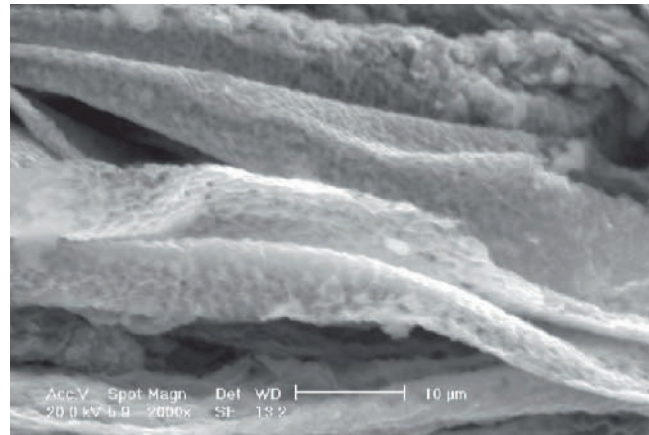
Figure 4f (Type A Defect; Casting No 2) A closer view of an apparently recrystallised silicate film, showing crystals close to 1 μm in diameter.

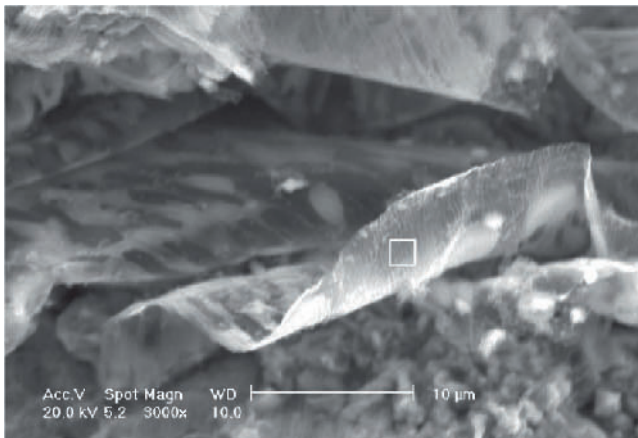
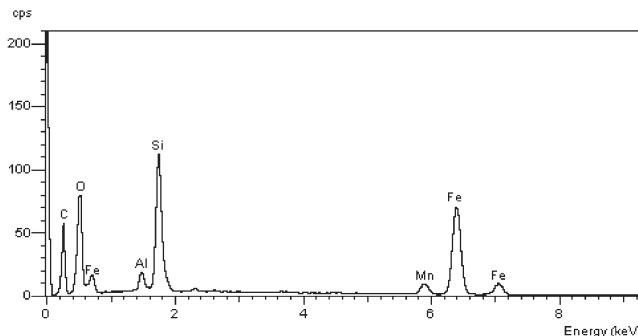
Figure 4g shows a thin film edge-on, so that its thickness can be estimated to be, at most, approximately 50 nm. The EDX analysis, typically seen in Figure 4g, convincingly indicate that this film is composed mainly of silicon and oxygen, possibly with some iron and even lower amounts of manganese. Thus it seems most likely that the thin films in Type A defects are an iron silicate, possibly containing a little Mn in solution.

Figure 4g. (Type A Defect; Casting No 2) A thin, fluted film seen edge-on to reveal its thickness in the region of 10-20 µm. The associated spectrum indicates that the film is an iron silicate.

Figures 4g and 4h, together with their associated spectra, clearly reveal the composition of these bubble trails to be characteristic of a silicate glass (high in Si, O possibly with some Fe and Mn). The thin films are translucent, again emphasising their thinness and their possible glassy nature. As a silicate, the glass-like nature of the films is understandable, as is the appearance of the brittle fractures to the ends of the broken tubular trails as seen in Figure 4c. These brittle glassy shards are likely to have formed during the sample preparation, at the instant of the breaking open of the sample to reveal the leakage defect.

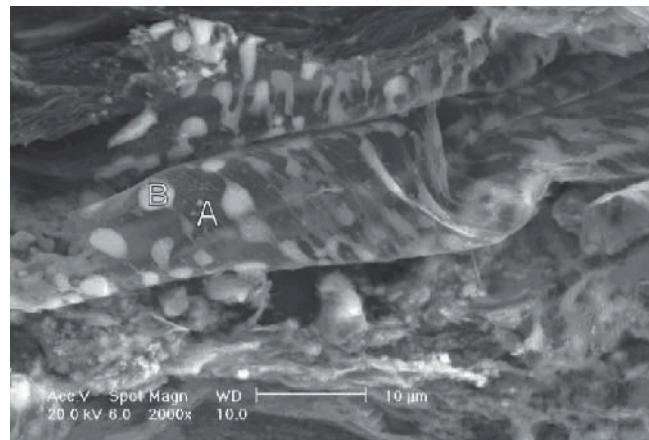
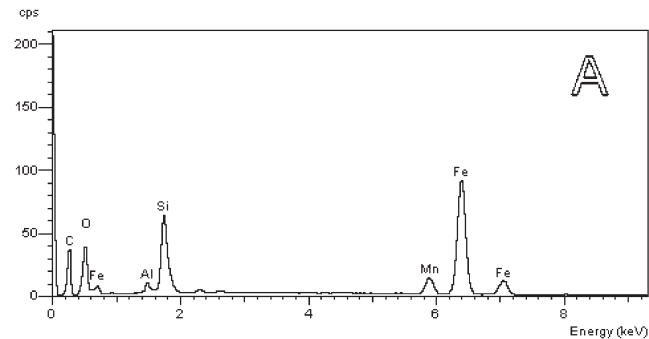
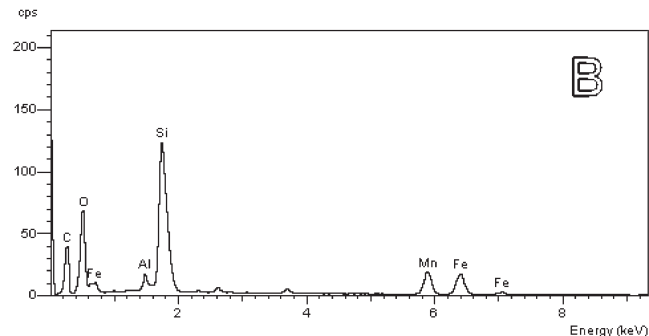
The white patches on parts of the films seen in Figure 4h appear to be lower in Fe than neighbouring regions, although it is recognised that comparative analyses of such thin material is likely to be significantly influenced by signals from the surrounding matrix.

Figure 4h. (Type A Defect; Casting No 2) A spectrum from 'A' sampling the main area of the silicate film showing it to be relatively high in Fe, contrasting with the low content in the white spot region 'B'.

The white patches observed on some of the films seen in Figure 4h are interesting. An examination of the FeO-SiO₂ phase diagram shows that FeO-SiO₂ materials containing greater than 37w/o SiO₂ will be present as two phases, an FeO-SiO₂ phase (with about 37w/o SiO₂ and 63w/o FeO) and an essentially pure SiO₂ phase. Another possibility is a pure FeO phase and a 30w/o SiO₂ phase. The spacing between patches of segregates is in the region of 10 micrometers, and is of the order to be expected from diffusion distances in these conditions, suggesting an evolution of the silicate chemistry towards an equilibrium structure. (However, it should perhaps be recorded that in other SEM studies [5] of iron-rich compounds in cast Al-alloys, white areas appear to be associated with some kind of atmospheric corrosion that occurs on prepared metallographic specimens over a period of several days or weeks. It is not clear whether a similar effect may have occurred here.)

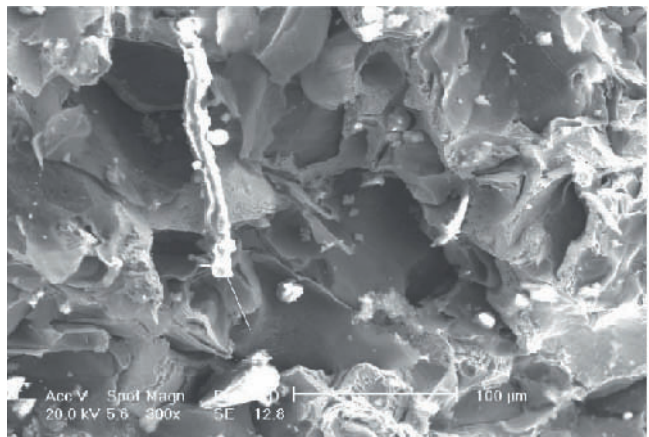
Finally, in Type A samples (Casting No. 2), a number of exudates of matrix iron were found entering the bubble trails (Figure 4i).

Figure 4i (Type A Defect; Casting No 2) An iron matrix extrudate, extruded into the void created by the leak path.

The presence of extrudates of iron (for instance Figure 4i), forced into the space created by the bubble trails during the solidification of the iron and the expansion of its graphite phase, confirms the fact (if confirmation were needed) that there is an open volume into which extrudates are free to extrude, so confirming the likelihood that the observed features actually do form a relatively open channel that could cause a leakage problem.

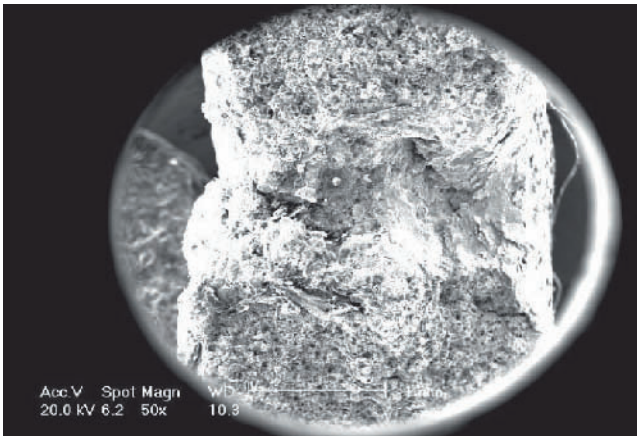
Type B samples (typified here by Casting No 3) appeared to have a significantly more serious leak defect. Figures 5a and 5b illustrate the complete wall thickness, showing the craters on the inner and outer faces of the casting to be several millimetres in diameter. In addition, the internal volume of the defect is of the order of a few cubic millimetres.

Figure 5a (Type B Defect; Casting No 3) A secondary electron SEM image of a cavernous leakage defect.

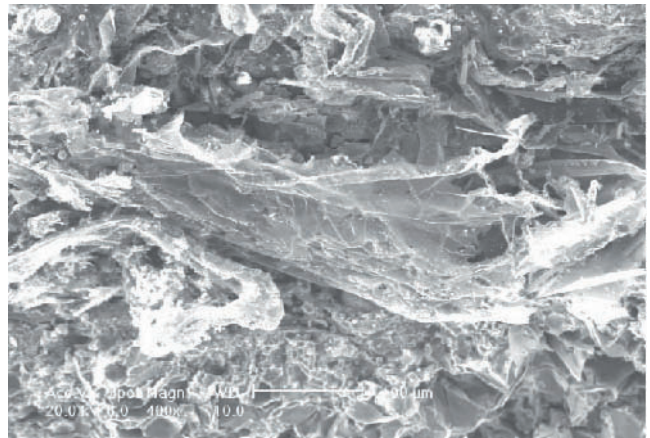
Figure 5d Close-up of 5c.

- *Type B Defects.* These defects represent severe damage from more serious outgassing events. The phenomenon seems more akin to a volcanic eruption, creating at the casting surface deep craters, having widths and depths measured in millimetres, which are easily visible to the unaided eye. In addition, a significant volume of internal material appears to have been subjected to a kind of churning action. It seems likely that in conditions of the out-pouring of huge quantities of gas, individual bubbles do not form, the flow being continuous, like a jet. The highly energetic churning of the surrounding matrix creates masses of siliceous oxide slag material, some of which could be the residue of the initial silicate trails. As the evolution of oxidising water vapour is replaced by products of pyrolysis of the organic binder, the trails are now formed by decomposition of these carbonaceous volatiles, creating carbon films analogous to the well-known lustrous carbon films commonly seen on the surfaces of grey iron castings. Even so, these films are in turn mechanically damaged by the force of the outgassing flow, as is seen in Figures 5c and 5d.

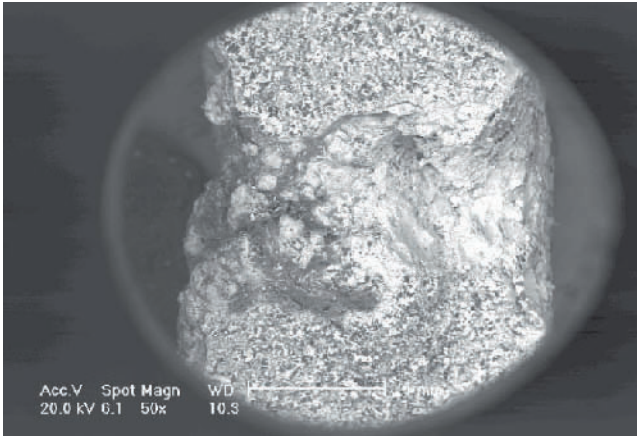
Figure 5b (Type B Defect; Casting No 3) The BSE image of the leak defect seen in Figure 5a.

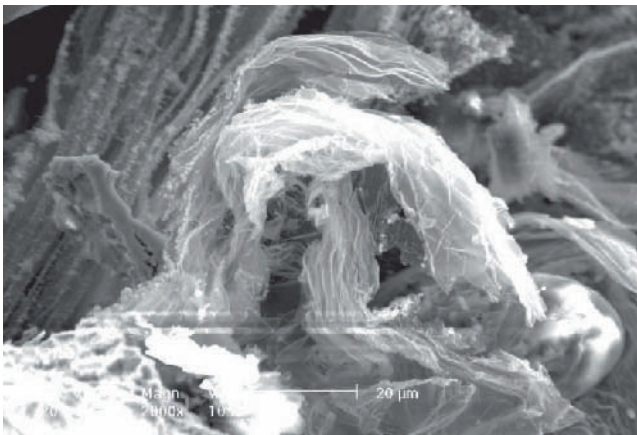
Figure 5c (Type B Defect; Casting No 3) Distorted remnants of carbon bubble trails (SE image).

Small regions containing residual bubble trails were noted as seen in Figure 5c. These regions exhibited signs of considerable damage. One fragment of film seen in Figure 5d is shown in successively closer views in 5e and 5f. This film is significantly flatter than those observed for Type A films. The film appears to be mainly composed of carbon (Figure 5g). In other areas, the mixed scene portrayed in Figure 5h shows a more convoluted bubble trail film that is also appears to be composed mainly of carbon. The light-coloured mass in the centre of the image appears to be an oxide slag, composed mainly of a silicate with perhaps a small content of Fe and Mn. The smooth feature on the right appears to be the metallic iron matrix. For good measure, the carbon response was satisfactorily checked by analysis of a graphite flake (Figure 5i).

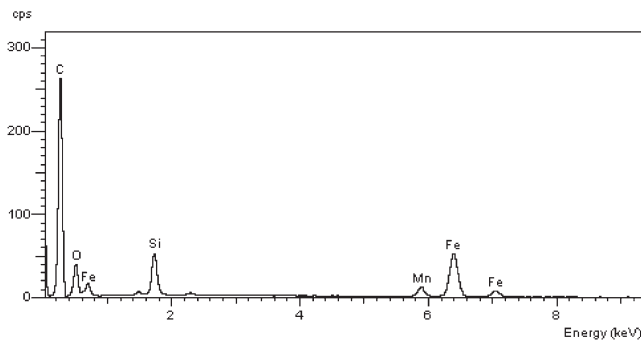
Figure 5g. Spectrum from rectangle on Figure 5f, showing the film to be high in carbon.

The silicate trails in Type A defects (Figure 4g and 4h) contrast with trails in Type B defects seen in Figures 5g and 5h that appear to consist mainly, and probably exclusively, of carbon, and seem likely therefore to be graphitic. The film seen in Figures 5d to 5f is substantially planar, and may be a remnant of the large bubble trail that surrounded the out flowing jet of carbonaceous gases in Type B events. For the smaller Type A events the only films that were observed were all of cylindrical tubular form.

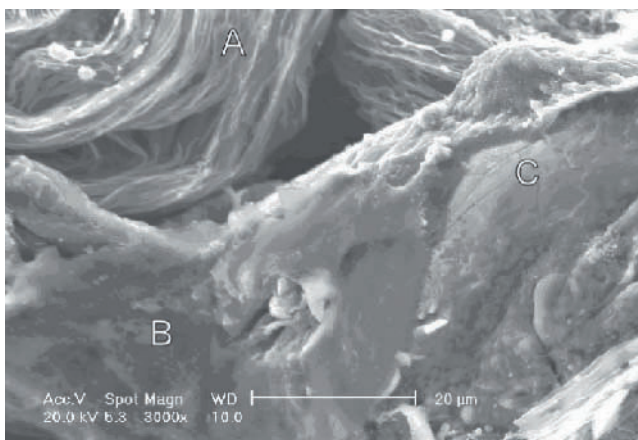
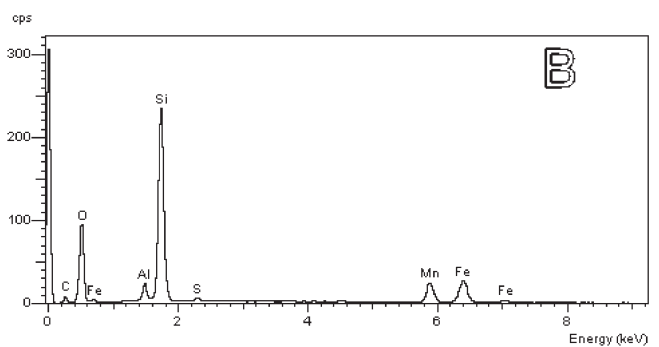
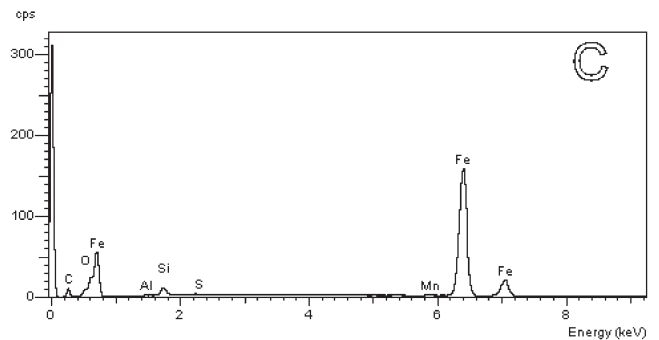
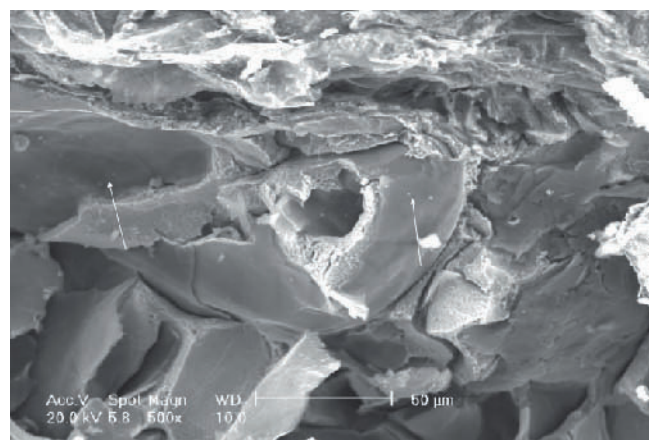
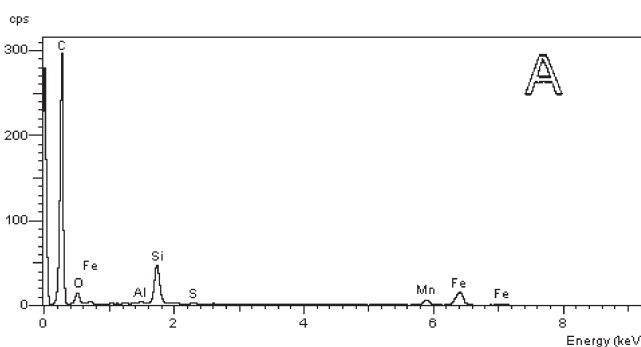
Figure 5h. (Type B Defect; Casting No 3)

Spectrum B indicates that the irregular mass is probably composed of a silicate slag containing Fe, Mn and Al.

Spectrum C of matrix, confirming it to be mainly Fe, with some Si and lesser impurities.

Spectrum A shows the bubble trail film to be nearly pure carbon although it is possible that some Si may be present (since the Si signal is relatively high compared to other signals such as Fe and Mn that almost certainly originate from the underlying matrix).

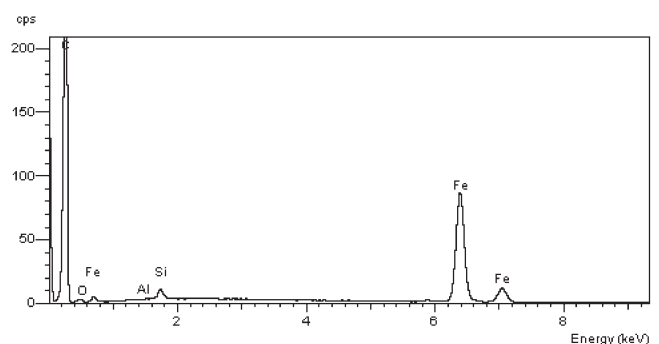
Figure 5i. Analysis of a graphite flake to confirm the sensitivity of the carbon response.
