## Field Survey of the 2018 Sulawesi Tsunami: Inundation and Run-up Heights and Damage to Coastal Communities

**Key words:** Tsunami, earthquake, field survey, inundation height, run-up height, Palu Bay, 2018 Sulawesi Earthquake.

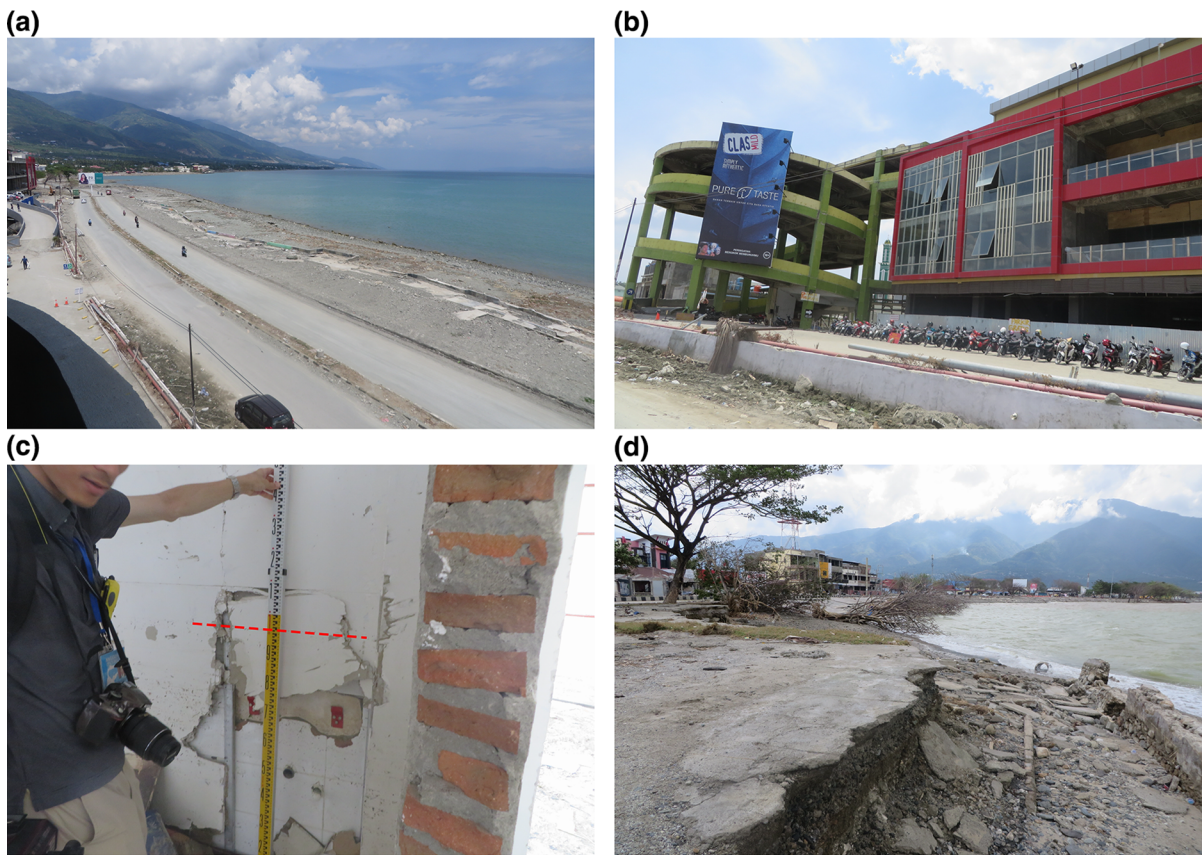
Figure 3

In Taman Ria a coastal road suffered severe damage, probably due to both the earthquake and tsunami. All of the houses, cafes and shops that were located seaward from the road were washed away due to the tsunami flow (see Fig. 3a). The measured inundation height in this area was 5.2 m. A multi-story shopping mall and parking garage are located about 500 m east of the point where the inundation height was measured. These structures served as a vertical evacuation destination for many people during the event. A spiral ramp providing vehicle access to the upper levels of the parking garage (see Fig. 3b) helped people to climb easily to the higher levels (a video posted by Channel NewsAsia (2018)

The campus of IAIN Palu is located just east of the aforementioned shopping mall. In the campus there were several two-story buildings, with the tsunami causing severe damage to the first floor. Inundation heights of 1.8 and 3.0 m were measured at two of these buildings, which were located 100 m and 200 m from the shoreline, respectively. It should be noted that since the inundation height was measured according to mudlines found inside the buildings (see Fig. 3c), the maximum water level outside might have been higher. The flow depth at the latter building (200 m from the shoreline) was 1.61 m, indicating how the tsunami at this point had enough energy to reach further inland.

the bay, probably by a combination of return flows and localized land subsidence (possibly indirectly caused by submarine landslides and/or liquefaction) at the coast (see Fig. 3d). Several broken trees were also found near the coast. They were folded toward the west, suggesting that there was a strong tsunami flow from east to west (which corroborates witnesses' reports of the direction of the incoming wave). A 2.7 m inundation height was measured at a tree in this park. It is important to note that the ground level at the location of this tree was 1.0 m above sea level at the time of the survey, but this level is 0.5 m below the estimated tidal level at the time of tsunami arrival, providing further evidence that localized land subsidence took place in this area. Another example of a part of the coastline that collapsed into the water was found about 1 km northeast from the park, where an inundation height of 3.3 m was measured.

Tsunami survey in the south area: **a** coastal area of Taman Ria, **b** spiral ramp at a shopping mall in Taman Ria, **c** mudline found inside a building on the campus of IAIN Palu, **d** part of the coast that collapsed into the water at Talise

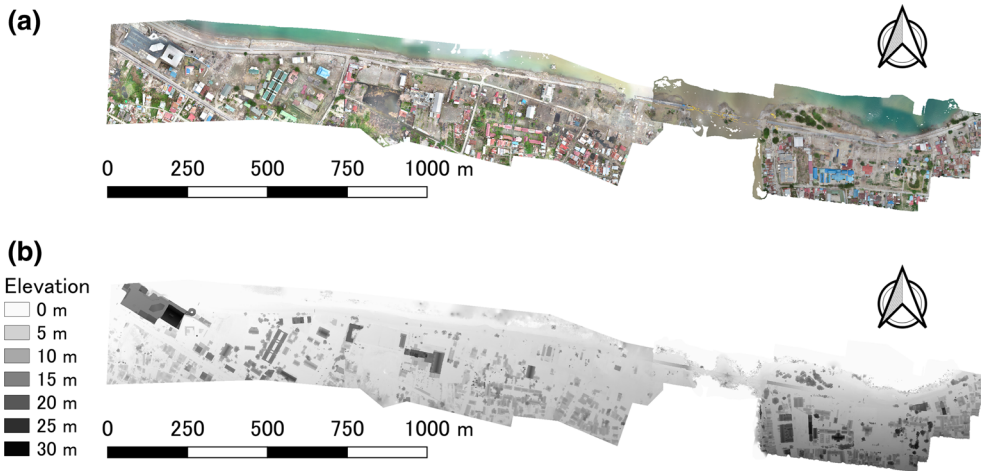
In some parts of the south area an aerial photographic survey was conducted, as mentioned earlier. Figure 4 shows the aerial image and DEM obtained from this survey. After analyzing the results, it would appear that the most severe damage was concentrated within 100–200 m from the shoreline, with hardly any structural damage observed after 200 m (it should be noted that in the most severely inundated areas some buildings had already been removed by cleaning efforts before the survey began, so it was

difficult to fully corroborate this observation). Considering the relatively flat ground elevation in this area, the rapid decrease in the degree of damage with distance indicates that the wavelength of the tsunami generated in Palu Bay was probably not as large as that of events generated by co-seismic vertical deformation.

Figure 4  
Results of an aerial photographic survey of the south area: **a** aerial image, **b** digital elevation model (DEM)

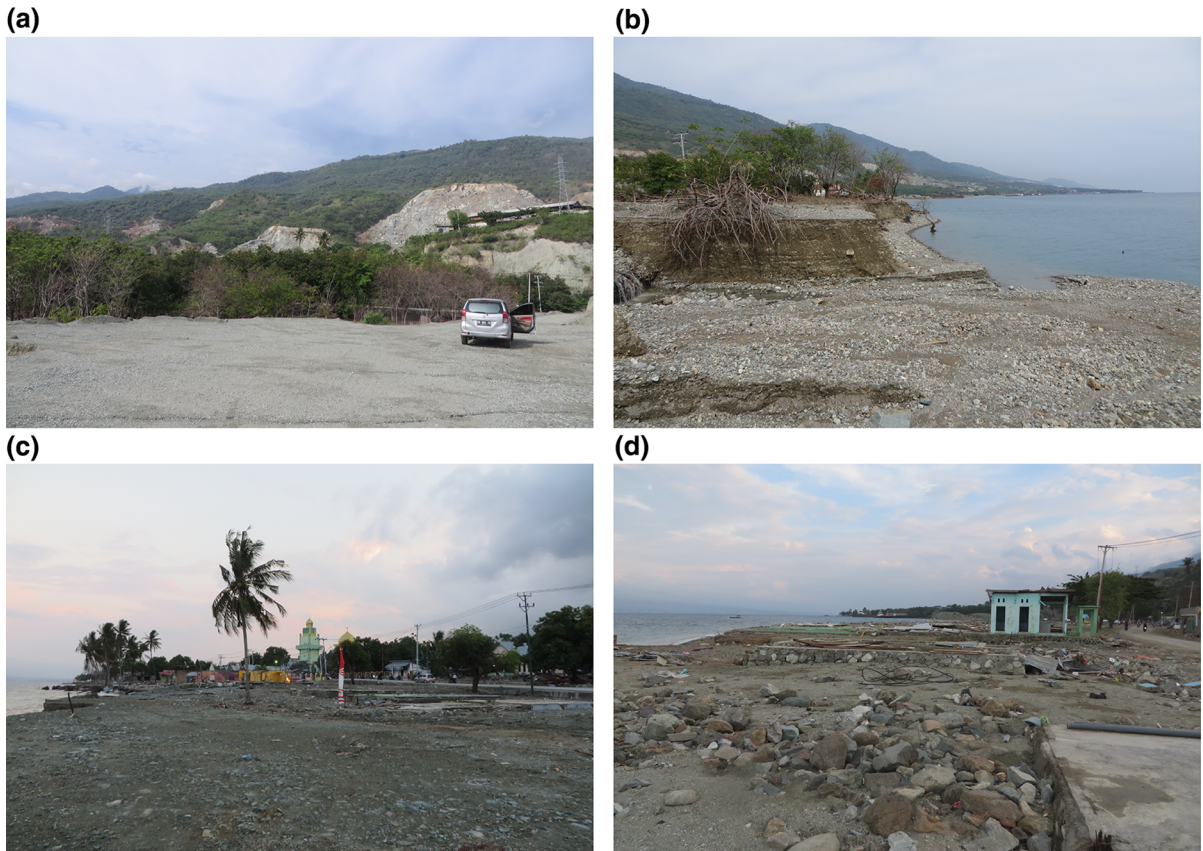
Figure 5  
Tsunami survey in the west area: **a** gravel quarries, **b** reclaimed land, **c** tsunami damage in Buluri, **d** tsunami damage in Loli

large amount of these materials. It was also noted that the mining companies had created some areas of reclaimed land to store gravel and then load it onto

barges (see Fig. 5b). The location of the river mouths and barge loading areas were often the same as the origin points of the waveforms filmed by Mr.

In Buluri two locations were surveyed. At one of the locations residents described that the water level reached the floor of their house, which was located around 100 m from the shoreline. The inundation height at this house was 6.8 m. The house was almost intact, but other houses located within 80 m of the shoreline were washed away. At another location in this area the tsunami reached a steep slope located around 70 m from the shoreline, where the run-up height was measured to be 6.0 m. From the shoreline to this point nothing was left except for the foundations of houses (see Fig. 5c). A similar scene of devastation was observed at Loli (see Fig. 5d). The tsunami reached a steep slope located around 90 m from the shoreline, where the run-up height was measured to be 4.1 m.

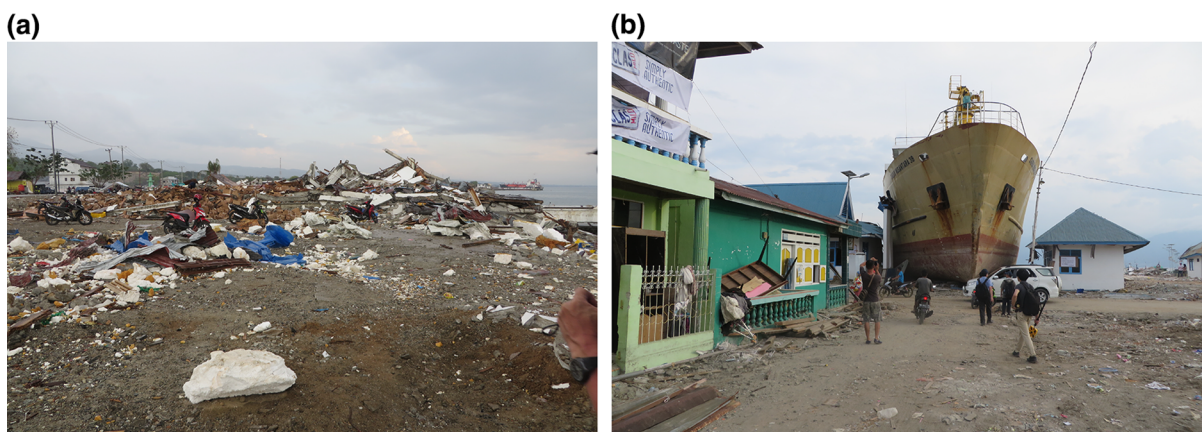
Figure 6

In Mamboro, severe damage was observed to structures in the low-lying coastal ground (within 50-150 m from the shoreline). Almost all houses and trees located seaward from the main road were washed away (see Fig. 6a). Inundation heights at two different houses in Mamboro were measured to be 4.7 m and 5.1 m. Both of the houses were located landward from the main road, and damage was rather limited (though some walls and fences were damaged) compared to houses located on the seaward

Tsunami survey in the east area: **a** tsunami damage in Mamboro, **b** grounded ship in Wani2

Wani2 has a small port, and several ships that were docked there were left stranded on the ground close to the pier (see Fig. 6b). A house located around 80 m from the quay of the port was surveyed, and the inundation height according to a mudline left on a window on the first floor was 1.7 m. The residents of this house mentioned that the highest water level they had observed had been higher than that mudline, though lower than the second floor of the house (the level of the second floor was 1.5 m higher than the level of the mudline). This indicates that the maximum inundation height at this house was between 1.7 m and 3.2 m. According to residents, the tsunami arrived 4 min after the earthquake.

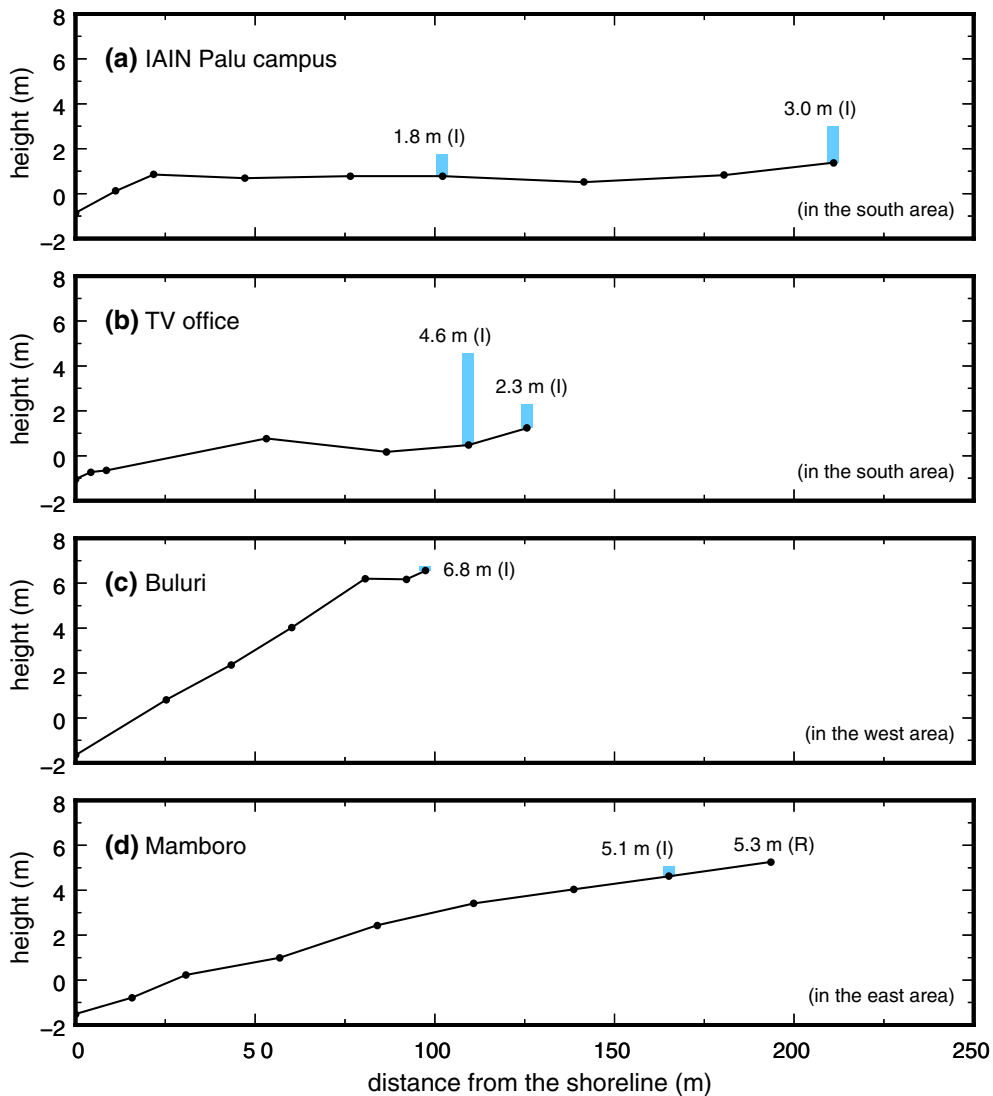
The tsunami inundation distance from the shoreline varied according to location. Figure 7 shows the profiles of the measured tsunami inundation and run-up heights and ground levels at four different locations. In the west area, as the mountains are located close to the coast, the inundation distance was around 100 m. In the east area the tsunami could travel further inland, as the slope is much milder than in the west area. On the other hand, in the south, which has a wide low-lying coastal plane, the tsunami reached more than 200 m from the shoreline at some locations. The results of an aerial photographic survey using a UAV clearly show that the tsunami reached further inland in this area, compared to the other areas surveyed. However, even in the south area

Profiles of measured tsunami inundation and run-up heights and ground levels at the time of the arrival of the tsunami: **a** IAIN Palu campus, **b** TV office, Palu, **c** Buluri, Palu, **d** Mamboro, Palu

the inundation distance did not go as far as the authors would have expected and severe damage to houses was found within around 200 m from the shoreline. For example, in the case of the 2010 Mentawai Islands Tsunami, in which the measured tsunami inundation and run-up heights were similar to those in the 2018 Sulawesi event, the inundation distance was longer than 400 m at some of the affected locations (Hill et al. 2012; Satake et al. 2013; Mikami et al. 2014). Although the topographical features varied from place to place (as shown in Fig. 7), overall the damage due to the tsunami in the

Palu Bay coastline was limited to a very narrow coastal area, which implies that the tsunami had a relatively short wavelength compared to that of tsunamis generated by co-seismic vertical deformation. Higman et al. (2018) reported that the period of landslide-generated tsunamis is shorter than that of tectonically generated events, and this could be considered as further evidence that the tsunami in Palu Bay was generated by landslides.
