The 16 September 2015 Illapel Earthquake and Tsunami: Post-Event Tsunami Inundation, Building and Infrastructure Damage Survey in Coquimbo, Chile

Abstract—The 16 September 2015 M_w 8.3 Illapel Earthquake generated a tsunami that caused severe building and infrastructure damage in Coquimbo, Chile. Initial reports indicated numerous buildings, transport, energy, water and coastal protection structures sustained varying levels of damage in response to tsunami exposure. A digital ‘census style’ survey was carried out in Coquimbo to measure and record tsunami hazard characteristics and associated buildings and infrastructure network component damage. Flow depths measured from 655 watermarks ranged from 0.1 to 4.7 m, with a 1.47 m mean and 1.02 m standard deviation. Over 3000 damage samples were recorded for tsunami exposed buildings and infrastructure components. Damage levels for 545 buildings showed most sustained partial but repairable damage at tsunami flow depths up to 2 m. A further 2544 damage samples were collected for transport, energy, water infrastructure network components and coastal protection structures. We observed undamaged infrastructure components in high proportions

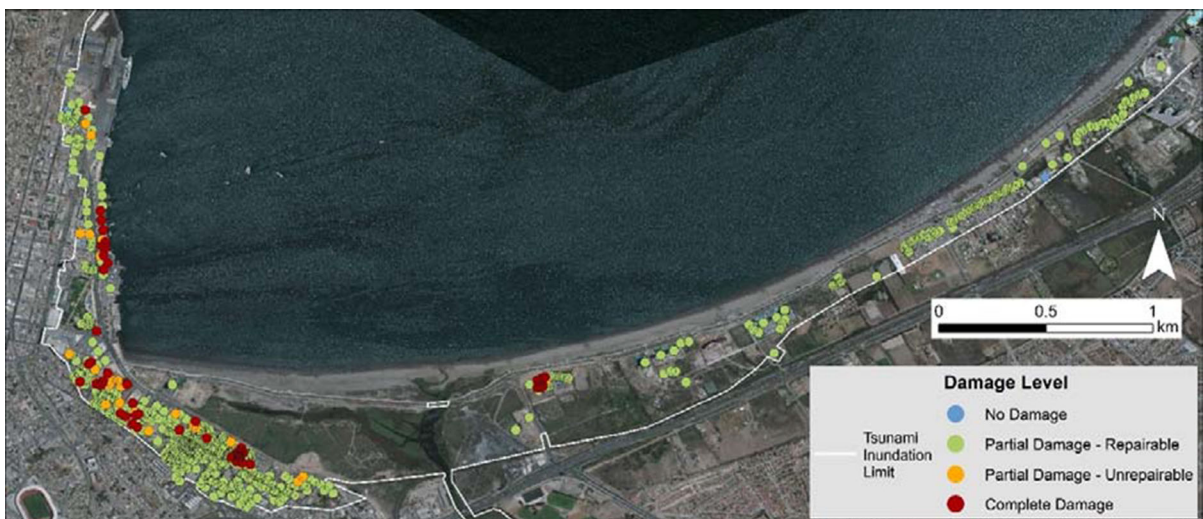
Figure 3
Surveyed building locations and damage levels

Over a four-day period, damage levels were recorded for 545 buildings (Fig. 3). Surveyed buildings were primarily used for residential, commercial (e.g. retail, restaurants) and industrial purposes. Construction frames are broadly classified as timber (106), ‘masonry’ (379), ‘reinforced concrete’ (14) and ‘steel’ (46). Flow depths measured at building locations ranged between 0.1 m and 4.5 m, with a mean of 1.01 m (SD 1.02 m).

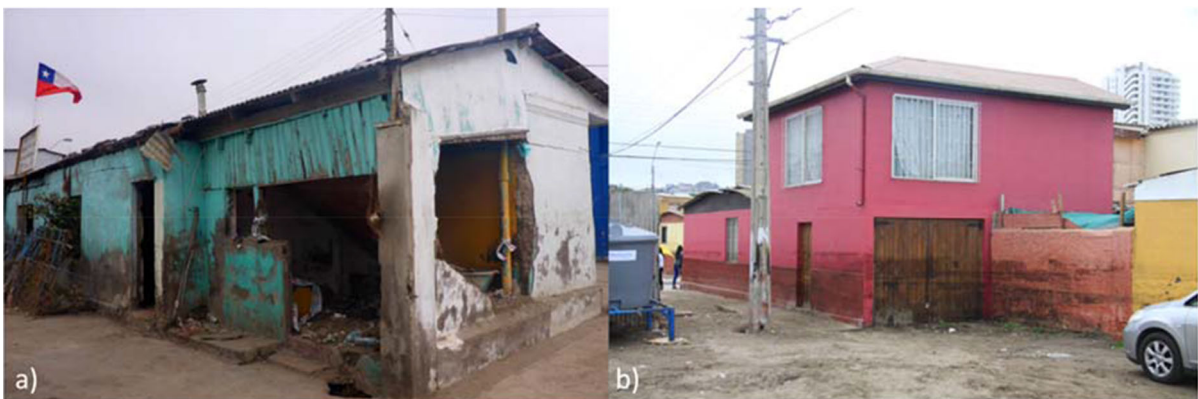
Figure 4

Most buildings (335) sustained partial damage, with 318 repairable (DL1) and 17 unrepairable (DL2). Unrepairable damage was observed due to external wall collapse or column failures (Fig. 4a), often occurring when depths exceeded 2 m. Most low-rise buildings (96%) sustained repairable damage when exposed to depths below 2 m, with damage observed when depths exceed 0.1 m to 0.2 m. Construction frames were undamaged in these cases (Fig. 4b) though, joinery, services and both internal and external doors and windows often required replacement. Only two tsunami exposed buildings surveyed sustained no damage (DL0) as the waves did not penetrate into the buildings.

Low-rise masonry buildings sustaining **a** partial but unreparable damage (DL2) from external wall collapse and column breakage and **b** partial but repairable damage (DL1) from first story inundation, indicated by flow depth watermarks present on the building exterior

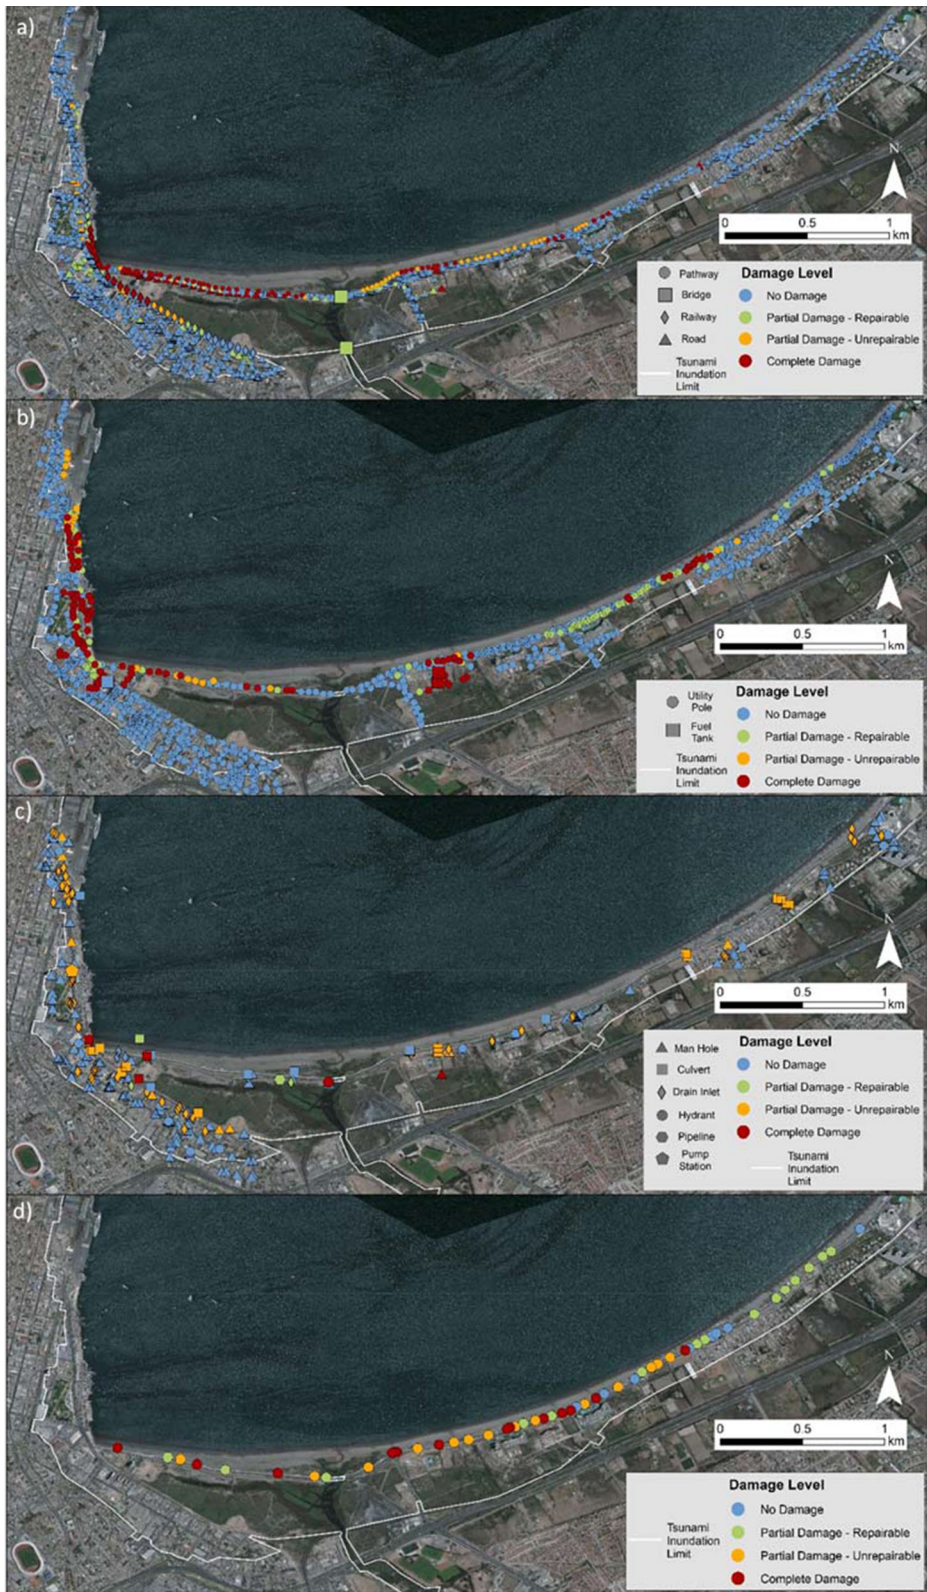
Roads Damage levels were recorded for over 25 km of roads (Fig. 5a). A high proportion (87%) of roads sustained no damage (DL0). Undamaged roads were commonly observed in Baquedano. Sheltering afforded by buildings, road and railway embankments and coastal protection structures in the survey area contributed to limiting most road damage (\geq DL1) within 250 m of the shoreline. Eye-witness accounts and drone footage indicated considerable disruption to undamaged roads particularly from debris deposition on local roads in the Baquedano and Coquimbo Port areas where vehicle transport was disrupted for several days after tsunami inundation. Debris and sediment deposition on roads were not recorded at the time of survey due to removal from post-tsunami clean-up activities.

Figure 5
Surveyed infrastructure component locations and damage levels surveyed for **a** transport, **b** energy, and **c** water networks, and **d** coastal protection structures

secondary roads near Coquimbo Port and Avenida Costanera tertiary road. Complete damage (DL3) for 1.1 km of roads was mostly observed along Avenida Costanera west of Quebrada de Peñuelas river. Here, we measured flow depths between 2 m to 3 m near sites where rubble-mound seawall and culvert failures instigated road embankment erosion and surface damage, making both lanes impassable (Fig. 6a). Avenida Costanera was also reduced to a single passable lane where these failures caused partial road damage (DL2). Complete and partial seawall and culvert damage observed on the seaward margin of Avenida Costanera indicates road damage was initiated by inland tsunami flows, opposed to return flows from water trapped in the wetland area (Fig. 1e). The Avenida Costanera coastal access road between Coquimbo and La Serena was completely disrupted for several days until temporary infill of scoured road embankment sections restored partial service for vehicles and pedestrians.

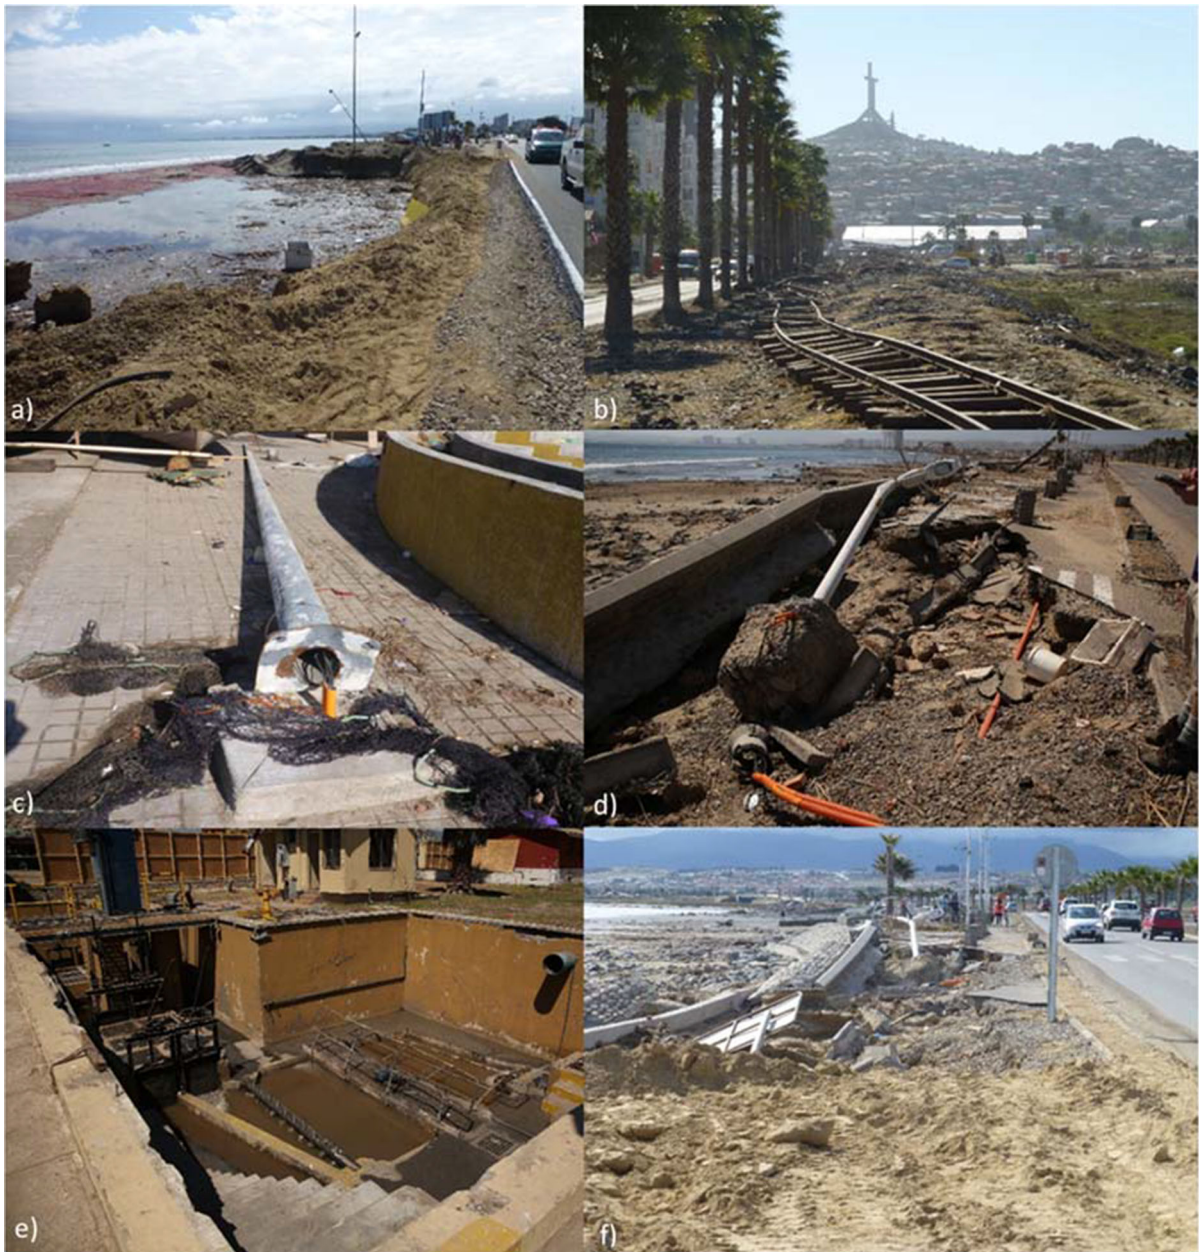
Figure 6

a Avenida Costanera road embankment and surface damage caused by culvert and seawall failure, **b** railway track warping and displacement, **c** utility pole failure from debris impact, **d** utility pole failure due to seawall failure and scouring, **e** pump station well exposed by superstructure removal, **f** seawall collapse causing pathway and road embankment damage on Avenida Costanera, with temporary fill to support transport service.

Costanera (4.7 km), with complete damage (2.5 km) caused by road embankment erosion and surface damage in response to coastal protection structure or culvert failures. Tsunami wave overtopping of

seawalls caused the complete removal of brick pavers and scour of underlying embankment fill (DL3). Partial damage to pathways disrupted the Avenida Costanera thoroughfare for cyclists, though pedestrian use remained possible.

Railways A single 2.05 km railway track in the survey area connects Coquimbo Port to the national railway network. The railway track sustained 1.2 km of damage (\geq DL1), including 0.65 km of complete damage (DL3) in the Coquimbo Port area due to seawall failure. Here, reduced protection resulted in embankment scour, removing railway track support. Railway tracks embedded in road surfaces sustained no damage, while partial (DL1) to complete (DL3) damage was observed along a raised embankment immediately seaward of Baquedano. Embankment overtopping caused scour and loss of support for railway ties, resulting in track movement and deformation (Fig. 6b).

Utility poles surveyed (80%) frequently experienced no damage (DL0) from tsunami inundation. Undamaged poles were observed for flow depths over 2 m though, electricity and telecommunication services were disrupted due damage to other poles carrying cables on the same distribution networks. Complete damage (DL3) was sustained by 10% of poles, often occurring in response to direct impact by debris, small boats and vehicles (47%) in the Coquimbo Port area (Fig. 6c). Where flow depths exceed 2.5 m utility poles may have also failed due to

debris loading on electricity service cables. Scouring of utility pole foundation support following seawall failure or road embankment erosion frequently caused their complete damage (40%) along the Avenida Costanera coastal esplanade (Fig. 6d). Scouring at the pole base initiated from wave overtopping of seawalls caused tilting or collapse, making poles unrepairable (DL2), while partial but repairable damage (DL1) was observed where bolts connecting base plates to foundation pads appeared to bend under pressure from hydrodynamic force without obvious signs of debris impact.

A potable water pump station 350 m south of Coquimbo Port was exposed to flow depths up to 3 m. Complete damage was sustained by both the masonry building superstructure (Fig. 6e), as well as plant and equipment (e.g. pumps, electrical circuitry, pipes). In-ground filters were partially damaged and reusable following clean-up and repair, while sediment and debris deposited in the dry well required removal. Hydrants, providing access to water main pipes sustained no or partial damage (DL1) when exposed to flow depths up to 2 m.
