Tool wear and hole quality investigation in dry helical milling of Ti-6Al-4V alloy

Hao Li · Gaiyun He · Xuda Qin · Guofeng Wang ·
Cui Lu · Linjing Gui

Received: 15 June 2013 / Accepted: 16 December 2013 / Published online: 12 January 2014
© Springer-Verlag London 2014

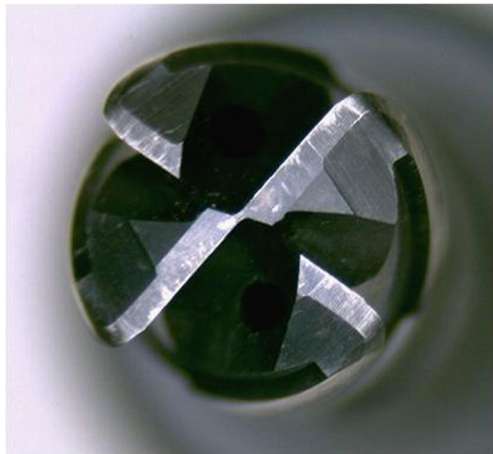
Figure 4 is the photography of initial wear of the front cutting edge zone after machining three holes (cutting time with 2.5 min). Image shows that the clearance face near the cutting edges presents the different color contrasts. Zones with different contrasts were analyzed by EDX technique, and the results show that the bright white region corresponds to tool substrate (WC-8 % Co) and coating materials (TiAlN); the gray region only corresponds to coating materials (TiAlN). The above results suggest that part of coating material has been removed. However, the geometry parameters of the cutter were measured by an optical microscope, and no significant changes were observed at the front cutting edges.

Fig. 4 Initial wear of the bottom cutting edge zone after machining three holes (cutting time 2.5 min)

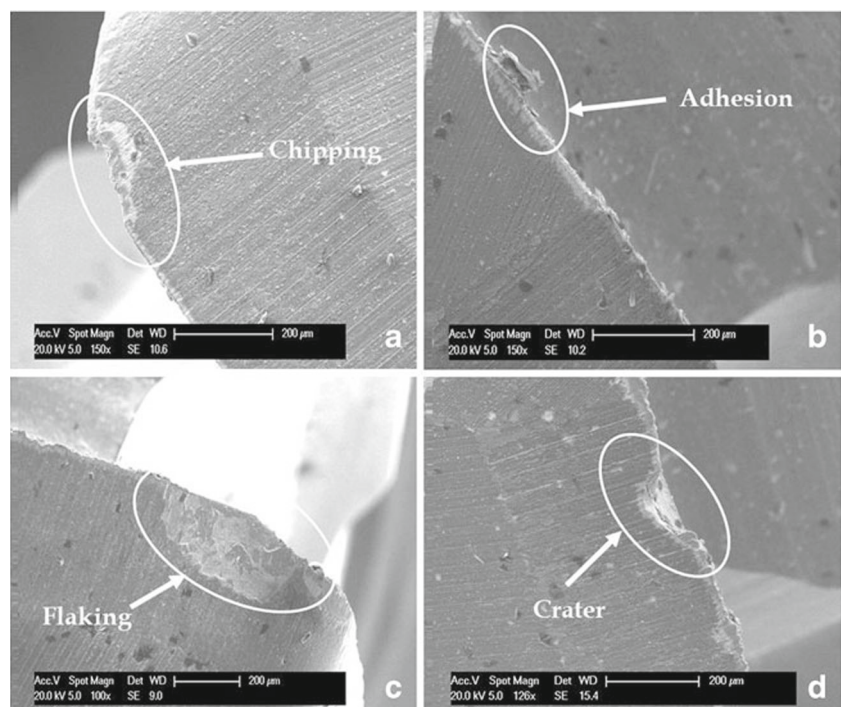
With the increase of cutting time, the phenomena described in the initial phase of tool wear showed increase in evolution. It is observed that more coating materials were lost compared with initial wear stage. The medium wear situation of front cutting edge zone after a cutting time of 12.5 min is shown in Fig. 5a. It is interesting to observe that the early chipping/fracture firstly occurred at the tool nose in general (the zone which is marked with A in Fig. 3). The main occurrence reason of this phenomenon is the highest cutting speed, and the cutting temperature [19] was reached compared with other positions at the front cutting edges in helical milling process. Furthermore, the helical milling process consists of a discontinuous milling process on the periphery cutting edge and a continuous drilling process on the front cutting edge [15]. The tool noses are subject to thermal cycles owing to discontinuous cut, and it will increase the wear rate to a certain extent. Chipping at the tool nose would lead to flaking with the cutting time increases, as shown in Fig. 5c. Although these flaking do

Figure 5b shows an image of the front cutting edge when cutting time reached 12.5 min. The good geometry shape of the front cutting edge was still obtained. However, the adhesion phenomena were observed as shown in the figure. The adhesion phenomena are formed due to the high pressure generated during cutting and the high chemical affinity of the tool to the workpiece material. Sharman et al. [26] has made similar observations in end milling of Inconel 718TM.

Fig. 5 Medium wear of front cutting edge: **a** chipping at cutting time of 12.5 min, **b** adhesion at the cutting time of 12.5 min, **c** flaking at the cutting time of 18.3 min, and **d** crater at the cutting time of 18.3 min

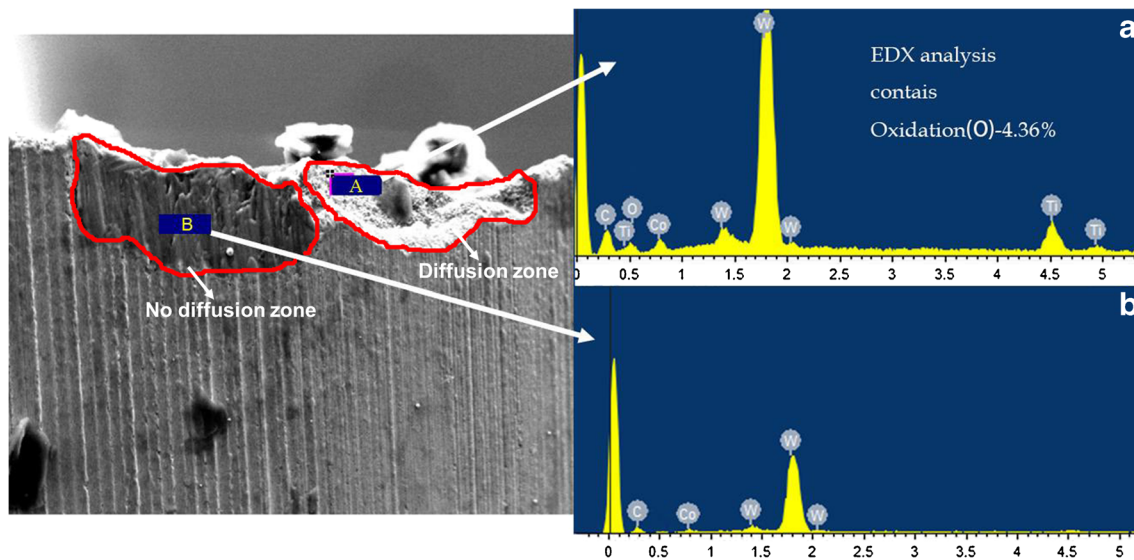
The EDX analysis result of worn front cutting edge is shown in Fig. 6, and two kinds of wear mechanism were observed through the results of SEM-EDX: diffusion and adhesion. According to Nabhani [27], the temperature of the cutting zone even at moderate cutting velocity is generally around 900 °C. At such high temperature, the titanium chip maintains a very high intimate contact with the tool rake and flank face especially at the condition with no protection of coating. The EDX analysis of the crater (spectrum A) proved that the diffusion wear exists in the crater section. In the spectrum, peaks of W and Co correspond to the tool substrate, while peaks of Ti corresponds to the workpiece materials. The diffusion between the cemented carbide tool and titanium alloys can embrittle the region of tool where diffusion happened [28]. The diffusion speed of carbon atoms from tool substrate is more rapid than metal atoms (Co and W) [19]. A carbon-deficient region appeared at the tool subsurface, and this may be the reason for the embrittlement of the tool. This process may lead to the more

Fig. 6 EDX analysis of bottom cutting edge zone (cutting time of 22.5 min)

serious brittle chipping/fracture. As shown in Fig. 6, chipping/fracture was observed at the diffusion zone of front cutting edges. It is interesting to find that oxidation mechanism that occurred during the dry helical milling process (spectrum A). Therefore, the combined action of diffusion, adhesion and oxidation generates the craters shown in Fig. 6. The flaking wear pattern was also observed in section B; the EDX result is shown in the spectrum B and no diffusion or adhesion occurred in section B.

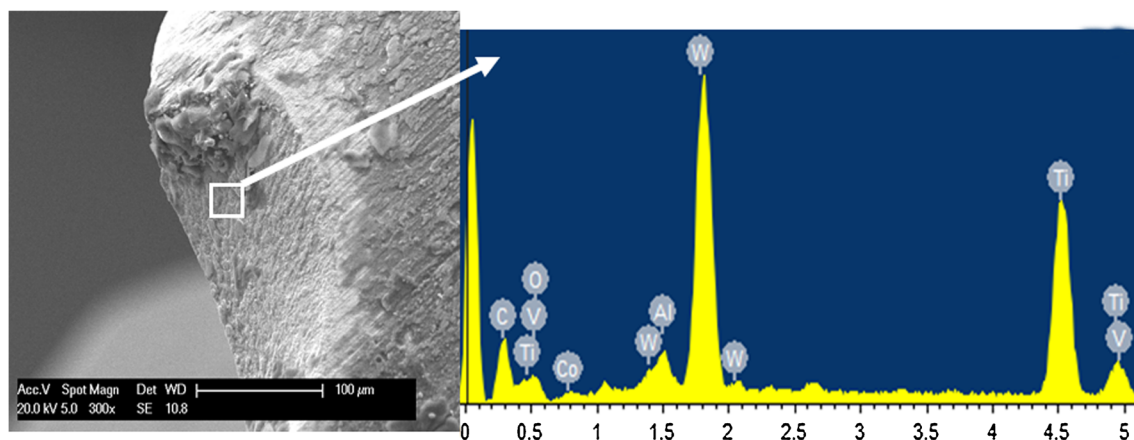
the plastic lowering phenomenon is not observed in the current study. As shown in Fig. 7, the more severe crater was also observed at the tool nose. EDX analysis of the crater was carried out, and the results are similar to the result of spectrum A in Fig. 6.

Fig. 7 EDX analysis of cutter nose (cutting time of 22.5 min)

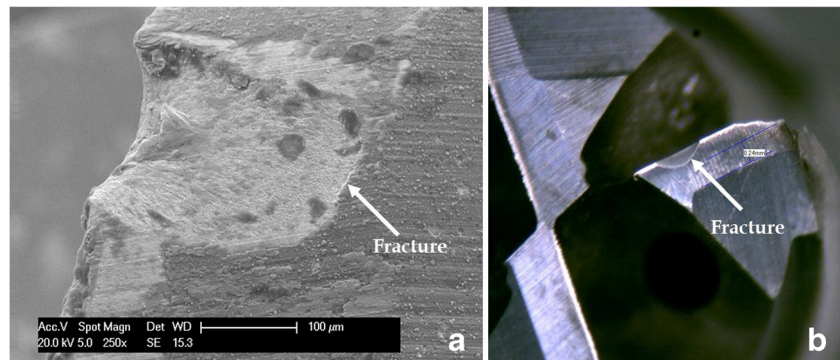
At the end of the tool life, the excessive chipping and fracture occurred in the cutting edge. The catastrophic fracture was observed at one of the tool noses (this region may reach the highest cutting temperature and cutting speed in helical milling process), as shown in Fig. 8a. However, the rest of cutting edges did not show significant change in geometry. The fractures were also observed at the other position of front cutting edge (Fig. 8b). High stress and cutting temperatures coupled with the brittleness of the substrate tool due to diffusion may accelerate the chipping, flaking, cracking, and fracture of the tool [30]. Catastrophic failure of the tool occurred without previous progressive

Fig. 8 Final wear of front cutting edge zone: **a** fracture at tool nose (cutting time 33.3 min) and **b** fracture at cutting edge (cutting time 33.3 min)

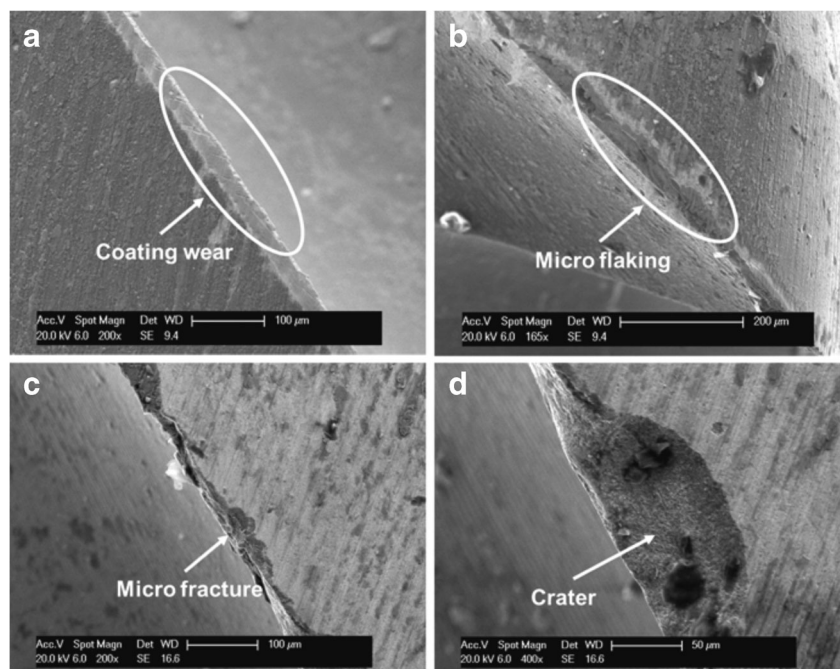
It is interested to find that the wear at the periphery cutting edge zone is not quite severe compared with the front cutting edge, and the occurrence time of obvious wear is much later. As shown in Fig. 9a, the coating material (TiAlN) in the vicinity of the periphery cutting edges was lost at the rake face of the periphery cutting edges when machined for 5 min, but no significant geometry change was observed. The loss of coating leads to the weakness at the cutting edges, and the flaking and chipping/fracture were followed with the increase of cutting time, as shown in Fig. 9b, c. Different from the chipping/fracture that occurred at the front

Micro-craters were also observed at the periphery cutting edges at the cutting time of 23.3 min, as shown in Fig. 9. The wear mechanism is similar to the mechanism at the front cutting edges, in which diffusion and adhesion were also observed using the EDX analysis method. The different point comparing with front cutting edge wear is smooth, and steady wear was widely observed at the periphery cutting edge (Fig. 10). This might be due to the following two facts: abrasion wear was more predominant than other wear mechanisms on the flank face of the periphery cutting edges, and better cutting environment (both in cutting heat and cutting force) is presented due to the unique characteristic in helical milling process. The interrupted and eccentrically machining process elevates the room for chip removing and heat flowing.

Fig. 9 The wear process of the periphery cutting edge: **a** coating materials lost at flank face (cutting time 5 min), **b** micro-flaking that occurred at the cutting edge (cutting time 12.5 min), **c** micro-chipping/fracture that occurred at the cutting edge (cutting time 18.3 min), and **d** micro-crater at the cutting edge (cutting time 23.3 min)

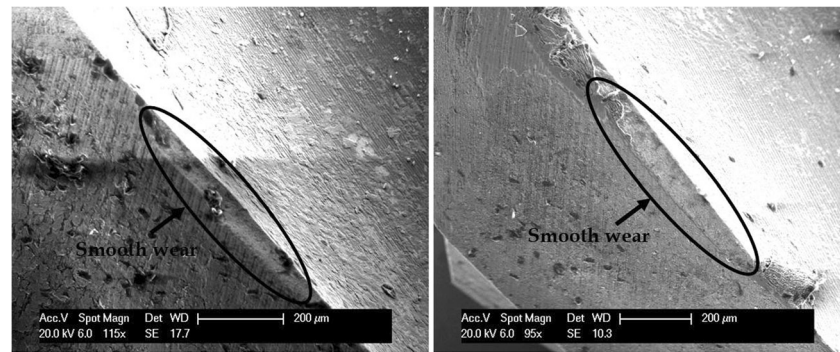
Fig. 10 Smooth wear at flank face of the periphery cutting edge zone (cutting time 33.3 min)

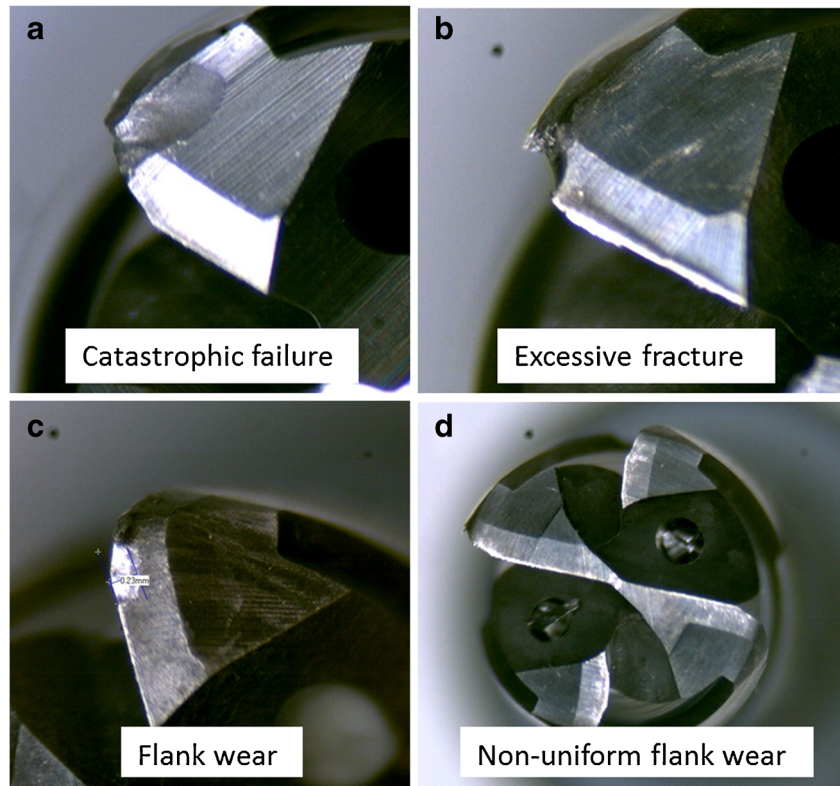
Fig. 13 Tool wear modes at the end of tool life under various cutting speeds (a 120 m/min, b 100 m/min, c 80 m/min, d 60 m/min)

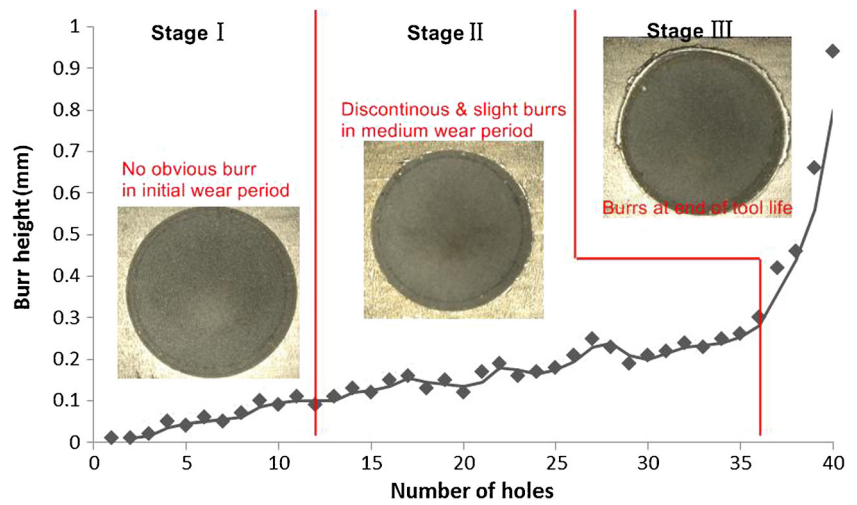
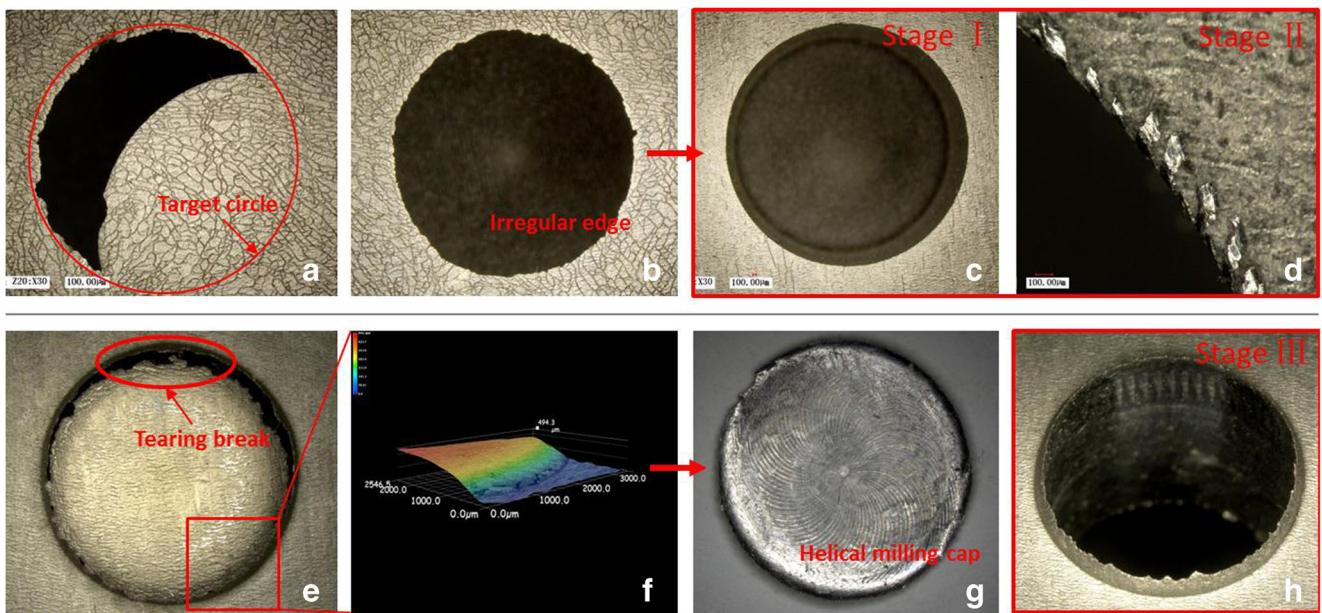
Fig. 17 Burr formation process at the exit of hole for three different stages: **a–c** initial wear of front cutting edge, corresponding to *stage I*; **a–e** burr formation process in medium wear of front cutting edge, corresponding to *stage II*; **e–h** burr formation at the end of tool life (*stage III*); **f** three-dimensional photo of helical milling cap

breakout burr [33]. Burrs may also be classified by the physical manner of formation. Plastic deformation of material includes lateral flow (Poisson burr), bending (rollover burr) and tearing of material from the workpiece (tear burr). As shown in Fig. 17a, the exit of the machined hole presented a crescent shape when the helical milling operation was almost getting to the end. The irregular edge can be observed when the front cutting edge (section B, shown in Fig. 3) was worn badly, but this irregular edge was not the final target circle; the final burr status of the hole exit depends on the wear condition of machining tools. In stage I, the residual workpiece of the irregular edge can be cut off by the corner of the cutting edge (section A, shown in Fig. 3) and the periphery cutting edge (section C, shown in Fig. 3) in the subsequent cutting process. As shown in Fig. 17c, no obvious burr can be observed in stage I because of the favorable cutting performance of the machining tool. However, the serious crater wear occurred at the tool nose (section A) with the increase of cutting times in stage II. This will cause lateral flow and bending when the irregular edge of the exit of the hole has been cut by worn front cutting edge and would lead to the rollover burr appearance at the exit of the hole, as shown in Fig. 17d. The helical milling cap appeared owing to the catastrophic failure at the front cutting edges with the increasing cutting time. As shown in Fig. 17e, f, the workpiece material was extruded out by the machining tool, instead of cutting them off, and then the large plastic deformation happened at the exit of the hole. When the thrust force reached the fracture limit of the workpiece material, the tearing break occurred at the boundary of the cap, and these led to the tear burr to happen in stage III, as shown in Fig. 17h.

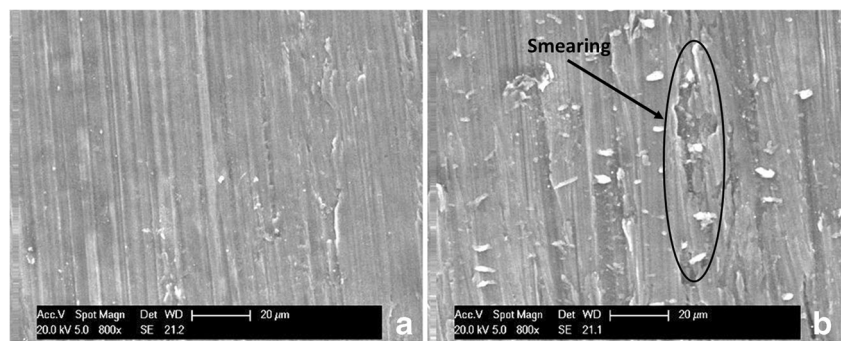
Fig. 19 Surface of the machined hole: **a** cutting time of 5 min, **b** cutting time of 18.3 min

The surfaces of the machined holes were observed by SEM both in the cutting time of 5 and 18.3 min, in which chipping/fracture did not occur in the periphery cutting edge at the first time point (5 min, the sixth hole), but occurred at the second time point (18.3 min, the 22nd hole). A visual examination of all the holes showed clearly that micro-smearing can be observed in some locations of the machined hole surface when the chipping/fracture happened (even though surface roughness was not always significantly affected), compared with Fig. 19a, b. Smearing is unacceptable to the aerospace industry because it may cover cracks and other surface defects leading to premature in-service failure of the component. From Fig. 19, we can know that the surface quality with the cutting time of 5 min is better than that in the cutting time of 13.8 min, but their surface roughness values almost kept in the same level, as red-marked circle (a and b) shown in Fig. 18. Therefore, surface roughness could not fully characterize the quality of the machined surface in hole-making process. When chipping/fracture and flaking occurred, many small hard particles of tool substrate were generated. Smearing in the machined surface might occur owing to the existence of these hard particles of tool substrate, and the breakage of periphery cutting edge will lead to the irregular cutting marks at the same time.
