Tool wear analysis in the machining of hardened steels

Álison Rocha Machado^{1,2} · Anselmo Eduardo Diniz³

Keywords Machining of hardened steels · Tool wear mechanisms · Continuous and interrupted cuttings · CBN, ceramic, and cemented carbide tools

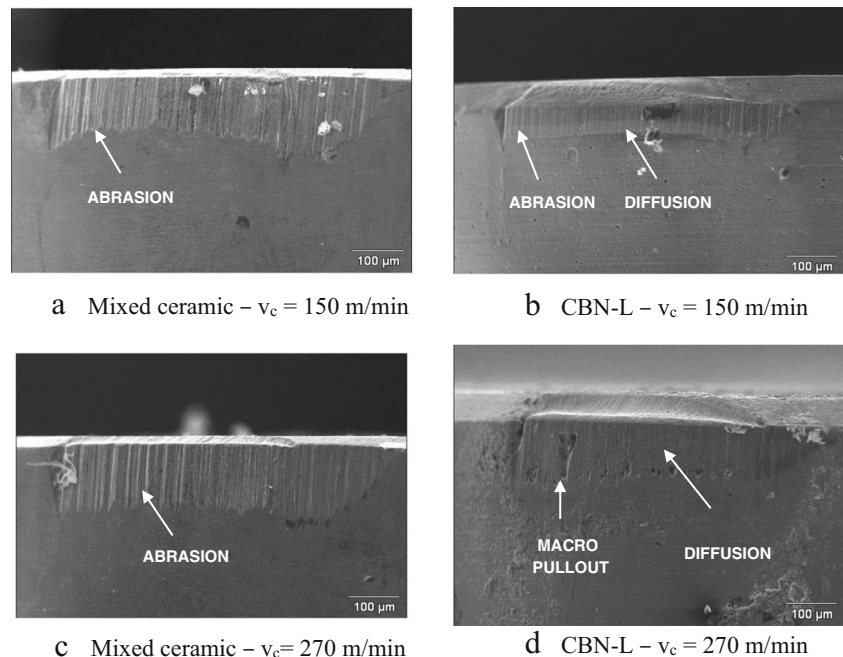
The main wear mechanism in the ceramic tool at both cutting speeds was abrasion, indicated by the thin scratches parallel to the cutting direction in Fig. 3a, c. The high chemical stability of the ceramics prevented the occurrence of diffusion, and the lower hot hardness of the mixed ceramic made abrasion possible. EDS (energy dispersive spectroscopy) analysis failed to reveal iron atoms in the ceramic wear lands, indicating that the diffusion and attrition did not occur. The scratches seen in the figures were caused by abrasion. Possible explanations for the abrasion were (i) it was caused by hard workpiece particles being scratched with the tool and (ii) the friction between the tool and workpiece removed the binder from the tool (which is much softer than the ceramic phase), and consequently, the hard particles were removed and abraded the tool, producing the scratches.

When the CBN-L tool was used with a cutting speed of 150 m/min (Fig. 3b), abrasive scratches occurred together with some smooth regions, indicating that the wear also

occurred because of diffusion. The CBN-L tool was made of CBN and an added ceramic phase that decreases the material's thermal conductivity and increases its chemical stability in the presence of Fe. At low cutting speeds, abrasion was the main wear mechanism although diffusion also occurred. However, when the cutting speed was increased to 270 m/min, the tool temperature also increased and the diffusion resistance of the tool was consequently insufficient to avoid flank wear caused by this mechanism. The severe crater wear shown in Fig. 3d is another hint that diffusion occurred, as this phenomenon is often the main cause of wear on the tool rake face. These findings can be observed in Fig. 3d, where the smooth flank and rake wear lands suggest diffusion. EDS analysis of several points on the wear land showed small amounts of Fe (maximum 12%), which was only present in the workpiece, indicating that it had reached the tool in a diffusive process. If more Fe together with layers of workpiece material were present on the tool, adhesion of the workpiece/chip material would very likely have occurred, but this was not the case. Therefore, it can be concluded that the presence of Fe on the tool indicates that diffusion was the main wear mechanism for this tool.

The only experiment where pull-out of macroscopic particles (Fig. 3d) occurred was the one in which a cutting speed of 270 m/min and the CBN-L tool were used. At this speed, the tool reaches higher temperatures, which probably caused the decrease in the tool binder resistance and consequent loss of cohesion between the binder and the CBN, allowing the large amount of tool material shown in Fig. 3d to be removed. However, abrasive scratches that could be caused by friction of these removed macroparticles against the workpiece cannot be observed in Fig. 3d. This can be explained by the fact that

Fig. 3 a–d Scanning electron microscope images of the worn tool flank faces used in the continuous cutting experiments

these particles were removed close to the end of the worn area, i.e., close to the end of the tool-workpiece contact.

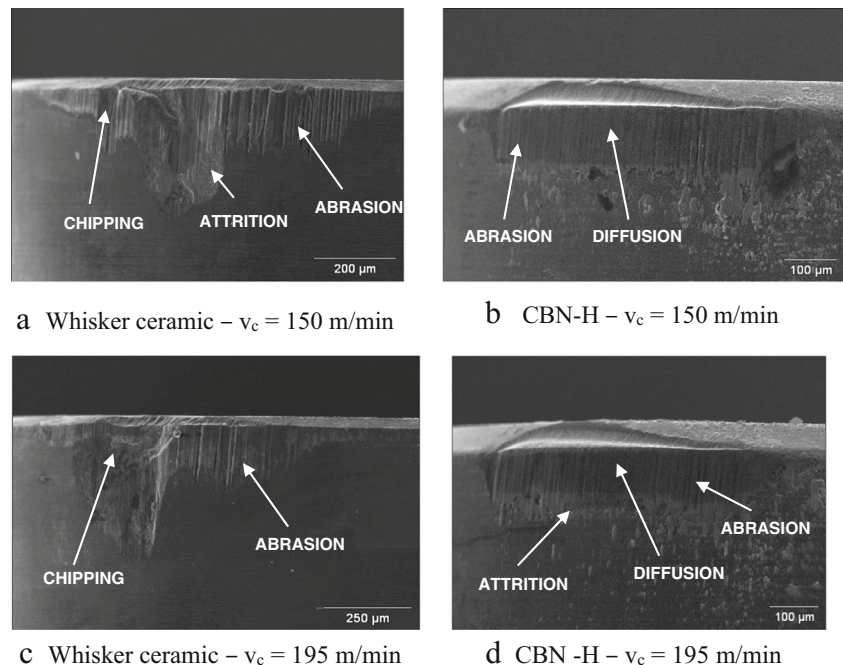
Figure 4 shows images of the edges used in the interrupted cutting experiments. The images show that the whisker-reinforced ceramic tool exhibited chipping of the cutting edge in all the experiments (Fig. 4a, c). Abrasive scratches were also present on the worn lands of the ceramic tools used. When the cutting speed was 195 m/min (Fig. 4c), the EDS analysis failed to reveal any Fe from the chip/workpiece material outside the chipped region, indicating that attrition did not occur and was therefore not the cause of chipping. Figure 4c also shows that the chipping of the cutting edge was not caused by thermal stress, as there are no cracks perpendicular to the cutting edge, a typical feature of this type of failure. All the cutting was performed on the curved portion of

the cutting edge since the depth of cut was smaller than the tool nose radius. Consequently, the chip thickness varied from zero at the tool tip to the maximum value at the end of the depth of cut. As can be seen in Fig. 4a, c, chipping occurred in the region of the tool where the chip was thickest, leading to the conclusion that the chipping was probably caused by mechanical shocks against the workpiece. The abrasive scratches seen in Fig. 4c (cutting speed of 195 m/min) again may have two causes: (i) scratching of the tool flank face by hard workpiece particles; (ii) removal of the tool binder as a result of friction of the workpiece against the tool, causing hard particles to be removed from and rub against the tool and so producing abrasive wear. The first hypothesis is more likely, since the cutting interruptions did not allow the tool temperature to increase to the point that the binder resistance was affected, thus avoiding hard particles being removed from the tool.

When the cutting speed was 150 m/min (Fig. 4a), EDS analysis revealed the presence of Fe inside the abrasive scratches in the ceramic tool, indicating that attrition was the main cause of this abrasion process. Attrition removed tool particles, which were then pushed by the movement between workpiece and tool, generating friction in the process, unlike what occurred when the cutting speed was 195 m/min. According to Trent and Wright [2], attrition occurs more easily at moderate cutting speeds. The fact that attrition is involved in flank wear when turning workpieces with high hardness proves that even a material without high ductility can be extruded between cutting edge and workpiece surface and sticks to the flank face. However, this happens without a thick layer of adhered material forming, as usually occurs when machining soft steels [3].

Fig. 4 a–d Scanning electronic microscope images of the cutting edges used in interrupted cutting

When the CBN-H tools were used (Fig. 4b, d), the tool rake face was smooth, indicating that diffusion was the cause of crater wear at both cutting speeds. The whisker-reinforced ceramic tool had higher chemical stability in the presence of iron than its CBN-H counterpart and therefore exhibited less crater wear than it (visual inspection). When the CBN-H tool was used, EDS analysis showed the presence of Fe in the lower edge of the flank wear region at both cutting speeds, indicating that attrition was the main wear mechanism in these experiments. Removal of hard particles from the tool by attrition probably caused abrasion, which can be seen by the abrasive scratches in Fig. 4b, d. Attrition in turn may have been stimulated by the low cohesion between CBN and its binder. Diffusion also played an important role in this wear, since some wear regions had a smooth appearance.

No chipping occurred on the CBN-H cutting edges even after 100 min of cutting, and consequently, this proves that CBN-H is sufficiently tough and can be used in a tool designed for this kind of cutting. Again, the CBN-H tools had longer tool lives than the whisker-reinforced ceramic tools (more than twice as long at both cutting speeds), proving that the wear mechanisms in the former (attrition and diffusion) were slower than the chipping process and wear mechanisms (abrasion and attrition) in the latter. Based on these results, it can be concluded that, in order to improve even more the suitability of using CBN-H material in the turning of hardened steel of interrupted surfaces, it is necessary to improve its chemical stability with iron (in order to either avoid or minimize diffusion) and to decrease the friction coefficient of the material (in order to minimize the adhesion of the material on the tool which precedes attrition) [2].

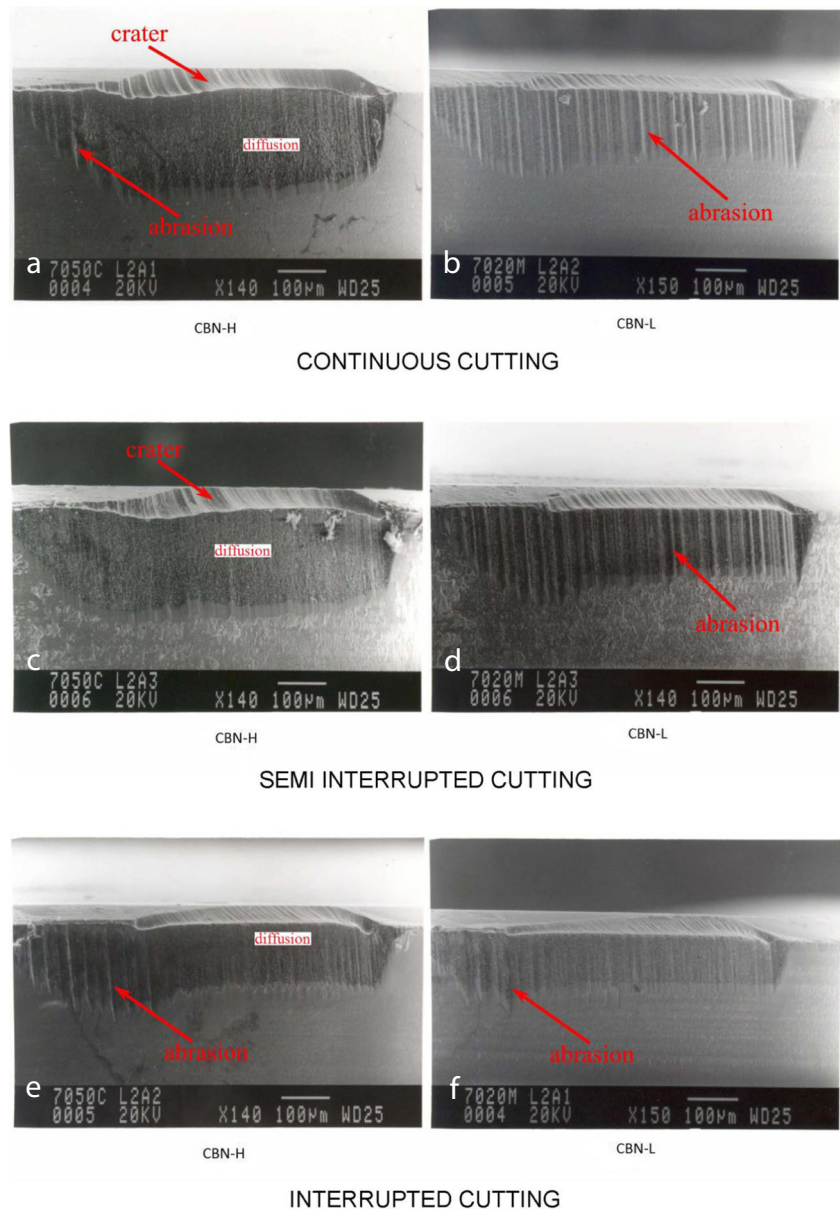
Figure 7 shows pictures of the worn edges taken in a scanning electronic microscope (SEM). It can be seen in this figure that no chipping or breakage occurred on the cutting edges even when interrupted surfaces were turned, proving that all the tools had sufficient toughness to resist the impacts inherent to the cutting of interrupted surfaces, regardless the tool material used.

Abrasion scratches can be seen in the secondary cutting edge (left side of each image) in almost all the images in

Fig. 7. This was attributed to the very low chip thickness in the region, which caused chip side-flow and further increased the specific cutting force in that point.

Figure 7 also reveals that abrasive scratches were present not just in the secondary cutting edge but also along all the wear regions when CBN-L tools were used, regardless the workpiece shape. Furthermore, crater wear in CBN-L tools was always smaller than in CBN-H tools. When the latter were used, the abrasive wear mechanism was only important in the interrupted cutting experiments. When continuous and semi-continuous surfaces were turned, the small abrasive scratches were not so clear, and there was substantial crater wear.

When CBN-H tools were used to turn continuous and semi-interrupted surfaces, the abrasive scratches on the flank face occurred only on the secondary cutting edge (tool tip). On the flank face (the kind of tool wear which led the tools to the end of their lives) just below the main cutting edge the wear was caused by diffusion, as the wear region had a smooth appearance. The low chemical stability and high thermal conductivity of the CBN-H grade made diffusion possible, as the tool temperature was higher and resistance to diffusion lower

When interrupted surfaces were machined using CBN-H tools, abrasive scratches could be seen in all the wear regions, but these were deeper in the secondary edge region because of the low chip thickness in this region. Diffusion also contributed to flank wear on the main cutting edge. This result shows that, even for interrupted cutting (condition in which CBN-H performed better than CBN-L in terms of tool life), when the tool temperature is not so high, diffusion is important, as it was cited before in this work. Therefore, it is necessary to find a way to increase the CBN-H chemical resistance (as already cited before), without harming its toughness, which is so important to resist to the frequent shocks of this kind of machining [7]. Other point to increase even more the wear resistance would be to increase of CBN-H hot hardness, in order to minimize the occurrence of abrasion, again, without harming toughness.

Fig. 7 a–f View of the worn flank face of the CBN tools

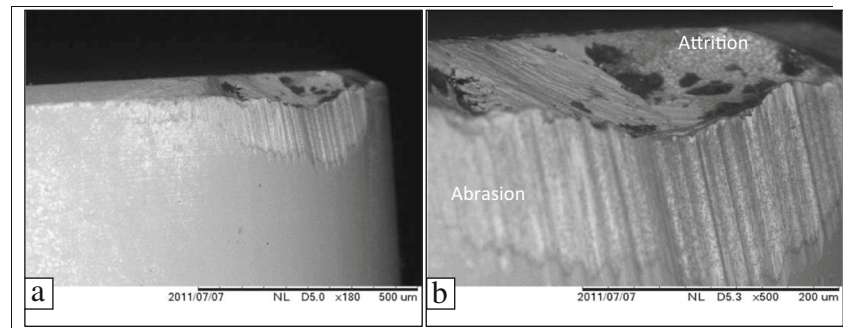
Camargo et al. [19] used polycrystalline boron nitride (PCBN) tools with a low CBN content (50%—CBN-L) and a ceramic binder ($\text{TiCN} + \text{Al}_2\text{O}_3$) coated with a thin layer of TiN (this coating contrasts with the substrate and helps identify the wear land) in dry machining of AISI D6 hardened steel (60 HRC) under several cutting conditions. They found that the main wear mechanism on the flank face of the tool (this kind of wear determined the end of tool life) was abrasion and on the rake face, attrition. Figure 8 shows the overall view of the worn area of a PCBN tool as an example of what occurred in all the tools tested. On the rake face, workpiece material can be seen to have adhered to the tool, and the rough appearance of the worn area indicates that attrition is the dominant wear mechanism. On the flank surface, the parallel ridges are a clear indication of abrasion. This result reinforces what was already

Fig. 8 **a** General view and **b** higher magnification of the worn area of a PCBN tool after machining of AISI D6 steel at $v_c = 250$ m/min, $f = 0.15$ mm/rev, and $a_p = 0.05$ mm

stated in this work: to improve even more performance of CBN-L in the turning of continuous surfaces of hardened steel, it is necessary, among other steps, to increase the tool hot hardness. Moreover, the use of the TiN coating on the CBN material that, besides helping to identify the wear land, could decrease the tool friction coefficient and, consequently, minimize adhesion, in this case it was not efficient enough because adhesion/attrition was an important wear mechanism.

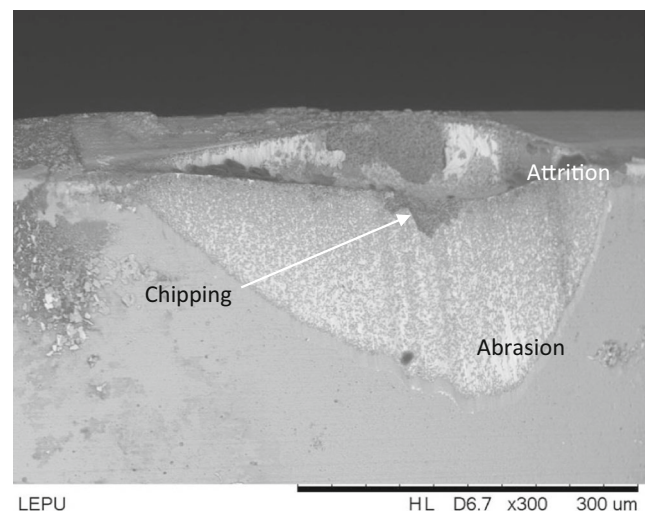
Bonfá [20] used the same workpiece material and cutting tool as Camargo et al. [19] to study the effect of the application of cutting fluid using the minimum quantity of lubrication (MQL) technique. The cutting fluid sprayed was Accu-Lube LB2000, a synthetic plant-based oil manufactured by Rocol – ITW Chemical Products Ltd. A flow rate of 60 mL/h was used. The air jet that conveyed the mist was adjusted to a pressure of 6 bar. The MQL nozzle was directed separately in three different positions (the MQL nozzle was positioned so as to deliver lubricant): (i) overhead, (ii) between the flank face of the tool and the workpiece, and (iii) between the secondary flank face of the tool and the workpiece. The results were compared with those obtained by Camargo et al. [19], which were based on dry cutting. Bonfá [20] showed that the abrasive wear clearly seen on the flank face of tools used in the dry condition (Fig. 8) was significantly reduced when cutting with MQL, regardless the cutting conditions and direction in which the mist was applied. Figure 9 is an example of the wear pattern found in all the tools tested. A large amount of adhered workpiece material can be seen on the tool rake and flank faces. The overall rough appearance of the worn area is an indication that attrition is taking place and dominating the wear. A few parallel ridges are also faintly visible, showing that abrasion was not totally suppressed. In practically all the tool cutting edges chipping can be seen at the end of the tool life, as depicted in Fig. 9.

Fig. 9 Tool cutting edge after application of lubricant from an overhead position using MQL; $v_c = 340$ m/min, $f = 0.05$ mm/rev, $a_p = 0.05$ mm

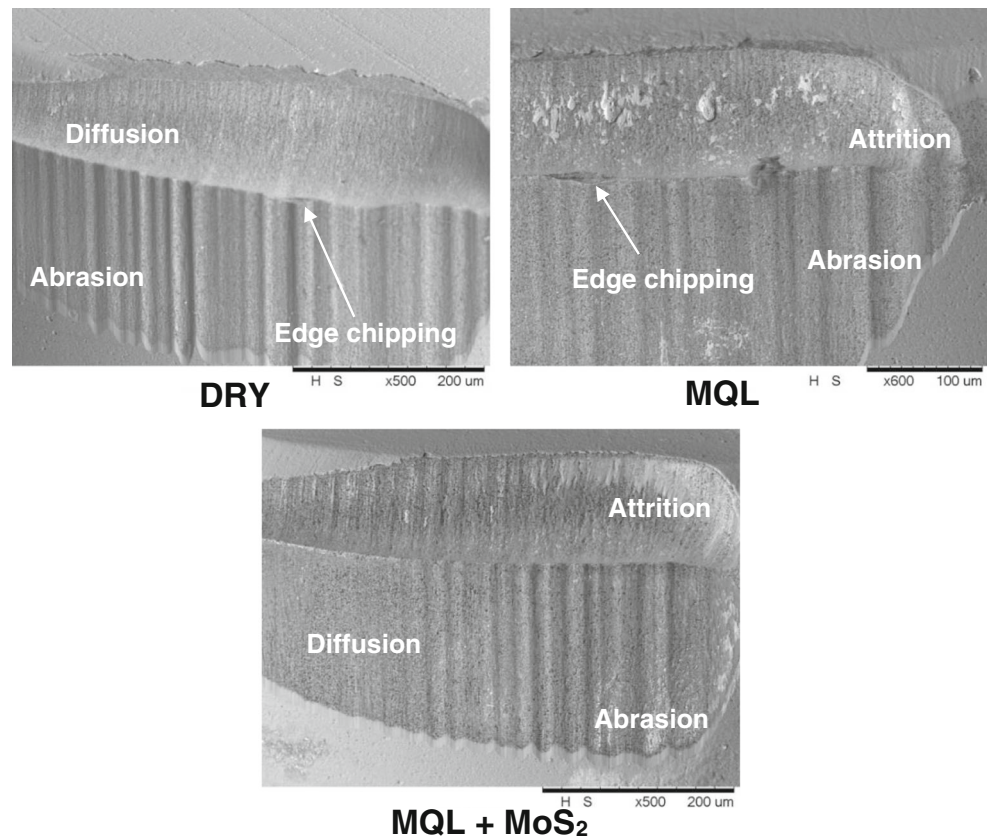
Figure 10 shows images of the tools used for the least severe cutting conditions tested. Although the tools were

Fig. 10 Tool wear after turning of AISI D6 steel under different lubrication/cooling conditions ($v_c = 150$ m/min, $f = 0.05$ mm/rev, $a_p = 0.2$ mm)

washed in a solution of HNO_3 for 5 min to remove adhered work material from the tool surfaces, this seems not to have been sufficiently long, because there is still some work material adhering to the surface. Crater and flank wear occurred under all lubrication/cooling conditions. On the rake face of the tools, a line can be observed close to the edges of the craters in all the figures. This is because the PVD TiN coating was removed beyond the edge of the crater by the movement of the chip. On the flank, in contrast, the coating wore out smoothly together with the substrate. The presence of adhered work material on the tool surface and the rough appearance of the worn area leads to the conclusion that the crater wear is dominated by attrition when MQL and dry conditions were used. In addition to attrition, diffusion also took place, as some smooth areas can also be observed. Abrasive wear is not discarded, although parallel ridges are only faintly visible. On the flank face the predominant wear mechanism was abrasion, regardless the lubrication/cooling conditions used. However, smooth surfaces were present, indicating that diffusion has also occurred. Diffusion wear is a strongly temperature-dependent mechanism, and when hardened steel is being machined, the temperature is high enough for this wear mechanism to occur, even with MQL. Microchipping can be observed at the cutting edge under dry and MQL conditions, but has been suppressed by the MoS_2 solid lubricant.

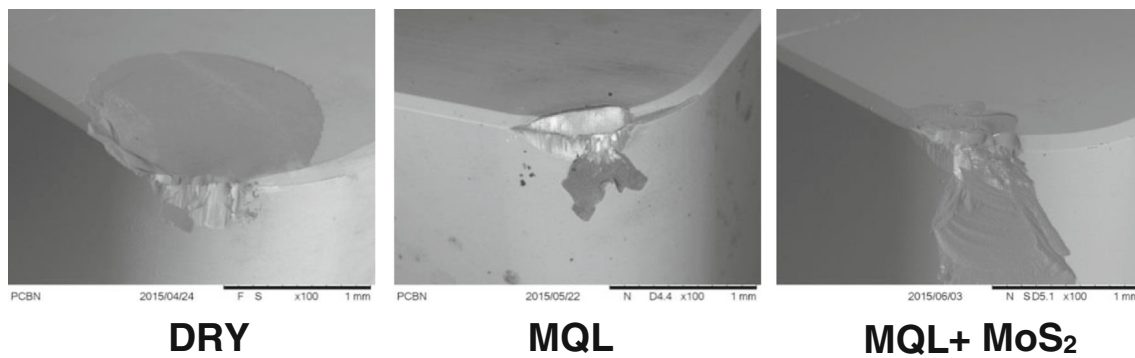
Tests at the highest cutting speed of 300 m/min resulted in very short tool lives (maximum 4 min with the smallest feed rate of 0.05 mm/rev using MQL + MoS_2) because the accelerated tool wear always involved microchipping at the tool cutting edge. Figure 11 shows the damage to the tools using a cutting speed of 300 m/min and feed rate of 0.10 mm/rev. This cutting speed is higher than the maximum recommended by the manufacturer (250 m/min).

Fig. 11 Damage to the tools tested using a high cutting speed ($v_c = 300$ m/min, $f = 0.10$ mm/rev, $a_p = 0.5$ mm)

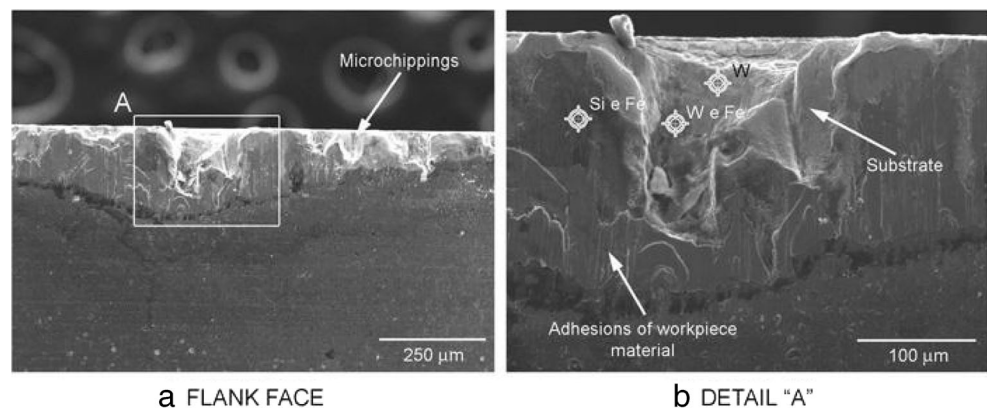
TiCN and TiN deposited by PVD. Figure 12 is included as an example of the various images in the work. It shows SEM micrographs of the tool used in the experiment with the following parameters: angle of inclination between the tool axis and a line perpendicular to the machined surface $\alpha = 45^\circ$; feed per tooth, $f_z = 0.25$ mm; radial depth of cut, $a_c = 0.40$ mm; cutting speed, $v_c = 300$ m/min; and axial depth of cut, $a_p = 0.25$ mm. The image on the right shows the results of an EDS analysis of several points on the flank face.

Figure 12 shows that microchipping (chipping smaller than the maximum flank wear land) and adhesion of workpiece material caused the cutting edge to fail. The EDS analysis in detail A of Fig. 12a shows the presence of Fe and Si from the workpiece material and W from the tool substrate. Microchipping can be seen along the whole cutting edge. In addition to analyzing tool wear at the end of the tool life, the authors checked tool wear throughout the test. At the end of the tool life, the wear mechanisms were analyzed in an SEM. They found that, at first, abrasion removed the tool coating on the portion of the cutting edge that removed chips that were thinner than the cutting edge radius. On the part of the edge that removed thicker chips than the cutting edge radius, attrition and diffusion caused crater wear. As cutting time increased, so the wear in the region where the tool coating had been removed increased, allowing the workpiece/chip

material to adhere to the tool in the flank wear region. The workpiece flow dislodged these adhesions, causing large particles of the tool substrate to be removed. In the region of the cutting edge where crater wear was the result of diffusion and attrition, the increase in crater size weakened the tool edge, leading to microchipping at the cutting edge. The authors concluded that neither mechanical nor thermal fatigue caused microchipping, since no cracks were seen on the cutting edges. They also concluded that the chippings and microchippings seen in Fig. 12 were caused by adhesion/attrition on one side of the cutting edge and by attrition and diffusion on the other. Furthermore, they noted that seemingly unlikely events can occur, including (i) wear caused by diffusion when milling this kind of surface, as the contact angle between cutting edge and workpiece is very small and the contact time in each tool rotation is therefore short; (ii) massive adhesion/attrition when machining material with low ductility such as hardened steel. Based on these results, it can be concluded that it is necessary, for this kind of operation, to use a harder tool, to avoid the early removal of tool coating and, consequently, adhesion/attrition and also with higher chemical stability in order to minimize diffusion. Of course, the improvement of these properties cannot be accompanied by the decrease of toughness, since this property is necessary to withstand the frequent shocks typical of milling operation.

Fig. 12 SEM images of the flank wear land at the end of the tool life ($f_z = 0.25$ mm, $a_c = 0.40$ mm, $\alpha = 45^\circ$)

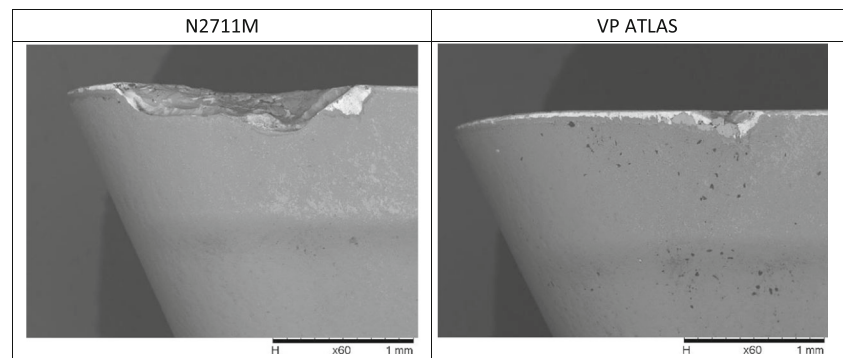
Fig. 14 View of the worn tools after each work material was milled under the cutting conditions of test 1 ($v_c = 120$ m/min, $f_z = 0.05$ mm, $a_p = 2.0$ mm)

Tool wear in test 1 before chipping started to occur was due mainly to attrition, although abrasion was also present. These conclusions were based on observation of the worn areas in the vicinity of the chippings on the flank face of these tools. Parallel grooves, mainly on the tool nose, indicate abrasion wear, while rough areas, mainly at the end of the depth of cut, indicate attrition wear. The life of the tool used to machine the N2711M steel was 40 min, against 10 min for the tool used to machine the VP ATLAS steel. This explains the greater damage in the tool used to machine the N2711M steel, although both tools reached the end of tool life criterion stipulated. A large amount of work material adhered to the worn area, promoting attrition (which was

confirmed by EDS analysis). As the wear increased, the cutting forces increased proportionally, leading to chipping. This microchipping increased as the cutting progressed, but not to the extent that the tool had to be immediately condemned. Only when the chipping extended over a large wear land and the tool reached the end of tool life criterion ($VB = 0.3$ mm) was the test stopped. This damage mode is quite common in milling operations and even more common when machining hard materials.

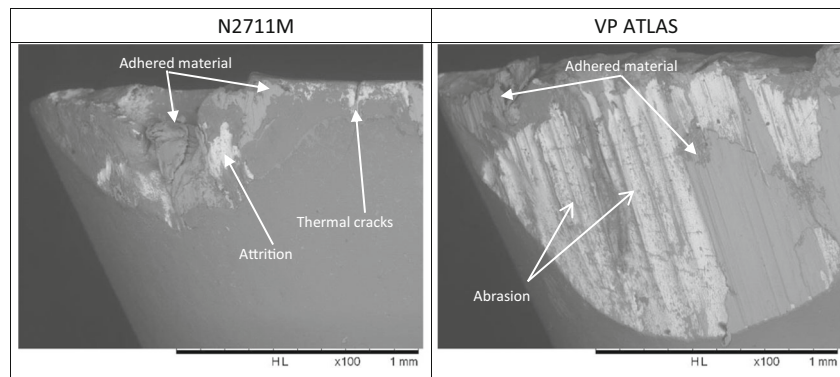
Fig. 15 View of the worn tools after each work material was milled under the cutting conditions of test 2 ($v_c = 215$ m/min, $f_z = 0.15$ mm, $a_p = 2.0$ mm)

In test 2, which had the most severe cutting conditions, the tool life when machining the N2711M steel was 8.5 min, against only 2.0 min for VPATLAS. Again, a large amount of workpiece material remained adhered to the scars on the tool (Fig. 15). This adhered material was responsible for the attrition wear mechanism identified on the flank surface of the tool used to machine the N2711M steel. Chipping was also observed in this tool, probably as the result of a mechanism involving thermal and mechanical cracks. A thermal crack is identified in Fig. 15 and, prior to chipping, there were probably other thermal cracks parallel to the one identified, before repeated mechanical shocks during each rotation of the cutter led to the destruction of the cutting edge.

The tool used to machine the VP ATLAS steel also exhibited chipping but to a lesser extent. The very short tool life, a result of the flank wear caused by abrasion, did not allow enough time for the cutting edge to be destroyed because of chipping, as occurred with the N2711M steel.

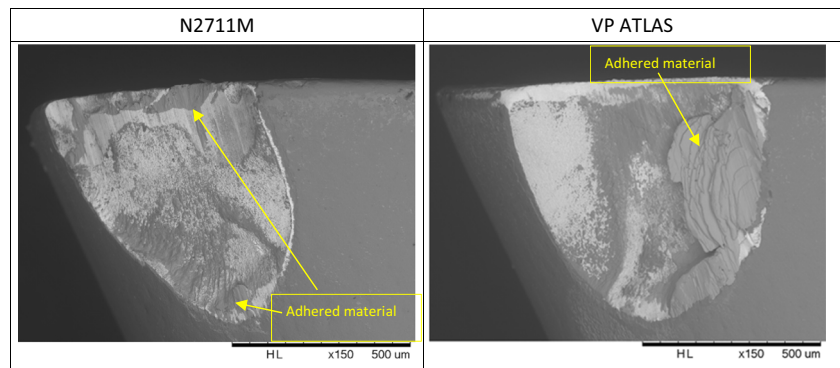
Fig. 16 View of the worn tools after each work material was milled under the cutting conditions of test 3 ($v_c = 127$ m/min, $f_z = 0.15$ mm, $a_p = 1.0$ mm)

The worn area of the tools used to machine both work materials under the cutting condition of test 3 (Fig. 16) shows the rough aspects on most of the area of the flank wear, which indicate the adhesion/attrition is the dominant wear mechanisms. The adhered work material also corroborates to this conclusion. Closer to the cutting edges, parallel ridges are observed indicating abrasion wear mechanisms. The tool used to machine the N2711M steel presents microchippings on the cutting edge. This is because of the much longer tool life when machining this work material compared to the VP ATLAS, consequently with larger numbers of mechanical shocks.

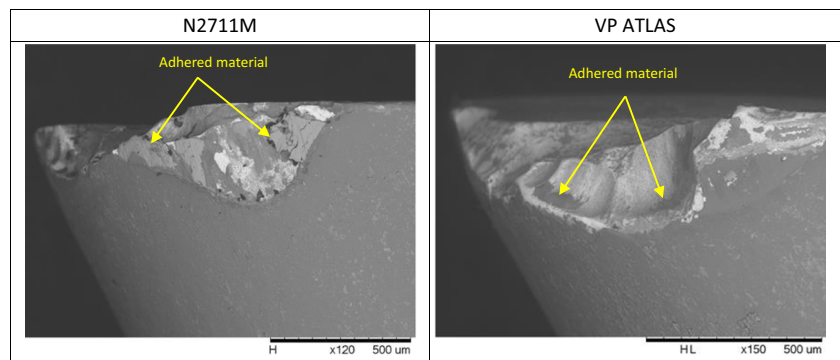
Fig. 17 View of the worn tools after each work material was milled under the cutting conditions of test 4 ($v_c = 214$ m/min, $f_z = 0.05$ mm, $a_p = 1.0$ mm)

The tools used to machine both work materials under the cutting condition of test number 4 have experienced large chippings. These chippings occurred after the tools worn typically by adhesion/attrition before as the consequence of adherent work material on the flank surfaces of the tools.

This results prove that, even when cutting a hard material, adhesion/attrition is an important wear mechanism and steps aiming to decrease tool friction coefficient must be taken in order to improve the tool performance. In the presence of chippings, tools presenting high toughness and wear resistance is advisable.
