# Weathering damage evaluation of rock properties in the Bunhwangsa temple stone pagoda, Gyeongju, Republic of Korea

**Abstract** The stone pagoda of the Bunhwangsa temple in Republic of Korea was made of piling small brick-shaped stones. The majority of stone bricks are andesitic rocks with variable geneses. Rock properties of the pagoda roof suffer partial significant deterioration, such as multiple peel-offs, exfoliation, onion-peel-like decomposition, cracks forming round lines and falling-off stone pieces. The stylobates and tabernacles at the four corners are composed of granitic rocks, which are heavily contaminated by lichens and mosses. Some of these contamination marks show dark black or yellowish brown colors by inorganic secondary hydrates. The four tabernacles and northern face of the pagoda body have been exposed to relatively high humidity, which causes light gray efflorescence as stalactites between the northern and western sides of the body. The efflorescences are composed of calcite, gypsum and clay minerals. The stone lion statues at the southeast and northeast corners are made of alkali granite, while the others are lithic tuff. Total rock properties of the pag

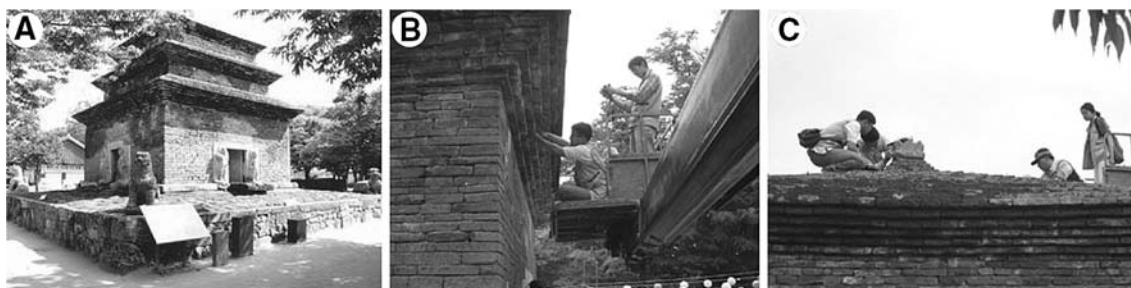
**Fig. 2** Field occurrences of the stone pagoda in the Bunhwangsa temple. **a** General view from the southwestern side. **b** Stalactite-like white precipitates collected from northern body rocks of the

pagoda. **c** Photograph shows detail survey in the uppermost roof of the third floor

There are many trees around the pagoda. They can block the sunlight and cause contamination with fallen leaves. There have been arranged several projects to protect the pagoda and improve the landscape, but there are still problems. The stylobate and foundation of the pagoda are polluted with all kinds of microorganisms and lower plants such as lichens and mosses. The body and roof stones have foliose lichens and higher plants (Fig. 2b, c).

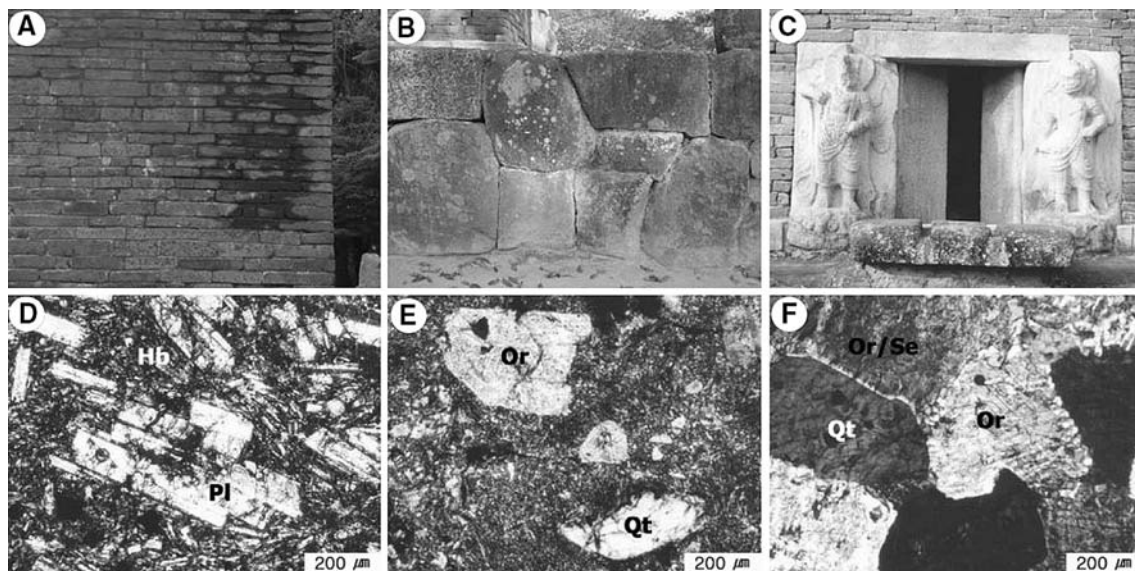
**Fig. 3** Constituting rock types and their microphotographs of host rocks of the stone pagoda in the Bunhwangsa temple. **a** Brick-shaped andesitic rocks of pagoda body is highly damaged by leakage of rain along fractures. **b** Basement rock materials are composed mainly of granitic rocks. **c** Stylobate, tabernacles and stone statues are composed of various granitic rocks. **d** Pilotaxitic

textures of plagioclase and chloritized hornblende in andesitic rocks from the pagoda body. **e** Andesitic tuff composed of tuffaceous groundmass and subhedral plagioclase of the pagoda body rock. **f** Quartz, alkali feldspar and biotite assemblage of alkali granite in the pagoda basement rock, which alkali feldspars are highly weathered into sericitic clay minerals

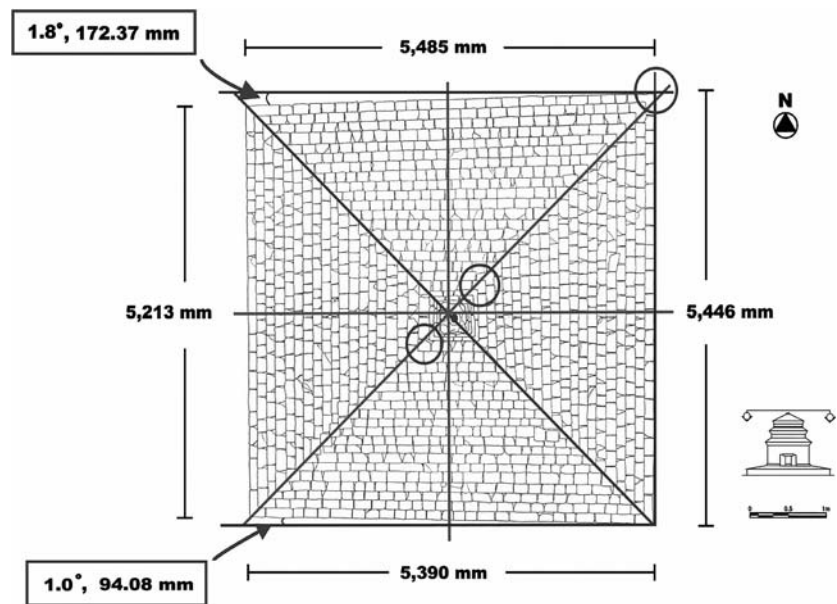
The structural instability of the pagoda was evaluated by detailed surveyed maps. The plane figure of the third roof stone, which is seriously distorted (Fig. 6), shows that the center point of the roof stone does not coincide with that of the Noban (top covering rock). When comparing the horizontal line to the vertical line at each direction, they are not at the right angle. The angle at the northeast side is off 1.8°, which is 127.38 mm in length. That at the southeast is off by 1.0°, which is a 94.08 mm horizontal offset. The authors believe that the uneven settlement of the pagoda caused this structural distortion.

**Fig. 6** Detailed measurements of structural instability in the uppermost third roof floor of the stone pagoda in the Bunhwangsa temple

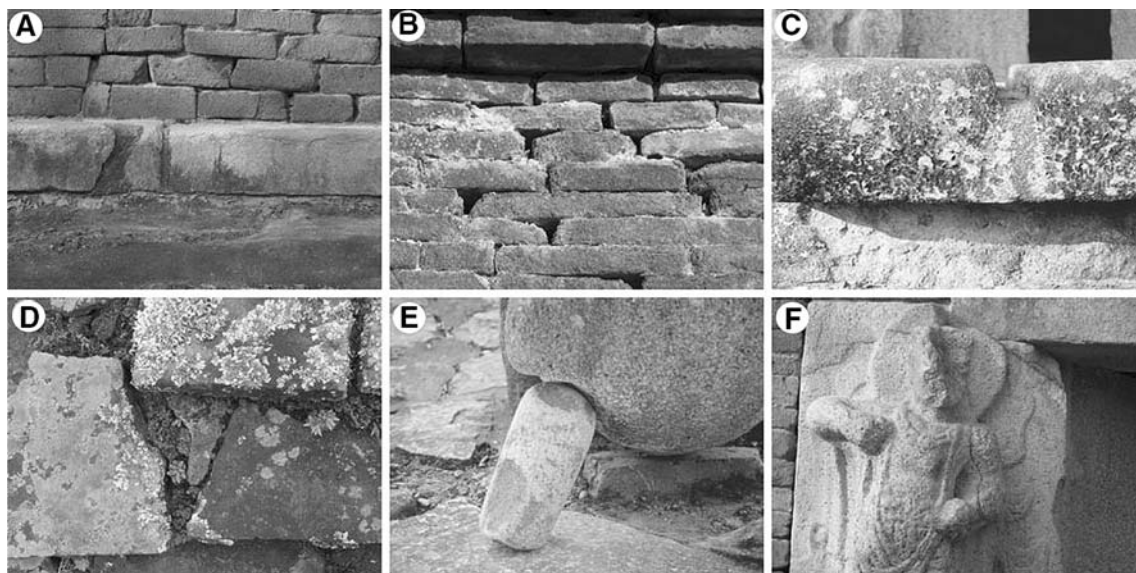
corners (Fig. 7). Especially, the andesitic rocks have many fragmental losses and cracks. The roof stones are in a serious condition due to weathering damages

(Fig. 7a, b), which are surface exfoliation, peel-off, and fragmental losses along the cracks (Fig. 7c, d). The four stone lion statues at the corners on the stylobate also

**Fig. 7** Fractures and cracks showing host rocks of the stone pagoda in the Bunhwangsa temple. **a** Sheeting exfoliations in the basement rocks. **b** Highly weathered surface of andesitic rock coated with white gray crusts due to the dust and air pollutants. **c** Stylobates and tabernacles altered with discolorations and

exfoliations. **d** Andesitic rocks on the uppermost third roof are severely deteriorated by weathering processes. **e** Stone lion statue with a broken leg. **f** Stone tutelary and beast statues show partly falling off and fractures along the marginal boundary

suffer from serious weathering damages (Fig. 7e). The Buddha relief sculptures standing at the gate of the tabernacles show losses, fall-off, and surface weathering along the marginal boundary (Fig. 7f).

The most urgent conservational measures are to cement the cracks, exfoliation, peel-offs, and fragmental loss, to lessen the structural instability, and to remove the secondary precipitates and vegetations on the surface. These recommendations can be applied to

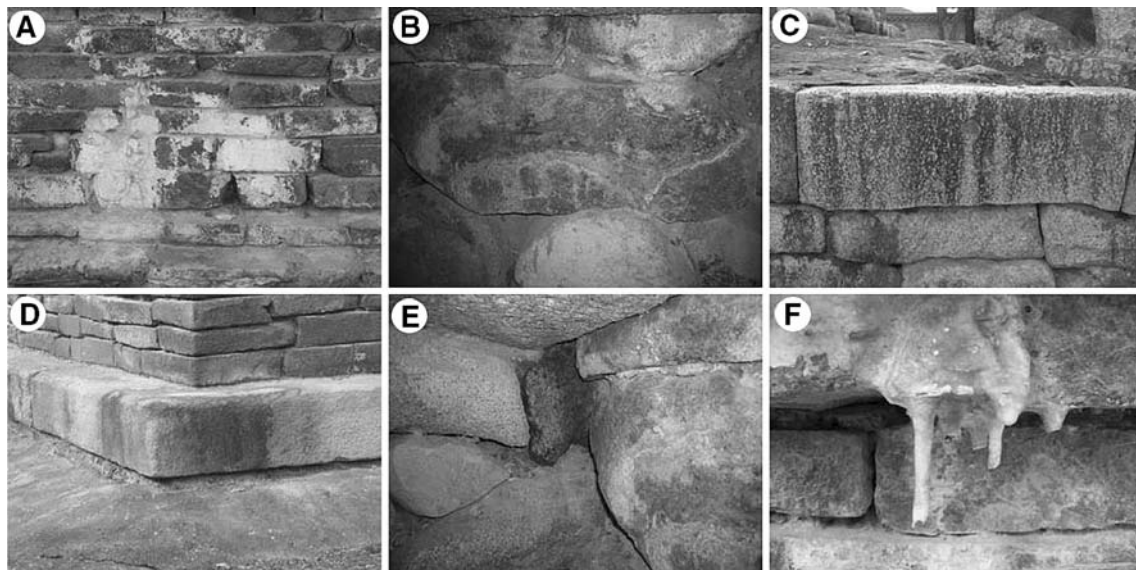
Bunhwangsa pagoda. The stalactites are widely distributed on the surfaces of the pagoda stone (Fig. 8a). The major mineral is calcite from the hydrochloric acid reactions and also other white efflorescence, such as gypsum or brucite can easily be found.

There are other kinds of white precipitates in crusts, which should be clay minerals from the weathering of the pagoda. The precipitates also combined with the dust by visitors. There are whitening events and yellowish brown precipitates of carbonates along the rain pathways inside the tabernacles (Fig. 8b). The grayish white precipitates dominated in the northern face of the pagoda, while the dark gray precipitates are common at the eastern and western faces, praying stone in the south and stylobates at all four faces. There are also secondary precipitates by chemical reactions between the vegetation and the stone (Fig. 8c, d). The yellowish brown discoloration inside the tabernacles and on the surface of the Buddha relief sculptures is also observed along rain-flowing paths with dust, soil, and grayish white precipitates (Fig. 8e, f).

**Fig. 8** Secondary contaminants of the stone pagoda in the Bunhwangsa temple. **a** Gray precipitates composed of calcite, gypsum and clay minerals. **b** Reddish brown precipitates by iron hydroxides occurred with the basement and inside of the tabernacle. **c** Dark brown contaminants coated basement rocks.

**d** Black contaminants and reddish brown precipitates occurred the basement of body rocks. **e** Reddish brown precipitates by iron hydroxides occurred with the basement and inside of the tabernacle. **f** Stalactite-like white gray precipitates formed boundary between the rock materials

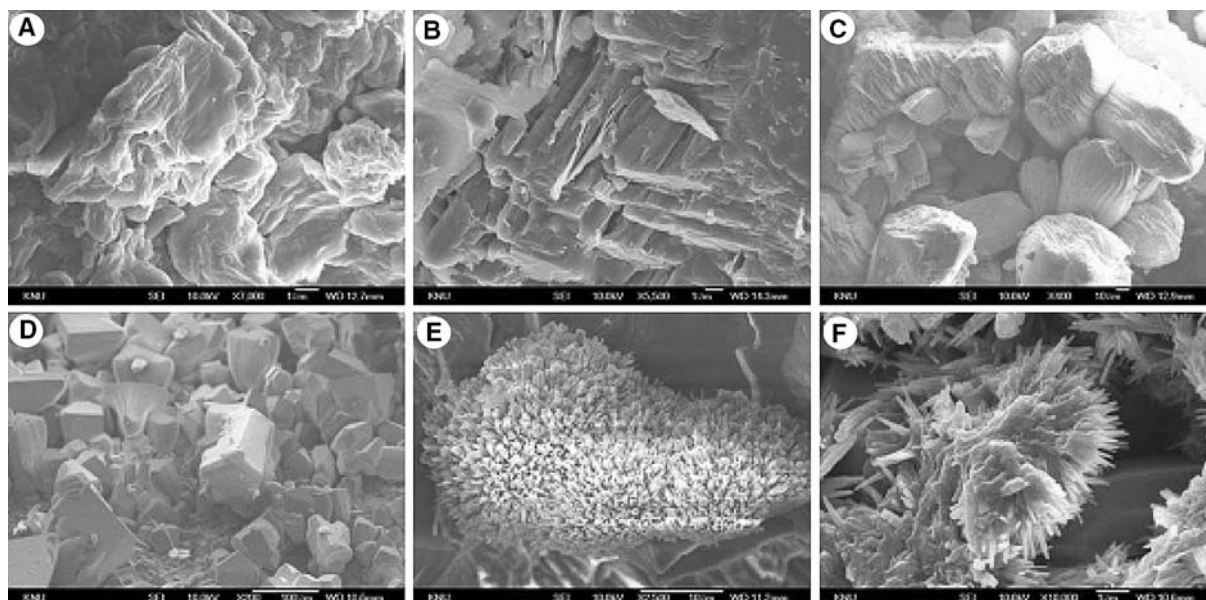
X-ray powder diffraction analysis was conducted for the mineral assemblages of the grayish white precipitates. As a result, the major mineral was calcite with trace of gypsum regardless of different peaks (Fig. 9), which was also confirmed by SEM. The authors observed authigenic kaolinite inside alkali granites formed during weathering processes (Fig. 10a). Clay minerals were also observed, which were created from plagioclase and biotite within the weathered andesites (Fig. 10b).

It can be easily observed that precipitates are on the surface and grayish white precipitates like stalactites are on the body surfaces and the lower parts of the roof stones. They SEM images suggest that calcite and gypsum were combined with clay minerals (Fig. 10c, d). The SEM images of the tuff, which was fallen off from the stone lion statues, are shown in Fig. 10e and f. The column- or needle-shaped minerals in the figures

**Fig. 10** Scanning electron microphotographs showing secondary minerals and precipitates of the stone pagoda in the Bunhwangsa temple. **a** Kaolinitic clay minerals formed with alkali feldspar of granitic rock. **b** Highly eroded biotite and plagioclase of the

andesitic rock. **c, d** Euhedral calcite and gypsum in the white gray precipitates formed rock surface. **e, f** Fibrous to acicular zeolitic clay minerals from the rhyolitic lithic tuff within the stone lion
