Remediation and analysis of kinematic behaviour of a roadway landslide in the upper Minjiang River, Southwest China

Yu Ding · Quancai Wang

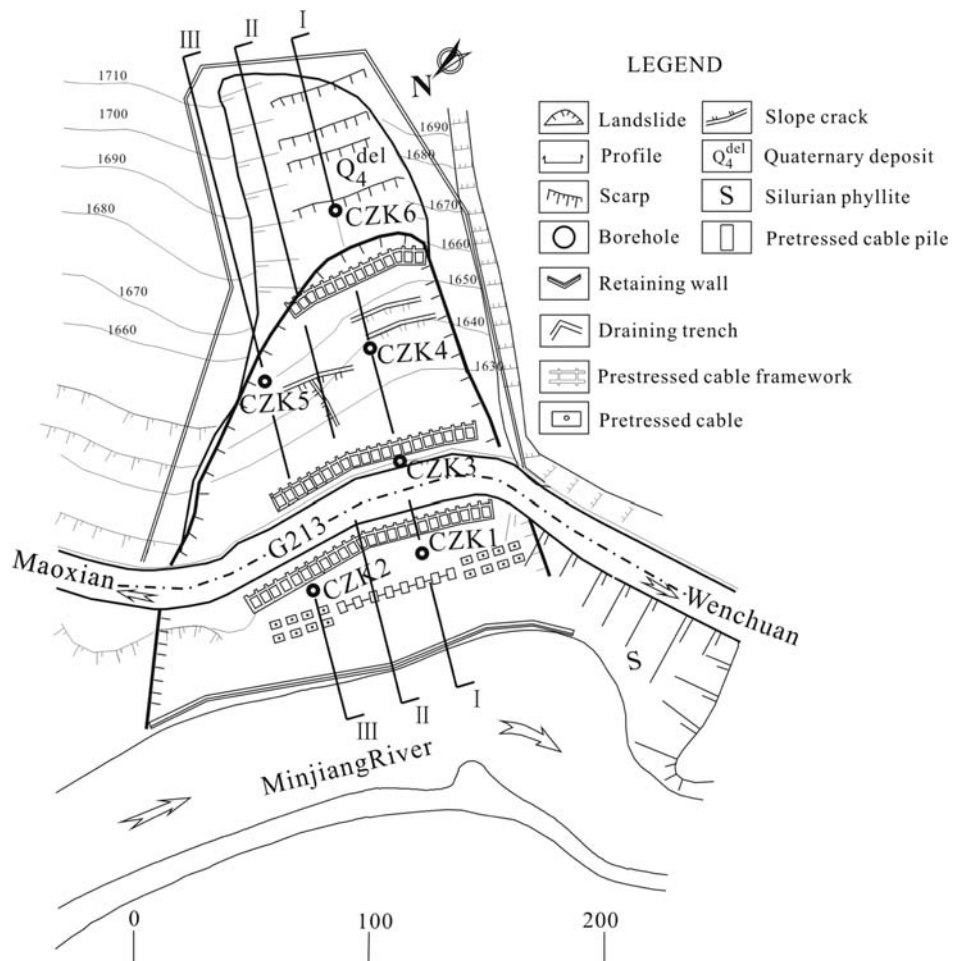
Fig. 2 Plan view of the Xiaozongqu landslide showing the geology, the geomorphology, the remedial engineering and monitoring

In order to control the rapid sliding and ensure road safety as soon as possible, two rows of the prestressed concrete frames were set along both sides of the roadway (Figs. 2, 4).

At the rear margin, the crown scrap of the Xiaozongqu landslide was so high as to be disadvantageous to landslide stabilization. So a raw framework of prestressed cables was set near the main scrap of the landslide (Figs. 2, 4). The purpose was to resist further failure of the rear and stabilize the overall slope.

As one of the triggering factors of the landslide, river erosion could lead to toe failure and produce an over-steepened toe. So, a raw retaining wall was built to protect against river erosion and provided more support for the slope toe (Figs. 2, 4). The masonry retaining wall consisted of 24 blocks of concrete slip-stone, with a surface slope of 1H:5V. Because of river erosion, the retaining wall could not be permanent; and its failure would induce a new movement or a larger slide. So it needed to be reconstructed whenever it failed. The influxing water tended to worsen the landslide, moreover; so it had to be drained away. A trench around the landslide was dug to change or cut off the influx path and thus reduce water infiltration (Fig. 2).

constructed outside the roadway, with the space between two piles being 6.0 m (Fig. 2). In addition, some individual cables were anchored along the extension line of the anchored piles.

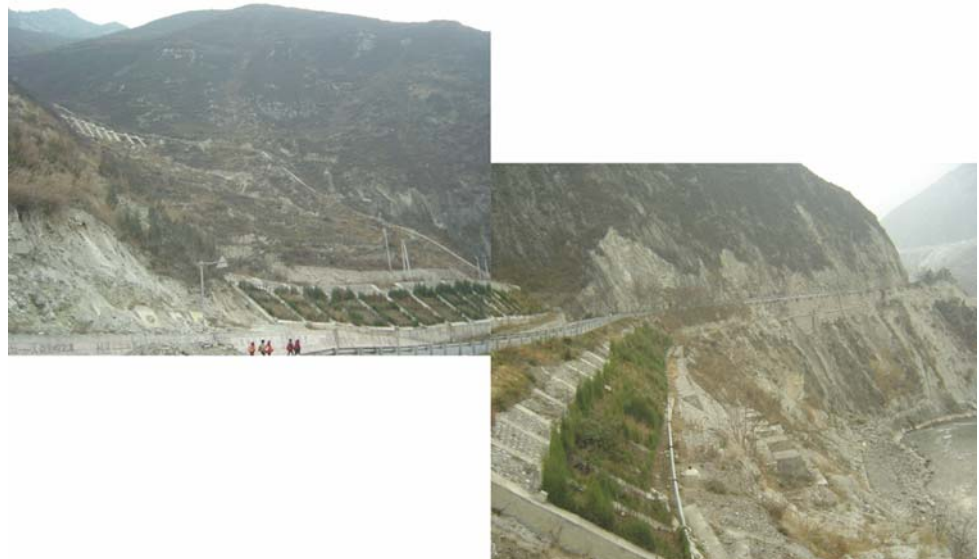
Fig. 3 Photograph of the Xiaozongqu landslide showing the geomorphology, the road, the landslide and the repaired slope

to further down-cutting and bank erosion in subsequent landslides. Figure 3 shows the remarkable sedimentary terrain of the landslide materials. Near the landslide, river erosion deflected the riverway sharply to form an obvious slope bulge shaped like a “nose”.

During the remedial periods, the roadside cuts and fills and head of the landslide were the most visible areas of drastically disturbed portions of the slide. In those areas, revegetation was needed to improve the appearance and protect the soil on the roadsides. The revegetation involved soil rebuilding, autochthonic grasses and woods replanting; and it created an environmentally friendly landscape matching the travel route (Fig. 3).

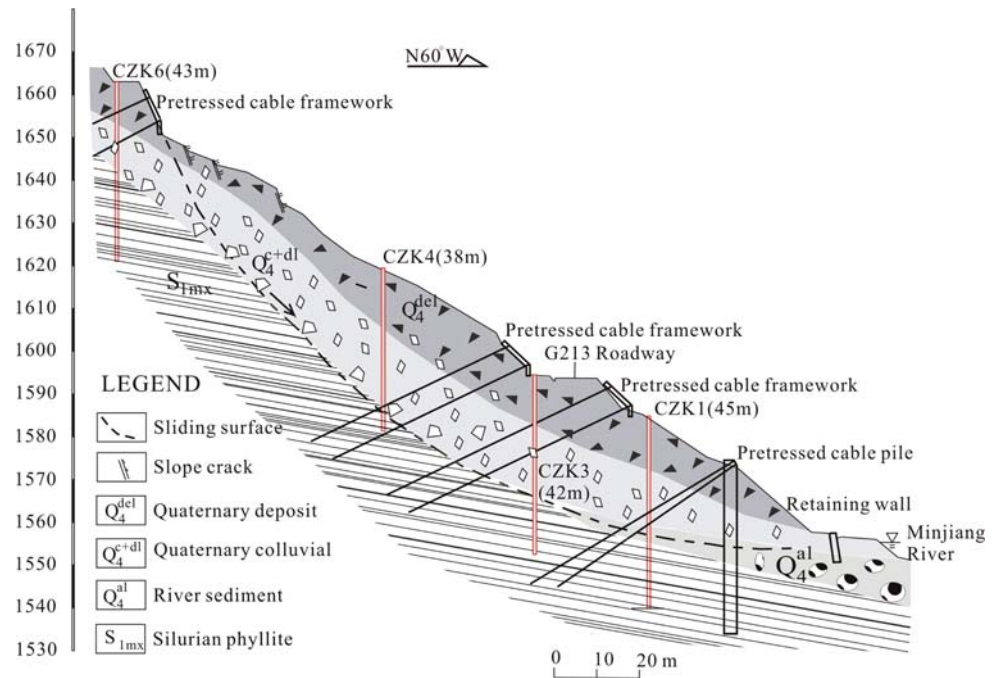
Fig. 4 Cross-section of the landslide profile I–I

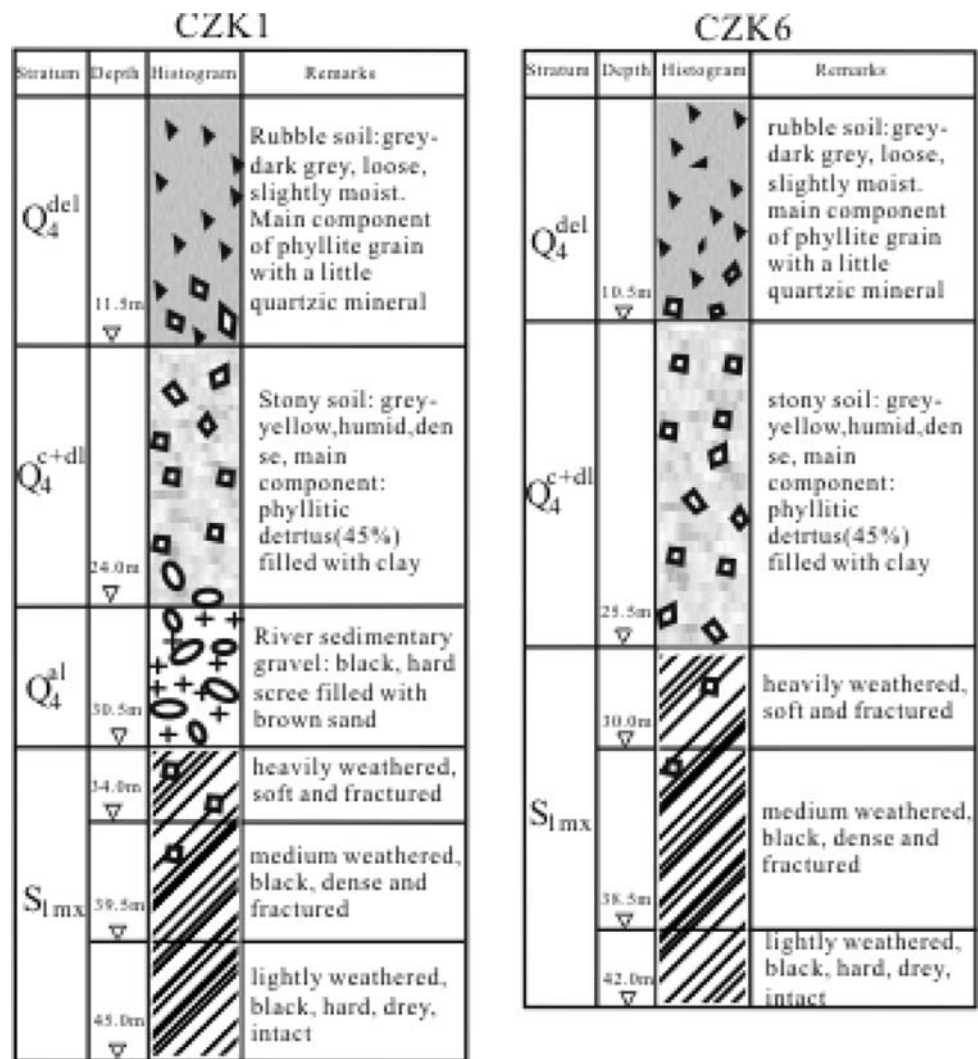
In addition, CZK1 indicates that there is olivary gravel interbedded between the stony soil and the phyllite. This gravel consists of the river sediment material, with some cobbles (Fig. 5).

Fig. 5 Borehole column of the landslide area: CZK1 at the slope toe and CZK6 outside the landslide (see Fig. 4). The similar others boreholes are unlisted

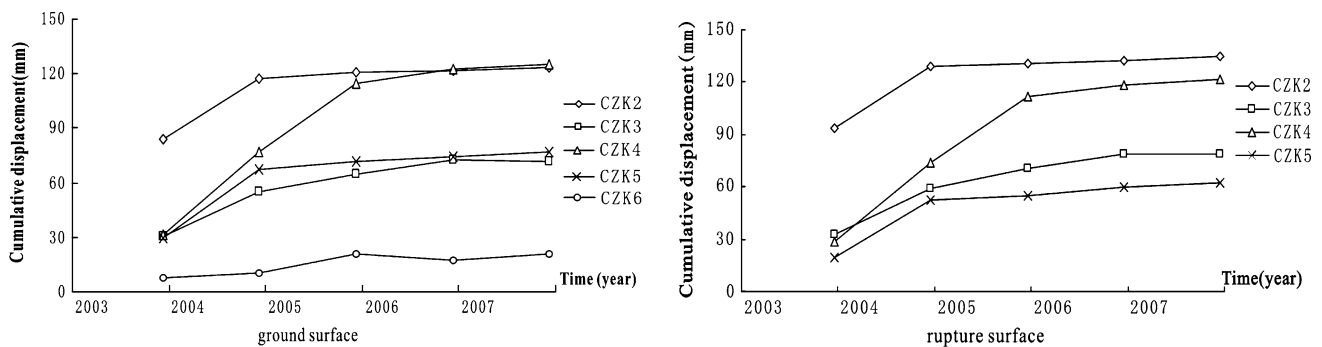
From the monitoring results, it was found that the landslide experienced three slide stages after remediation: a rapid slide in 2003 and 2004, a slower one in 2005 and relatively stability in 2006 and 2007 (Fig. 7). The average movement

Fig. 7 Cumulative displacement of the ground surface and rupture surface

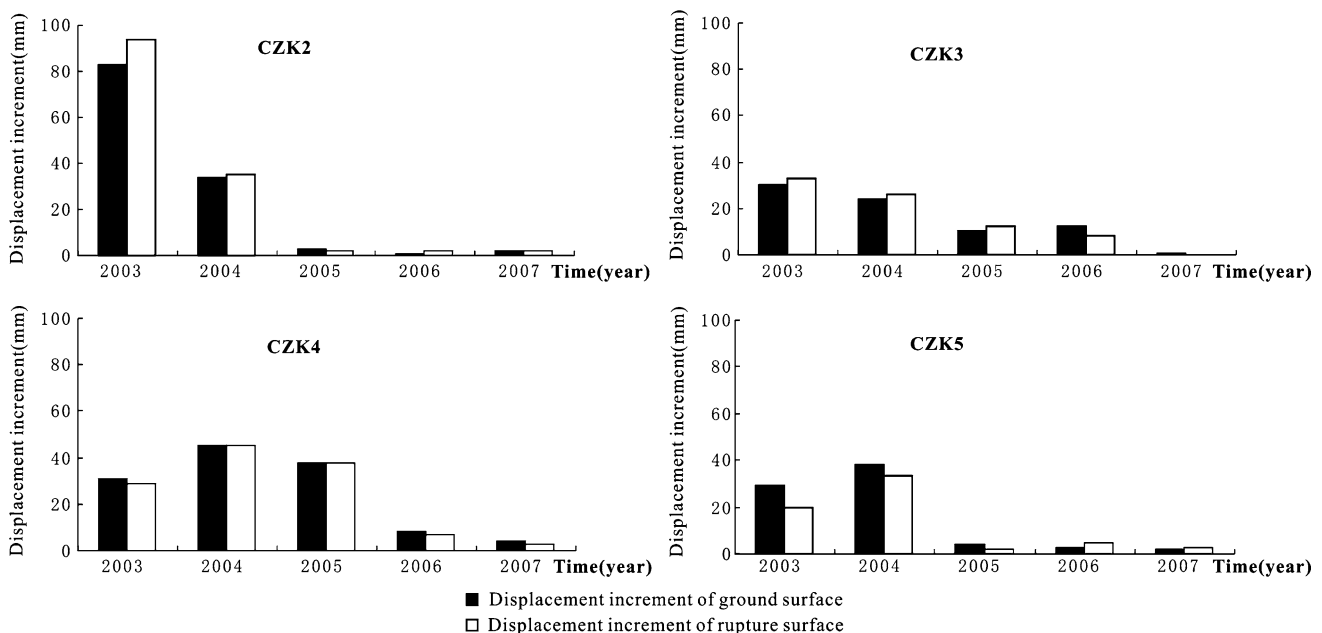
In general, the deformation of different sites on the slope is inconsistent with a rotational landslide. The displacements and movement rates differ for different boreholes (Fig. 8). The displacement of the fore position was found to be larger than that of the rear margin of the landslide at the initial stage (Wang 2005), but the inverse became true after 2005. The movement rates of CZK3 and CZK4 were larger than those of the CZK2 in 2005 and 2006, and the slide rate of all boreholes became miniscule, thus manifesting a consistent lowering trend. As revealed in of CZK6, which is

Fig. 8 Displacement increment of the ground surface and rupture surface

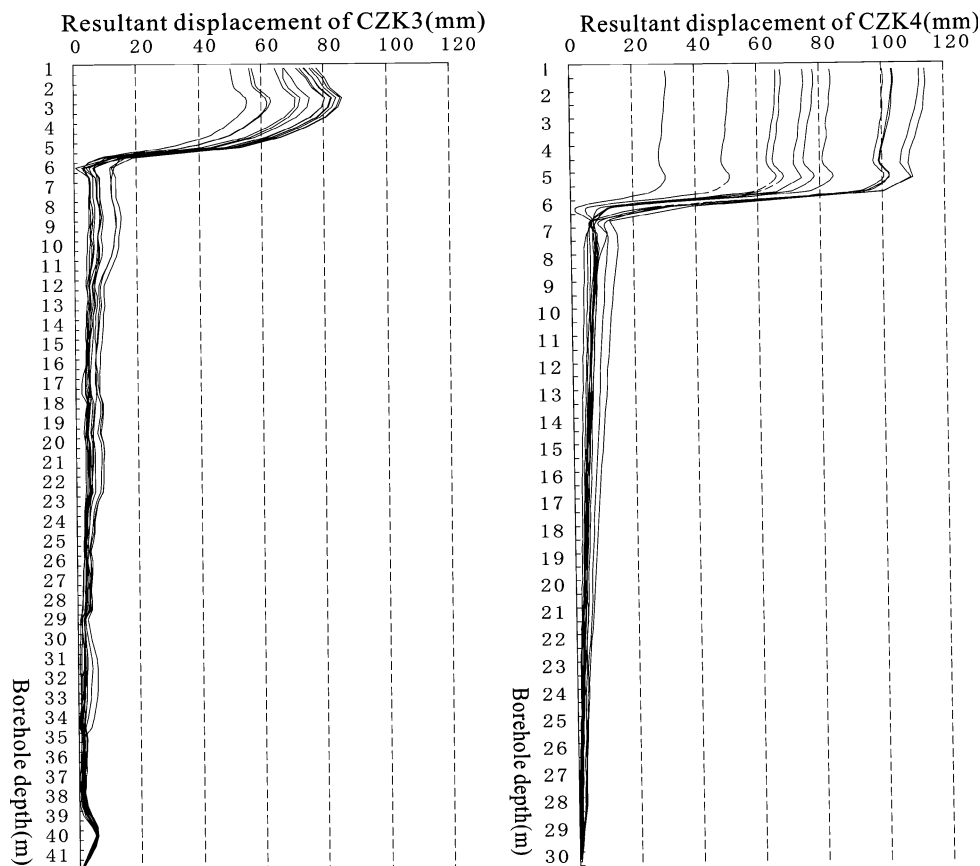
The subsurface deformation of the landslide is characterized by small displacement in the deep zone and a larger displacement in the shallow zone. As determined from the full depth of boreholes CZK3 and CZK4 (Fig. 9), it is

evident that the monitoring displacements declined sharply on the rupture surface, where they closely represent the deformation of the ground surface (Table 2). Below the rupture surfaces, the deformation is small. In the case of a landslide under remediation, once the prestressed cables work well, they lock the landslide stably onto the bedrock so that the deep rupture will close up soon. In this study, however, there exists no additional slope surface protection except for the concrete frameworks, so partial failure tended to occur along the shallow ruptures, especially in the transitional zones of the middle section. Shallow failure is very common in mountainous areas and is likely to be a hazard. Xie et al. (2004) point out that rainfall-induced shallow landslide is a major hazard in mountainous terrain.

Fig. 9 Inclinometer graph of subsurface displacement versus depth of CZK3 and CZK4
