Hydrogeological and geotechnical assessments of the Kadifekale landslide area, İzmir, Turkey

G. Tarcan · M.Y. Koca

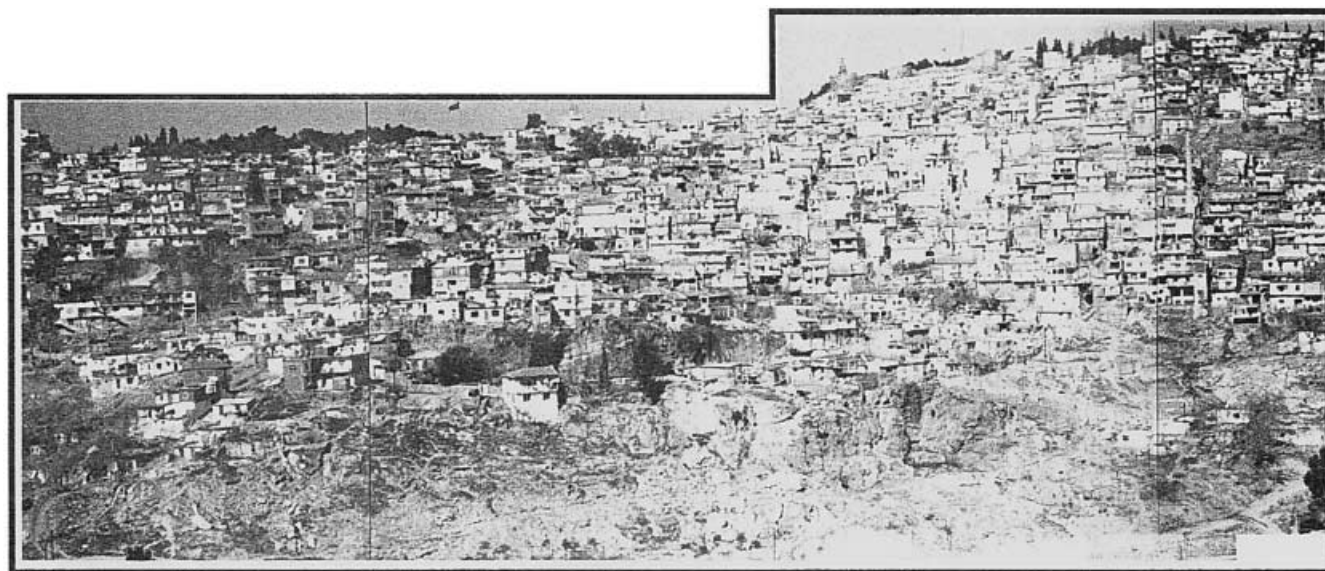
Fig. 2

difekale, Mt. Pagos, stands in the impressive ruins of a castle and its walls were built by Lysimachus during the reign of Alexander the Great, which still dominates İzmir today. Agora, or marketplace, is the another ancient settlement area of İzmir and is also located in the study area. It was originally constructed during the rule of Alexander the Great. What remains today, however, dates from the rebuilding under Marcus Aurelius after a devastating earthquake in 178 AD. At the present time, unplanned urbanization, a high rate of population increase and emigration from village to city have played an important role in disturbing the balance of hydrogeological and geotechnical processes, and have caused the occurrence of landslides in the Kadifekale area (Fig. 2).

A view of the Kadifekale Hill and its high density housing

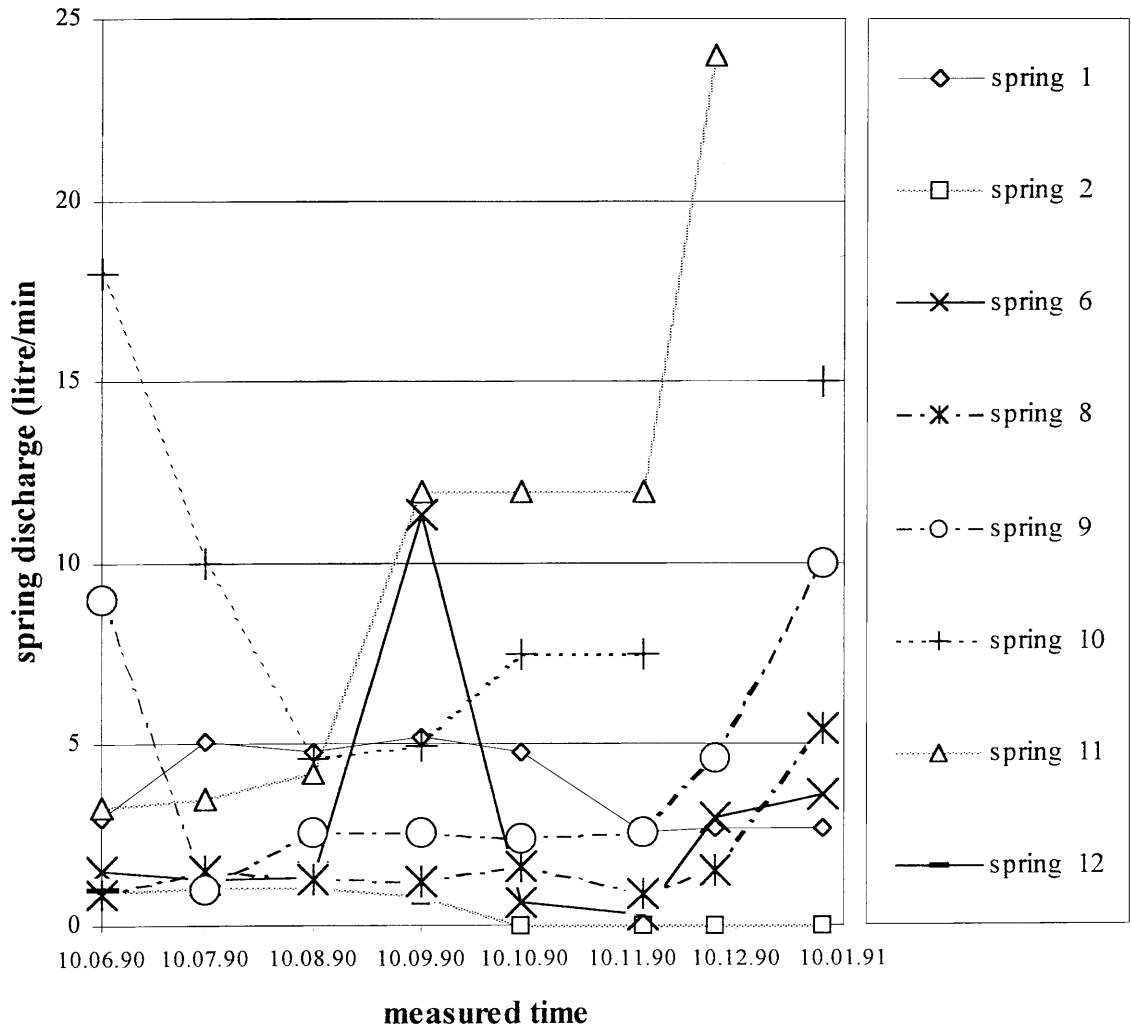
Fig. 6 Monthly variations of some spring discharge quantities in the field

fall, (2) water leakage from the water mains of the city and (3) leakages from the septic holes. Variations in the discharge of some springs cannot be explained only by rain infiltration into the ground (Fig. 6). Sudden spring quantity variations have also been observed in some springs because of leakages from water mains and excessive water usage.

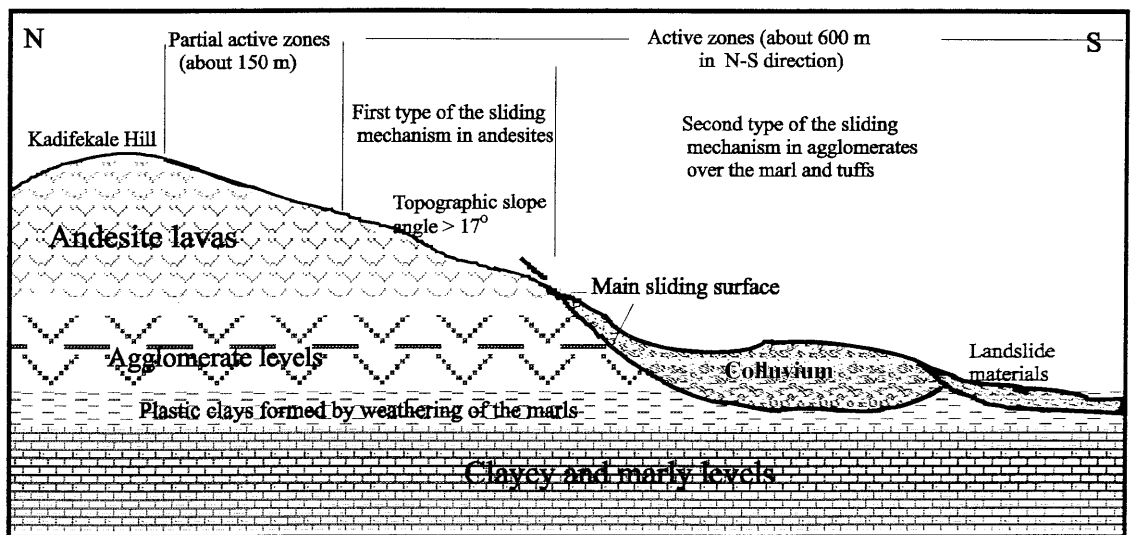
Fig. 7 Schematic geological sketch showing the landslide mechanism in the study area

The second type of movement in the Kadifekale landslide area is very important because of the large-scale damages it causes. A large landslide occurred in the Veziraga district, which was caused by agglomerates sliding over the marl and tuff. Agglomerates are highly fractured, and fractures are open and consist of cemented andesite blocks with tuffs. They are found lying concordant with tuffs and unconformably with marls. Landslides in agglomerates are formed when agglomerates slide on marls and clays, which are formed by weathering of the tuffs. Both rock units are highly weathered. The residual saturated shear strength parameters are in the range of $C_r = 0.4 \text{ kg/cm}^2$ and ϕ_r varies between 10 and 15°. Sliding of agglomerates on marl and tuff layers is made easy by the surface and groundwater running along the open joints that exist in the agglomerates. As the groundwater runs along the discontinuities it increases the pore water pressure and also weathers the rock mass. The sliding mechanism is more clearly shown in Fig. 7.

Kadifekale and its surroundings are divided into three zones by taking into account the rock mass movements, morphology and geological structure of the area. There is an active zone, a partially active zone, and a stable zone (Figs. 7 and 8). In the active zone, there are more slopes and landslides are actively observed. Buildings are cracked and the ground is fractured in the area. The partially active zone encircles ~60–150 m wide area around

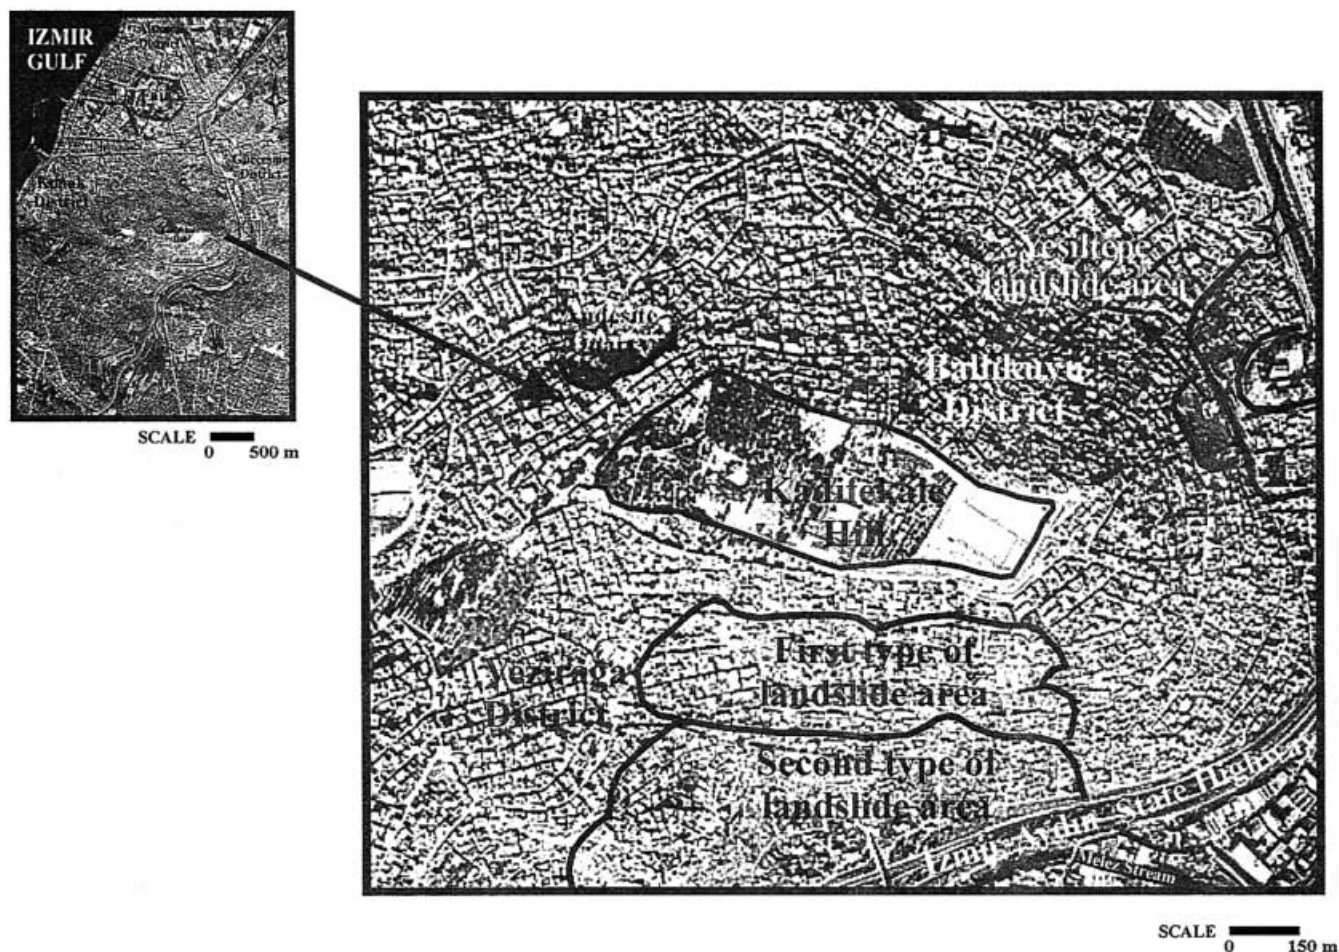
Fig. 8

A view of the study area from air photographs and the first and second type of landslide fields south of Kadifekale Hill in Izmir

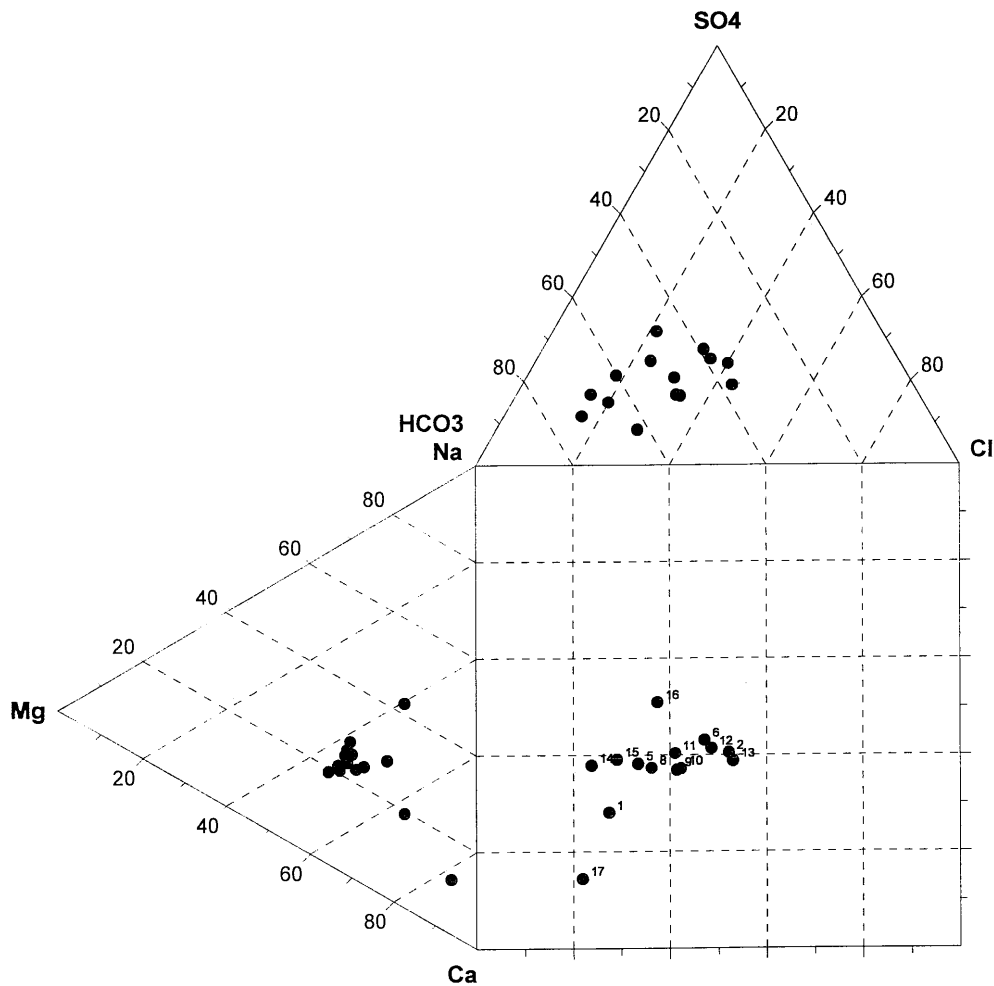
Fig. 9
Durov diagram of waters from the study area. Spring numbers (1–15) are the same as Fig. 3, springs 16 and 17 correspond to unpolluted andesite and limestone respectively

others in Fig. 9 because spring 1 discharges from Neogene sediments, and springs 16 and 17 are located in different area. All the other waters discharge from Kadifekale volcanics and reflect the changes caused by pollution.

centrations (Table 3, Fig. 9). Ion concentrations (particularly Ca and Mg) and hardness of waters discharged from Kadifekale volcanics are quite high with respect to the natural andesite waters. This is because of the water leakage from the water-mains of the city, and leakages from the sewage system and/or septic holes.
