# Some problems associated with past mining at a mine in the Witbank coalfield, South Africa

S. E. T. Bullock · F. G. Bell

**Key words** Pillar failure · Void migration · Burning coal seams · Spoil heaps · Acid mine drainage

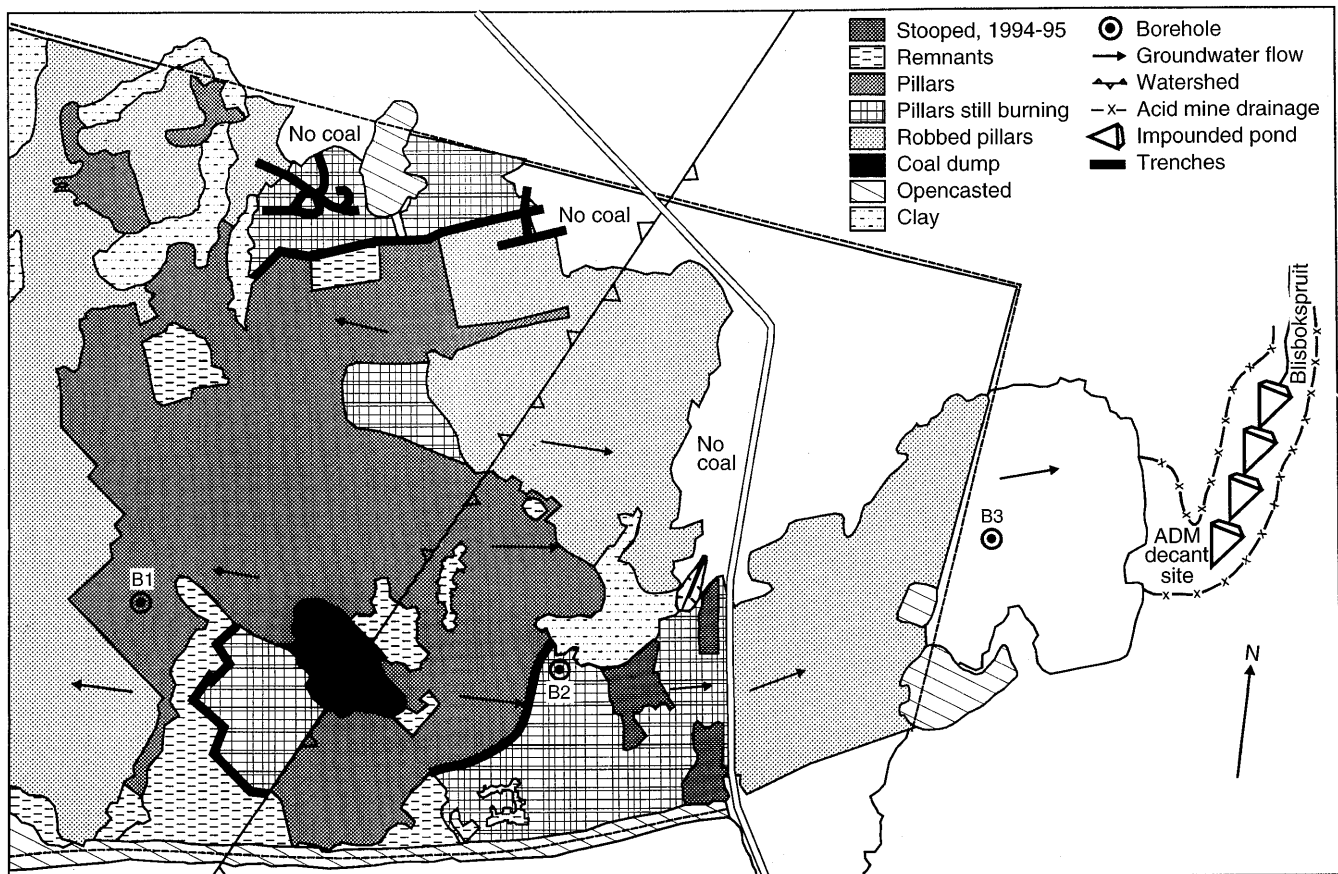
Fig. 3

Mining methods used at the mine site. Also shown are areas where underground fires still burn, the local watershed and the position of the polluted stream. Note that one of the spoil heaps is just off the map to immediate west

Various attempts have been made to control or extinguish the burning coal in the mine. These include construction of cut-off trenches, which were backfilled with earth, around burning zones (Fig. 3) and injection of water into the workings. In addition, the suggestion has been made to collapse the workings by subsurface explosions to try to inhibit the access of air. As this is just as likely to increase the access of air, the suggestion has not been put into effect. None of the efforts has had any real success. Burning appears to have bypassed many of the trenches simply because they were not long enough or wide enough and water injection has made no impression on the burning coal. The latter is probably because no barriers were placed to stop water draining away. In addition, water injection may take considerable time, sometimes years, to be successful. The programme was not continued for a long enough time, a matter of weeks being insufficient. In fact, there can be potential problems associated with water injection. First, carbon monoxide and hydrogen may be produced from water-gas reactions with burning coal, and these would be emitted at the surface. Secondly, the release of heat of condensation causes the temperature to rise in the mine.

In an attempt to ameliorate the impact of underground water entering the stream, a series of four pollution control ponds was constructed (Fig. 3). A side-stream of the seepage water was directed into the upper reservoir, while the remaining flow entered the nearby stream below the ponds. Residence time in the ponds is not known but is likely to vary with season. Comparison of water quality data, especially of samples 13 and 14, shows that the effect of cascading part of the seepage water through the decantation ponds is negligible. There is even cause to suspect that aluminium is being leached from soil particles in the ponds as aluminium concentrations leaving the lowest pond are about double those of water at the V-notch flume.

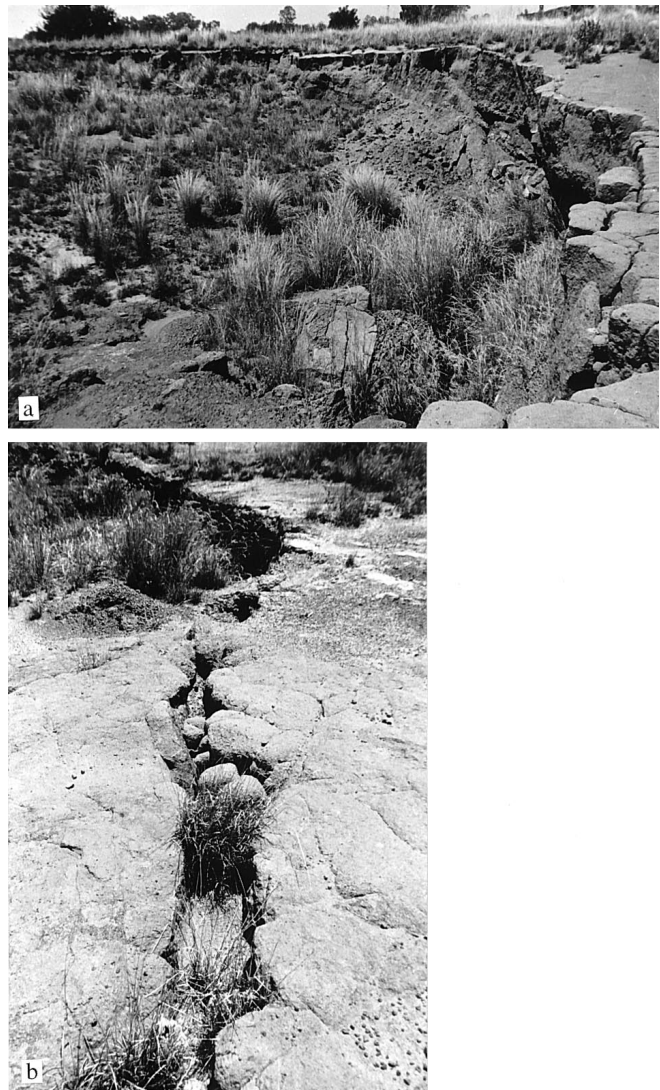
The failure of a single pillar increases the stress on surrounding pillars, causing them to fail in domino fashion. The surface subsidences caused by multiple pillar failure are generally several hundred square metres in extent and the collapsed areas often are bounded by near vertical sides (Fig. 4a). Surface tension cracks around the outer edges of the collapsed areas are typically 200–800 mm in width and can extend in length for up to 100 m (Fig. 4b).

The roof strata at the mine are generally weak and incompetent shales, and are in tension between the pillars. Obviously, the length of the span between pillars and the strength of the rock beam are all important in terms of roof collapse. High compressive stresses acting in the vicinity of the pillars can cause failure of roof strata. Stresses tend to develop at an angle to the maximum compressive stress. In the incompetent roof strata this tends to be at a high angle ( $75^\circ$ ). These stress fractures combined with interpillar tensional areas have caused collapse, resulting in upward void migration through overlying strata, until the weathered zone is reached. Generally, the weathered material has subsided by 2 to 3 m, but in some cases the weathered material has collapsed totally into the old workings, leaving voids 15–20 m deep. The resultant crownholes at the surface have diameters between 5 and 10 m and are often regularly spaced (Fig. 5). Tension cracks, varying in width from 200 to 500 mm, are found around the perimeter of the crownholes.

**Fig. 4**  
a Subsidence due to pillar failure. b Tension crack developed as a result of subsidence

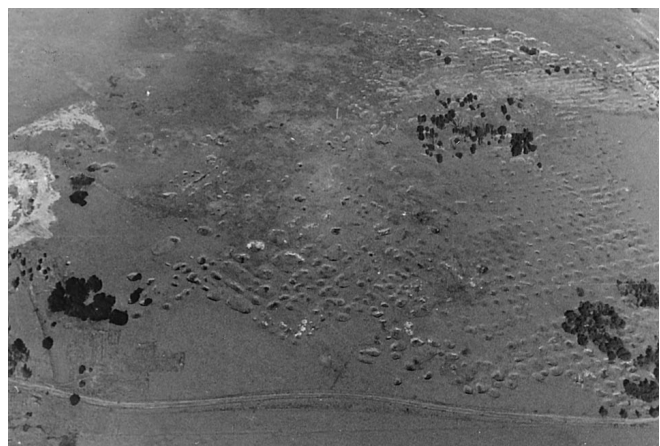
The roof rock in the bords may collapse with time. This leads to void migration, but the rocks which collapse bulk, so that void migration ultimately comes to an end. However, if seams are at shallow depth (e.g. less than about ten times the height of the workings), then void migration can give rise to the appearance of crownholes at the surface.

**Fig. 5**  
Pattern of collapses at the surface due to void migration in bord areas

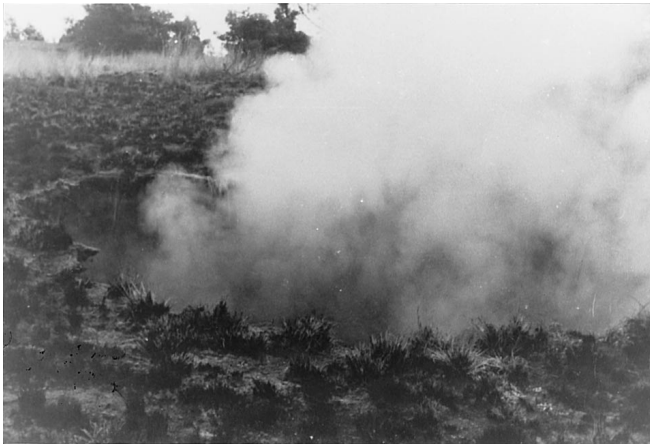
Fig. 6

Most of the factors outlined here exist at this particular mine where spontaneous combustion of coal has occurred since around 1947. For example, surface subsidence has given rise to crownholes and tension cracks which extend to mine level. These allow free passage of air into the mine workings. In addition, the fracturing and collapse of pillars have provided a greater surface area of coal and air can permeate these fractures in coal pillars. Some burning pillars have collapsed and weakened the integrity of the remaining pillars, leading to further multiple pillar failure and related subsidence, thus further aggravating the problem. Table 1 indicates that these coals are low-rank bituminous coals. It also shows that the sulphide content, and therefore pyrite content, is frequently greater than 2%, and so presumably enhances the process of spontaneous combustion. Although the natural moisture content of the coal prior to the abandonment of the mine is unknown, it is assumed that it is now higher, since the mine is flooded or partially flooded in places. Certainly, sulphurous steam emanates from many crownholes almost continuously (Fig. 6) and from some tension cracks. The partially collapsed nature of the workings impedes the rapid flow of air, and so heat is not readily conducted away from hot spots. Indeed, the existing conditions appear almost ideal for the spontaneous combustion of coal.

Gases (mostly steam) escaping from a crownhole

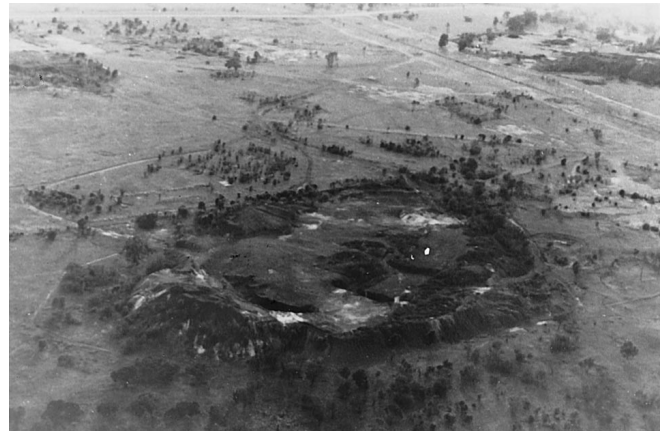
Aerial view of one of the spoil heaps on the mine site. White patches are areas where spoil has been burnt

trates the ground. There are no small water courses near the spoils to suffer pollution from such runoff. As the spoil heaps on the mined-out area are not near any urban centre, no attempt has been made at restoration. Spontaneous combustion of carbonaceous material, aggravated by the oxidation of pyrite, is the most common cause of burning spoil (Beever 1982). Coal and carbonaceous materials may be oxidized in the presence of air at ordinary temperatures, below their ignition point. At relatively low temperatures an increase in free moisture, which occurs in poorly compacted spoil, increases the rate of spontaneous heating. Oxidation generally takes place very slowly at ambient temperatures, but as the temperature rises, oxidation increases rapidly. As already noted, the lower-rank coal in the spoil heaps is reactive and accordingly susceptible to self-heating. When heated, the oxidation of pyrite and organic sulphur in coal gives rise to the generation of sulphur dioxide. If there is not enough air for complete oxidation, then hydrogen sulphide is formed. Sulphur gases emanating from these spoil heaps can be readily detected by the nose, especially after rainfall. Noxious gases emitted from burning spoil include carbon monoxide and carbon dioxide.

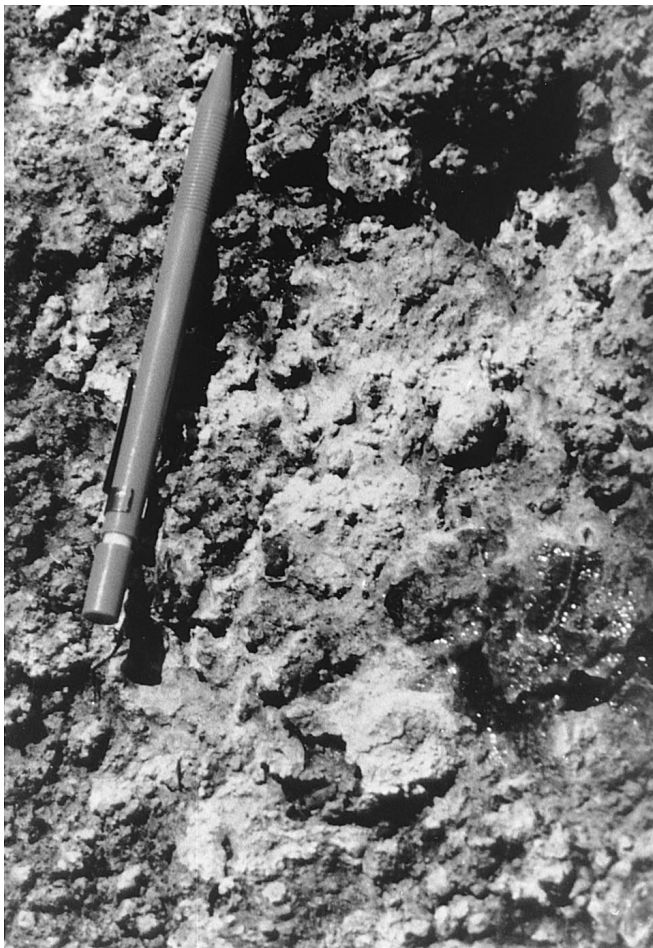
Evaporation of acid mine drainage leads to the precipitation of various salts on and in the uppermost layers of the soil (Fig. 9). X-ray diffraction analysis of such salts indicated the presence of halite NaCl, soda-alum, NaAl(SO<sub>4</sub>)<sub>2</sub>·12H<sub>2</sub>O, various members of the jarosite family of minerals (e.g. hydrojarosite, natrojarosite and possibly plumbojarosite), KFe<sub>3</sub>(SO<sub>4</sub>)<sub>2</sub>(OH)<sub>6</sub>, and a small amount of calcite, CaCO<sub>3</sub> (Fig. 10).

**Fig. 9**  
Precipitation of salts from acid mine drainage water on the surface of the soil

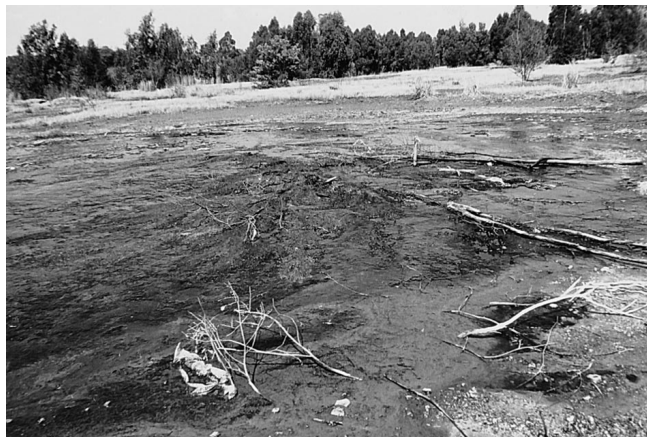
The acidity of the seepage water and the high TDS concentration have affected vegetation locally. A denuded area of approximately 3 ha exists in the coal sub-outcrop area between the eastern boundary of the mine and the decantation ponds. In this area, almost all plant life has been killed (Fig. 11). Most plants cannot tolerate low pH

garded as a major cause of plant toxicity in acid soils. As the total aluminium concentration in the seepage water is over 100 mg l<sup>-1</sup>, aluminium is likely to have played a role in the destruction of vegetation in this area. Other than

**Fig. 11**  
Decimated vegetation killed by acid mine drainage water
