Glenosphere disengagement in a reverse total shoulder arthroplasty with a non-Morse taper design

Abstract

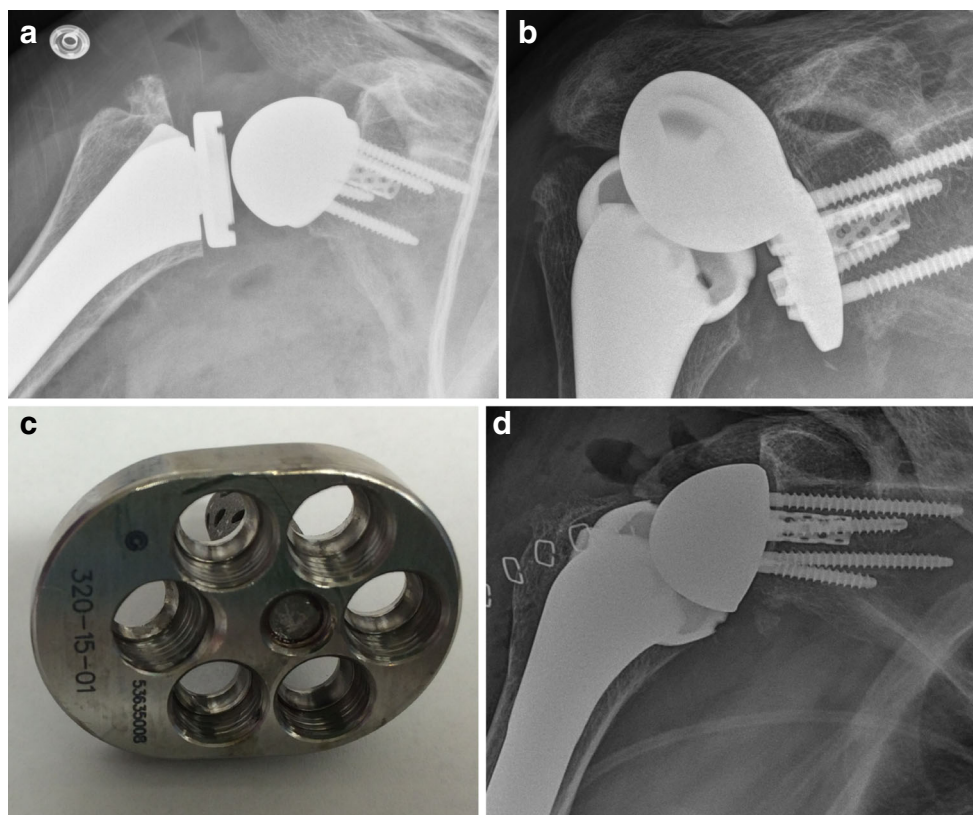
Immediate postoperative radiographs demonstrated a clear stepoff between the glenosphere and baseplate (Fig. 1). The patient was followed and initially did well, with no change in his implant position. However, he returned at six months with increased shoulder pain and significantly reduced motion. Radiographs demonstrated complete disengagement between the

glenosphere and baseplate. The patient subsequently underwent a revision of the baseplate, glenosphere and polyethylene. Intra-operative findings included complete disengagement of the glenosphere from the baseplate as well as a broken central screw, with clear evidence of cross threading. There was no obvious evidence of soft tissue interposition or incomplete glenoid reaming. Intra-operative fluoroscopy was used to ensure complete seating of the glenosphere. Postoperatively, the patient did well clinically and at the seven month follow-up demonstrated a pain-free right shoulder with 120° of active forward flexion, 90° of abduction and 20° of external rotation.

Fig. 1 Case 1: **a** immediate postoperative radiographs showing clear stepoff between glenosphere and baseplate; **b** complete glenosphere disengagement; **c** baseplate with tip of broken screw still cross threaded; **d** postoperative radiographs after revision (note glenosphere flush with baseplate)

In the Equinox[®] system, the hole in the glenosphere is not in the centre but several millimetres superior. Therefore, the central screw is inserted perpendicular to the baseplate, but since the hole in the glenosphere is not central, the screw will not appear to be entering perpendicular to the glenosphere. This predisposes the central screw to engaging the threads of the baseplate offangle and hence cross threading. Finally, the Equinox[®] baseplate has a unique central cage for bone graft that allows bony ingrowth to the glenoid. There is nothing preventing the bone graft from entering the region of the threads on the baseplate. Therefore, if a substantial amount of bone graft was placed, it could either prevent the screw from full seating or interlocking between the screw and baseplate threads. Both scenarios would lead to a screw that was not fully seated, predisposing to an incompletely engaged glenosphere. These unique features make this design more susceptible to both incomplete seating and complete disengagement and could explain why the overall incidence of disengagement and incidence of complete disengagement were higher. Surgeons who use this system should be aware that disengagement can still occur despite intraoperative feedback of complete seating. To overcome this complication, we recommend adequate surgical exposure to prevent soft tissue interposition, complete bony reaming, avoidance of excess bone graft in the baseplate cage and awareness that the locking

screw is not inserted perpendicular to the glenosphere. If there is any concern, intra-operative fluoroscopy should be used to ensure full seating.

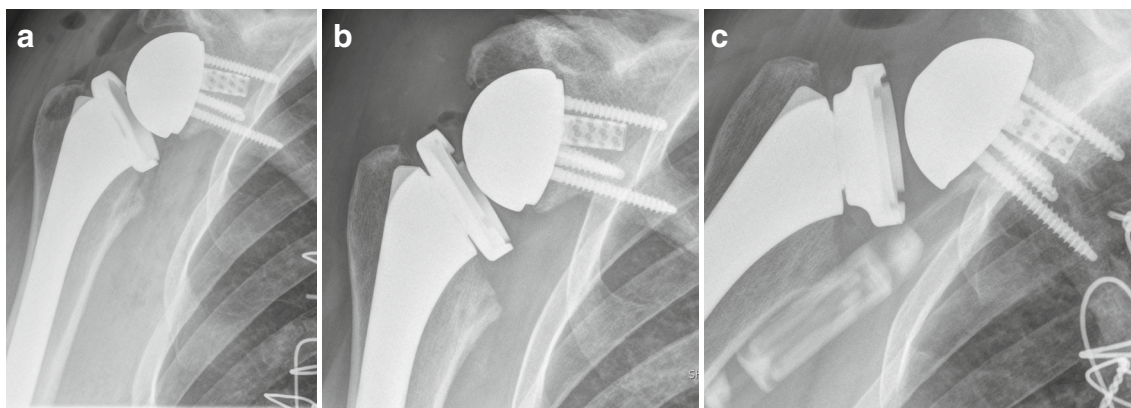
Fig. 2 Case 2: **a** immediate postoperative radiographs with clear stepoff between glenosphere and baseplate; **b** stable incomplete glenosphere disengagement at two months; **c** postoperative radiographs after revision surgery (note glenosphere flush with baseplate)

As with Case 1, immediate postoperative radiographs demonstrated a clear stepoff between the glenosphere and baseplate (Fig. 2). The patient was followed and was recovering appropriately, with no change in implant position, at two months. Due to concern of impending complete disengagement as encountered in case 1, revision surgery was offered. Intra-operatively, the glenosphere was still strongly fixed to the baseplate and the central screw was intact. There was a small lip of bone superior to the baseplate, which was likely the cause of the incomplete seating. The lip of bone was removed, the glenosphere was revised and a new central screw was placed. Intra-operative fluoroscopy was used to ensure complete seating of the glenosphere. The patient did well clinically, and the four month follow-up demonstrated a pain-free right shoulder with 145° of active forward flexion, 90° of abduction and 30° of external rotation.
