Harald Kugel
Christoph Bremer
Marco Püschel
Roman Fischbach
Horst Lenzen
Bernd Tombach
Hugo Van Aken
Walter Heindel

Hazardous situation in the MR bore: induction in ECG leads causes fire

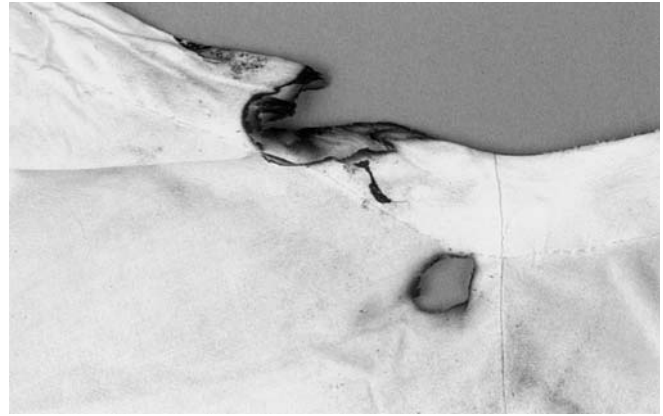
Fig. 1 Section of the patient's shirt with burned-in holes

Particles of molten plastic were found on the blanket and on the shirt of the patient. Over the right upper thorax a large hole was burned into the shirt (Fig. 1).

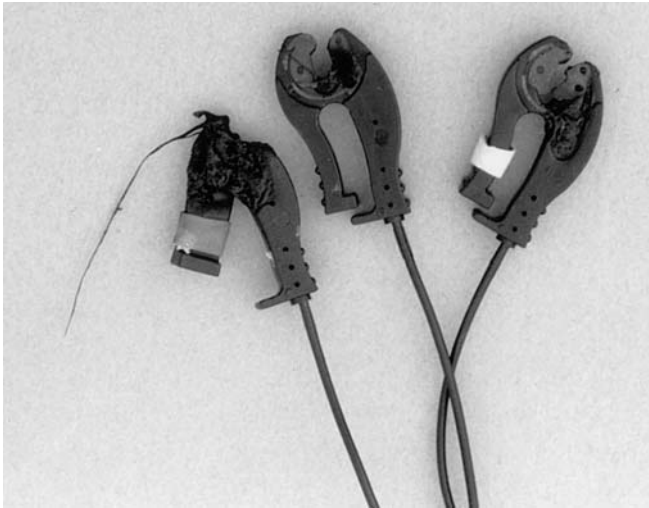
A closer inspection of the ECG leads revealed that the plastic clips at the connection of the ECG lead and the

Fig. 2 Partially molten plastic clips. The most affected clip on the left had been fixed at the most cranial position

electrodes were deformed and partially molten, especially the uppermost positioned electrode, depicted on the left in Fig. 2. The plastic foils of the electrodes were stained with soot; however, they were not molten or perforated and remained intact (Fig. 3). Skin burns were found at the position of the electrodes (Fig. 4).

While the exact sequence of events leading to the fire in this specific case is not fully understood, the analysis shows that a number of conditions may have led to the hazardous behaviour. We assume that coupling took place not with alternating B_1 , the magnetic component of the exciting electromagnetic field in the transmitting body coil, but with E_1 , its electric component. Induction in the ECG cabling caused by E_1 led to a high-voltage built up at the position of the electrodes. Due to galvanic or capacitive coupling, current could flow through the patient. The energy was dissipated to heat mostly at the position of the highest impedance, which was either at the contact of electrodes to skin or at the contact of the lead to the electrodes, i.e. at the contact clips. It is known that energy dissipation may lead to burns if current through a closed current loop is led through a high impedance, e.g. formed by a skin–skin contact [12]. The galvanic resistance between electrode and skin can be 500–6000 ohms, depending on skin preparation [13]. The observed burns at the electrode–skin contact may be due to energy dissipation at this position; however, the fact that the electrodes were unaltered, while the plastic clips were partially molten, hints to larger energy dissipation at the lead–electrode contact. The galvanic resistance of the uninterrupted contact of clip and electrode was between 5 and 500 ohms and depended on motion. When the leads are correctly connected to the monitor, heat dissipation is low. An improper grounding or connection to the monitor causes heat dissipation at the electrode, so that temperature increases with time. It may affect the skin, but the temperature remains probably too low to inflame cloth; however, preliminary experiments have shown that voltages induced into the ECG cabling by the applied TSE sequences are sufficiently high to induce sparking between the contact clip and an appropriate counterpart, e.g. the graphite mine of a pencil. Especially if the conducting edge of the clip has loose contact with the electrode, i.e. the clip is not firmly fixed so that the galvanic contact is frequently interrupted due to patient movement, sparks between clip and electrode emerge. Sparking is significant with an open-ended cable that is not grounded, but sparks could also be detected with a cable properly connected to the monitor. The findings described in this report indicate a significant heating at the contact of lead and electrode, presumably caused by a loose contact with induction of sparks. The heat released by the sparks deformed the clips, and the sparks inflamed the surrounding cloth.

The risk of high-voltage induction can be reduced with small excitation fields (head coil or surface coils for excitation), small pulse angles (gradient-echo sequences with low pulse angles), short conductors (shorter than 1/2 wavelength in the surrounding medium, i.e. shorter than 2.35 m in the air, and shorter than 25 cm for conductors in the body, assuming similar dielectricity of body tissue and water), high impedance of conductor, positioning with maximum distance from coil leads (exciting and receiving coils). In contrast to the external ECG unit used in the case described here, the built-in trigger unit of the scanner seems to be safe. Its lead is shorter and has a higher resistance of 60 k ohms. No sparking could be induced under identical conditions using the built-in unit with this lead.

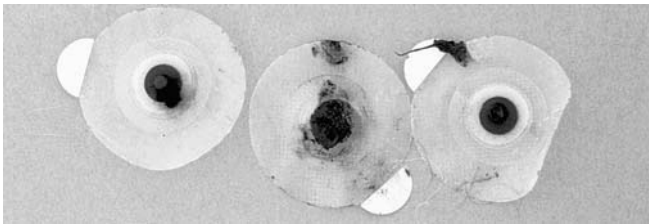
Fig. 3 The electrodes with still-intact plastic foil. The electrode in the middle was connected to the most cranial clip

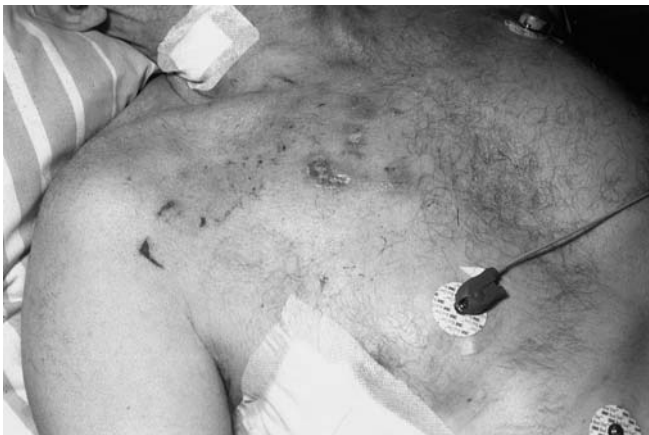
The subsequent physical examination of the patient revealed second- to third-degree burns at the position of the ECG electrodes. In addition, it was noticed that the patient was perspiring, and thus had a galvanic contact to the supporting cushion.

At the position of the electrodes there was scab on the skin; slightly above was an extended erythroderma. The patient complained about severe pain. The wound was immediately covered with a sterile bandage.

Fig. 4 Burns on the right thorax of the patient. In the MR scanner the ECG electrodes had been fixed at these positions
