Norman Kerle · Benjamin van Wyk de Vries ·  
Clive Oppenheimer

## New insight into the factors leading to the 1998 flank collapse and lahar disaster at Casita volcano, Nicaragua

Received: 12 December 2001 / Accepted: 18 November 2002 / Published online: 19 March 2003  
© Springer-Verlag 2003

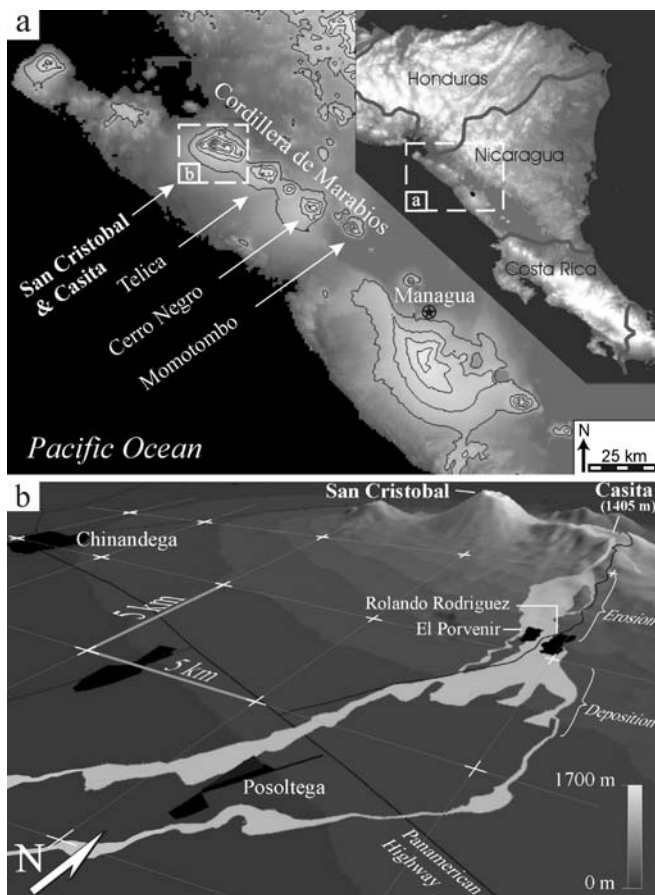
More than 2,500 lives were lost when a flank collapse led to a lahar that descended Casita volcano in October 1998 and destroyed two towns (Fig. 1). The event was immediately attributed to strong rainfall produced by Hurricane Mitch, which was devastating large parts of Nicaragua and Honduras at the time. The initial belief in a breached crater (releasing ponded rain water) as the source of the disaster was quickly discredited (Sheridan et al. 1999). A post-disaster structural study, based on image analysis and analogue modelling, identified edifice-wide deformation at Casita, with a gravity slide forming in the

**Fig. 1** a Map of Casita volcano within the Cordillera de Marabios. b Illustration of the extent of the 1998 debris avalanche and lahar event. The flow destroyed the towns of El Porvenir and Rolando Rodriguez (>2,500 fatalities), several bridges along the Panamerican highway and led to further fatalities in Posoltega. Rainfall data during Hurricane Mitch were collected at the Chinandega weather station, located approximately 20 km west and 1,300 m below the Casita summit

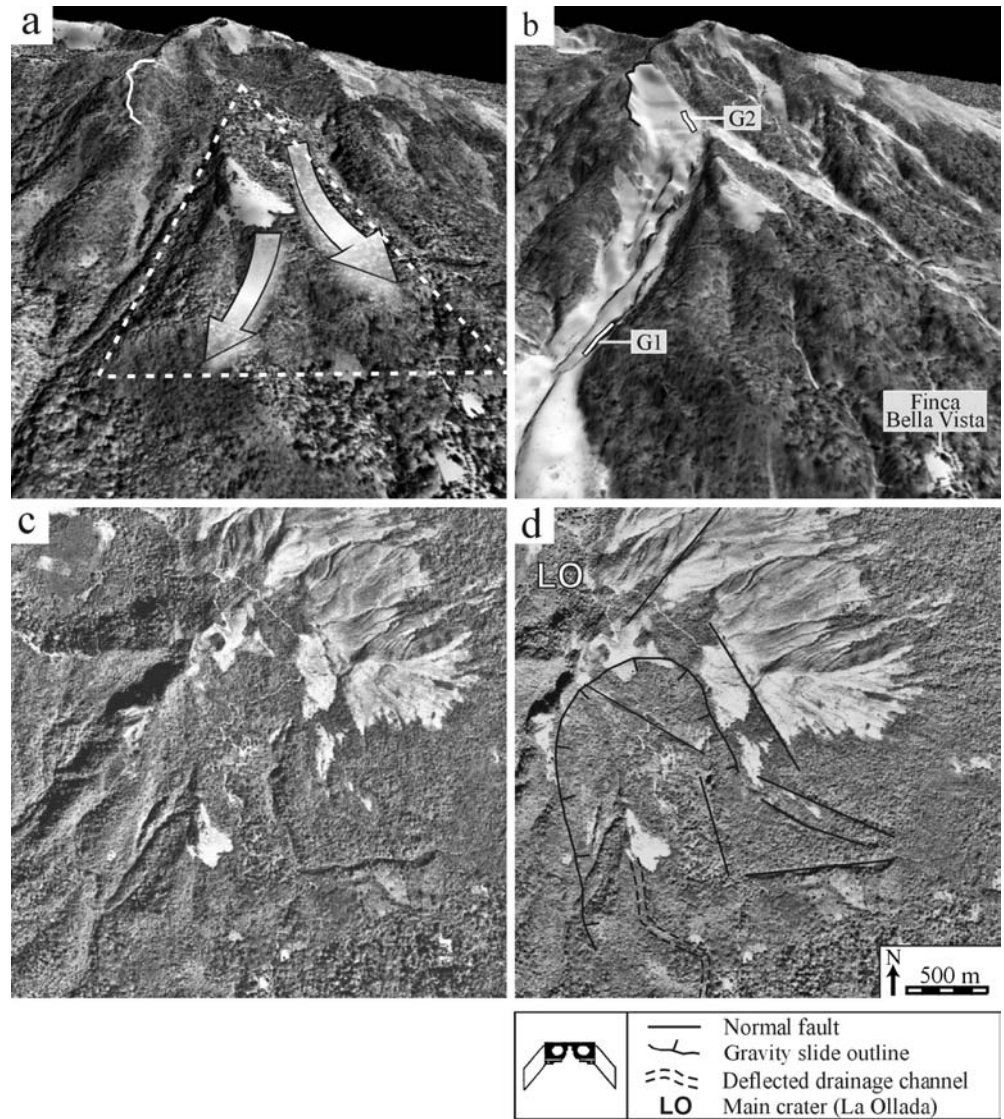
**Fig. 2** **a** Pre- and **b** post-disaster DEMs of Casita, surface-draped with corresponding aerial photographs acquired in 1996 and 2000. Note how edifice-wide deformation has resulted in a triangular gravity slide along Casita's southern flank, forming adjacent ravines through which avalanche material descended following the flank collapse (*solid lines* indicate failure scarp). The locations of gullies G1 and G2 surveyed before and after the 2000 rainy season are indicated. **c, d** 1996 stereogram of Casita's south-east sector, with major faults and deflected drainage channels indicated. All stereograms in this paper are best viewed with a standard pocket stereoscope

Figure 2 shows pre- (a) and post-event (b) digital elevation models (DEMs) of Casita's south-eastern flank, surface-draped with aerial photos taken in 1996 and 2000, respectively. The DEMs outline the crescentic gravity slide that is marked by steep headwalls, which enclose a roughly triangular area delimited in the east and west by prominent ravines, and by basal thrusts in the south. The main debris avalanche followed the western one of the

ravines, while approximately 15% of the material overflowed into the eastern ravine (Scott et al. 2003). An analysis of the structural features, including the steep, horseshoe-shaped rim, and deflected fault lines and drainage channels (Fig. 2c, d) has suggested ongoing edifice deformation (Kerle and van Wyk de Vries 2001), which is thought to have begun at least 500 years ago, and is considered to be the result of a hydrothermally altered core (van Wyk de Vries et al. 2000). Such deformation, however, also implies the possibility of changes in erosion patterns, and an active headward propagation of gullies located within the western ravine originating at the collapse site (Montgomery and Dietrich 1988, 1989; Hovius et al. 1998). A set of aerial photos spanning 42 years (Table 1) was obtained to investigate such temporal changes in gully size and extent. Three stereo, pre-event datasets, acquired in 1954, 1987 and 1996, were used in the analysis. While an orthorectification of the 1996 photos was possible, poor image quality and lack of camera information for the 1954 and 1987 photos precluded using them for topographic correction. However, image quality and scale were sufficient for all datasets to be used in a qualitative stereoscopic analysis in ERDAS Imagine's StereoAnalyst (essentially a digital stereoscope). Figure 3 depicts stereograms of the Casita failure area and the western ravine, which is dominated by two principal gullies. Each stereo-pair is complemented by a drawing that outlines areas of hydrothermal alteration, the principal and secondary gullies and depressions, and the extent of the flank failure. Note that the stereograms are vertically exaggerated as a function of photo-overlap and flying height, which must be considered during photo interpretation. When viewed with a pocket stereoscope, it is apparent that the overall shape of the gullies in 1996 was not different from 1954 and 1987. An apparent decline in hydrothermal activity over the time period covered by the photos, associated with an increase in vegetation cover, is likely to have contributed to the stability. Only the shallow depression upslope from the principal gullies had grown in extent. Of greater concern for flank instability appears to be a depression labelled D1 in the 1954 structural map. However, the apparent undercutting of the slope is virtually unchanged in the 1996 photos.

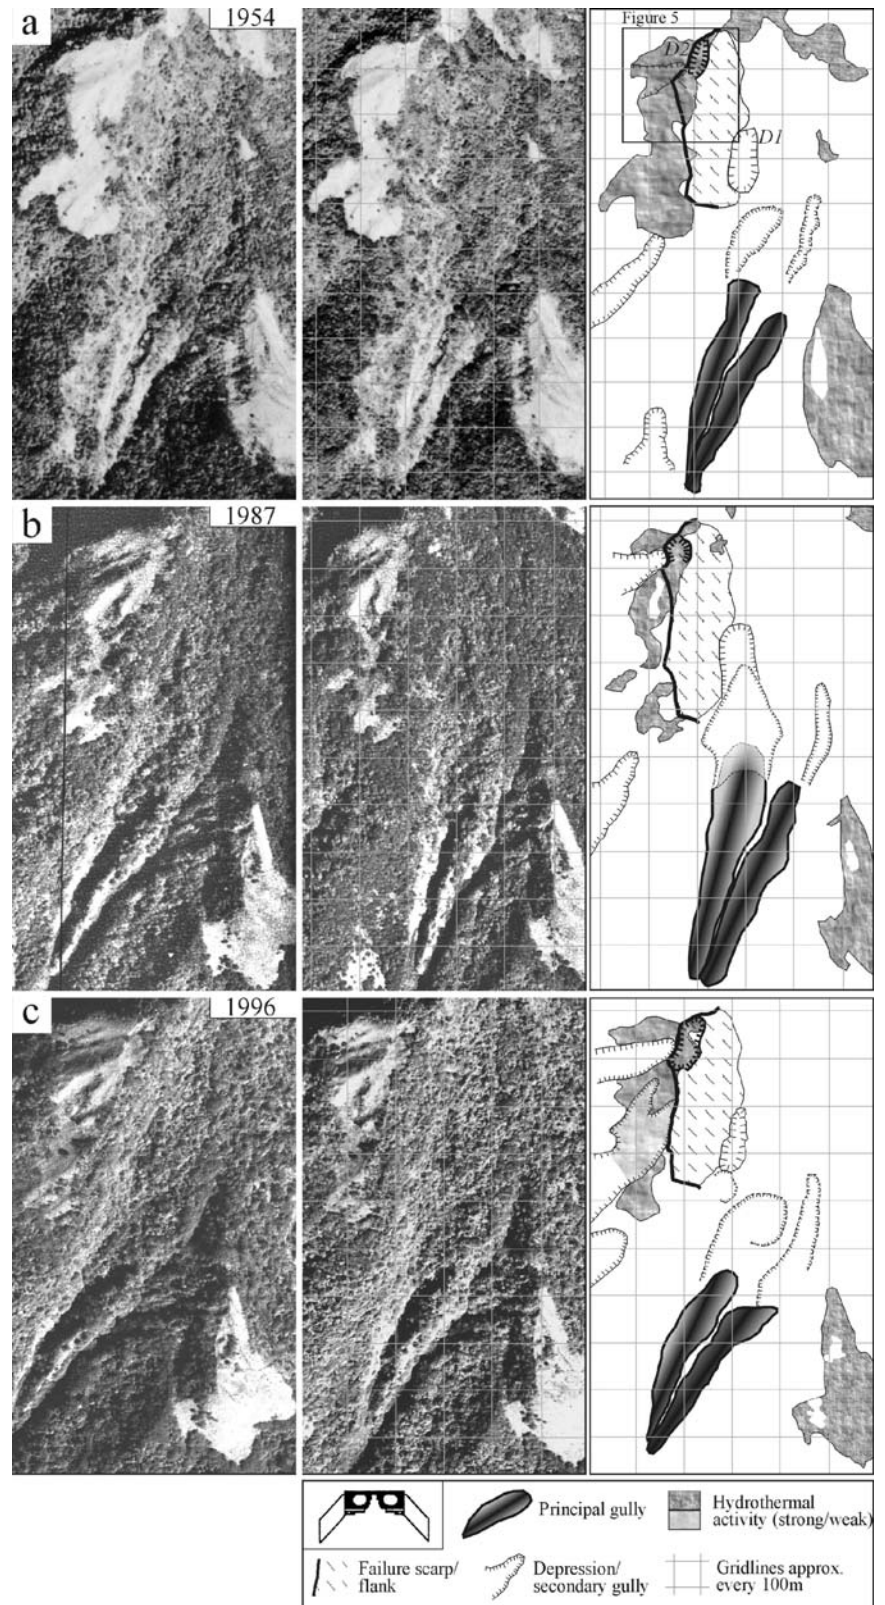
While the morphology of the western ravine shows high temporal stability, significant changes occurred near the top of the failure scarp (indicated by the solid black line in Fig. 3). The north-eastern section of the hydrothermal field contains an oval-shaped depression (D2 in Fig. 3a). In 1954 it was only faintly apparent, and had a length of approximately 60 m. By 1996 it had deepened and extended to about 110 m in length, as illustrated in the close-up stereograms shown in Fig. 5b, c. By the time of failure, the section had extended along more than a quarter of the length of the eventual failure scarp, and was entirely incorporated in the collapse material (Fig. 3c). Although the magnitude of the change in depth can not be quantified due to the aforementioned inferior quality of the 1954 photos and lack of camera information, the increase in size in all three dimensions is clear. The depression further corresponds precisely to an area of highly fractured and brecciated lava and tephra, strongly hydrothermally altered, and with clear signs of subsidence (Fig. 5a). The area is distinctly separated from a well-layered, largely undeformed and unaltered section to the south. This deformation would have fuelled further fracturing, and facilitated infiltration of meteoric water, the effects of which are discussed in more detail in a later section.

**Fig. 3a–c** Stereogram time series of the 1998 flank failure site and the western ravine through which the initial avalanche travelled, and corresponding structural drawings. Photographs shown were acquired in **a** 1954, **b** 1987 and **c** 1996. The photos document a lack of significant morphological change in the principal gullies, an increase in depth and extent of a small depression (*D2*) within the failure area, and a decrease in hydrothermal activity, evidenced by increased vegetation cover

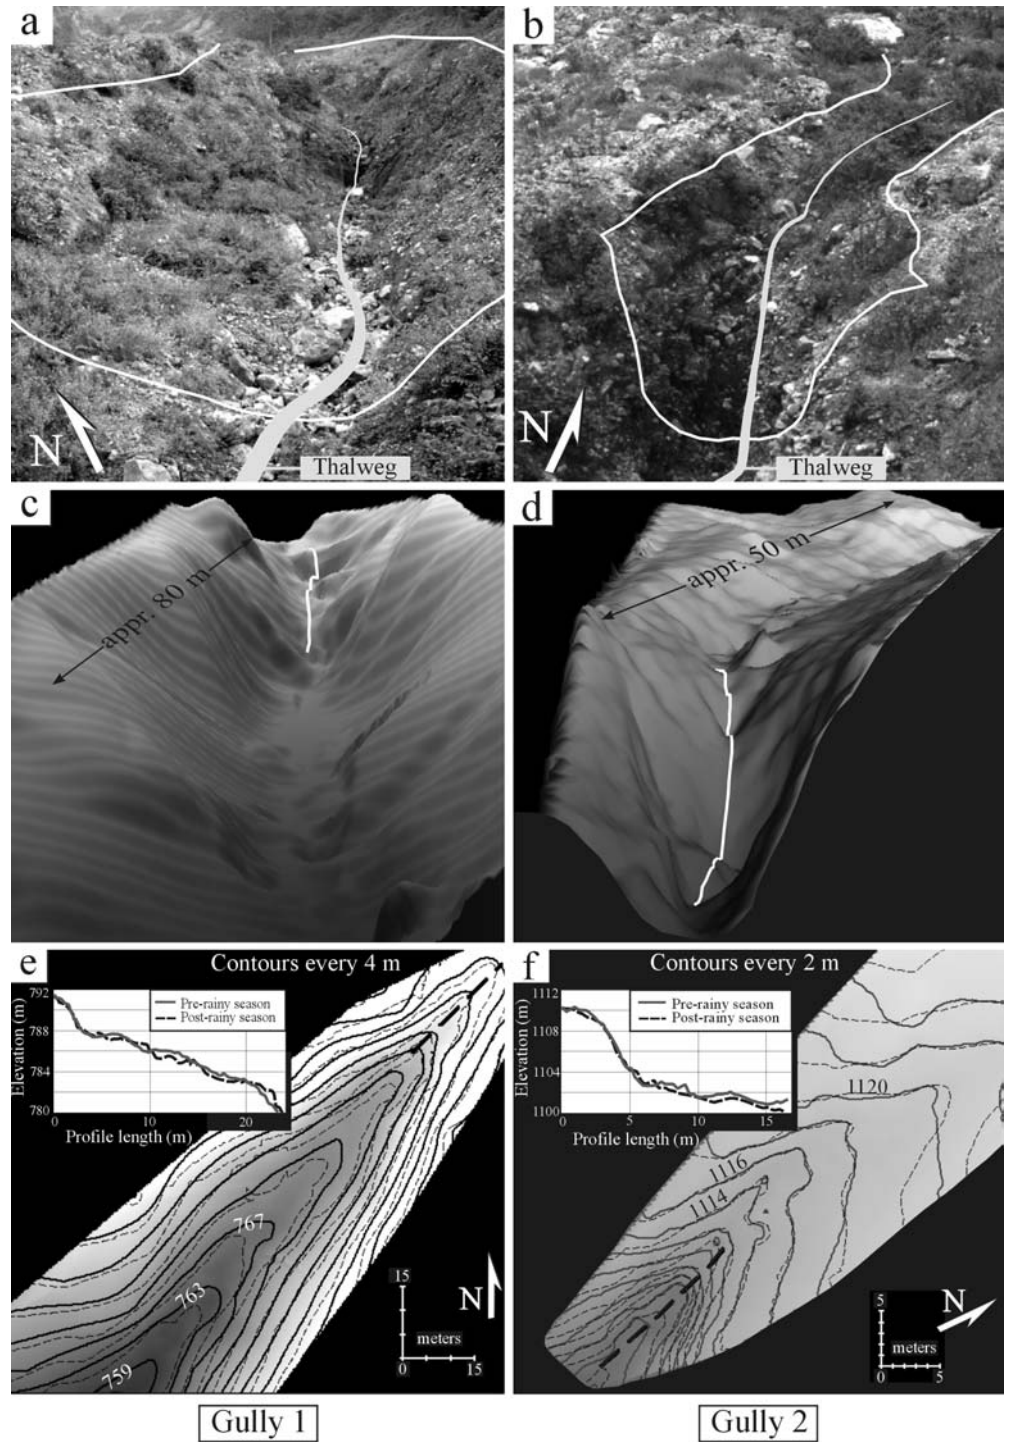
The stabilising effect of vegetation was lost when the avalanche denuded the ravine (see Mejia-Navarro et al. 1994). To test for short-term changes in morphology, two gullies, G1 and G2 (Fig. 4a and b, respectively, locations marked in Fig. 2b), were surveyed. The surveys were carried out in March and November 2000, effectively bracketing the annual rainy season. Approximately 1,600 mm of precipitation were recorded in Chinandega during that time, including more than 400 mm between 30 September and 3 October during Hurricane Keith (INETER, archived data). For each gully, between 170 and 350 measurements were collected with a Geodimeter Total Station during each survey, resulting in detailed DEMs with 0.3-m grid spacing. Figure 4c, d illustrates the topography of both channels before the rainy season. The

lack of significant long-term change in gully morphology observed during the time-series photo interpretation was mirrored by the survey. Despite strong rainfall and lack of vegetation, no appreciable changes occurred along the gully heads. Figure 4e, f shows superimposed contours for both gullies, interpolated from the respective pre- and post-rainy season data. Profiles for the actual gully head (thick hatched line, and solid white line in c, d) are virtually unchanged. The survey suggests that gradual erosion from surface runoff plays a limited short-term role in gully propagation. This can be explained by the slope material, which consists of block- and boulder-rich deposits from previous avalanches, which provide resistance to fluvial erosion (Fig. 4a, b; see also Fig. 5 in Kerle and van Wyk de Vries 2001). Previous studies, both in temperate (Montgomery and Dietrich 1988; Dietrich et al. 1993) and tropical (Hovius et al. 1998) environments, have identified mass failures along gully heads as the primary engine for drainage network expansion. The lack of steady, erosion-induced morphological change in the surveyed gullies, even under favourable conditions, points to a similar mechanism at Casita.

**Fig. 4a–f** Analysis of morphological changes in two gullies within the western ravine over the course of the 2000 rainy season. **a, b** Photographs of the gullies, with the approximate extent of the area surveyed (*thin white line*) and the thalwegs indicated. **c, d** DEMs of the surveyed gullies, interpolated from the pre-rainy season data collected with a Geodimeter Total Station. **e** Contour lines calculated from the pre- and post-rainy season datasets of gully 1 and **f** gully 2 (refer to Fig. 2b for gully locations). *Insets* show elevation profiles of the two gully heads, which demonstrate that no upslope gully propagation occurred during the 2000 rainy season. The profiles are marked by *solid white lines* in **c** and **d**, and *thick hatched lines* in **e** and **f**. See text for discussion

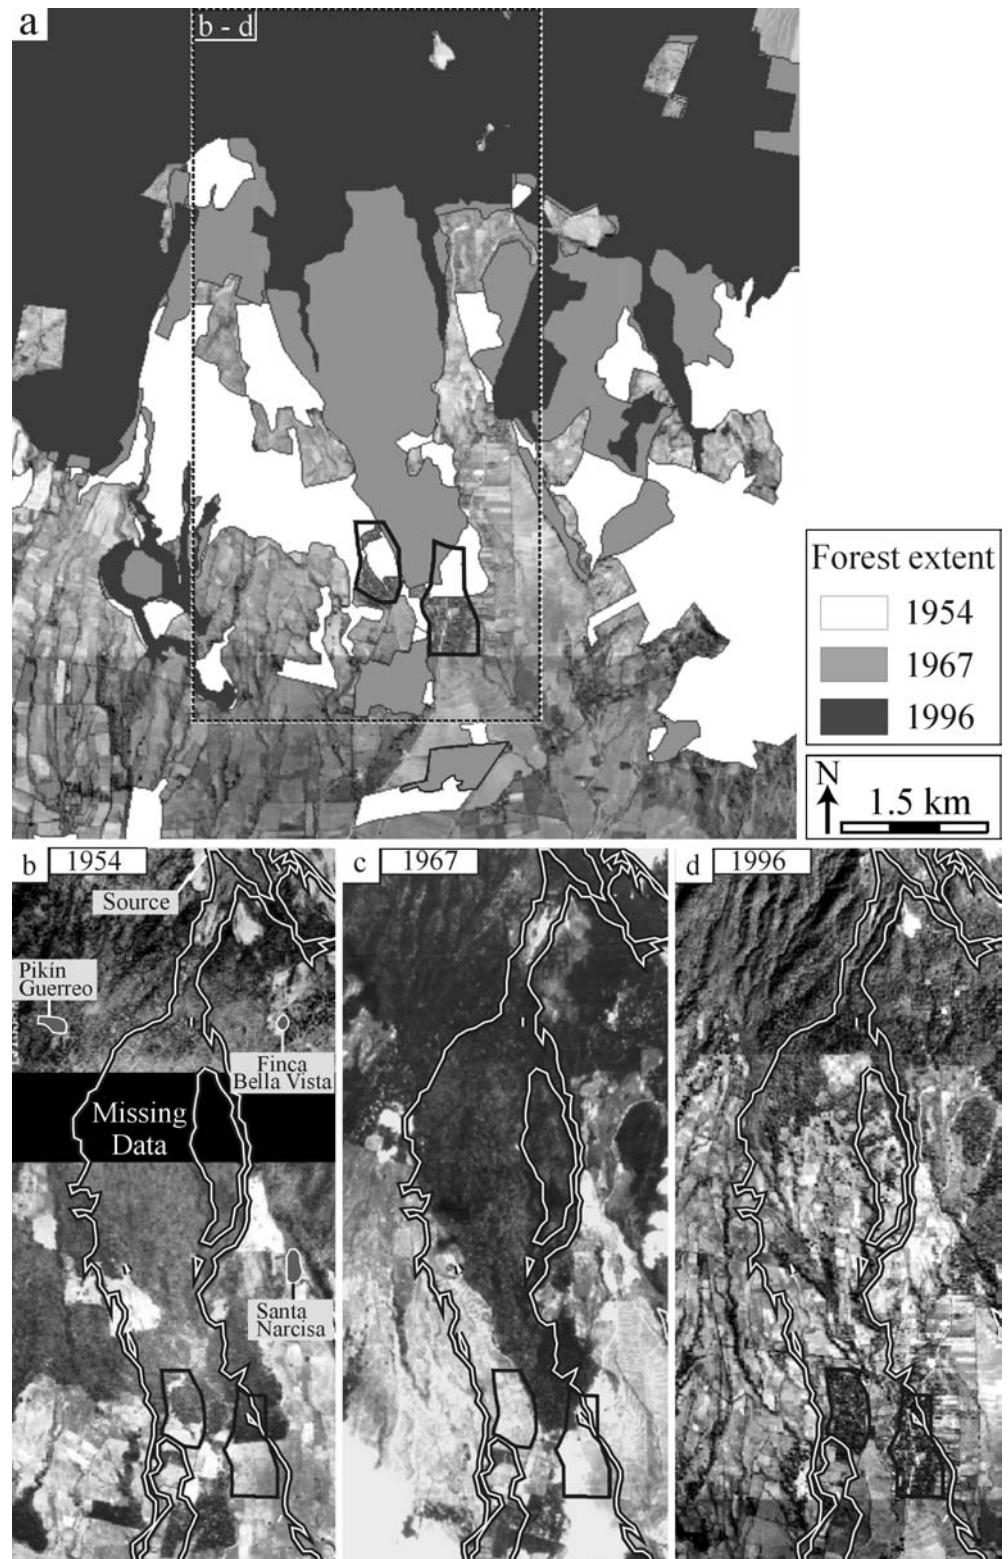
The 1954 and 1996 aerial photos, as well as a declassified 1967 Corona satellite photograph, were used to document deforestation on Casita's southern lowlands during that time, in particular in the area affected by the 1998 lahar. Figure 8 shows the extent and location of all images. The actual photographs show that by 1954 much of the belt between the Panamerican highway and the volcanoes had already been deforested. The continuation of that trend, especially north of the destroyed towns, is mirrored in the time-series presented in Fig. 7a. The extent of forests in 1954 (white), 1967 (light grey) and 1996 (dark grey) are superimposed. The white and light grey areas essentially depict the land deforested by 1967 and 1996, respectively. The individual images, with the lahar boundary overlaid, are shown as Fig. 7b–d. By the time the lahar occurred, of the 6 km of forest that originally separated the town locations from the lahar source, less than 2 km remained.

**Fig. 7a-d** Summary of deforestation on Casita's southern slope and in the area covered by the 1998 avalanche and lahar. **a** Outline of forested areas in 1954 (white), 1967 (light grey), and 1996 (dark grey). **b-d** Aerial and satellite photographs documenting how much of the forest that separated the towns of El Porvenir and Rolando Rodriguez in 1954 had disappeared by 1996, greatly increasing the vulnerability of the towns to lahars. The extent of the lahar deposits is outlined, as are the locations of the destroyed towns

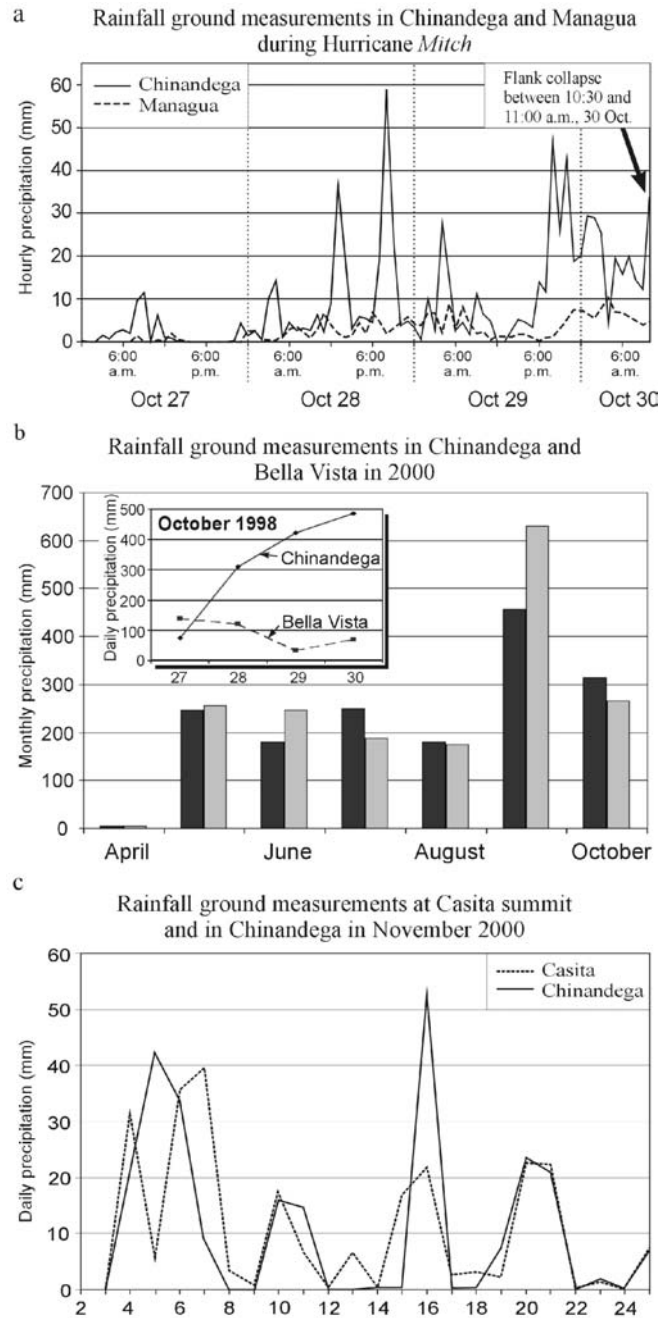
westerly flow spawned by Mitch's broad circulation (Ferraro et al. 1999; Fig. 9a). With the flank collapse occurring between 10:30 and 11:00 a.m. on 30 October, approximately 750 mm of rain were recorded over some 83 hurricane-affected hours before the disaster. The graph

**Fig. 9** **a** Hourly precipitation values recorded during Hurricane Mitch in Chinandega and Managua. For approximately 83 h before the collapse on 30 October, 1998, hurricane-related rainfall was recorded in Chinandega, while Managua was largely unaffected. **b** Monthly rainfall recorded in Chinandega and at Bella Vista (located above 700 m on Casita's south flank) during the 2000 rainy season. The data show good agreement, suggesting a limited orographic effect at Casita. However, daily values recorded at Bella Vista during Mitch are significantly lower than at Chinandega (for example 34 mm on 20 October, compared with more than 420 mm at Chinandega), casting doubt on their reliability (inset; source: INETER 1999). **c** Daily rainfall at Casita weather station and in Chinandega

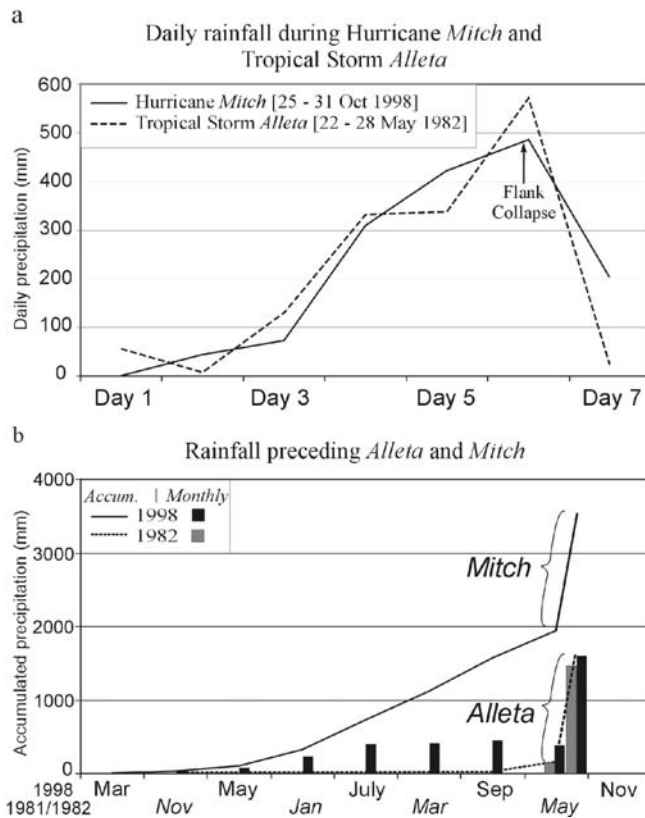
**Fig. 10** **a** Normalised daily rainfall during Tropical Storm Alleta and Hurricane Mitch. Note that rainfall during both events was comparable (a total of 1457 vs 1,538 mm, respectively). **b** Accumulated rainfall in the months preceding Mitch and Alleta, plotted on a normalised, monthly scale. A total of 164 mm fell before Alleta, and more than 1,900 mm before Mitch (source: INETER 1999). Note the horizontal chronological offset in **b** for the 1981/1982 and 1998 data

As noted earlier, tropical storm Alleta in 1982 did not lead to flank collapse, despite comparable rainfall (1,457 vs 1,538 mm over 7 days), and a higher daily maximum of 570 mm on 27 May 1982 compared with 485 mm on 30 October 1998 during Mitch (Fig. 10a; INETER 1999). The principal difference between the two events is the occurrence of Alleta at the beginning, and of Mitch at the

end of the rainy season. The accumulated rainfall plotted for both events in Fig. 10b shows that only 164 mm of rain were recorded at Chinandega over 6 months before Alleta, compared with more than 1,900 mm that fell in the 1998 rainy season prior to Mitch. Casita's infiltration capacity is well known, and is reflected in its indigenous name of Apastepe, meaning 'Hill full of water'. This refers to the absence of surface streams, and the abundance of wells in the lowlands at the foot of the volcano (J. Incer Barquero, personal communication). Infiltration rates as high as 119 mm in only 3 min were measured by one of us (NK) near the failure area. Given the watershed of the 1998 failure area of approximately 75,000 m<sup>2</sup>, some 56,000 m<sup>3</sup> of rainwater would have fed into the failure material over the 83 h before the event. Together with significant previous precipitation, this resulted in infiltrated water accounting for at least 18% of the flank collapse volume (see Scott et al. 2003).

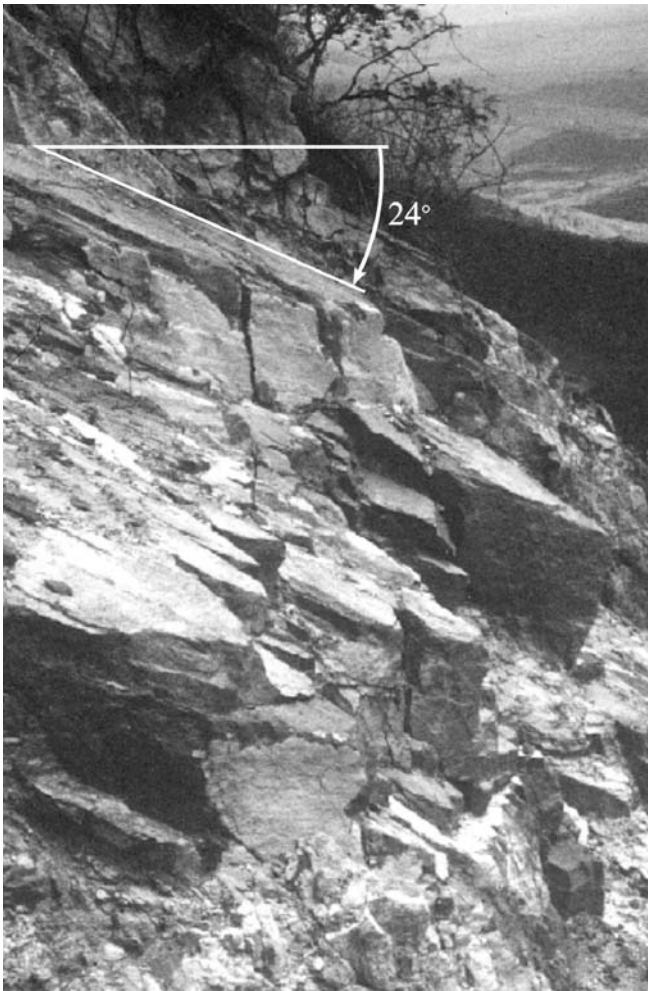
**Fig. 11** Lava and tephra lithologies dipping south by as much as 24°. Viewing direction is towards the east. Photo location is indicated in Fig. 5a

a fast pressure rise (Harper 1975). Surface flow drainage is not slope-parallel, but produces a curved flow field that directs seepage forces outwards from the slope (Iverson and Reid 1992). Such flow, which also leads to shear stress, is facilitated where low-conductivity layers are encountered (Reid and Iverson 1992), a condition provided by the clay-rich bedrock layer. At Casita this was increased by flank material dipping towards the south by as much as 24° (Fig. 11).

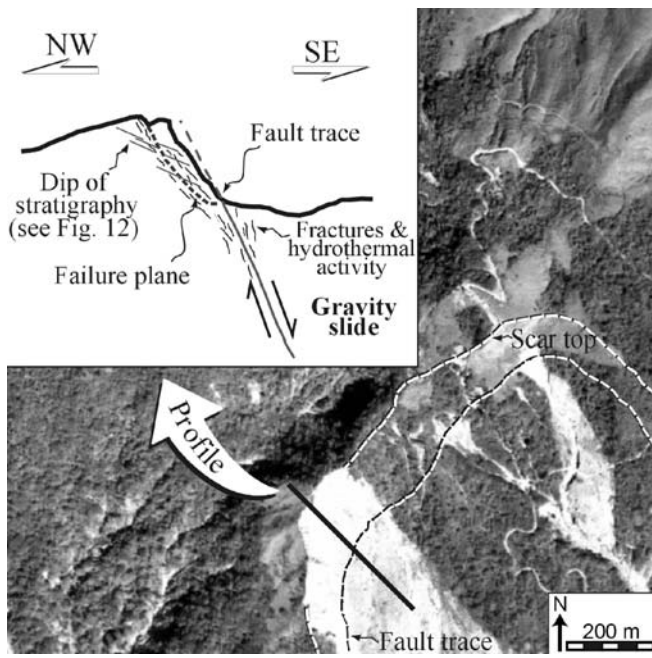
**Fig. 12** Post-failure orthophoto, superimposed with the approximate location of the gravity slide boundary fault and the top of the scar. *Inset* shows a structural cross section of the failure cliff

earthquakes have occurred in its vicinity in the past. Damage reports for seismic events in 1938 and 1955 indicate a strong intensity amplification by the volcanic structures, as well as the ability of such events to open new surficial cracks and fissures. Given that several comparable earthquakes occurred between Alleta and Mitch, notably in 1983 and 1987 (magnitudes of 6.0 and 6.2, respectively), we can assume that those events had a cumulative destabilising effect on Casita's summit area. The consequences for the 1998 failure site could have been particularly severe, as the failure plane runs above the gravity slide-bounding fault (Fig. 12).

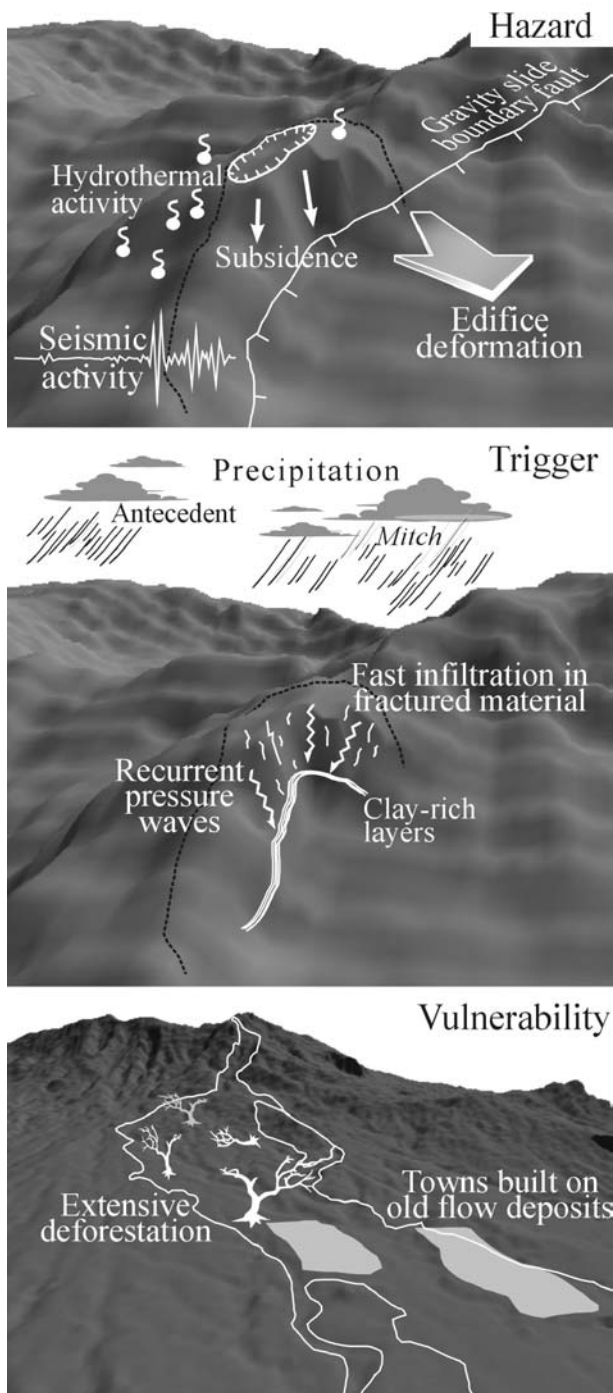
**Fig. 13** Cartoon summarising factors that influenced the flank collapse hazard and trigger, and the vulnerability of towns on Casita's southern flank. *Dashed line* denotes collapse scar
