Damage assessment for the 2018 lower East Rift Zone lava flows of Kīlauea volcano, Hawai‘i

Elinor S. Meredith^{1,2} · Susanna F. Jenkins^{1,2} · Josh L. Hayes^{1,3} · Natalia Irma Deligne^{3,4} · David Lallemand^{1,2} · Matthew Patrick⁴ · Christina Neal^{4,5}

Received: 14 June 2021 / Accepted: 27 April 2022 / Published online: 6 June 2022
© The Author(s) 2022

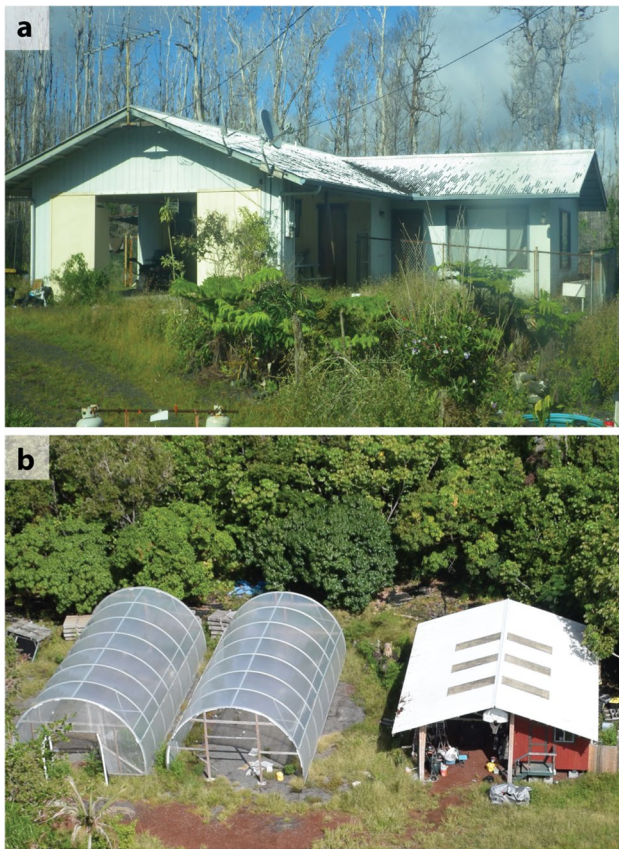
Fig. 2 Photographs taken in lower Puna of **a** a wooden dwelling with a metal roof (taken 18 December 2019) (Photo credit: E. Meredith); **b** non-residential structures: plastic shade houses on the left, wooden accessory building on the right (taken 6 November 2018) (Photo credit: US Geological Survey)

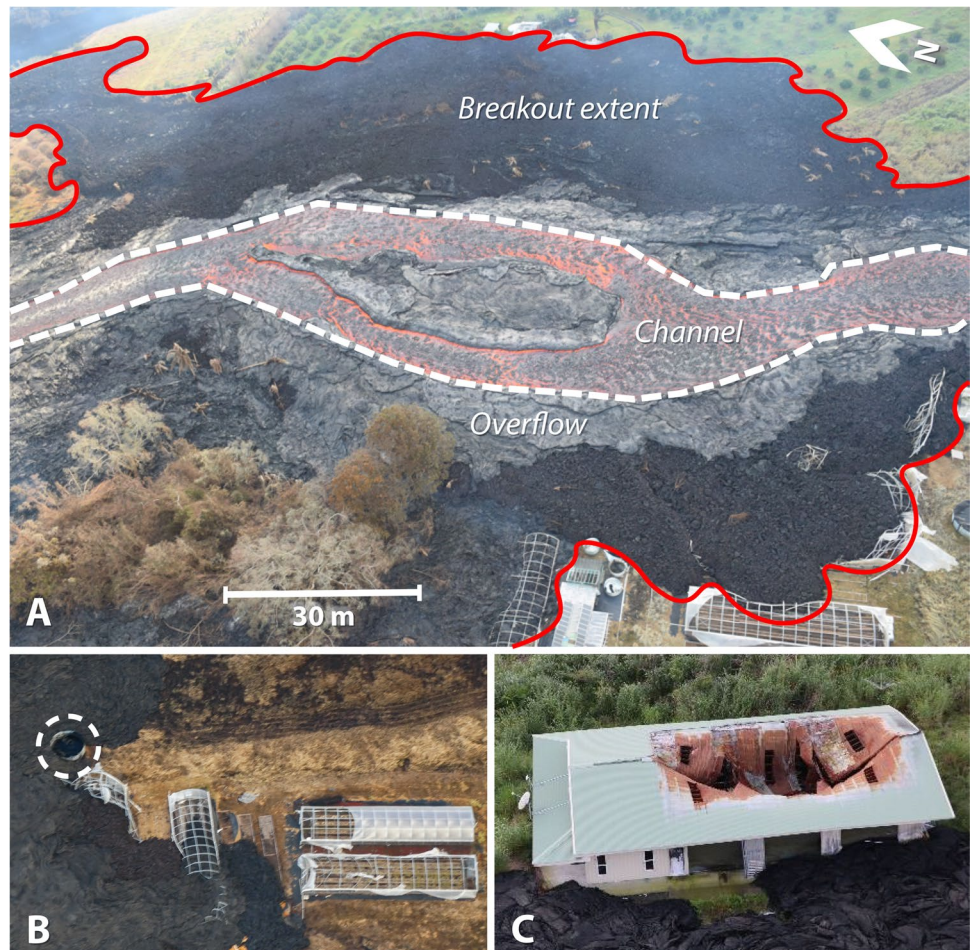
and subsequent explosion, possibly of a propane tank or vehicle engine (Fig. 10c).

Fig. 10 Photographs taken by helicopter of **a** an aerial view of breakout flows of ‘a‘ā textures and pāhoehoe overflows from a main Ahu‘ailā‘au (fissure 8) lava flow channel in the north of the flow field and damaged farming structures (taken 20 May 2018), **b** lava of < 2-m thickness partially surrounds a water tank indicated with a dashed white circle (left), plastic farming structures damaged in contact with lava (centre), and plastic farming structures damaged but not in contact with lava (right) (taken 2 September 2018), and **c** a metal structure in contact with the lava flow, which appears to have suffered fire damage that resulted in the collapse and corrosion of the metal roof classified as DS3 (taken 6 November 2018) (Photos credit: US Geological Survey)

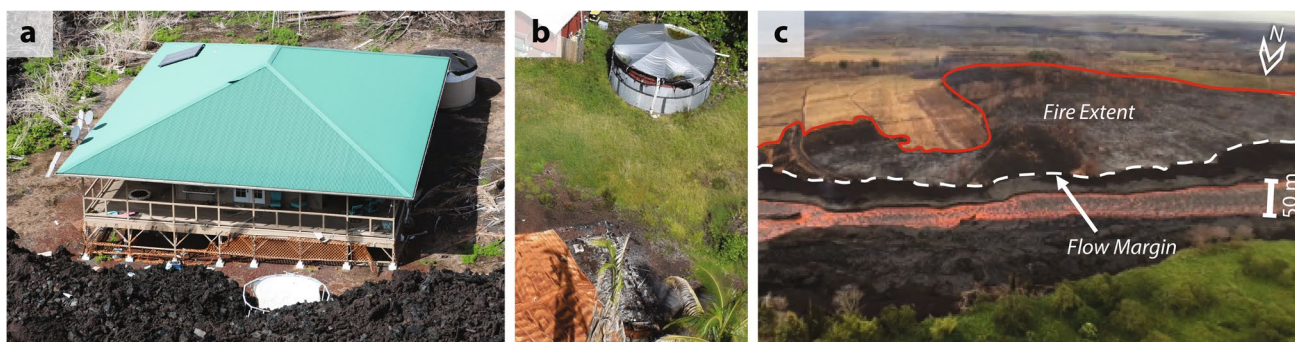
Lava-induced fires were a prevalent cause of damage, with damage to structures up to 595 m from the lava flow margin (Figs. 12 and 13). Fire damage was observed predominantly in the southwest direction away from the lava flow, in the downwind direction of prevailing trade wind; we hypothesise that fire spread due to volcanic gases downwind from the vents, ocean entry, or the flow itself, killing and drying vegetation in this direction (Fig. 13c). Footage also

Fig. 13 Photographs taken during the lower East Rift Zone (LERZ) eruption of **a** a wooden dwelling not in contact with the lava flow categorised as DS1, with melting of plastic cladding caused by the thermal effects of the lava (taken 6 November 2018), **b** damage to a structure by fire classified as DS5 (foreground) and a metal water tank

categorised as DS1, with melting of plastic covering caused by the thermal effects of fire (background) (taken 6 November 2018), and c green vegetation in the north side of the lava flow channel and dried vegetation with fire damage in the south side (taken 29 June 2018) (Photos credit: US Geological Survey)

available combustible materials (outdoor furniture), could reduce the potential for fire damage.

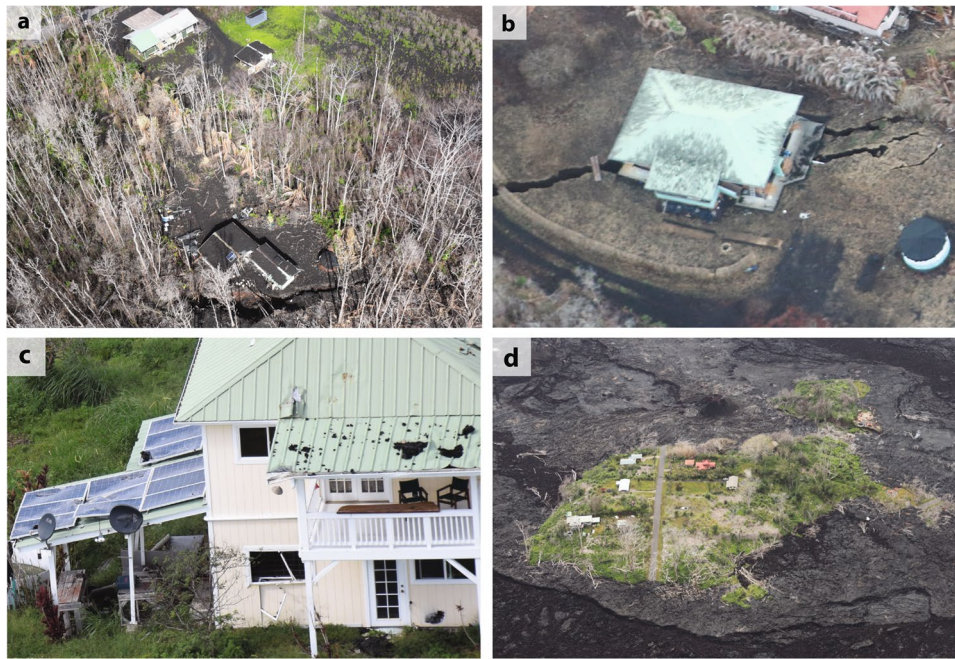
Fig. 14 Photographs taken from helicopters of **a** structures with white roofs covered in tephra, close to a fissure in the foreground; roofs of structures with tephra clean-up evident in the background. Vegetation damaged by gas and steam emitted from the fissures. Ground-surveys showed corrosion to structures from gas and steam impacts (taken 6 November 2018), **b** fissures that have opened underneath a

dwelling that is still intact (DS1) (taken 6 August 2018), **c** damage to solar panels (left) and metal roof (right) of a dwelling by large clasts classified as DS1 (taken 6 November 2018), and **d** structures with no access roads, located in a kīpuka surrounded by lava (taken 18 March 2019). Photos credit: US Geological Survey
