Berg Huettenmaenn Monatsh (2022) Vol. 167 (7): 325–331  
<https://doi.org/10.1007/s00501-022-01238-y>  
 © The Author(s) 2022

## Potential Causes for Cracking of a Laser Powder Bed Fused Carbon-free FeCoMo Alloy

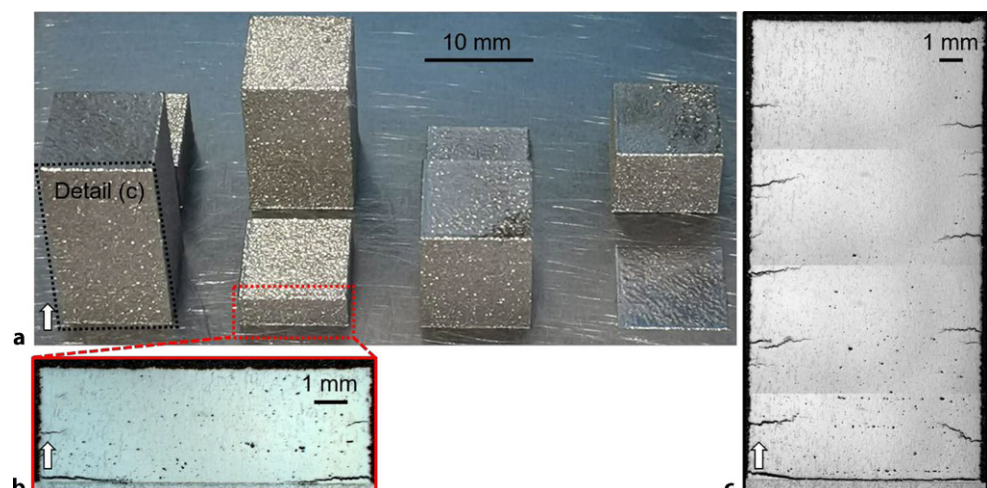
Fig. 1: **a** Macroscopic specimen overview. LOM micrographs of specimens with **b** 100 layers, and **c** 500 layers. It can be seen that cracks start from the transition zone to the building platform and from sample edges. The white arrows mark the building direction

samples with 100 layers and 500 layers are depicted in Fig. 1b and c, respectively. These cross-sections exhibit cracks, which initiate from the edges of the samples, and also the presence of a delamination between AM sample and build platform at the bottom of the micrographs is obvious. Additionally, Fig. 1c shows that all cracks propagate almost perpendicular to the build direction, which is indicated by the *white symbols* in the left bottom corner of the micrograph.

A regular arrangement of the cracks can be seen in both samples. This regularity indicates stress accumulations, which lead to the formation of the observed cracks. In a recent work [11], we determined similar stress accumulations by means of strain profile measurements using synchrotron radiation. These accumulations are responsible for crack formation of a LPBF carbon-containing cold-work tool steel. As the manufacturing process is identical, the investigated alloy may also have failed through process-related thermal stresses in the tensile regime at the sample edge.

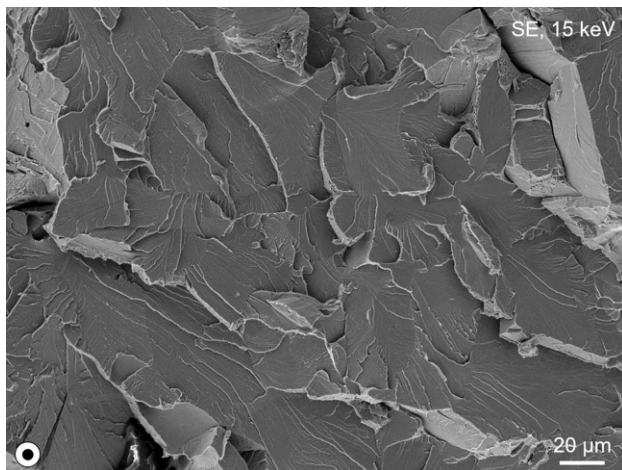
Fig. 2 depicts an exemplary SEM fractograph of the crack surface. Based on its morphology, the failure mode can be clearly assigned as brittle transcrystalline cleavage fracture.

Fig. 2: Exemplary SEM fractograph showing transcrystalline cleavage fracture. The *white symbol* marks the building direction

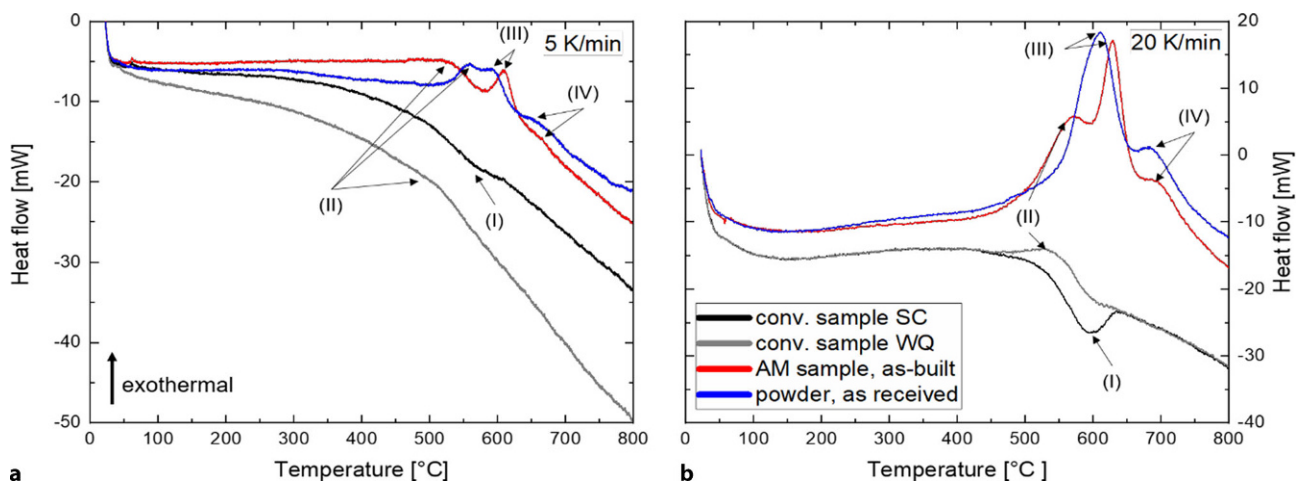
The occurrence of brittle ordered domains has been investigated as a first possible reason for the observed cleavage fracture. Therefore, DSC heating experiments were conducted in accordance with investigations performed by Turk et al. [12]. Special attention was paid to the heat flow at a temperature of  $\sim 590^\circ\text{C}$  [13], at which a disordering peak should emerge if the material contains ordered domains. Fig. 3a and b depict typical DSC curves, in which the heat flow is plotted as a function of the sample temperature, for the two heating rates of 5 K/min and 20 K/min, respectively. It can be clearly seen in Fig. 3b that the endothermal ordering peak (I) at a temperature of  $590^\circ\text{C}$  only exists in the conventionally manufactured slow cooled (SC) sample.

This can be explained because this ordering process requires a certain amount of time, which cannot be guaranteed if the material is quenched too rapidly. Although LPBF is characterized by extremely rapid cooling conditions, the formation of these brittle ordered phases could have been possible during in-situ tempering processes by layers welded on the already existing ones. However, the conventionally manufactured and rapidly quenched (WQ) reference sample, the powder, and the AM sample exhibit no such endothermal disordering peak. Therefore, it can be concluded that no disordering process has occurred because no ordered domains were present in the starting condition (i.e. as-built state of the AM sample) at the beginning of the DSC experiment. Consequently, the formation of brittle ordered domains is not likely to cause the transcrystalline material failure of the LPBF samples.

Fig. 3: DSC curves for different sample conditions at heating rates of **a** 5 K/min and **b** 20 K/min. Peak (I) only emerges during heating of the conventionally manufactured slow cooled (SC) sample. Zero lines have been subtracted

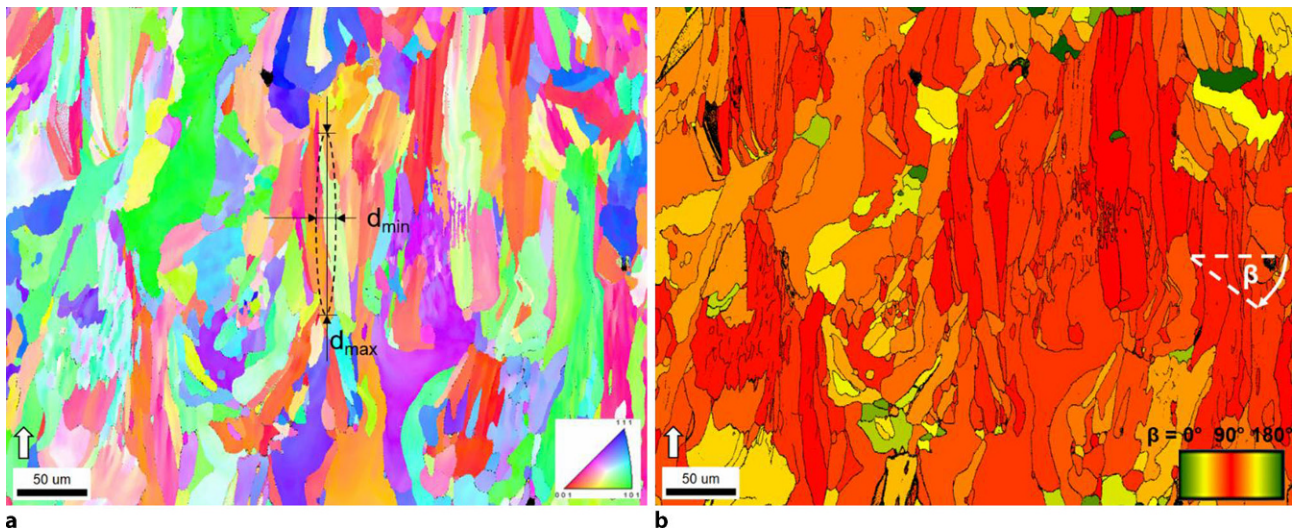
Fig. 4a shows the inverse pole figure (IPF) color map, which was determined using EBSD on the electropolished surface, of a sample with 100 layers. The *white arrow* in the bottom left corner marks the build direction during

Fig. 4: **a** IPF color map for bcc phase with calculated  $d_{\min} = 19.2 \mu\text{m}$  and  $d_{\max} = 86.5 \mu\text{m}$ . **b** GOS map depicting a strong epitaxial grain growth. The white symbols mark the building direction

Fig. 4b depicts the same scan but as a map of the grain orientation spread (GOS). This illustration shows the orientation of grains through the angle  $\beta$  relative to the horizontal axis. It can be seen that the majority of the grains is depicted in red and orange and these grains are therefore oriented almost parallel to the build direction. Hence, a strong epitaxial grain orientation is obvious. These epitaxial structures can be explained by the nature of the AM process [19].

In terms of cracking, no correlation between grain orientation and crack propagation was found as the failure occurred in a transcrystalline manner. Due to the relatively coarse grain structures, which were found using EBSD,

a significant contribution to cracking is possible. In order to avoid a coarsening during LPBF, Zhang et al. [20] investigated the influence of different *VEDs* on the grain structure of commercially pure titanium. This approach could also result in significant grain refinement and thus in a possible improvement of crack resistance of the investigated Fe-CoMo alloy. The change of *VED* may also alter the porosity of the produced material, as too low levels would generate lack-of-fusion while too high levels can induce keyhole porosity. The control of laser power profile temporally and spatially may provide further flexibility [21–23].

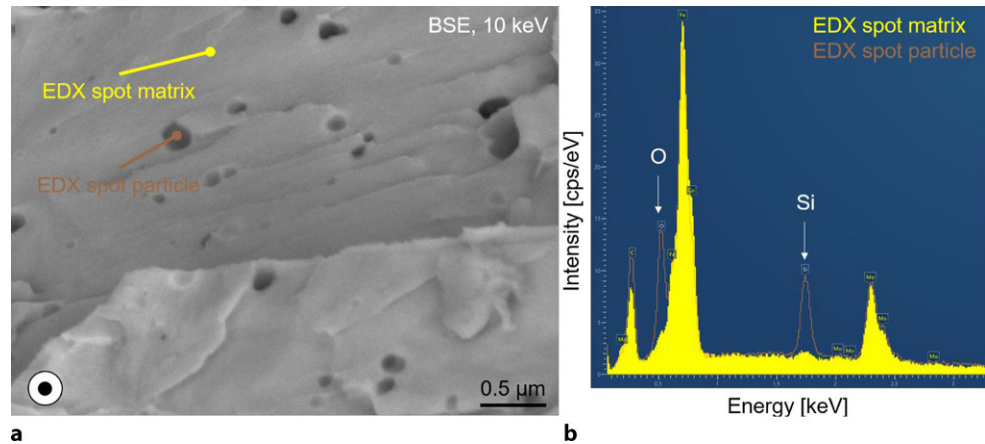
Fig. 5: **a** BSE SEM fractograph with corresponding **b** qualitative EDX spot spectra of matrix and particle composition. The latter can be clearly assigned to silicon oxide. The *white symbol* in **a** marks the building direction

Fig. 5a shows a high resolution BSE SEM fractograph, in which a transcrystalline cleavage failure can be seen (cf. Fig. 2d). The presence of dark spherically shaped phases with dimensions below 300 nm is obvious. As darker depicted structures in the BSE mode comprise lighter elements, the presence of oxides was assumed. Evidence of their presence on the crack surface is given by the EDX spot measurements depicted in Fig. 5b. A comparison of the matrix spot and the particle spot clearly assigns these non-metallic inclusions as silicon oxides.

These Si-rich inclusions probably formed due to the presence of residual oxygen during atomization or in the Argon gas atmosphere of the LPBF process. This assumption is in accordance with an investigation of a LPBF 316L steel published by Zhong et al. [25]. In order to reduce the risk of cracking due to such Si-rich non-metallic inclusions, a promising approach would be to atomize a powder without Si additions as this element is not mandatory for the mechanical performance (i.e. hardness level) of the investigated alloy.

Out of the potential cracking reasons discussed above, the presence of silicon oxides on the crack surface is the one with the highest probability of causing the failure of the investigated FeCoMo alloy. As a further potential cracking

The occurrence of non-metallic inclusions was determined as the most probable cause for cracking. EDX spot measurements clearly revealed that these inclusions comprise Si and O. Because a further reduction of O contamination during atomization and LPBF is hard to realize, a promising approach to avoid the formation of these silicon oxides is to remove Si from the powder. The latter is not mandatory for the mechanical performance of the investigated FeCoMo alloy.
