# An Integrated Geomechanical Investigation, Multi-Parameter Monitoring and Analyses of Babadağ-Gündoğdu Creep-like Landslide

Halil Kumsar<sup>1</sup> · Ömer Aydan<sup>2</sup> · Hisataka Tano<sup>3</sup> · Sefer Beran Çelik<sup>1</sup> · Reşat Ulusay<sup>4</sup>

Received: 28 February 2015 / Accepted: 19 August 2015 / Published online: 1 September 2015  
© Springer-Verlag Wien 2015

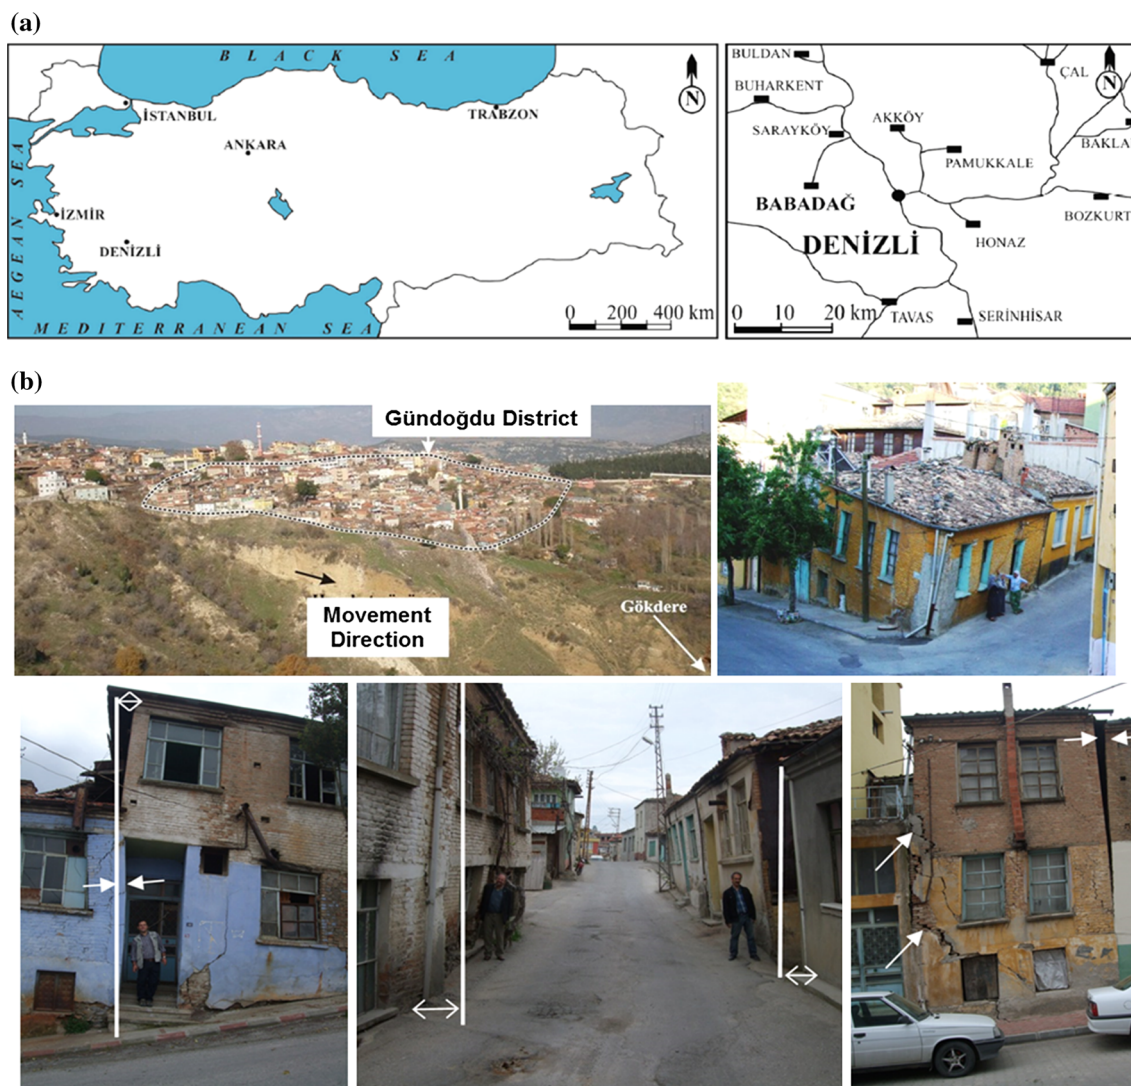
**Fig. 1** a Location map of Babadağ town, b views from the unstable Gündoğdu district and some damaged houses

Due to the slope movements, which have been still continuing, the local people living in the Gündoğdu district have been negatively affected. Some selected damages on the structures in the Gündoğdu district resulted from the creep-like landslide are shown in Fig. 1b.

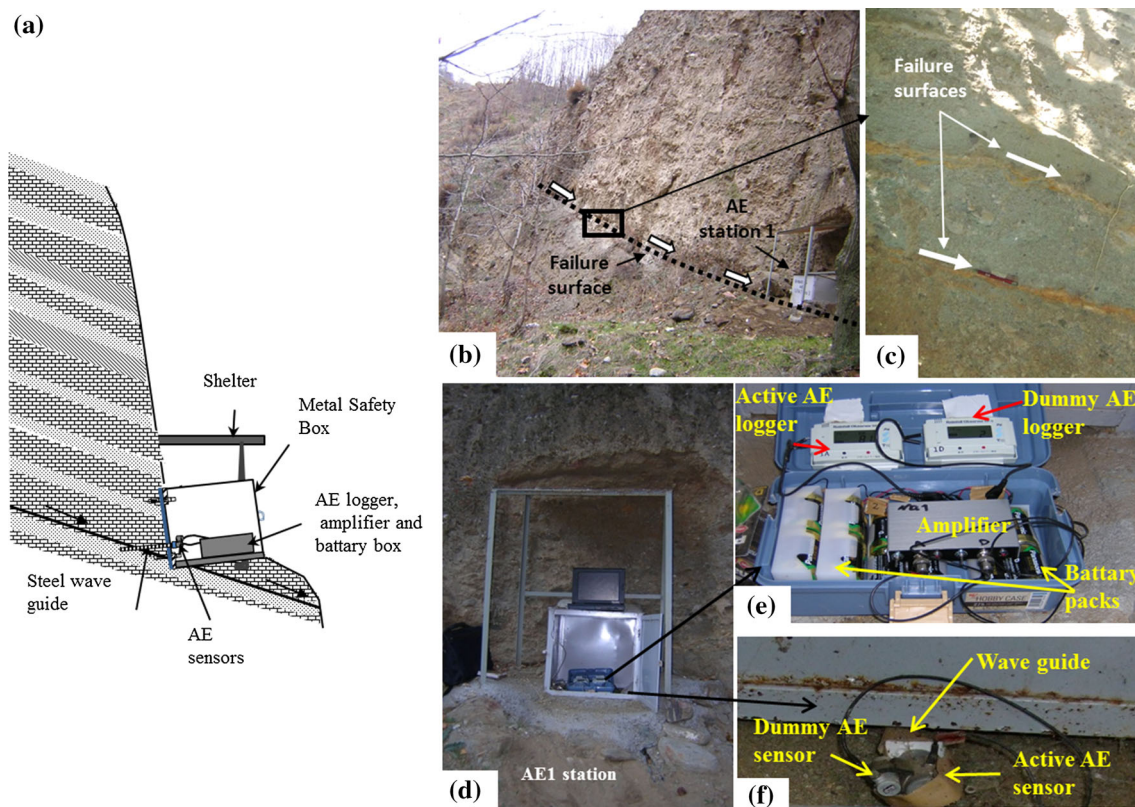
**Fig. 11** a An illustration of the in situ acoustic emission (AE) measuring system used in this study (modified after Tano et al. 2006a), b location and measuring system of AE1 station at the toe of

the Gündoğdu landslide, c failure surfaces observed at AE1 location, d power supply, loggers and amplifiers of AE1 station, e active and dummy AE sensors and wave guide of AE1 station

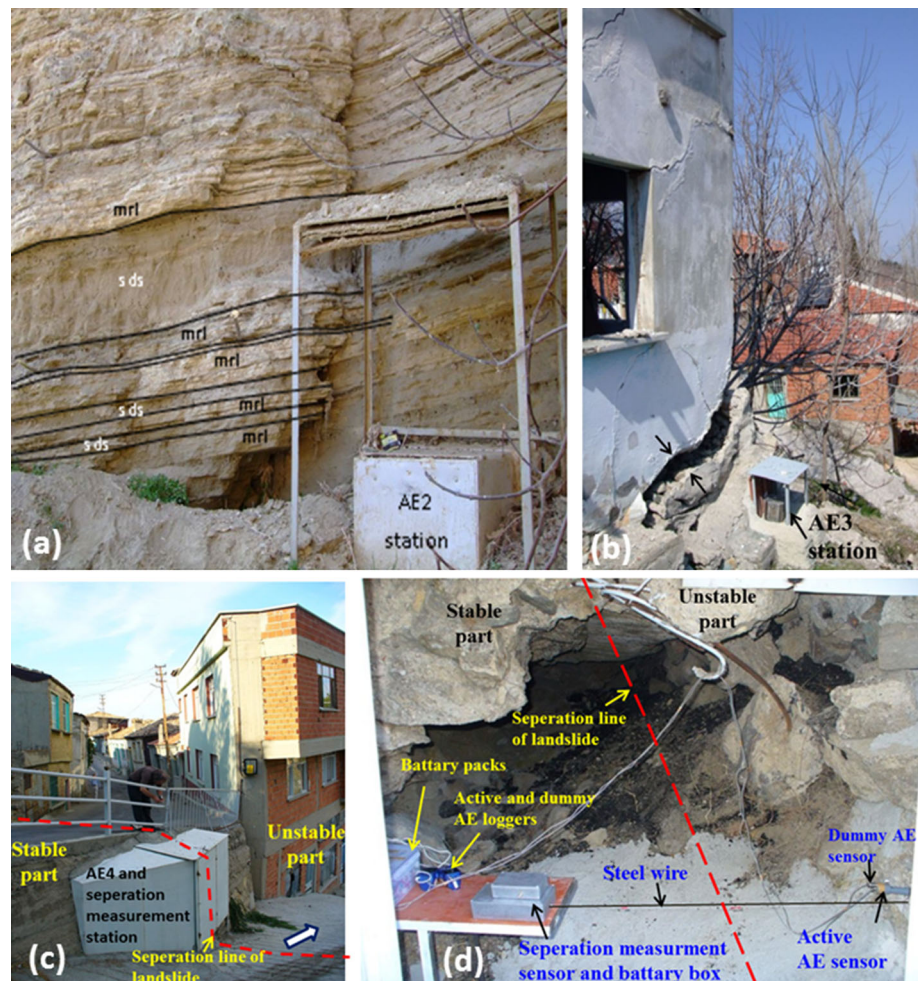
**Fig. 12** **a** AE2 station and sandstone (sds)-marl (mrl) succession, **b** AE3 station and structural damages, **c** location of AE4 station, **d** active and dummy sensors, loggers and battery pack of AE4 station

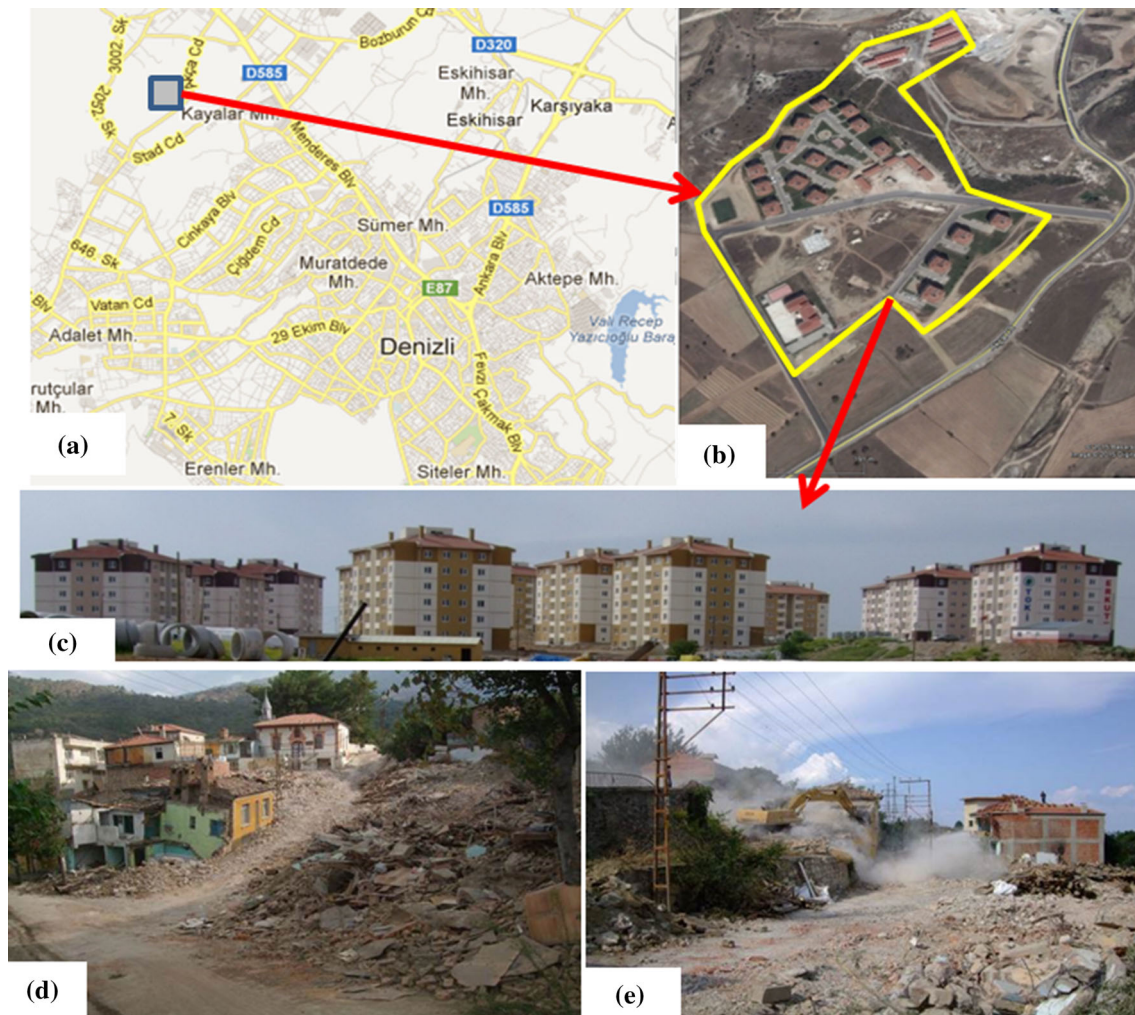
**Fig. 22** a–c Location of the new settlement area and the apartments for the people of Gündoğdu district, d–e views from the demolished houses after Gündoğdu district was evacuated

The houses were demolished (Fig. 22d, e) after the people moved from the Gündoğdu landslide area in Babadağ, according to the regulations written in the second article of No. 7269 numbered law. The authors suggested that this area should be used as a geopark area to show the effects of a creep-like landslide to people for focusing their attention on future planning of cities and towns.

On the basis of the results from this long-term project, the Construction Ministry of Turkish Republic designated the Gündoğdu district as “An Area Subjected to Natural Disaster”. After this declaration, a new settlement place for the people living in the district was selected where their new houses, workshops and ateliers were built, and then the people moved there since 2012.
