Shallow cover over coal mining: a case study of subsidence at Kamptee Colliery, Nagpur, India

Abstract Shallow land cover over old underground workings at Kamptee Colliery has led to the development of ground collapse, with three crown hole subsidences recorded in a 10 year period. As the land above the workings has been developed, it was considered that for safety purposes areas with less than 15 m of competent rock should be established. The paper discusses the Multi-electrode Resistivity Imaging (RI) and Ground Penetrating Radar (GPR) undertaken over an area of 800 m × 200 m, which indicated that where a competent cover was present it was very thin.

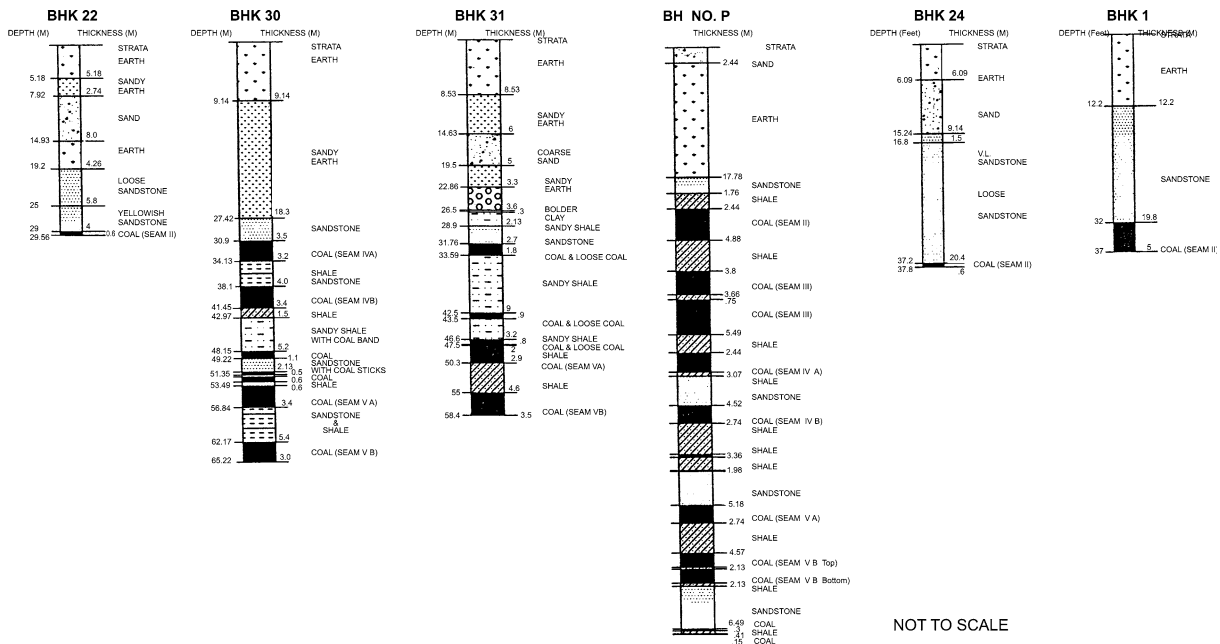
Fig. 3 Borehole logs at Kamptee Colliery over old underground workings

The Kamptee Colliery is in the Lower Gondwana Formations and being a basal structure has a 'horse-shoe' shape aligned in a N-W direction. The coal seams proved in six boreholes are indicated in Fig. 3. Bore-

hole P indicates the presence of eight coal seams which have been numbered II, III (two seams), IV (two seams) and V (three seams). Seam 1, known to occur elsewhere in the Middle Barakars Formation, is not present in the study area.

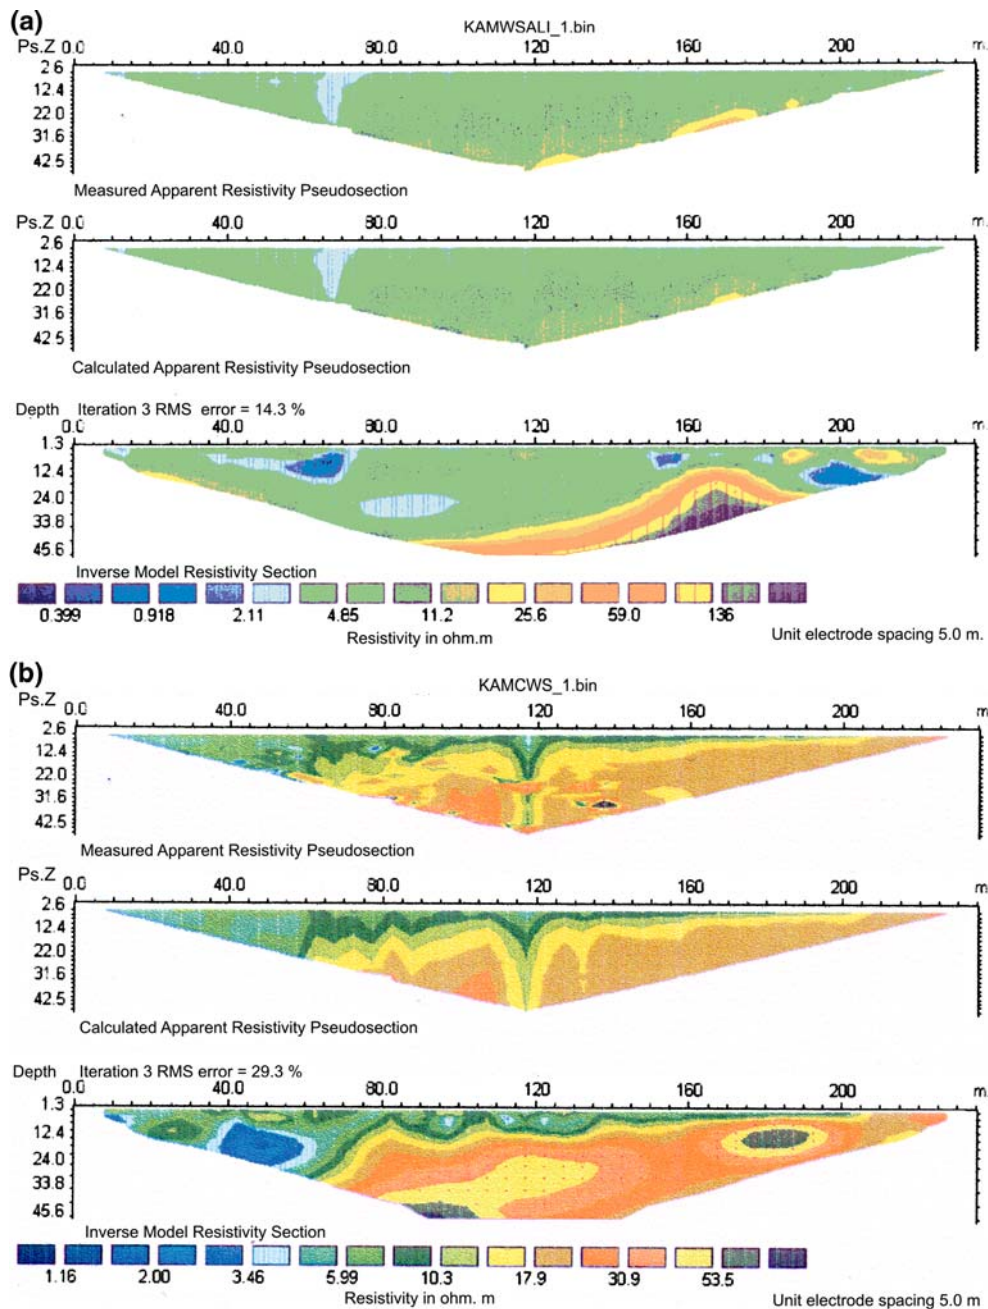
Fig. 4 a, b Wenner–Schlumberger configuration inverted resistivity section along the traverse AA1 and CC1

Figure 4 shows the Wenner-Schlumberger (WS) profiles along traverse AA1 and CC1, giving the measured apparent resistivity pseudosection, the calculated apparent resistivity pseudosection and the inverse model resistivity.

In traverse AA1, a high resistivity zone of more than 136Ω was recorded at chainage 150–180 m at a depth of 25–30 m, indicating the presence of seam IV (BH K30, Fig. 3). The low resistivity material ($<59 \Omega$) overlying seam IV represents soils and loose sandstone. A high resistivity zone is also shown in CC1 ($>53 \Omega$) between chainage 90–95 m at a depth of 38 m, corresponding to seam II at 37.2 m depth in BH K24. The overlying low resistivity zone is again due to soils and loose sandstones.

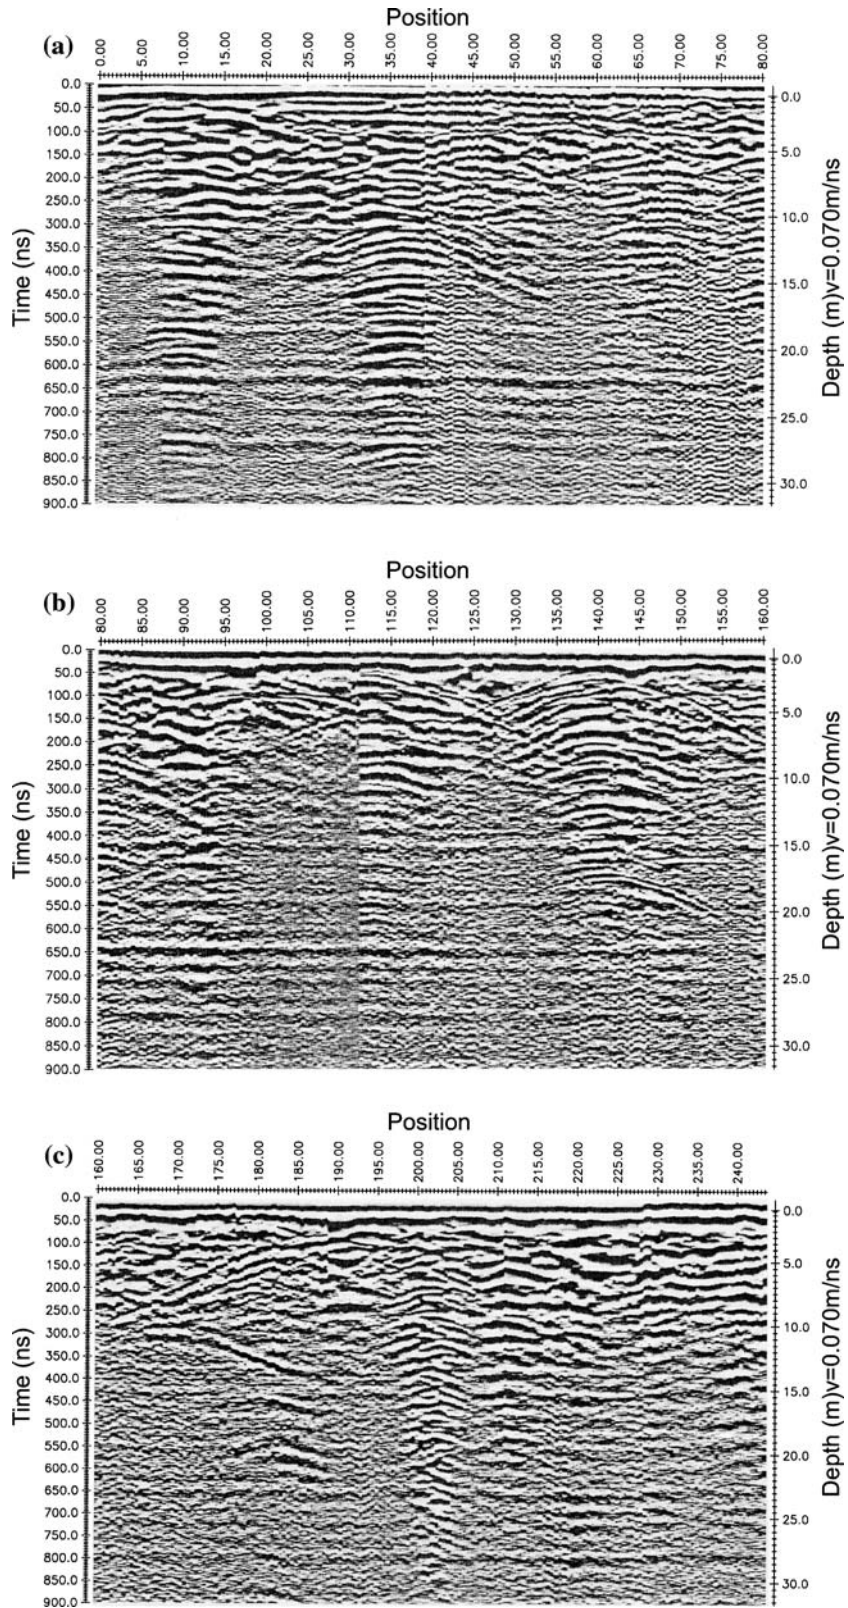
Fig. 5 GPR signatures along the Profile GG1

Ground Penetrating Radar surveys were carried out in the subsidence areas and over the underground workings (GG1 and G2G3, Fig. 2). Traverse GG1 was 243 m long and divided into three sections: 0–80 m (the guest house), 80–160 m and 60–243 m (damage zone). As can be seen from Fig. 5, the radar signatures for section I (0–80 m) indicate the strata are disturbed to a depth of 30 m. Some cavities were indicated at a depth of 10 m at chainages 12 and 35 m. The formation of these cavities is likely to be related to the underground development of the seams shown in BH K31. The strata in this zone are very weak and friable with no hard strata present.

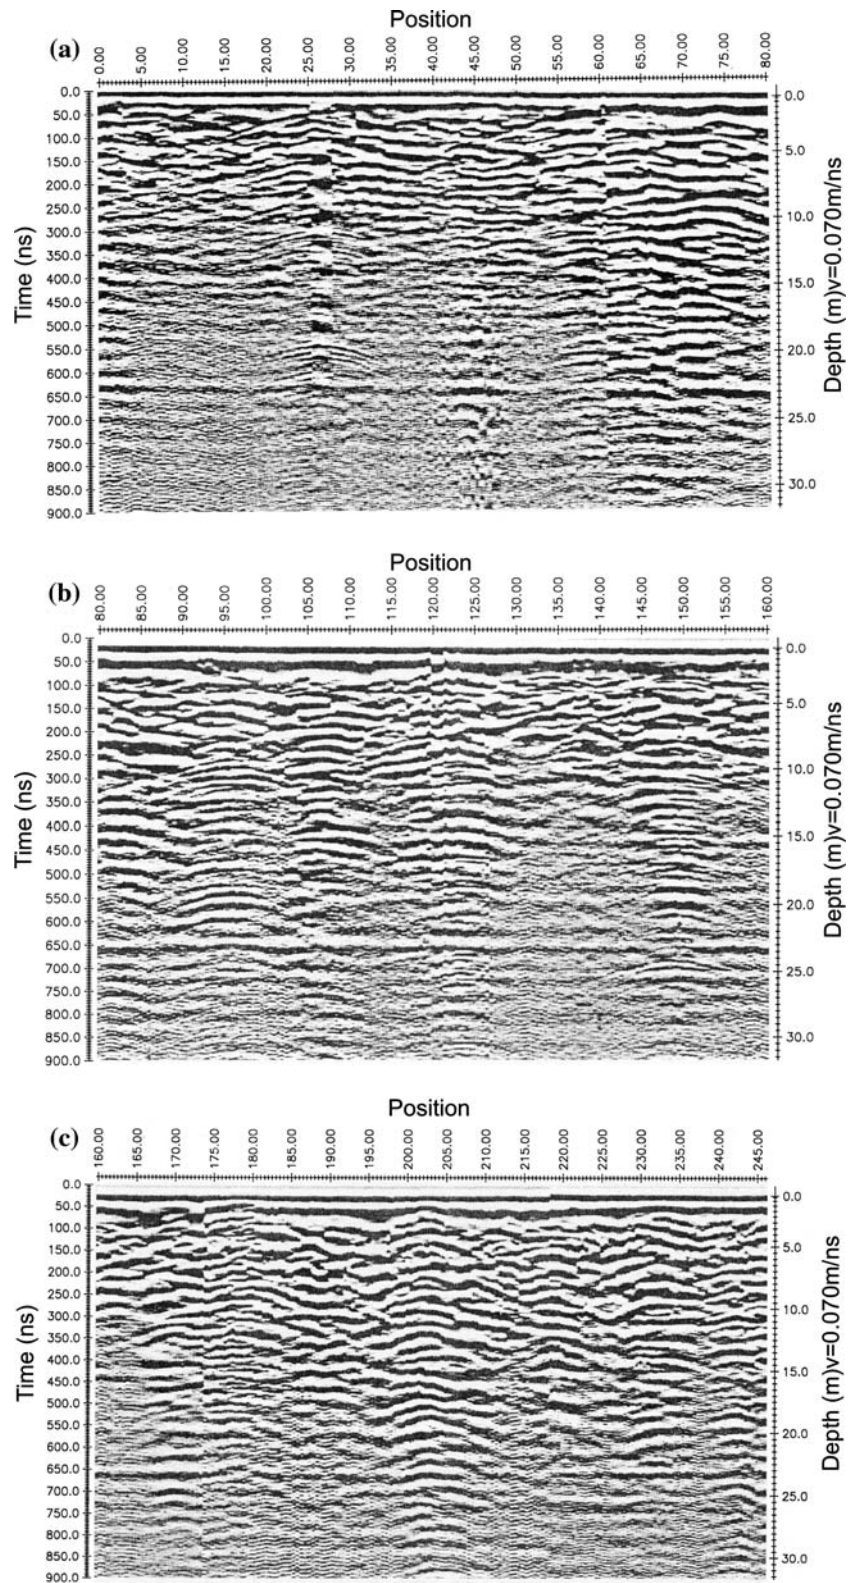
Fig. 6 GPR signatures along the Profile G2G3

Traverse G2G3 (Fig. 6) starts at the colony (along line AA1 line) and ends close to a subsidence (chainage 245 m). The radar signatures show various disturbed and less disturbed strata in the first two sections (chainages 0 to 120 m). Between chainages 120–160 m the strata is relatively undisturbed to a depth of 10 m, below which it is very disturbed. Cavities are present at chainages 95, 105, 123 and 150 m, at depths varying from 5 to 8 m. This is due to void migration associated with seam III which has no competent cover (see BHs

K22 and K24, Fig. 3). Between chainages 160–245 m, which includes the area parallel to the AA1 line, roadside and damaged buildings (Fig. 4a), the strata are weak and disturbed to chainage 175 m. A cavity is indicated 8 m below the surface at chainage 202 m. It is known that below 30 m extensive extraction took place from the coal seams indicated in Fig. 3.

Based on this, the colliery management have been advised that for safety reasons, residents in the dangerous zone where no competent cover is present should be evacuated.

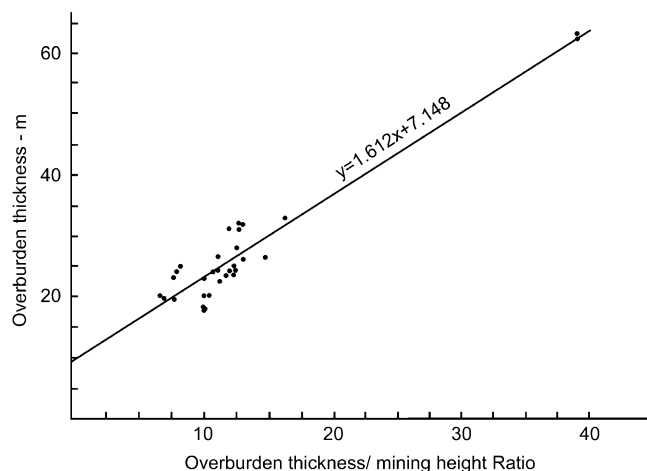
Fig. 7 Relationship between overburden thickness (h) and mining height (m)

Interpretation of the GPR traverses (GG1 and G2G3) and RI sections (AA1 and CC1) shows that in the study area the overburden cover is less than 15 m and there are many underground voids which may develop as crown holes in the future (Fig. 7).
