# Evaluation of remedial measures against foundation leakage problems of earth dams on pervious conglomerate strata: a case study

**Abstract** This paper presents a case study on foundation seepage problems encountered at an earth dam over the last 55 years with various remediation efforts. The Pipasi Dam, 26.0 m in height, was built on a pervious foundation without any seepage control measures during its first phase construction. The geological conditions along with the leakages, remedial measures and the evaluation of the groundwater level measurements are presented. It is concluded that the past seepage problems within the dam foundation were caused by the geological condition. Neogene conglomerate outcrops in both abutments, and is overlaid by the relatively thin Quaternary deposit in the riverbed. Early treatments, such as the cutoff wall placed beneath the upstream toe and the upstream clay blanket, were only carried out in individual locations, and thus cannot form a continuous and complete spatial waterproofing system. The installed grouting curtain was regarded as a complete control measure. However, the initial design arrangement was changed during its actual installatio

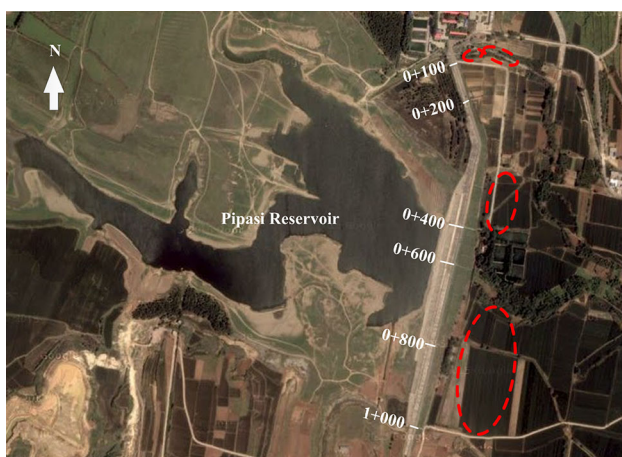
The dam is lower than 3.8 m at station 0+950 to 1+200 on the terrace in the right bank, but unfortunately the conglomerate layer is directly exposed below the low dam section. This conglomerate layer varies in thickness from 8.0 to 15.0 m, and the maximal unit absorption reached 4.04 L/(min m m); thus, this is the primary seepage zone. The reservoir water flowed into the conglomerate layer, and out to the downstream ground surface along the boundary of the downstream conglomerate and red clay layers. Then this leakage water spread towards the downstream land between stations 0+700 and 1+000, and a wet area was seen at this location.

**Fig. 5** Abnormal seepage emerged points and wet areas, which are highlighted in red colour, in the downstream

The above analyses revealed that the groundwater divides at the dam site are near stations 0+250 to 0+350, stations 1+050 to 1+100, and at the elevations of 118.0 and 124.0 m, for the left and right banks respectively. Correspondingly, leakage points were observed downstream at elevations between 107.0–114.0 m, and between 110.0–115.4 m, respectively. When the reservoir level rose to an elevation of 120.0 m, the seepage water in the left bank discharged directly out from the downstream toe; by contrast, that in the right bank bypassed the downstream toe, and entered into the downstream land at stations 0+700 to 1+000, and led to a large wet area.

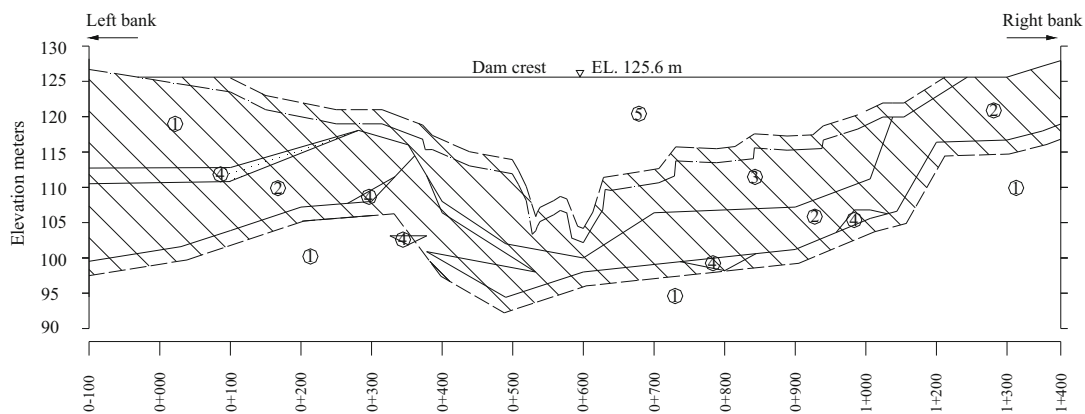
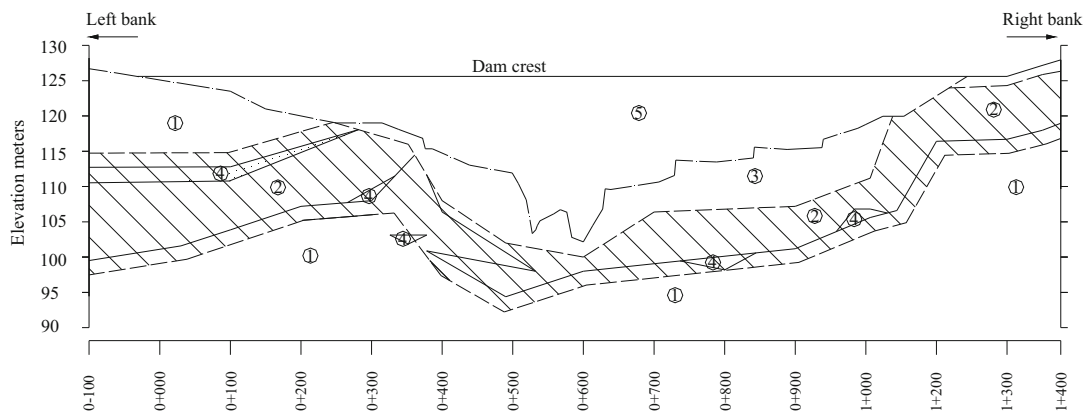
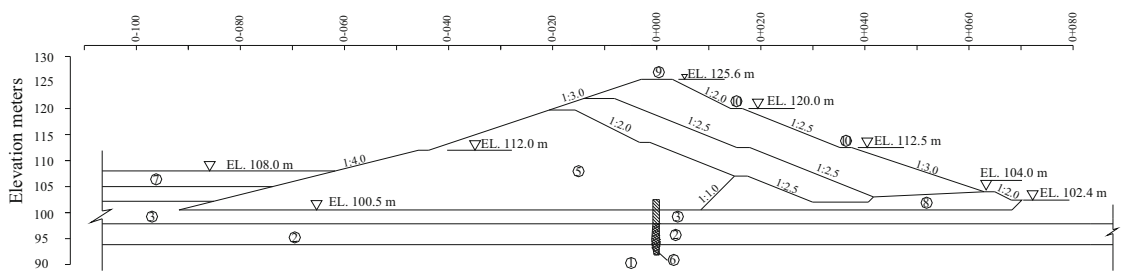
**Fig. 6** Cross section along the axis of the grouting curtain (a, b), and typical section from downstream to upstream direction (c), showing the initial design and actual layouts

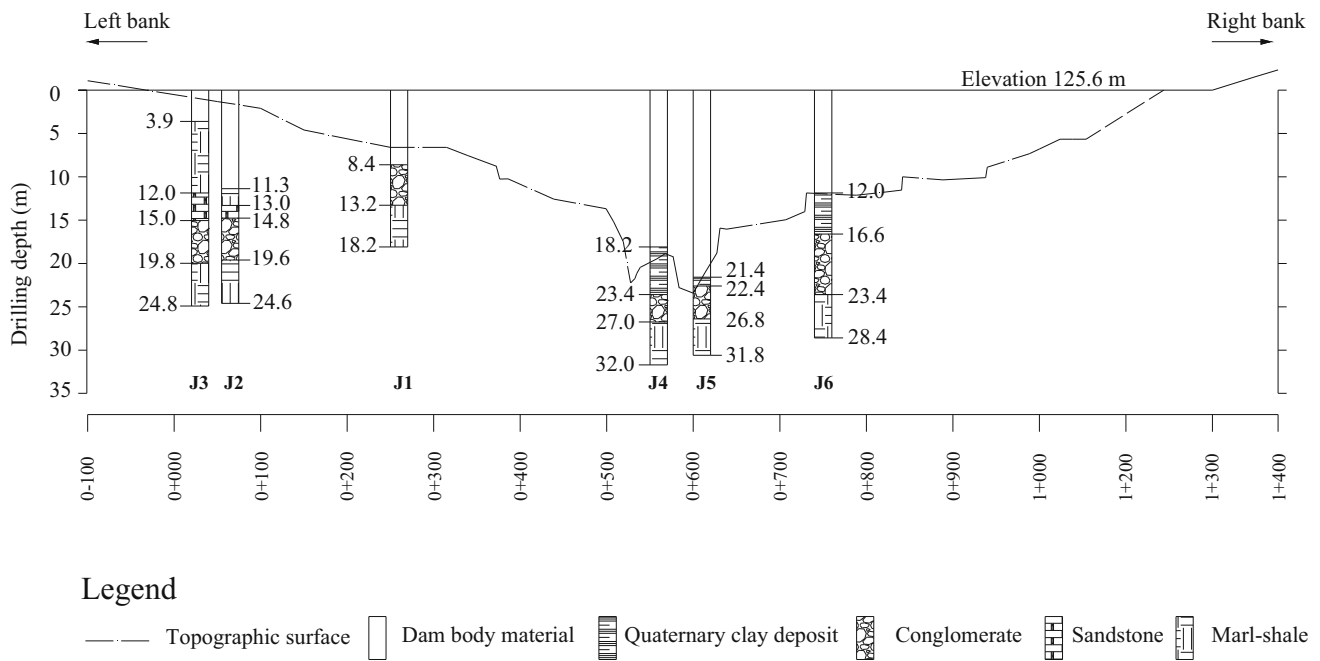
**Fig. 7** Logs of check holes of longitudinal section to examine the grouting curtain

Based on the geology information and data acquired from check holes, it can be found that the grouting effectiveness was significant in the locations where the conglomerates are cemented with calcareous or arenaceous matrix and cracks were connected, and in contrast, that was ineffective where the conglomerates are cemented with mud matrix and cracks were not connected.

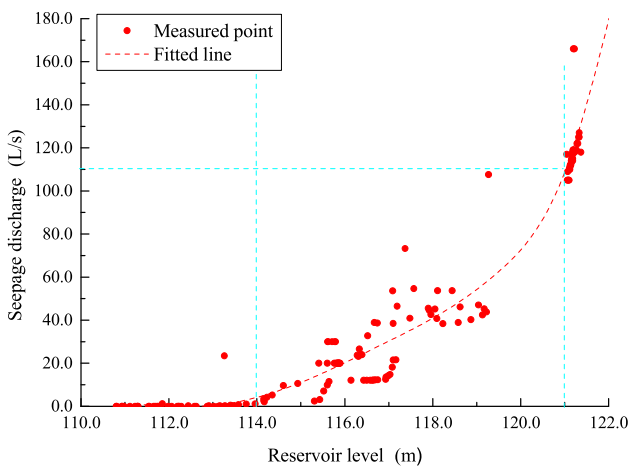
that obvious leakages emerged in the riverbed when the reservoir level was above an elevation of 114.00 m, and the rise in the reservoir level was still directly affecting the total leakage amount. Specifically, the relationship between the total discharge and the reservoir water level can be explained by the power function, which agrees more or less with the general law for earth dams on pervious conglomerate strata (Lee et al. 2005). In addition, a discharge of 0.12 m<sup>3</sup>/s was measured when the reservoir level reached an elevation of 121.0 m, and in contrast, the recorded value was 0.42 m<sup>3</sup>/s under the same operation condition before the grouting.

**Fig. 13** Relationship between reservoir water level and foundation seepage discharge

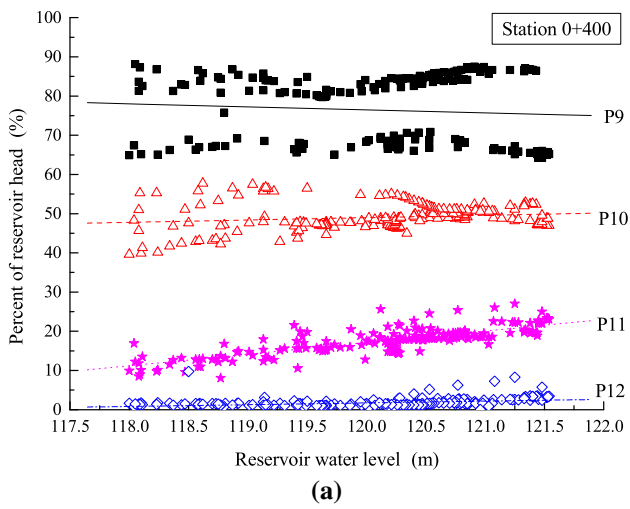
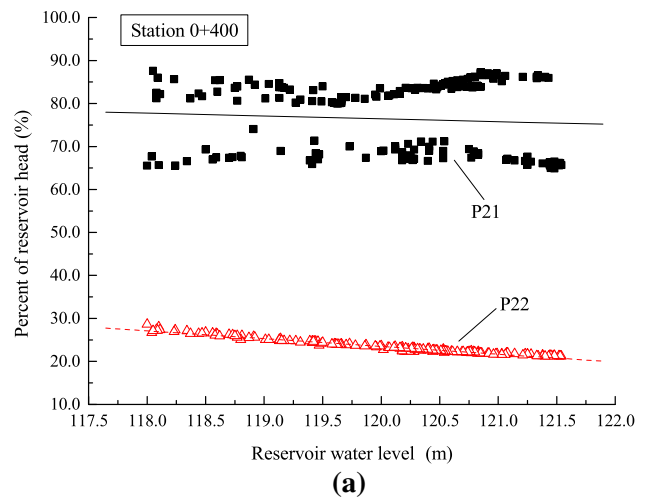
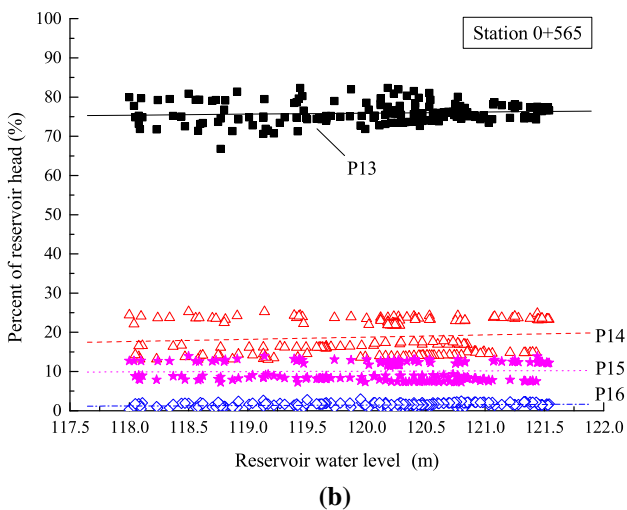
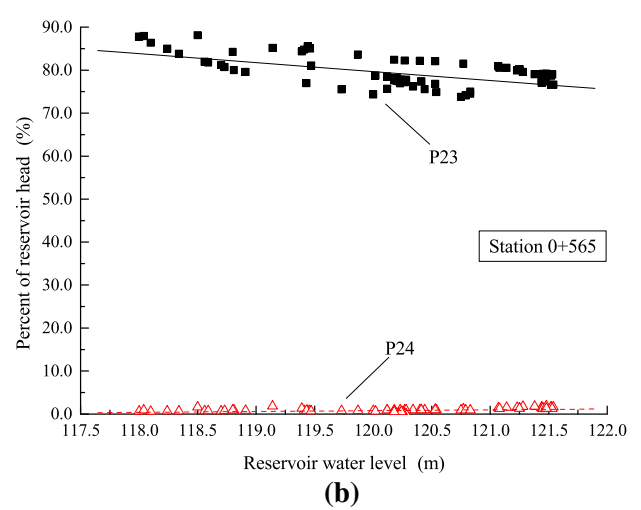
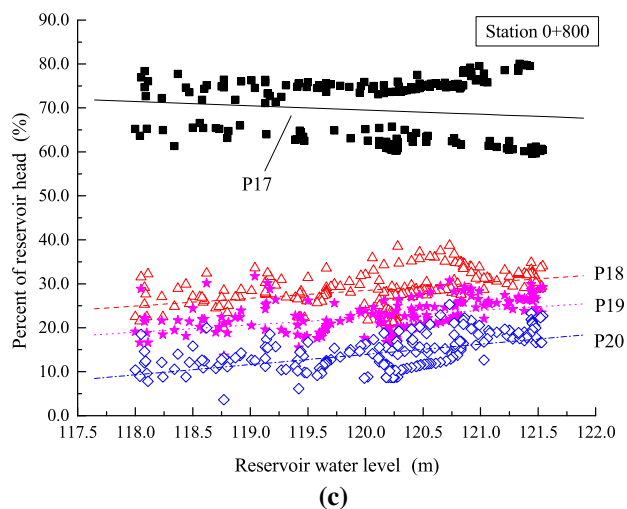
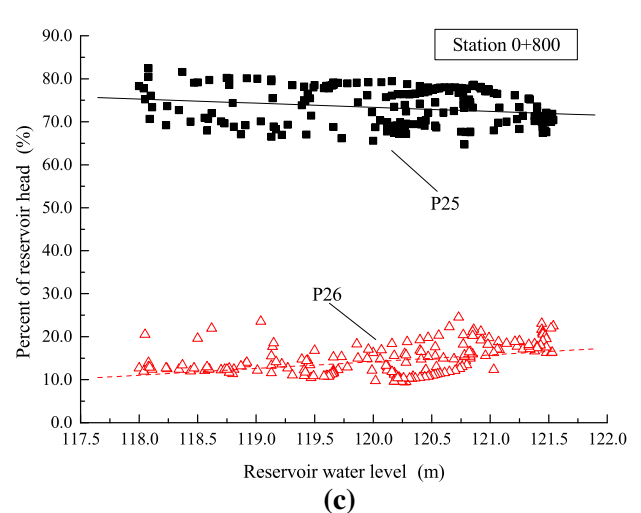
It is observed from Fig. 16 that the grouting curtain is effective in lowering the groundwater level in the conglomerate layer at sections of stations 0+565 to 0+800. As shown in Fig. 16, the grouting curtain bears about 50 % of the groundwater head difference from upstream to downstream in the dam foundation, which is consistent with the expected value of design. However, for the section at station 0+400, the groundwater head difference is linear along the river flow direction. This result indicates that the performance of the grouting curtain is not guaranteed at this section, or there is a pervious zone along the boundary of the conglomerate and natural deposit layers.

**Fig. 16** Groundwater head in the conglomerate layer in percent of the difference from upstream to downstream

**Fig. 17** Groundwater head in the natural deposit clay layer in percent of the difference from upstream to downstream

suggested that a secondary grouting curtain downstream from the existing one, extending at least 2 m into the dam body, should be installed covering the conglomerate and natural deposit layers to eliminate future seepage problems. In addition, considering the likelihood of the failure of the grouting curtains, it is also suggested that relief wells should be installed along the downstream toe to prevent excessive uplift pressures and piping through the foundation.
