Dynamical process of the Hongshiyuan landslide induced by the 2014 Ludian earthquake and stability evaluation of the back scarp of the remnant slope

Hai-Bo Li¹ · Xiao-Wen Li² · Yu Ning³ · Shu-Fang Jiang⁴ · Jia-Wen Zhou¹

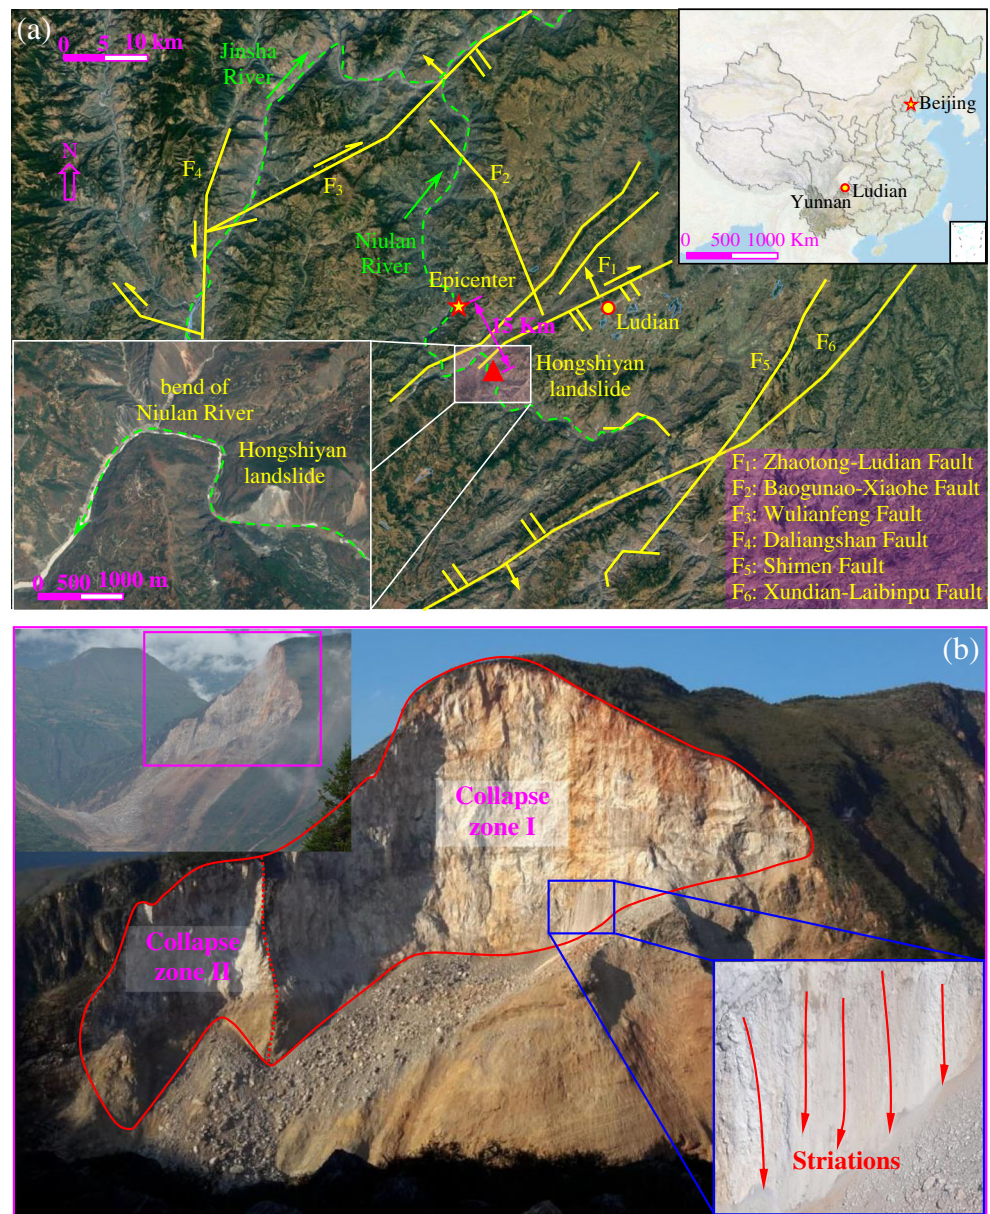
Fig. 1 Location and shape of the Hongshiyuan landslide: **a** map of Hongshiyuan landslide; **b** site photos of Hongshiyuan landslide

The Hongshiyuan landslide is in a narrow valley that is deeply incised. The Niulan River flows in the valley from southeast to northwest and has a width of approximately 100 m. The original Hongshiyuan Mountain was located at a bend in the Niulan River and had a steep slope of 54–61° before the earthquake. It is a three-sided mountain with a height that rises approximately 760 m above the riverbed (Fig. 1a, b).

forward edge and at the bottom of the back edge of the landslide (as shown in Fig. 1b), and the particle size of the avalanche masses is generally small (as shown in Fig. 4b).

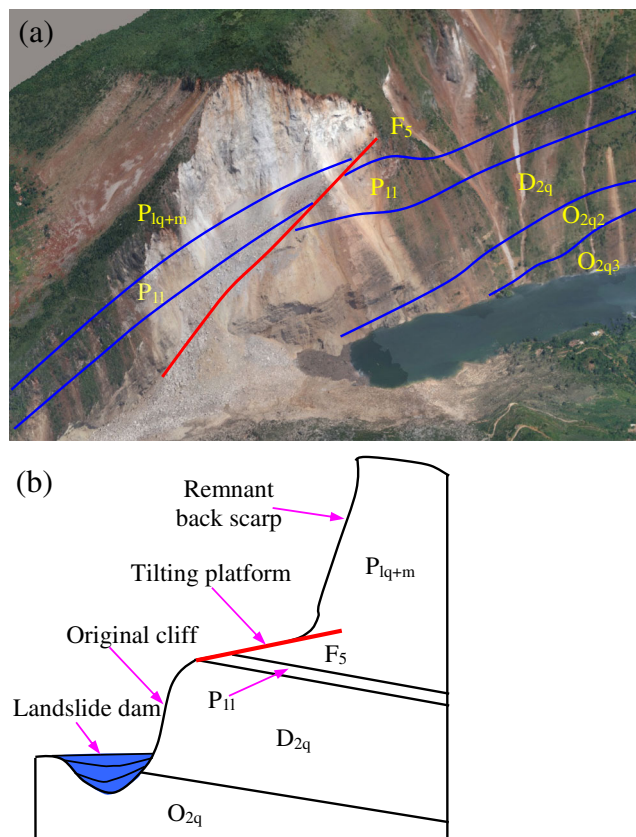
As shown in Fig. 2, the original Hongshiyuan Mountain is exposed, with little vegetation on the surface, presenting a typical layered structure. The main strata from top to bottom are from the Permian (P), the Devonian (D) and the Ordovician (O), respectively. The rock strata mainly dip toward the mountain and its downstream side, with a strike of N20°–60°E, a dip direction to the NW and a dip angle of 10–30°. The rock masses are mainly thick or very thick limestone and dolomitic limestone at the upper part of the slope, and a thin layer of sandstone and shale

As a result of long-term geological movement, the rock strata present low-angled folds or flexural deformations. A fault, F5, is developed in the middle of the slope with strike of N5°–15°W, a dip direction to the SW and a dip angle of 40–50°. F5 is a control fault extending approximately along the whole landslide with a fault zone of typically approximately 0.5–1.0 m in thickness, and it mainly consists of fragmented rocks and fault gouges. Numerous approximately vertical structural joints and bedding joints are developed and multiply interlaced at the surface of the rock slope. The rock mass was broken, and many small cliffs can be found at the slope as a result of previous small collapses.

Fig. 2 Geological conditions of the Hongshiyuan landslide: **a** geology of Hongshiyuan landslide; **b** geologic section of Hongshiyuan landslide

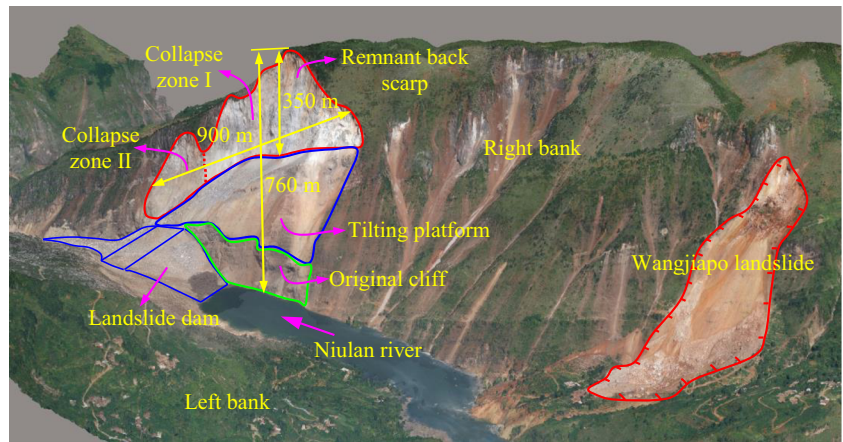
To investigate the topographical changes after the landslide, UAV technologies have been used to obtain a high-resolution 3D image model of the Hongshiyuan landslide. As shown in Fig. 3, after the 2014 Ludian Ms 6.5 earthquake, the topography of Hongshiyuan Mountain changed significantly. The aspect of the Hongshiyuan landslide presents a huge chair shape. A tilting platform with the strata gently dipping toward the mountain and the downstream side divide the slope into two parts; the upper part of the slope is a huge remnant back scarp with a height of 350 m and a total width of approximately 900 m along the river; the lower part is an original cliff with a height of 120 m. The back edge of the landslide is large, steep and rough, and it forms the main failure surface. In contrast, the shear sliding surface at the forward edge of the landslide is short and smooth, with obvious striations. Two

connected collapse zones (I and II) can be obviously distinguished from the landslide surface.

Fig. 3 High-resolution 3D image model of the Hongshiyuan landslide

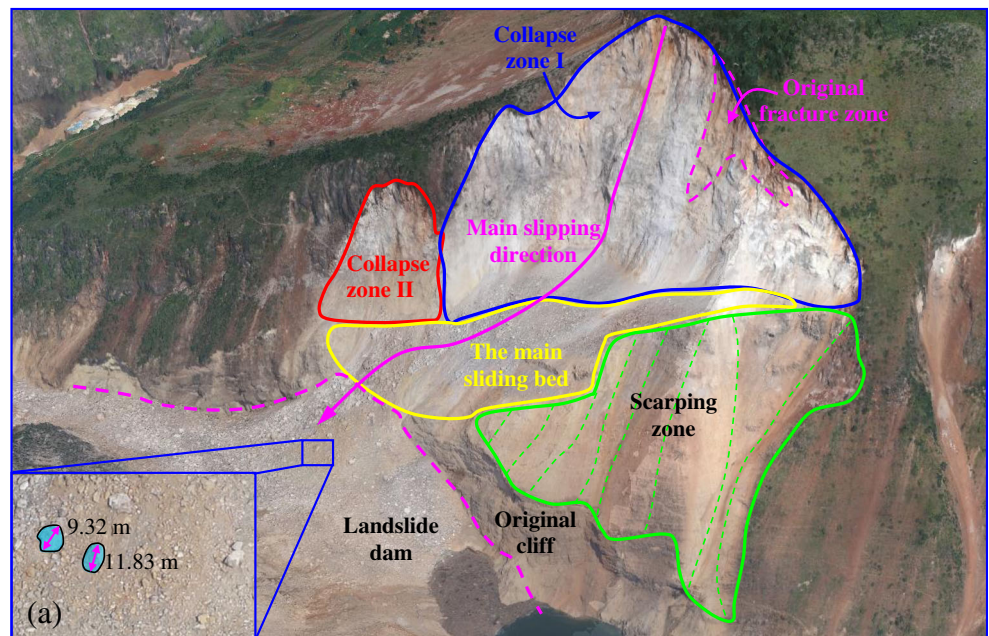
The Hongshiyuan landslide is a typical earthquake-induced failure. The unique terrain and the seismic loads are the main reasons for the landslide. As shown in Fig. 4a, under the instantaneous seismic loadings of the 2014 Ludian Ms 6.5 earthquake, tension fractures extended and transfixed rapidly, which formed the steeply sloped open surface of the back edge. At the same time, shear failure suddenly occurred along weak structural planes near the fault zone of F₅ and formed the sliding surface of the forward edge. The slope in collapse zone I failed and slid toward the free surface. Folding and collapse occurred because of the steeply sloped open surface of the back edge. Rock masses fell, hit the bulgy tilting platform and broke into pieces. The weathered and relatively broken anti-sliding rock body at the tilting platform then suddenly collapsed and was crushed. The landslide preferentially developed in this direction and made it the main sliding bed. The sudden crushing of the anti-sliding rock body and the scarps of the main sliding bed in turn induced collapse II (Figs. 1b and 4a). Part of the landslide body slid over the up-inclined tilting platform and left multiple striations and scratches, making it an obvious scarping zone.

Approximately 12 million m³ of rock collapsed from the upper part of Hongshiyuan Mountain, hit and scarped the tilting platform, crushed and slid into the Niulan River to form a huge V-shaped landslide dam. Combined with UAV 3D image modelling technology and field sampling, the particle size distribution of the landslide dam has been studied. As shown in Fig. 4a, b, the avalanche masses are generally small; the biggest particle size of rock mass is less than 20 m and huge stones (having a particle size that exceeds 2 m) account for just 10% of the mass.

Fig. 4 Field investigation of the Hongshiyuan landslide: **a** dynamic process of the earthquake-induced Hongshiyuan landslide; **b** particle size distribution of the landslide dam

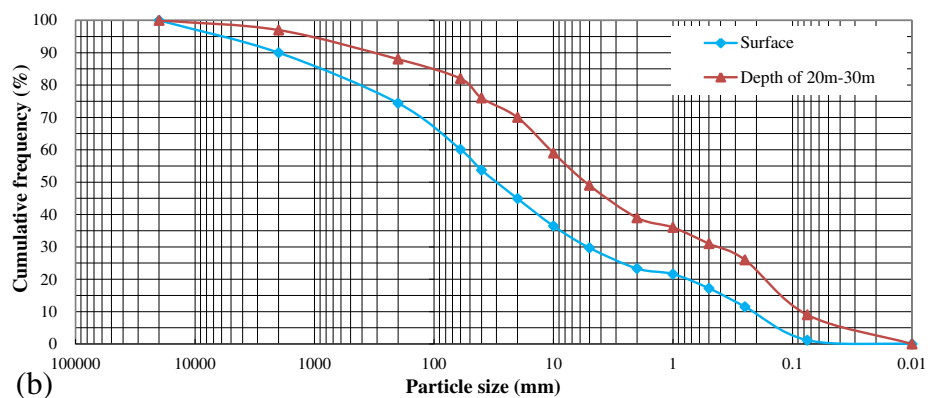
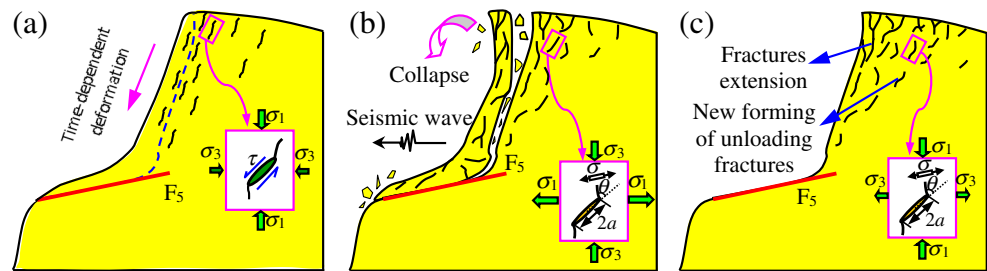
As shown in Fig. 5a, in its virgin state, and due to long-term weathering and gravity effects, the original slope is gradually deforming toward the free surface because of the upper-hard-and-lower-soft structural characteristics and development of

Fig. 5 Failure mechanism of the Hongshiyuan landslide: **a** time-dependent deformation stage; **b** earthquake-induced failure stage; **c** unloading recovering stage

the controlling fault F_5 . Tension stresses are concentrated at the upper edge of the slope. As a consequence, micro-crack initiation, propagation and coalescence occur and finally develop into many controlling fractures approximately parallel to the free surface. For example, a marked original fracture, which is eroded probably by aperture and water circulation, can be observed at the top edge of the slope (Fig. 4a). These fractures are recognised as the plane along which the collapse occurred. The tension fractures and fault F_5 cut the slope, making it a potentially unstable block.

As shown in Fig. 5c, once the landslide occurs, tension stress relieves instantaneously. The rock mass is in an instantaneous unstable stress state, and its rebound deforms toward the mountain side instantly. The sudden unloading and rebounding leads to tension stress concentrated at the tips of the pre-existing fractures (Cai 2008; Li et al. 2017). The fractures extend rapidly, and the rock mass at the back scarp of the remnant slope is highly damaged. Stress redistributes and spreads into the deeper rock mass of the slope and gradually reaches a new balance. This, in turn, induces the initiation, propagation and coalescence of new cracks, and new unloading damage occurs at the back scarp of the remnant slope. Toppling and small collapse tend to occur during this stage.

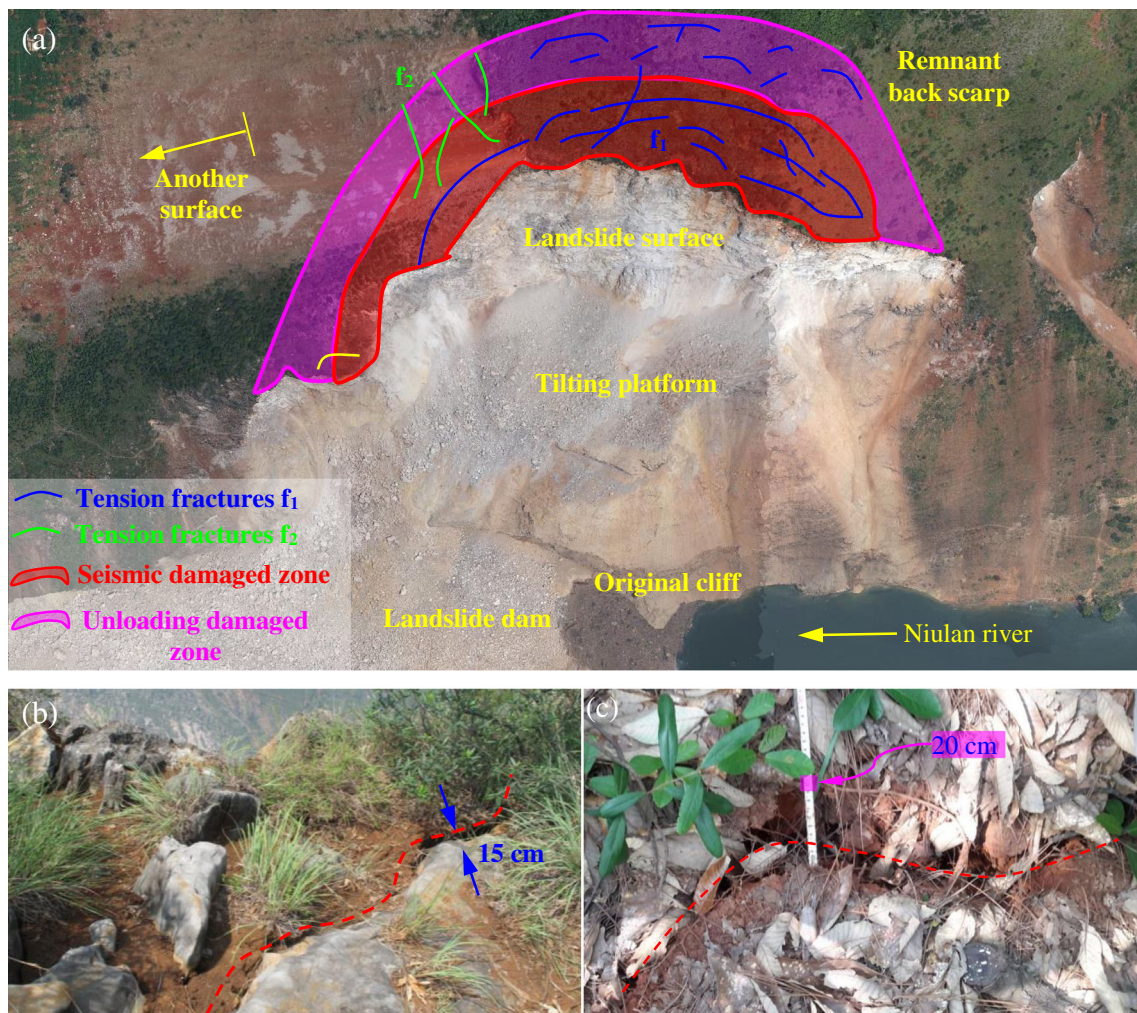
Fig. 6 Tension fracture and damage zone distribution on the remnant slope: **a** damage zone distribution on the remnant slope; **b** tension fracture zigzagging downstream of the top edge of the remnant slope; **c** tension fractures in the unloading damaged zone

One group of the preferred fractures f_1 is mainly distributed in nearly east-west directions with steep dip angles of 78–83°. The majority of the cracks are open, and one of the widest cracks found in this area reaches 30–40 cm in width, with a visible depth of 1.0–1.5 m and stretching for 3–15 m. The longest crack reaching 60 m is found at a distance of 12–

20 m from the top edge of the slope with an open width of 10–15 cm and a visible depth of 1.0–1.5 m, zigzagging to the downstream side of the top edge of the slope (Fig. 6b). The other cracks are distributed in various sizes, and most of them stretch approximately parallel to the landslide surface, followed by some stretching approximately perpendicular to the surface.

Another group of preferred fractures f_2 is developed at the downstream top area of the slope, approximately perpendicular to the landslide surface because of unloading failure in another steep free surface downstream of the slope. The fractures f_2 are approximately parallel to the downstream free surface of the slope with a strike of $N15^\circ\text{--}55^\circ\text{E}$, a dip direction to the NW and a dip angle of $76\text{--}83^\circ$. However, the stretch lengths, opening widths and visible depths of the fractures f_2 are much lower than those of the fractures f_1 . Another notable feature is that the density, opening degree, porosity and connectivity of the fractures, whether f_1 or f_2 , decrease with distance from the edge of the slope, as shown in Fig. 6a.

probabilities of the rock mass, the remnant slope can be divided into three zones: the seismically damaged zone, the unloading damaged zone and the stable zone (as shown in Figs. 6a and 9). The seismically damaged zone is near the edge of the landslide surface with a width of 10–30 m, and the rock mass is highly damaged because of the earthquake, the sudden dynamic unloading and the rebounding deformation after the landslide. Tension fractures are densely developed with a spacing of approximately 5 m. These fractures are approximately parallel to the landslide surface with a wide opening of 1–40 cm. Toppling and small collapse are most likely to occur in this area because of the steep landslide surface, highly damaged rock mass and tension opening fractures. The unloading damaged zone is next to the seismically damaged zone and approximately 40–60 m from the edge of the landslide surface. Numerous unloading fractures developed in this area, while the density and opening degree generally do not exceed 5 m and 15 cm, respectively, which are much smaller than those of the seismically damaged zone. The rock mass is stable in a static state, while tension cracks are increasing continuously because of the time-dependent unloading and deformation induced by the steep landslide surface. Unloading failure may occur in this area if the seismically damaged zone fails and slides without treatment. Outside the unloading damaged zone is the stable zone, where few cracks can be found and the rock mass is relatively intact and stable.

Hence, in order to guarantee the safety of the high rock slope and reduce secondary earthquake or rainstorm disasters, comprehensive treatment measures must be taken to ensure the long-term stability of the remnant slope. Slope cutting must be used to clean the unstable rock mass in the seismically damaged zone and the unloading damaged zone, reducing the slope and increasing stability. Active support systems, such as rock bolts, prestressed cables and shotcrete–bolting–mesh are applied to strengthen the slope and reduce unloading damage. Coaction of rock bolts and shotcrete are employed to reinforce potentially unstable rock blocks. Closing treatment and concrete replacement are used for the unexcavated fractures and weak structural planes. Loose bodies and local potentially unstable rock masses along the edge of the remnant slope should be eliminated, and a passive prevention net must be set to prevent gravel slide. Slope protection and drainage systems must be set at the stable zone along the ridge line. Finally, much greater importance should be attached to slope stability monitoring and early warning.

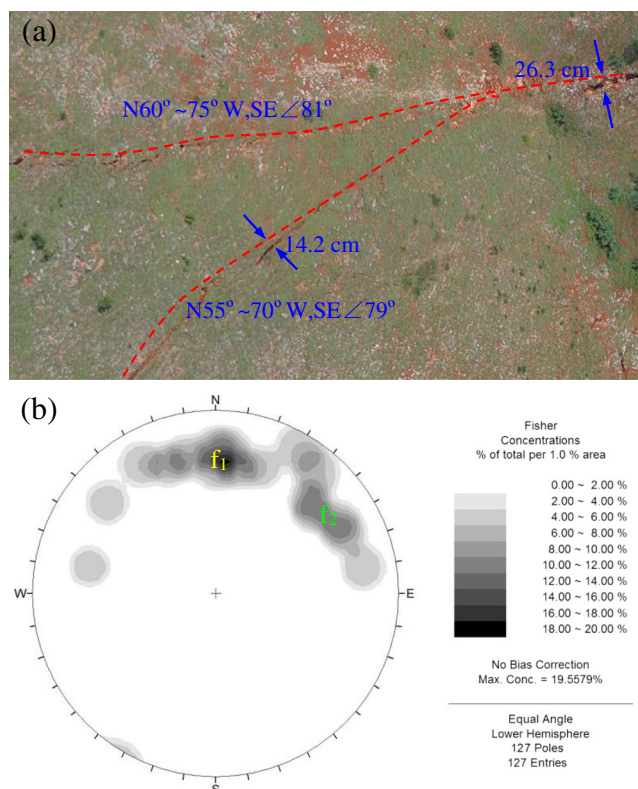
Fig. 7 Fracture identification and statistics using unmanned aerial vehicle (UAV) 3D image technology: **a** fracture identification; **b** fracture statistics

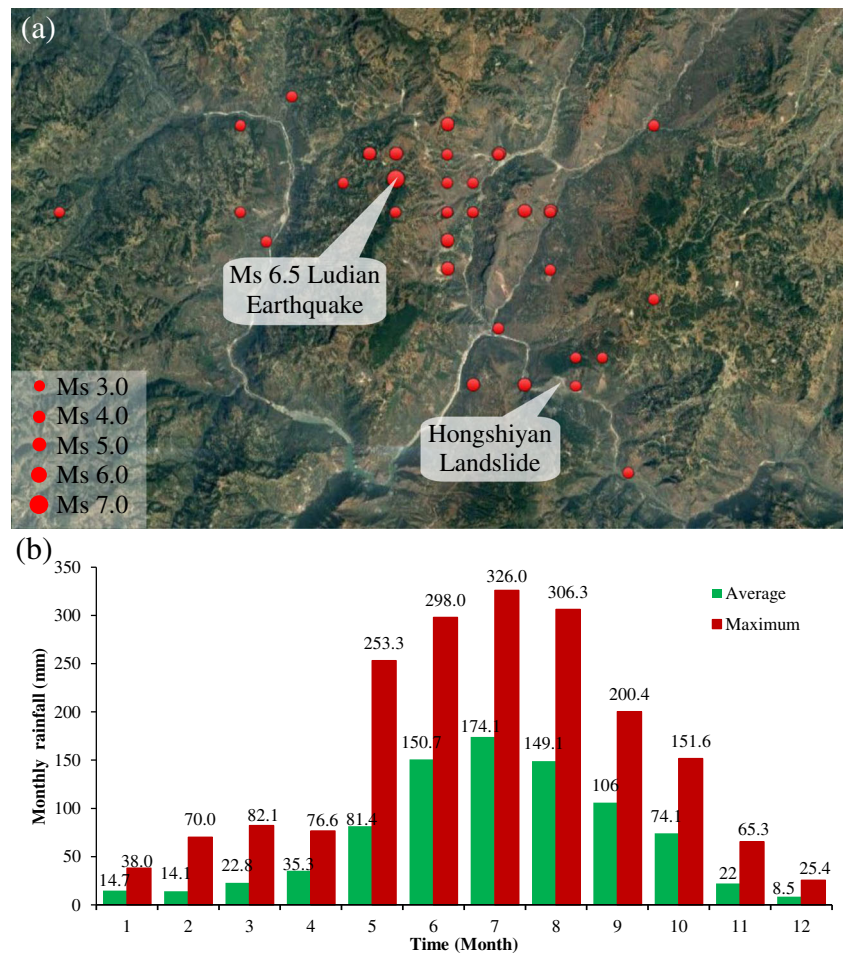
As shown in Fig. 8a, aftershocks have occurred frequently in the Hongshiyuan landslide area since the 2014 Ludian Ms 6.5 earthquake. By the end of August 2017, at least 32 aftershocks registering a 3.0 magnitude or higher have followed the main tremor. These aftershocks have a great effect on the security and stability of slopes, especially for earthquake-induced slopes such as the remnant slope of the Hongshiyuan landslide. As shown in Fig. 9a, the aftershocks have a similar effect mechanism as that of the main tremor on the slopes. The bulge shape (three-sided hanging) and the steep slope surface have a significant seismic amplification effect on the back scarp of the remnant slope. Moreover, the deep steep tension fractures cut the rock mass at the back scarp of the remnant slope into many column-shaped potentially unstable rock blocks, which means that the relatively independent potentially unstable blocks were more strongly affected by seismic loadings during the aftershock. At the same time, a wedge-splitting effect should not be ignored as seismic loading provides a tension–compression cycle stress state during the aftershock. In the compression stress state, the tension fractures have a closing tendency, while the existence of debris falling during the previous formation and expansion of tension fractures would cause splitting stresses at the tips of the tension fractures (Feng et al. 2009; Zhou et al. 2013). As the seismic accelerations generally decrease from the top to the bottom of the slope, the differential distribution of seismic acceleration would induce shear stress concentrations at the tips of the tension fractures. As a consequence, the tension fractures have a tendency to propagate along the shear stress and toward the landslide surface. Finally, tension–shear failure occurs, and toppling and small collapses occur (Zhou et al. 2010; Stead and Wolter 2015).

As shown in Fig. 8b, the Hongshiyuan landslide area in southwestern China belongs to a typical mainland monsoon climate; rainfall occurs unevenly throughout the year, mainly from July to September. The annual average precipitation is 852.8 mm, while the precipitation from July to September reaches 579.9 mm, accounting for approximately two-thirds of the annual precipitation. The maximum monthly precipitation even reaches 326.0 mm. As shown in Fig. 9b, heavy rainfall has a notable effect on the security and stability of the remnant slope. Rainfall infiltration forms a hydrostatic pressure zone on the back edge of the tension fracture and

Fig. 8 Unfavourable conditions at the Hongshiyuan landslide area: **a** aftershock occurrence at the Hongshiyuan landslide area since the 2014 Ludian Ms 6.5 earthquake; **b** monthly average rainfall in Ludian County

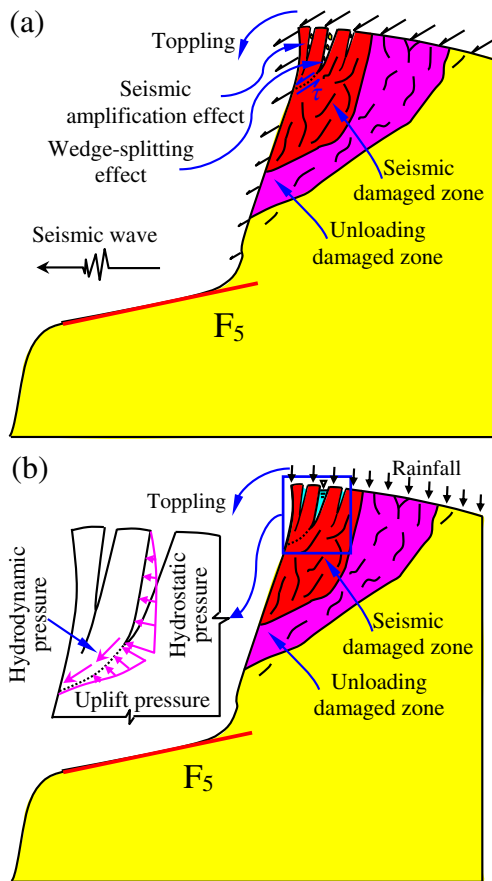
In an extreme circumstance where an aftershock occurs during the rainy season, under the tension–compression cycle stress state, the tension fracture and shear surface have an instantaneous closing tendency because of the compression stress, the pore space volume decrease and pore water passage blockage. The pore water cannot be dissipated promptly,

inducing an instant excessive static pore water pressure and decreasing the effective stress. Tension fractures extend rapidly because of the coupling effect of tension and shear stress, as well as the excess static pore water pressure accumulation. This mechanism is similar to the wedge-splitting effect, which would induce rapid toppling and collapse at the back scarp of the remnant slope.

Therefore, the remnant slope is stable overall, while toppling and small collapse are possibly occurring along the edge of the landslide surface, particularly at the back scarp of the remnant slope because of the steep landslide surface, well-developed tension fractures, highly damaged rock mass and frequent occurrence of aftershocks and rainstorms.

Fig. 9 Toppling and collapse analysis of the rock mass at the back scarp of the remnant slope under aftershock conditions (a) and under rainstorm conditions (b)

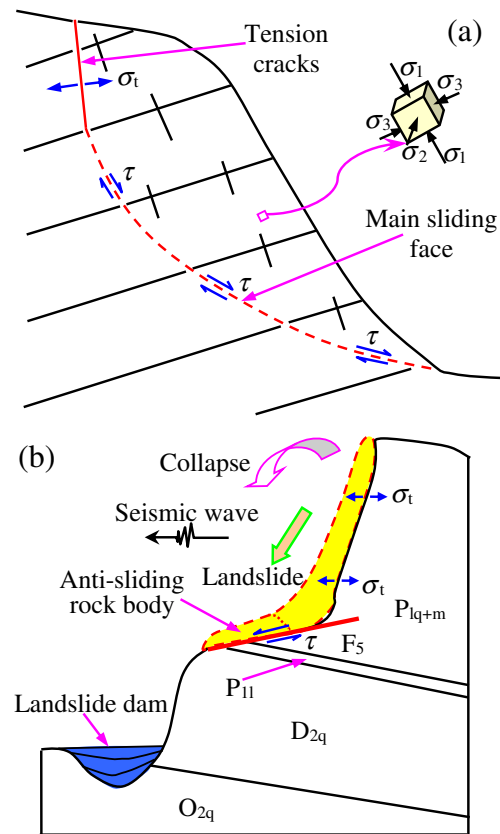
the surface of the slope can be summarised as the following state: the maximum principal stress σ_1 is approximately parallel to the surface of the slope, the minimum principal stress σ_3 is approximately perpendicular to the surface of the slope and the intermediate principal stress σ_2 is approximately parallel to the strike of the slope. The slope failure follows the principle of limit equilibrium and the Mohr–Coulomb criterion. The minimum principal stress σ_3 is a compressive stress and, at best, a small unloading tension stress. Shear stress concentrations initially occur at the weak faces and the slope toe. Then, a short shear slip belt forms and gradually pierces. The slope deforms toward the free surface, inducing tension stress concentrated at the upper edge of the slope. In addition, tension fractures finally occur and the landslide befalls (Brideau et al. 2009; Clague and Stead 2012).

For the Hongshiyuan landslide shown in Fig. 10b, the seismic loads first induce numerous tension fractures, forming the steeply sloped open surface of the back edge. Then, tension–shear failure occurs along the controlling fault zone of F_5 and forms the sliding surface of the forward edge because of the continuous acceleration seismic waves. The sliding block is shattered and crushed under the complex tension–

Fig. 10 Failure mechanism comparison between the Hongshiyuan landslide and a conventional landslide: **a** conventional landslide; **b** Hongshiyuan landslide

compression cycle stress. The crushed rock masses “pour down” as avalanches rather than sliding off as conventional landslides. The large steeply sloped open surface of the back edge is the main failure face that controls the Hongshiyuan landslide. In addition, large numbers of tension fractures developed at the back scarp of the remnant slope of the Hongshiyuan landslide. These fractures are basically steep, open and approximately parallel to the free surface (Fig. 6b, c). As for conventional landslides, the shear slip faces in the forward edge usually control the slope failure and the tension fractures at the top edge are much smaller and shallower in comparison to those of the Hongshiyuan landslide.
