In situ failure investigation and time-dependent damage test for columnar jointed basalt at the Baihetan left dam foundation

Quan Jiang¹ · Bin Wang¹ · Xia-Ting Feng¹ · Qi-Xiang Fan² · Zhilin Wang² · Shufeng Pei¹ · Shan Jiang³

Received: 13 June 2018 / Accepted: 3 October 2018 / Published online: 22 October 2018
© Springer-Verlag GmbH Germany, part of Springer Nature 2018

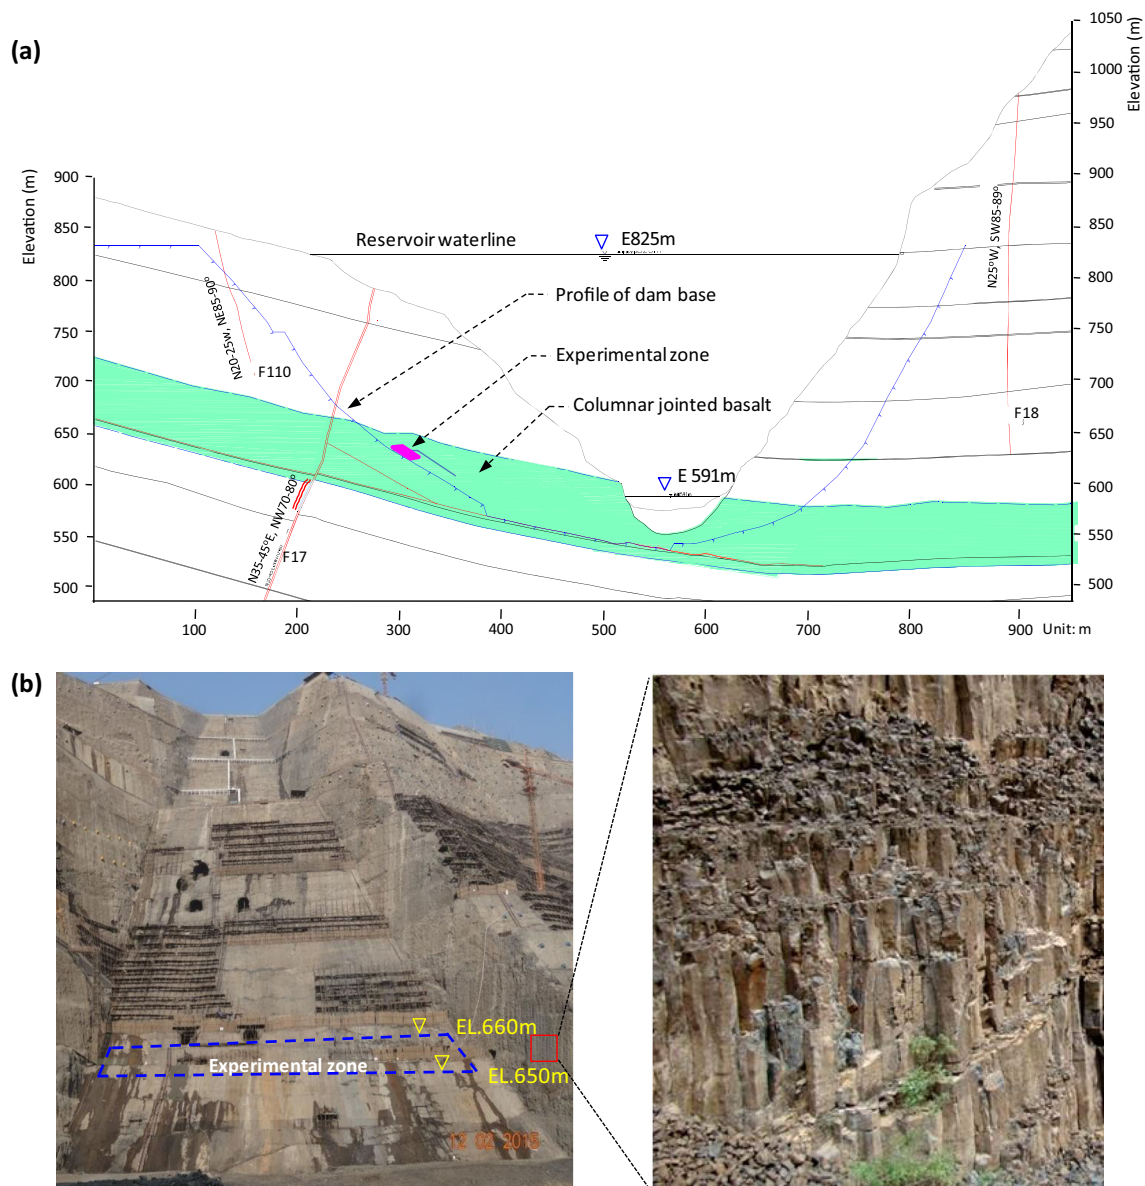
Fig. 2 The Baihetan dam foundation: (a) typical geologic transverse profile of the valley; (b) exposed columnar jointed basalt on the left dam site

experimental zone was selected at an altitude of 650–660 m, as shown in Fig. 2b, for a more detailed investigation of the CJB structure and its time-dependent damage behavior after excavation.

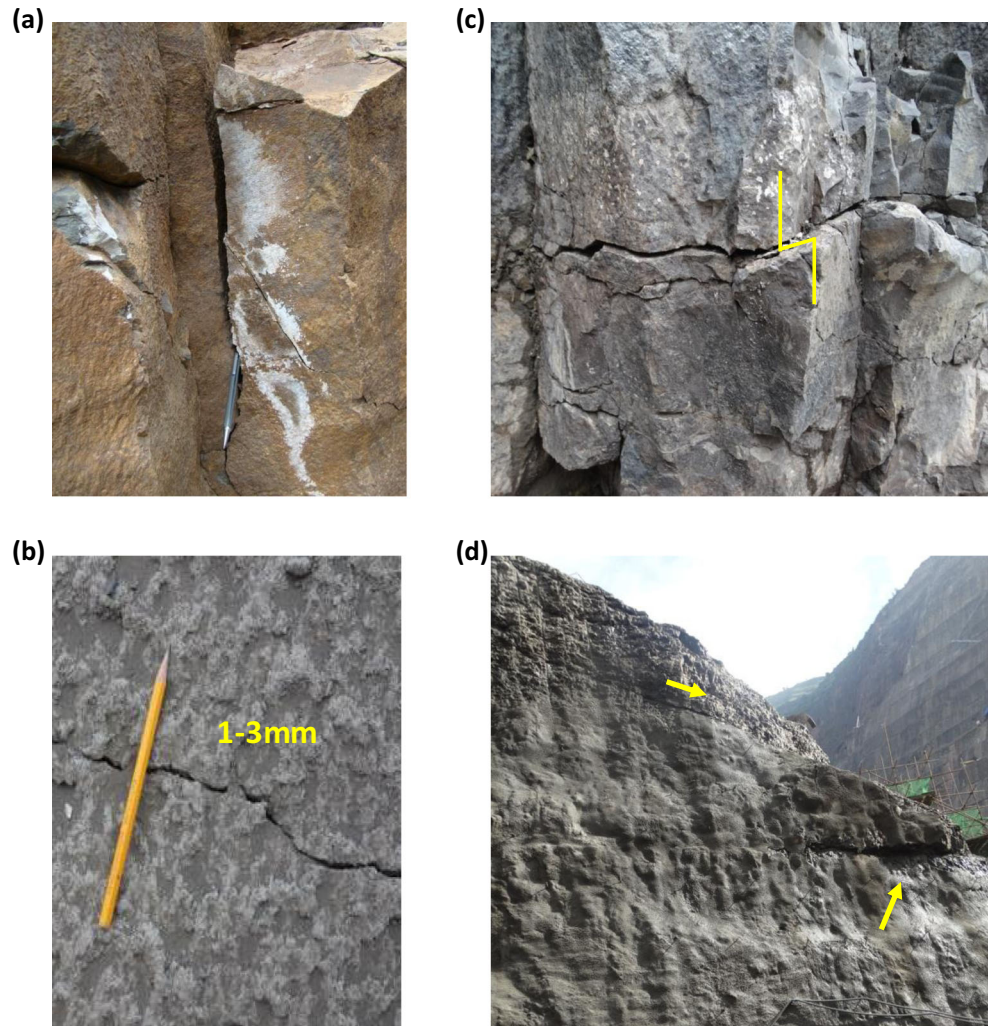
The field investigation showed that this exposed columnar jointed rock mass exhibited several types of failure modes, including opening of columnar prisms, cracking of concrete, loosening of internal joints, and shearing deformation of horizontal joints (Fig. 7). These kinds of failure may all be related to the CJB joint sets.

- 1) The opening of the columnar and vertical internal joint sets induced in the separation of columnar prisms, as well as the disintegration of the columnar block itself, as shown in Fig. 7a. These local deformations of columnar prisms may easily lead to the cracking of sprayed concrete on the dam base (see Fig. 7b).
- 2) The opening of horizontal internal joint sets easily resulted in the shearing tendency of the columnar blocks, as shown in Fig. 7c. This type of opening may also cause extra shearing deformation and even local collapse due to the reduced frictional resistance if no appropriate supporting measurements were applied, as shown in Fig. 7d.

Fig. 7 Field failure performances of columnar jointed basalt exposed on the dam foundation: (a) opening of columnar prisms, (b) cracking of concrete, (c) loosening of internal joint, (d) shearing deformation of horizontal joint

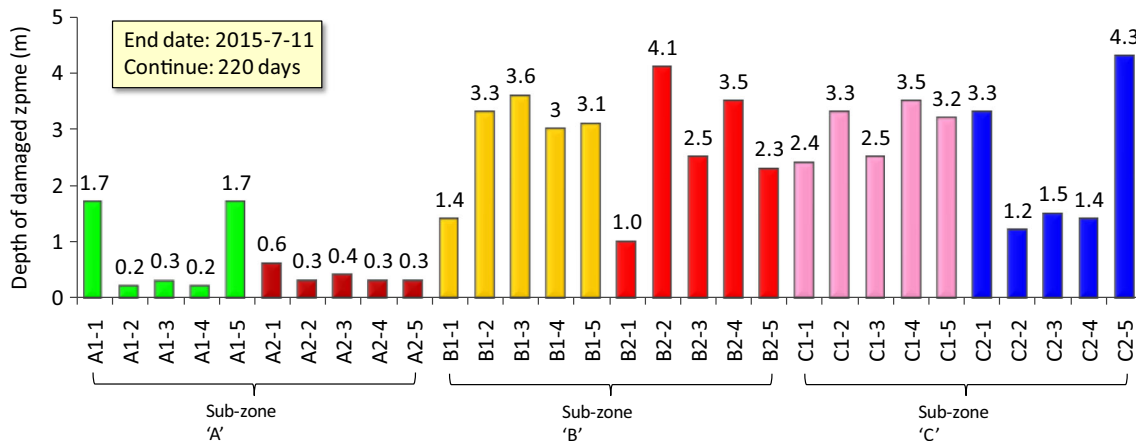
The field testing of the CJB experimental zone lasted for 7 months. All the detected curves of P wave velocity versus depth for the boreholes showed that the lower P wave velocity appeared at the shallower part and the higher P wave velocity appeared at the deeper part (i.e., undisturbed rock mass) in the borehole, as shown in Fig. 10. These results indicated that both the final stable damage depth and the EDZ stable time were different in different subzones; for example, the average CJB damage depth at subzone A was smaller than subzones B and C, as shown in Fig. 11.

Fig. 11 Total tested depths of EDZ in the CJB experimental zone (results at 220 days after excavation)

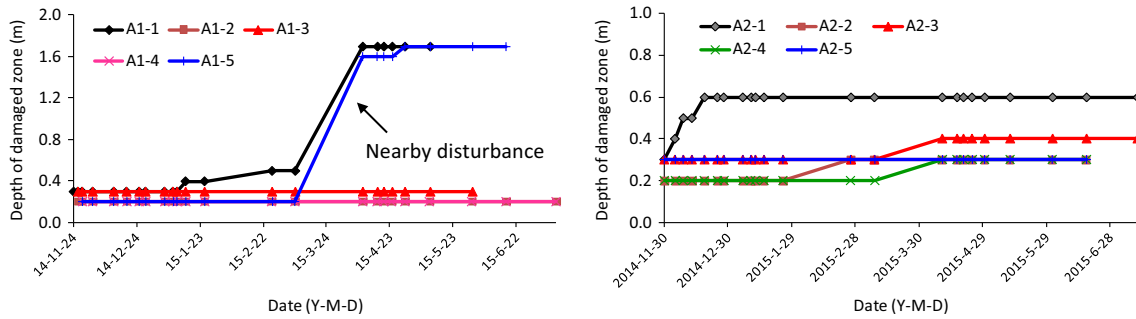
- 1) The average P wave velocity of the undisturbed CJB was approximately 5132 m/s, but that of the damaged columnar jointed rock mass was in the range of 4800–3200 m/s in subzone A. The final depth of the EDZ stabilized within less than 15 days; whereas the adjacent blasting opening could induce a sharp depth increase that could be observed in boreholes A1–5 and A2–1, as shown in Fig. 12.
- 2) In subzone B, the average P wave velocity of the undisturbed CJB was approximately 5072 m/s, but that of the damaged columnar jointed rock mass was in the range of 4700–2960 m/s. It was evident in Fig. 13 that the CJB in subzone B had time-dependent damage behavior, as the damage depth increased with time continuously, until

Fig. 12 Temporal evolution of the CJB damage depth gained in subzone A

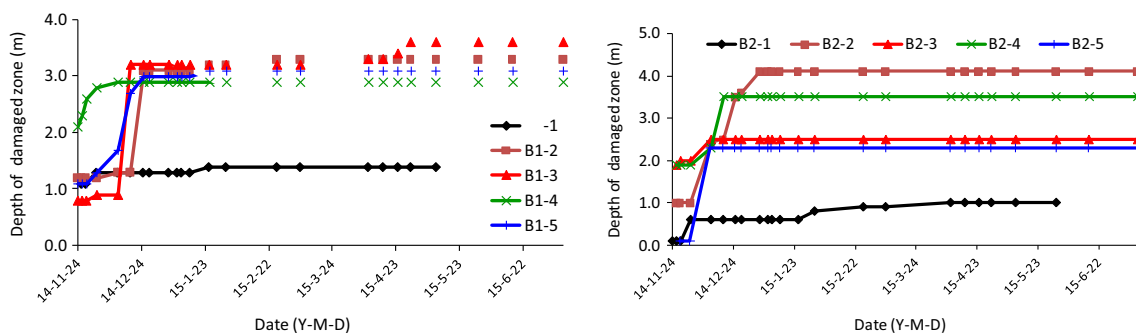
Fig. 13 Temporal evolution of the CJB damage depth gained in subzone B

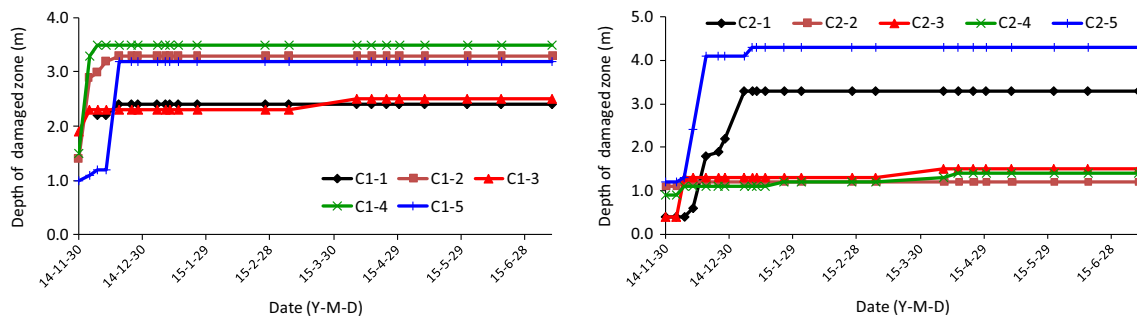
- 3) The average P wave velocity of the undisturbed CJB was approximately 5085 m/s in subzone C, but that of the damaged columnar jointed rock mass was in the range

of 4600–2890 m/s. The CJB at subzone C also obviously had time-dependent damage behavior, as shown in Fig. 14. Consistent with the findings in subzone B, it took approximately 3045 days for the EDZ depth evolution to stop.

Fig. 14 Temporal evolution of the CJB damage depth gained in subzone C

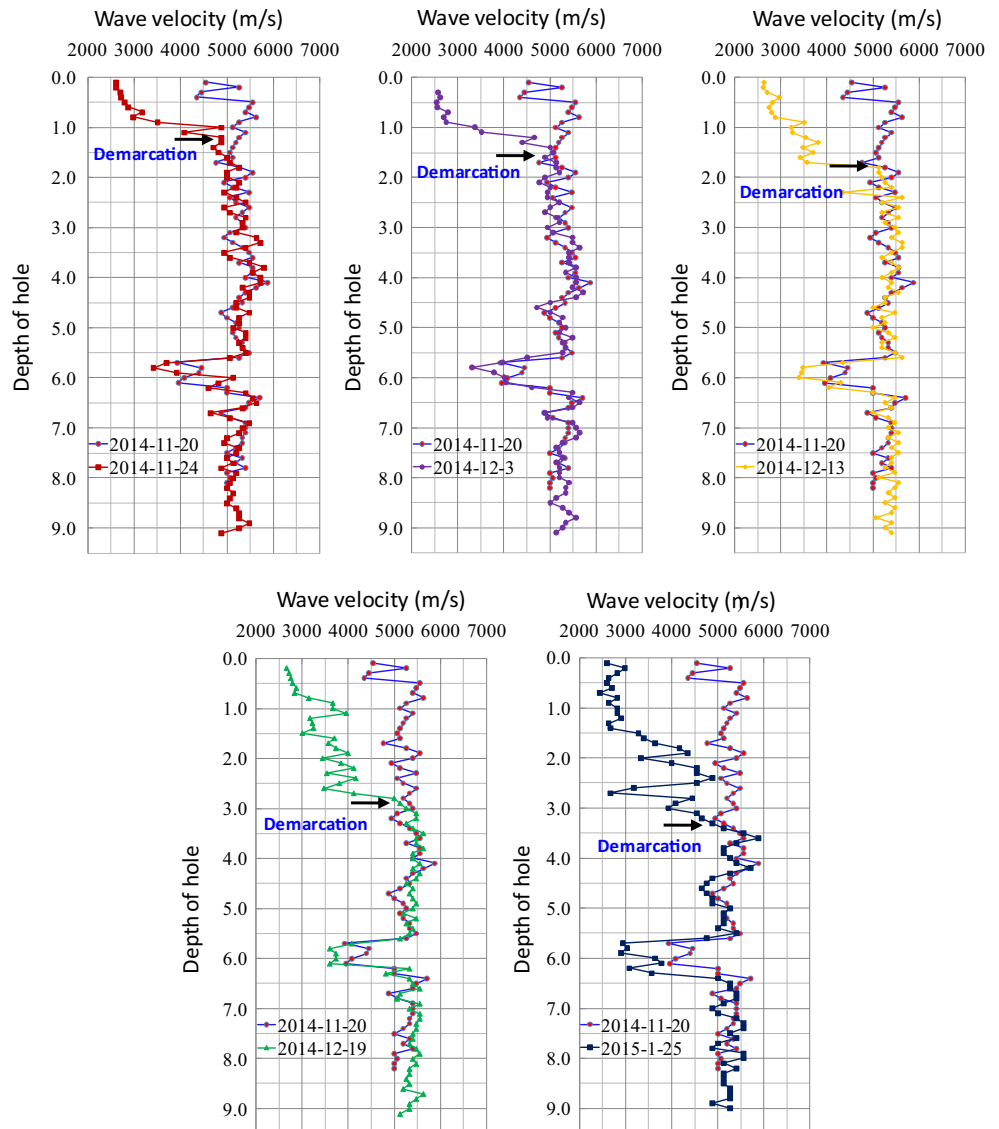
Fig. 16 Typically time-dependent reduction of P wave velocity curve and increase of damage depth in EDZ

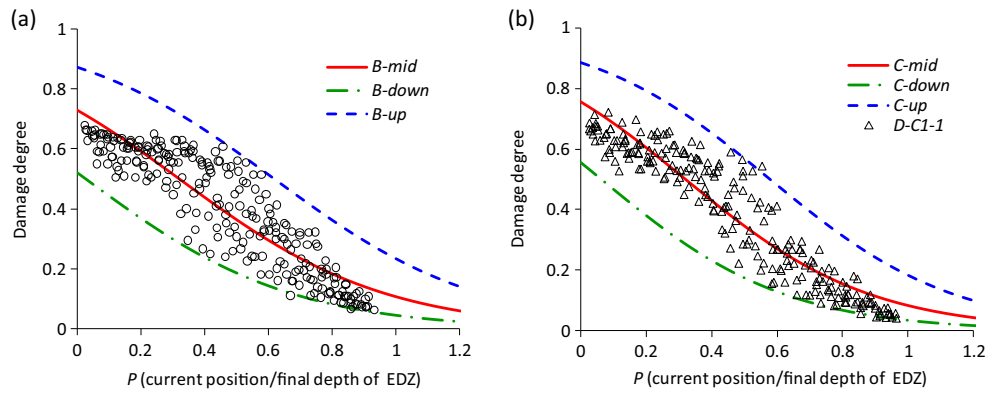
heterogeneous damage after excavation. As shown in Fig. 17, serious damage occurred at the opening of the hole, whereas no or little damage was found in the deeply undisturbed rock mass. Regression analyses were carried out based on the damage data of the B and C subzones, and the results indicated the Sigmoid function can ideally describe the spatial distribution of spatial damage degree for the Baihetan columnar jointed rock mass from the surface to the interior. It is shown in terms of Eqs. 4 and 5,

Fig. 17 Regression analysis respectively for the damage data of subzone B (a) and subzone C (b)

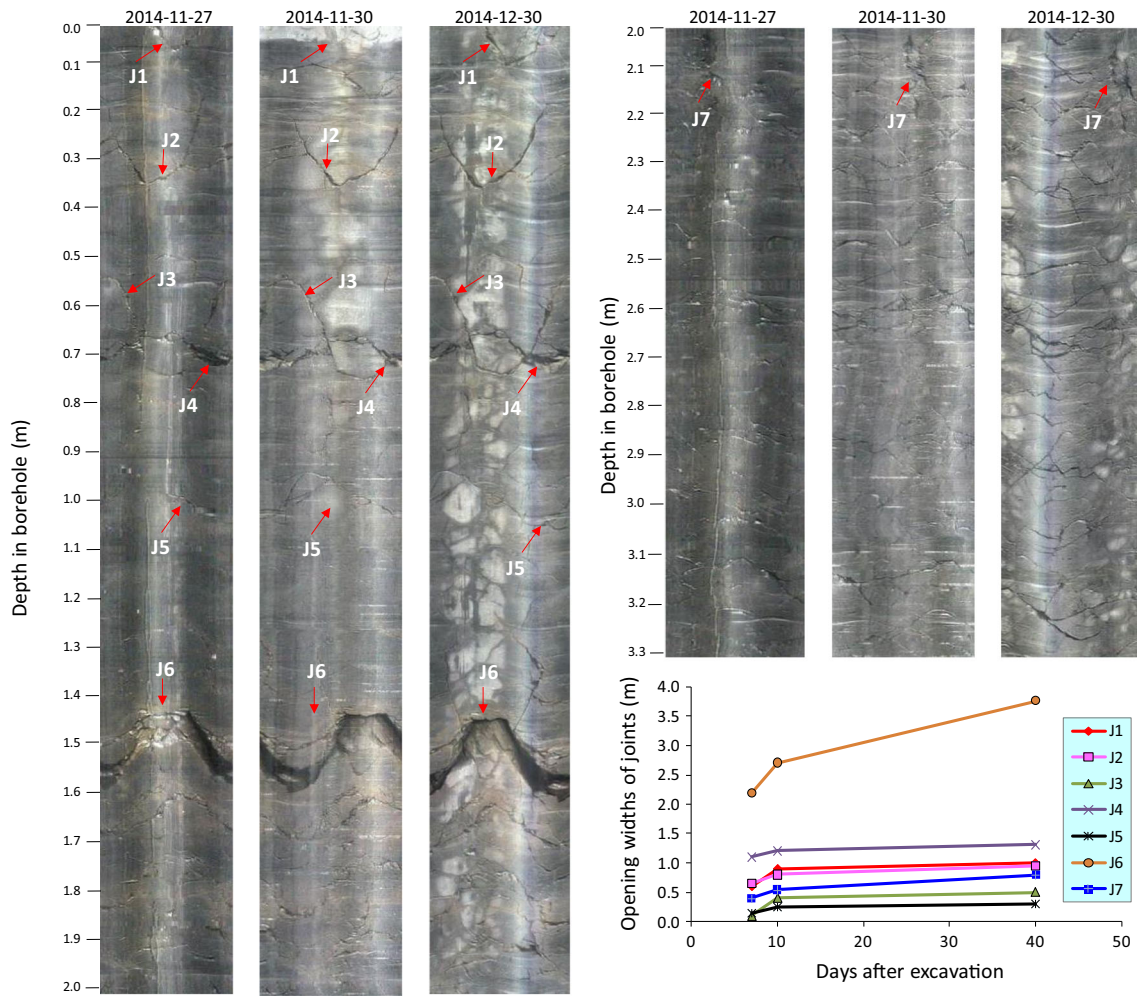
Fig. 19 Time-dependent cracking development of the borehole jointed rock mass observed by digital borehole camera

Successive field observations using a digital borehole camera indicated that the unloading damage mechanism of the Baihetan CJB was mainly related to the time-dependent opening of the initially blank and closed joints after excavation. For improving the mechanical properties of the damaged CJB, two reinforcing methods, i.e., the injection of liquid cement and the installation of prestressed rock bolts inside this damaged rock mass, have been suggested.

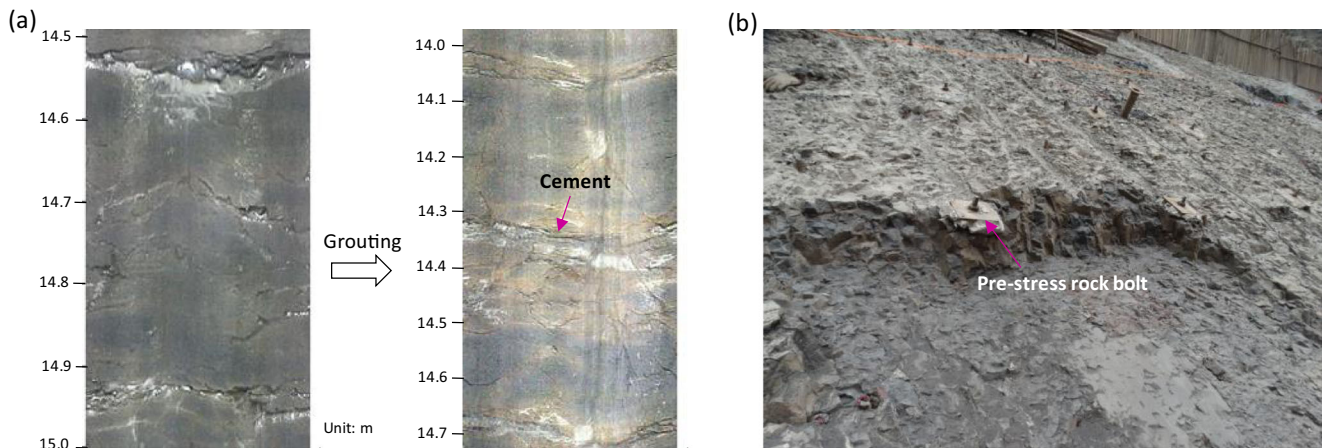
Fig. 20 Actual reinforcement for the jointed basalt: (a) grouted cement observed by digital borehole camera; (b) pre-stress rock bolt on the dam foundation

- 1) Perform the injection of liquid cement inside the damaged rock mass, which can solidify the joints and fill their lacunas, i.e. to increase the effective loading area, and also improve the C_0 and φ of the CJB;
- 2) Install prestressed rock bolts to enhance the normal stress on joints and restrain further cracking of the CJB.

During the actual reinforcement of the columnar jointed basalt on the dam foundation, wet-ground cement with 0.5 MPa pressure was grouted inside the columnar jointed rock mass and rock bolts with 120 kN prestress were also installed to limit the time-dependent deformation and damage (Fig. 20). The corresponding DBC test indicated that these methods can improve the integrity of the columnar jointed basalt.
