# Landslide-related maintenance issues around mountain road in Dasha River section of Central Cross Island Highway, Taiwan

The winding Dasha River section of the Central Cross Island Highway in Taiwan is 9.44 km long. More than 20% of its length has been rerouted in the past six decades due to landslide-induced maintenance problems. To investigate the influence of geological conditions on the maintenance of this mountainous road section, this study establishes inventories of highway alignments and nearby landslides based on interpretations of multi-temporal aerial photos and highway maintenance records. Types of landslide and topographic features are verified through field investigation, and the engineering characteristics of rock masses are evaluated using the Q-method semi-quantitatively. The results reveal that three sections with rerouting of road or structural modification are located near the undercut slopes of the Dasha River and the boundaries of strata where water erosion and scouring are active and considerable gullies develop. Various metamorphic strata with intricate folds are formed by orogenic deformation and metamorphism under the influence of weathering, such as wa

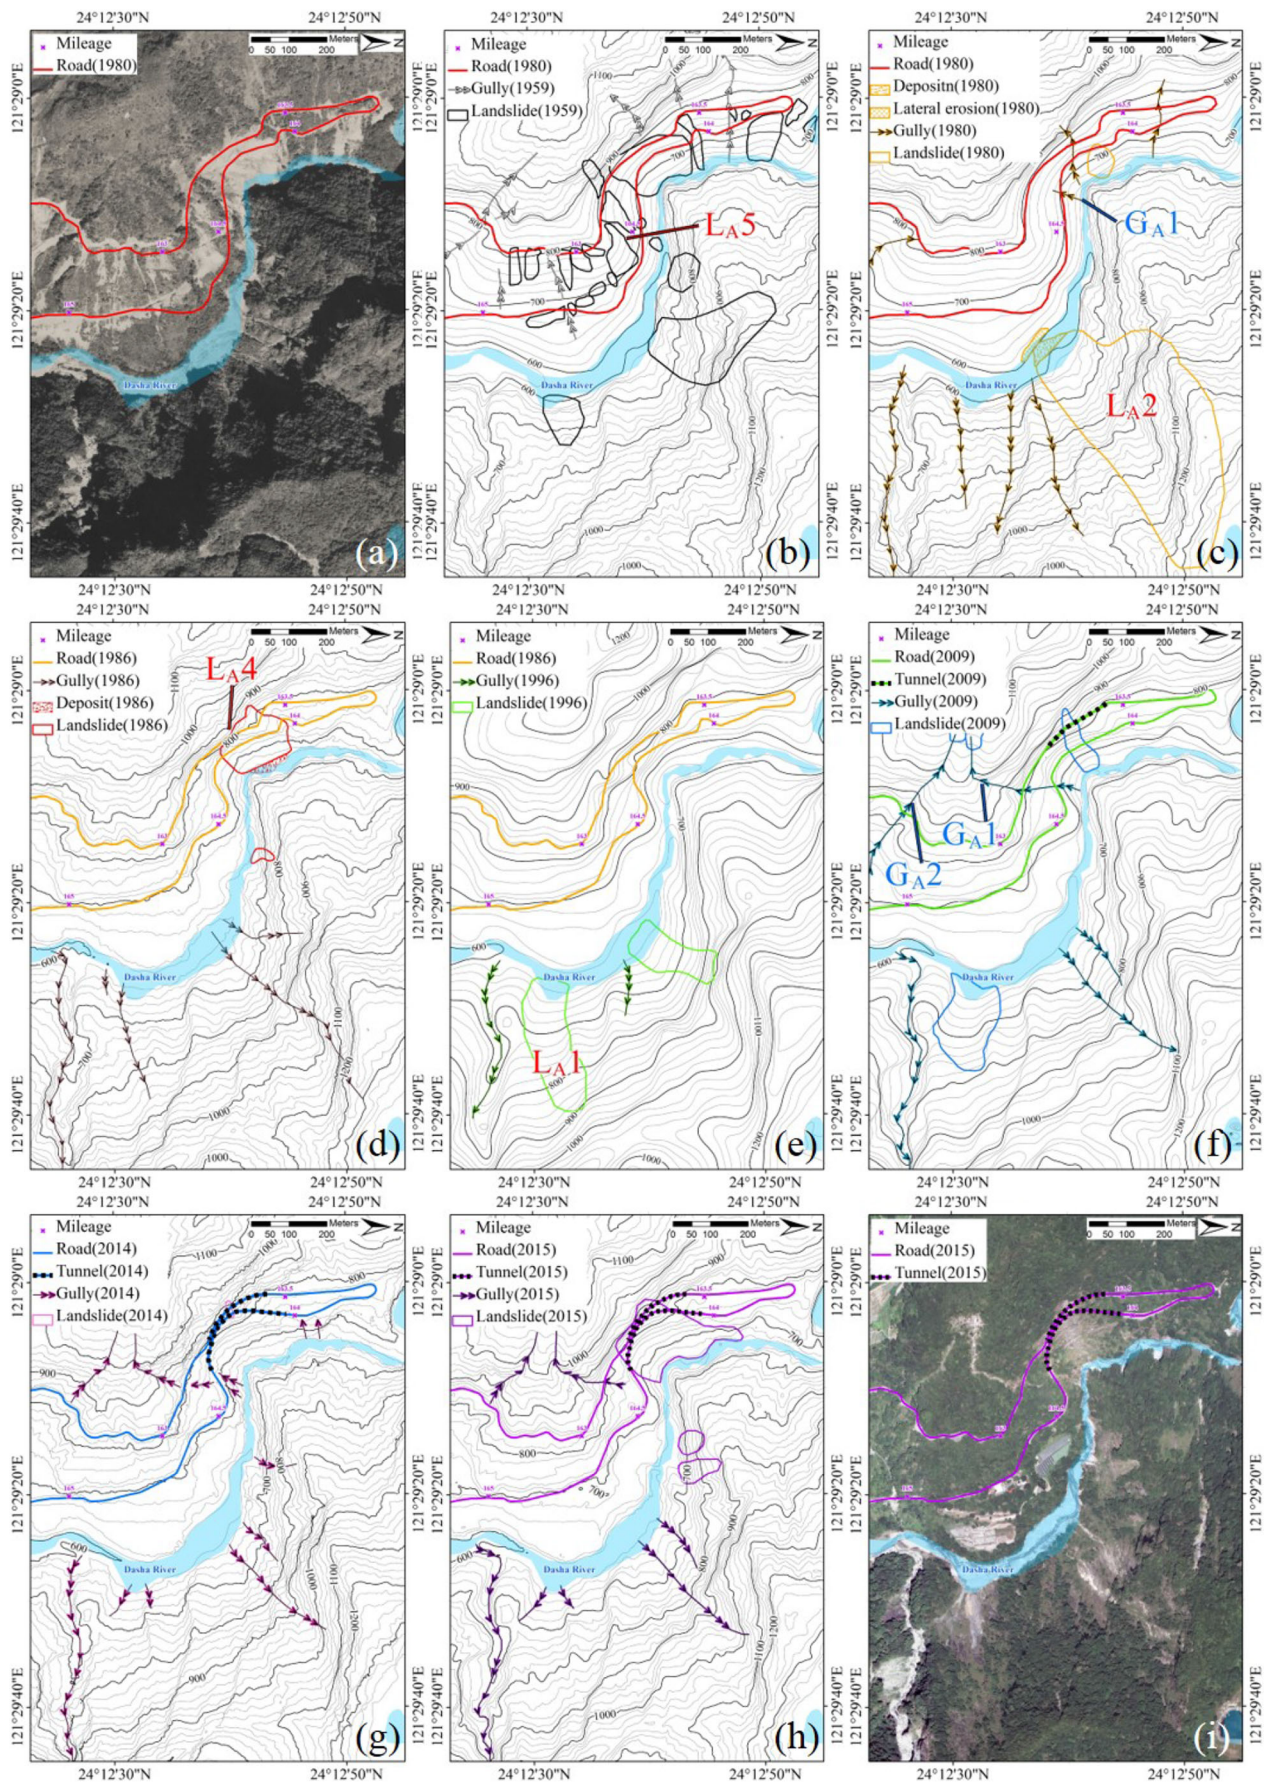
(Fig. 9b).  $L_{A3}$ ,  $L_{A2}$ , and  $L_{A1}$  were located along the undercut slope of the left curved bank.  $L_{A2}$  was significant in the 1980 aerial photo (Fig. 9c), which shows debris following the collapse piled up within the Dasha River, causing the river to become narrow to a minimum width of approximately 20 m. Where a slip-off slope had been located, the water flow turned to wash the right bank, causing significant lateral erosion.  $G_{A1}$  near the boundary between subzones A1 and A2 developed upward from the river side, reaching above the upper road (Fig. 9c). The highway in subzone A1 was rerouted to its current course during 1980–1986 (Fig. 9d). The interpreted  $L_{A4}$  during the initial stage after completion of the Tai-8 highway was completely exposed. The landslide developed upward above the upper road, with debris piled up to the other side (left bank) of the Dasha River. Several years later, except for the enlargement of  $L_{A2}$ , the slopes in subzone A1 were relatively stable and vegetation recovered. The nearby river was obviously widened in 1996 due to the reactivating of  $L_{A1}$  and its length and width increased to 400 m and 100 m, respectively (Fig. 9e). Reactivating of  $L_{A1}$  was observed in the 2000–2003 images. Although the highway was rerouted far from the river and was insignificantly affected by the reactivating of  $L_{A1}$ , the collapsed debris piled up within the river temporarily, leading to the development of a new gully ( $G_{A2}$ ) from the side of the river. The gully quickly eroded upward, meeting  $G_{A1}$  around 2005 (Fig. 9f–h).

$L_{A4}$  and the gullies significantly affected the highway in subzone A2.  $L_{A4}$  was distributed widely along the highway following its construction, with two gullies north of its (Fig. 9b). Gully  $G_{A1}$  continuously developed and formed a boundary on the downstream side of  $L_{A4}$ . While  $L_{A4}$  shrank in downslope side of the lower road,  $G_{A1}$  developed 10 m above the upper road. The debris of  $L_{A2}$  piled up in the river and worsened the lateral erosion of the side of the upper stream.  $L_{A4}$  reactivated in 1986 and became significantly larger (Fig. 9d). The bare slope near  $L_{A4}$  was steep with debris scattered along the highway. It is believed that the 1986 photo was taken during the highway repair work following the collapse.  $L_{A4}$  became larger again in 1987, causing the roadbed of the upper road to disappear completely. Around 1987, the upper road was rebuilt in a neighboring mountain, passing through this section in the Xibao Tunnel. Reactivating of  $L_{A4}$  continued until 1991. During this period, the lower road was rerouted toward hillside and passed through the Guyuan Tunnel. Even after the highway was rerouted,  $L_{A4}$  was reactivated intermittently.  $G_{A1}$  met  $G_{A2}$  in 2005. An opened

**Fig. 9** Interpretation of aerial photo for zone A. Aerial photos that were taken in 1959 (a) and corresponding interpreted results (b). Interpreted results of 1980 photo with contours from orthophoto base map (c); results displayed using contours extracted from DSM that is produced using corresponding photos taken in 1986 (d), 1996 (e), 2009 (f), and 2014 (g). Aerial photos that were taken in 2015 (i) and corresponding interpreted results (h) are also given

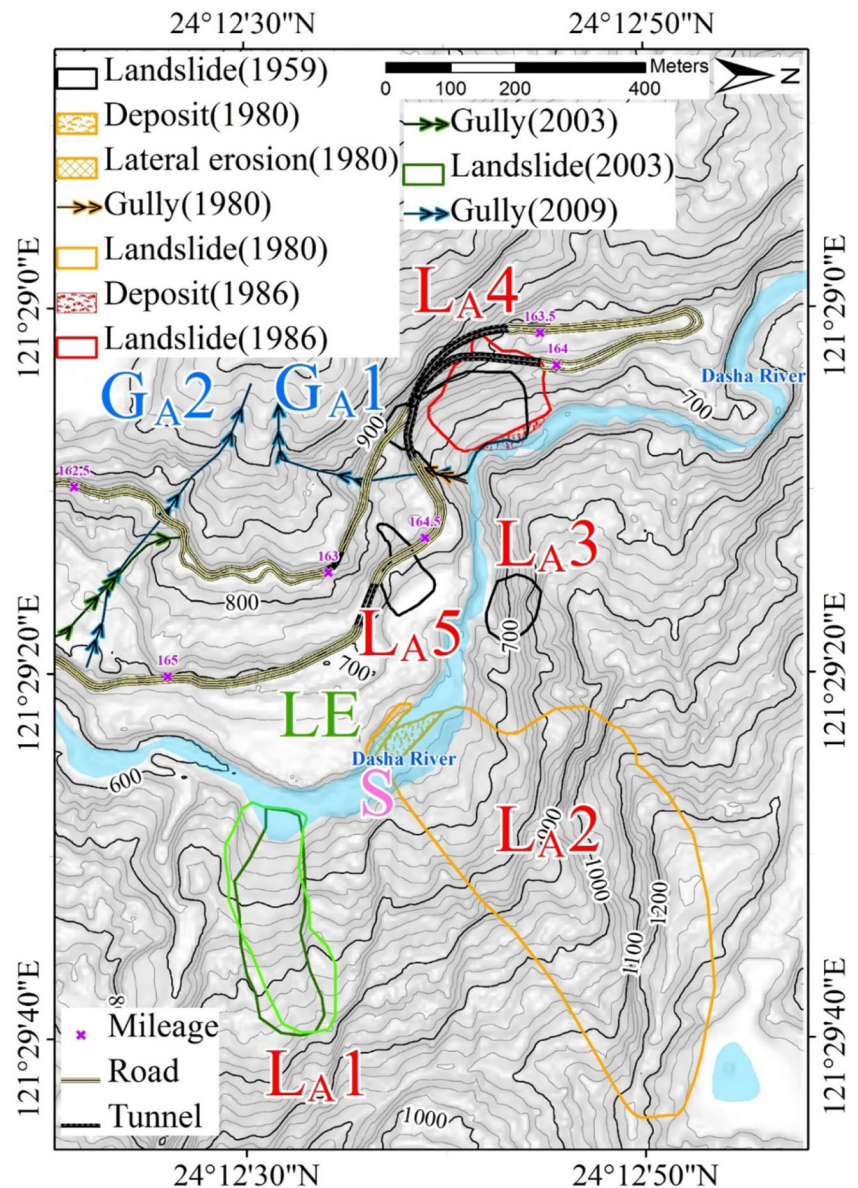
**Fig. 10** Variations of terrain in zone A. Contours extracted from DSM, produced using 2015 aerial photo. L denotes landslide, G denotes gully development, LE denotes lateral erosion and undercut slope along a river bank, and S denotes pile-up along a river bank, including a slip-off slope

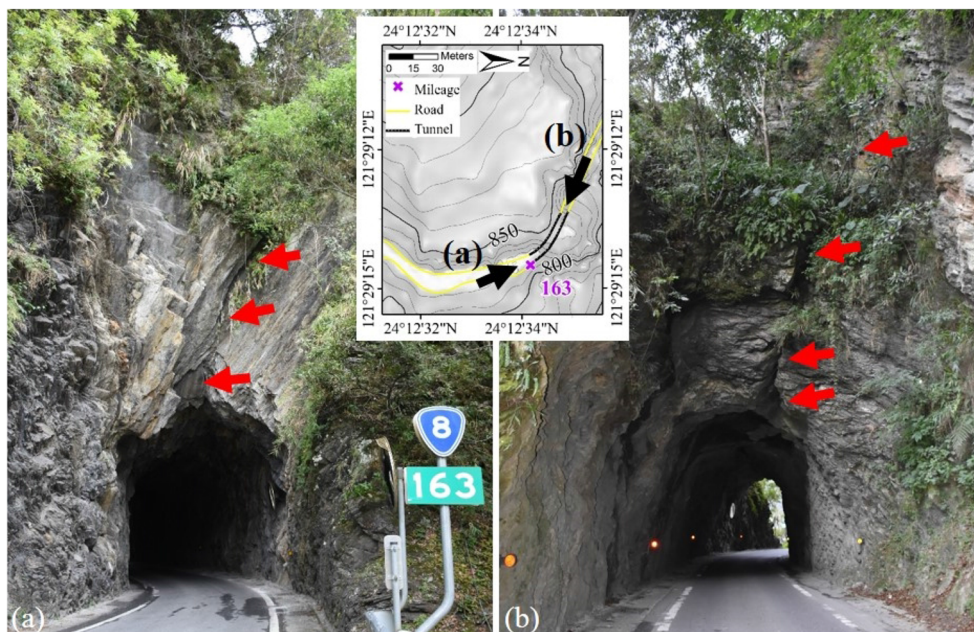
crack on the vault of the unlined tunnel at Sta. 163 between  $G_{A1}$  and  $G_{A2}$  was reported in 2013 (Fig. 12). The recovery of vegetation is observed along  $G_{A2}$  after mitigation was carried out near the lower road in 2012. However, the scope of bare slope near the area where these gullies met has gradually become larger since then.

Fig. 12 Images of unlined tunnel near Sta. 163 k. Opened fracture observed on tunnel vault (a) and developed to slope surface above tunnel (b)

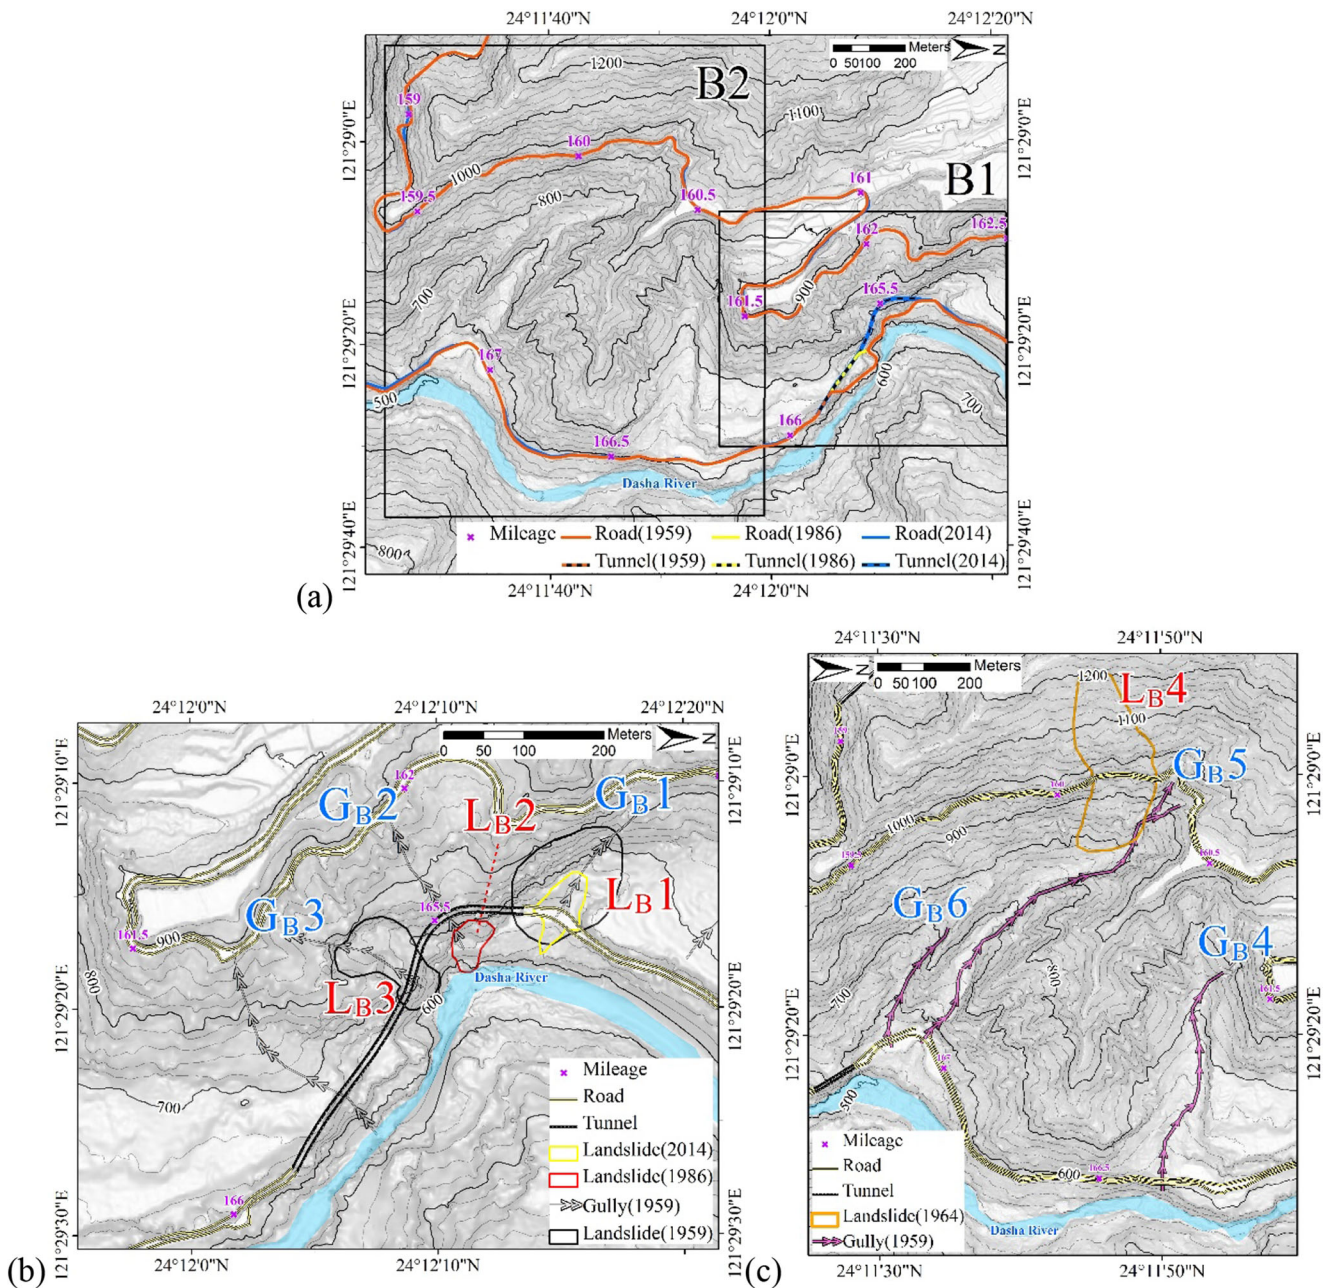
**Fig. 13** Variations of highway alignment in zone B (a). Topographic feature varied in subzones B1 (b) and B2 (c)

In Fig. 13 c,  $G_{B4}$  to  $G_{B6}$  are markedly longer than  $G_{B1}$  to  $G_{B3}$ . Collapses are identified on the slopes along both sides of  $G_{B4}$  to  $G_{B6}$  in successive aerial photos. The spatial distributions of these collapses are typically northeast-southwest. Landslide  $L_{B4}$ , which occurred in the head area of  $G_{B5}$  in 1964, is representative. Since mitigation measures were taken in response to  $L_{B4}$ , its activity was far less than that of  $L_{B2}$  and the slope near  $L_{B4}$  has been stable for more than five decades. In contrast, in the vicinity of the intersection of  $G_{B4}$  with the Dasha River, the river bank has gradually shrunk over a long period and has exhibited features of potential collapse in recent aerial photos. Figure 14 shows the diachronic variation of

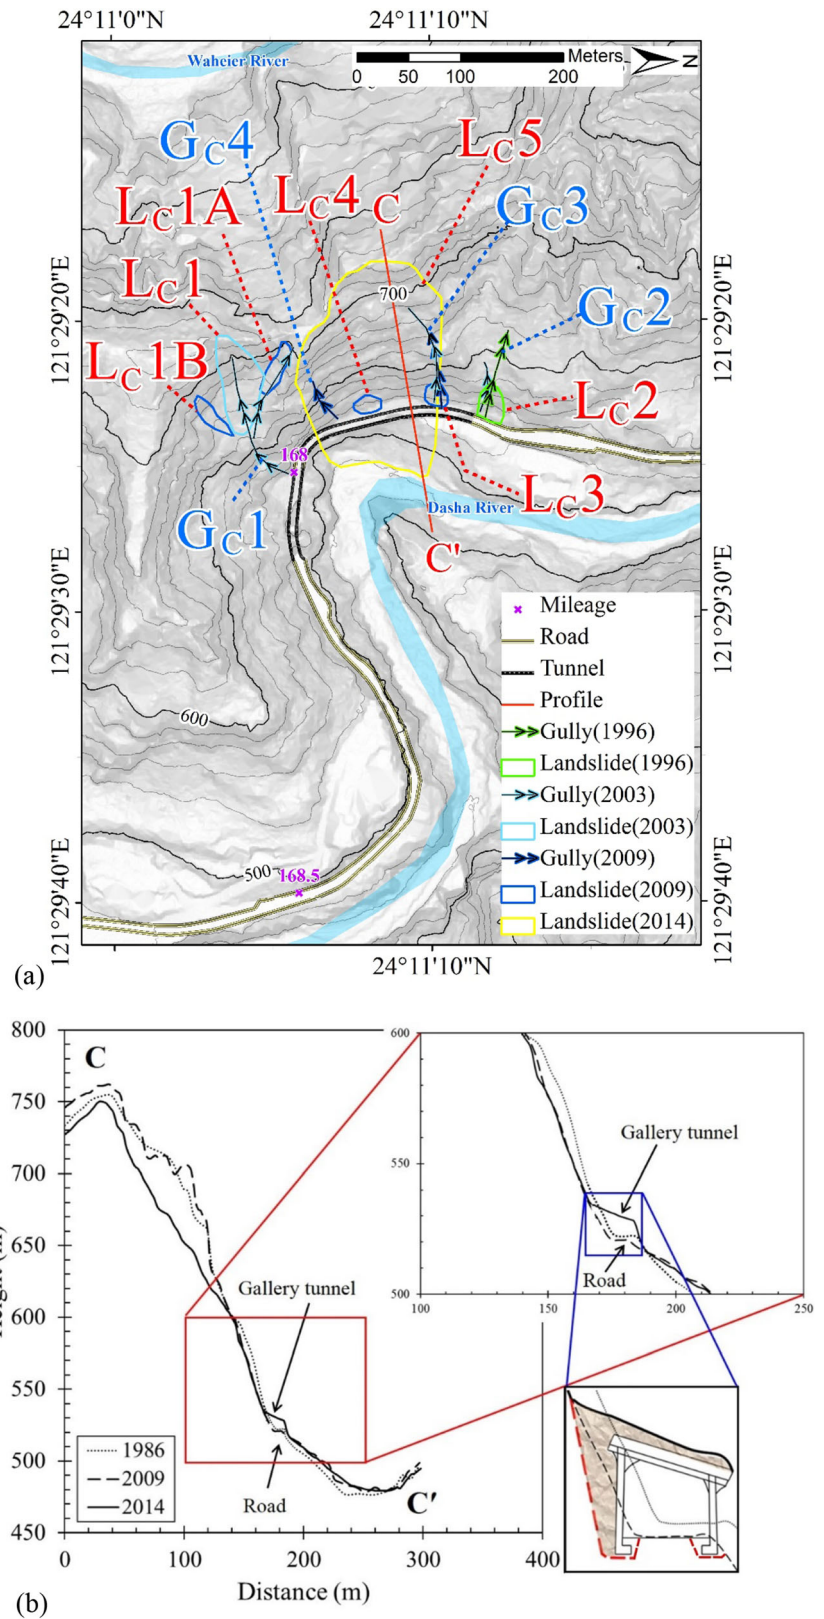
northern boundary of L<sub>C2</sub> southward to its middle area. The highway in zone C was widened in 1996 by cutting into the hillside slope. Local collapses can be seen near the cut slope in the 1998 photo. The collapse near G<sub>C1</sub>, which developed upward, was significant, reaching the local hill ridge in 2000. In the 2001 aerial photo, the gallery tunnel was wider than the highway. The hillside slope in the gallery tunnel had been cut to maintain the width of the road and to enable the construction of the gallery foundation. The bare slope along G<sub>C1</sub> was enlarged and interpreted as landslide L<sub>C1</sub> or the reactivating of piled debris along G<sub>C1</sub>. L<sub>C1</sub> was larger in 2003 and again in 2009. Meanwhile, two new gullies developed from the middle part of the slope and two landslides (L<sub>C1A</sub> and L<sub>C1B</sub>) were observed; gullies G<sub>C3</sub> and G<sub>C4</sub> developed upward to their corresponding upper cliffs. The landslide in Oct. 2009 was large and merged with L<sub>C3</sub>, L<sub>C4</sub>, and their neighboring area to form the huge L<sub>C5</sub>. Mitigation measures were completed at the end of 2012. However, new bare slopes above the gallery tunnel and close to the hill ridge are observed in the 2019 image, in which debris was scattered in G<sub>C2</sub> and had moved downward. Figure 17 shows the diachronic variation of interpreted landslides and gullies in zone C. The *Q* values in zone C are in the range 0.14–355.56, with an average of 21.98.

**Fig. 15** Variations of terrain in zone C (a) and profile of EE' (b)

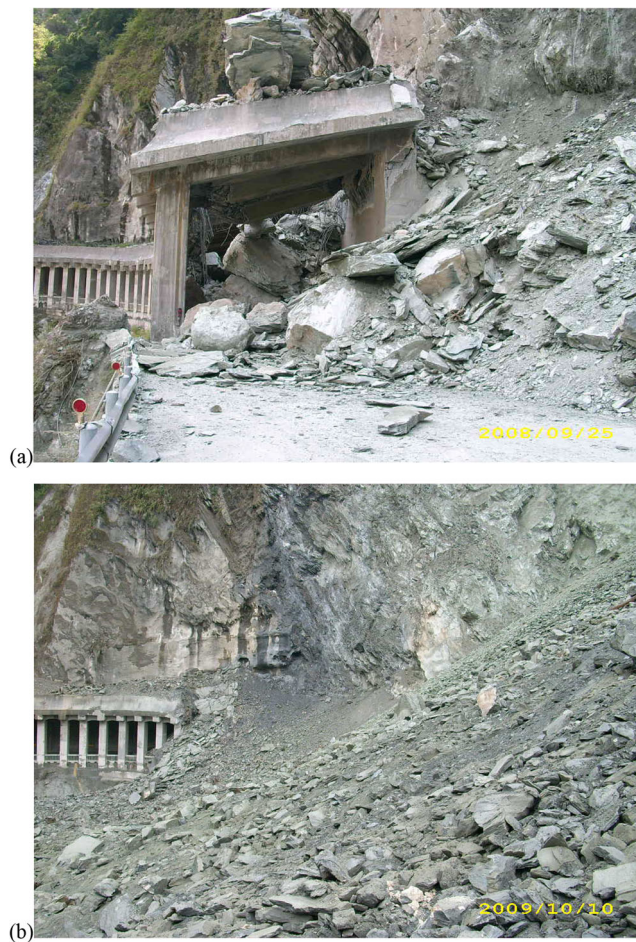
**Fig. 16** Gallery tunnel successively damaged in Sep. 2008 (a) and Oct. 2009 (b)
