Stability analyses of dams using multidisciplinary geoscience approach for water reservoir safety: case of Mpu Damsite, Southeastern Nigeria

Abstract

Keywords Damsite · Seepages · Uplift pressure · Dam foundation · Composite bedrock · Reservoir safety

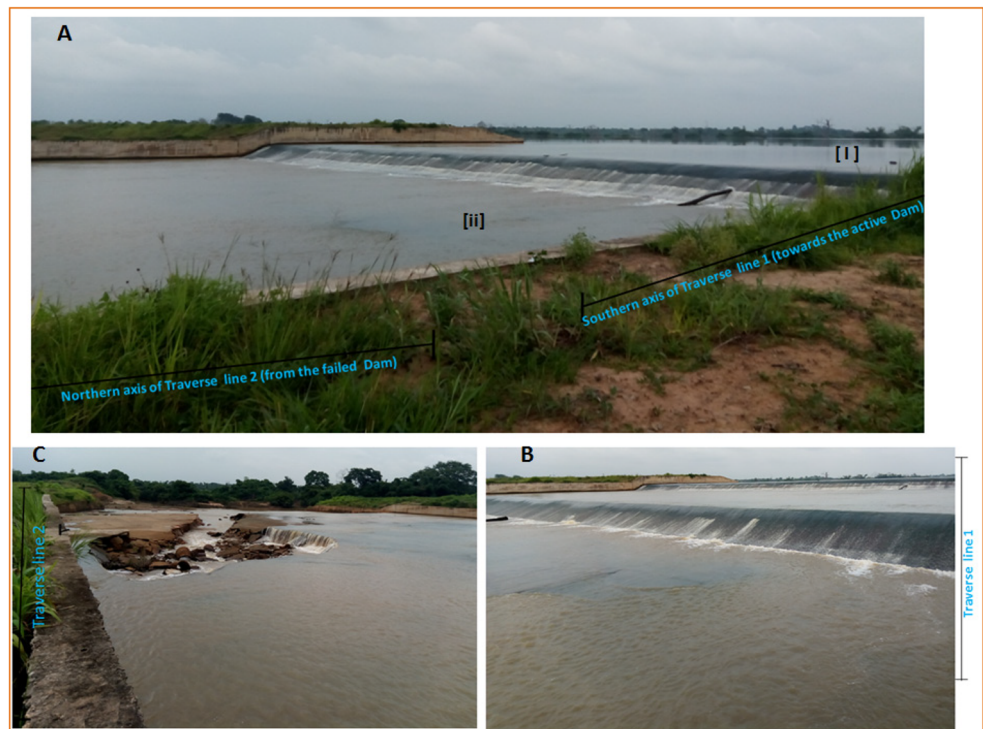
Fig. 1 The dammed water reservoirs. **a** Axis showing the downstream end of traverse line 1 between reservoir I (R-I) and reservoir II (R-II) and the upstream edge of traverse line 2. **b** Embankment demarcating reservoir I and II. **c** Downstream edge of traverse line 2 along the failing section of the dam by the tail water (R-III)

For the fact that these bedrocks underlie the supposed zone of foundation influence, the subsurface image of the damsite was outlined for forensic assessment, particularly, to verify major cause of sagging at the tail water axis (see Fig. 1c).

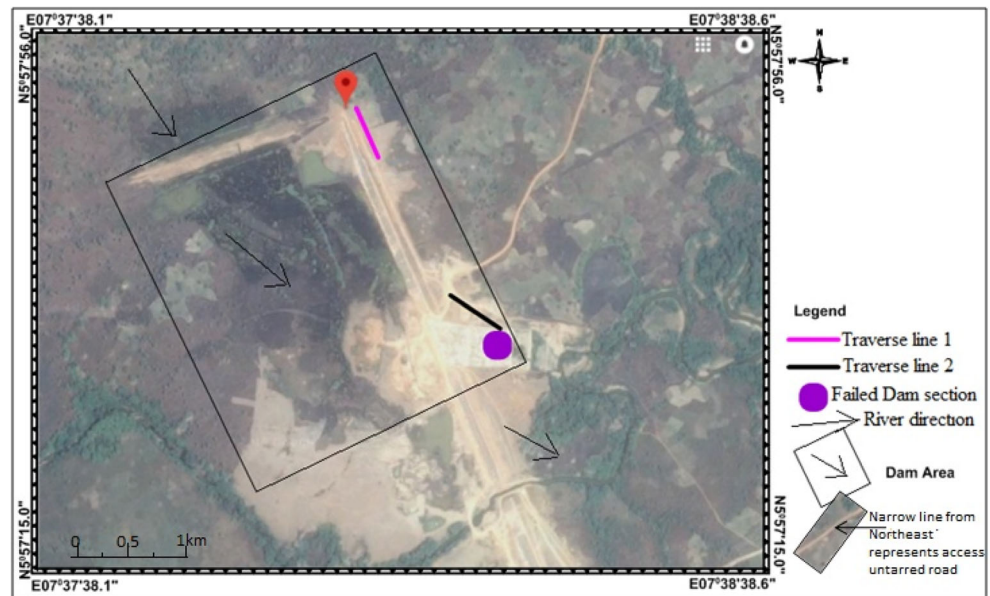
Fig. 2 Google Earth imagery of the damsite at a syncline where Asu River Group overlapped with Ezeaku Group (with a NE-SW fracture trace crossing an untarred road at the Northeastern part of the image)

field expression of a fracture trace identified towards northeast of the landscape view of the damsite (see Fig. 2). Typically, the linear features constitute structural weak zones between bedrocks (Prucha 1992; Tiren 2012) but the rock mass, mainly the Asu River Group, was manually confirmed as hard by breaking the outcrops in more than one (1) hammer blows, unlike that of Ezeaku Group that was broken in a single stroke. The Asu River Group is getting jointed with intense weathering of matrix where it has been exposed to chemical alterations or ferruginization (Fig. 5I), yet, its fresh shale occurred massively in hard flakes (Fig. 5II) but in hard seam-like formation (Fig. 5III). The fresh shale was quarried around Mpu district (Fig. 5IV) for chipping and aggregate materials, hence, would relatively be proved as indurate. However, the overlying unit B was identified as flaggy (Fig. 6I), highly fissile (Fig. 6II), slickensided (Fig. 6III) with siltstone

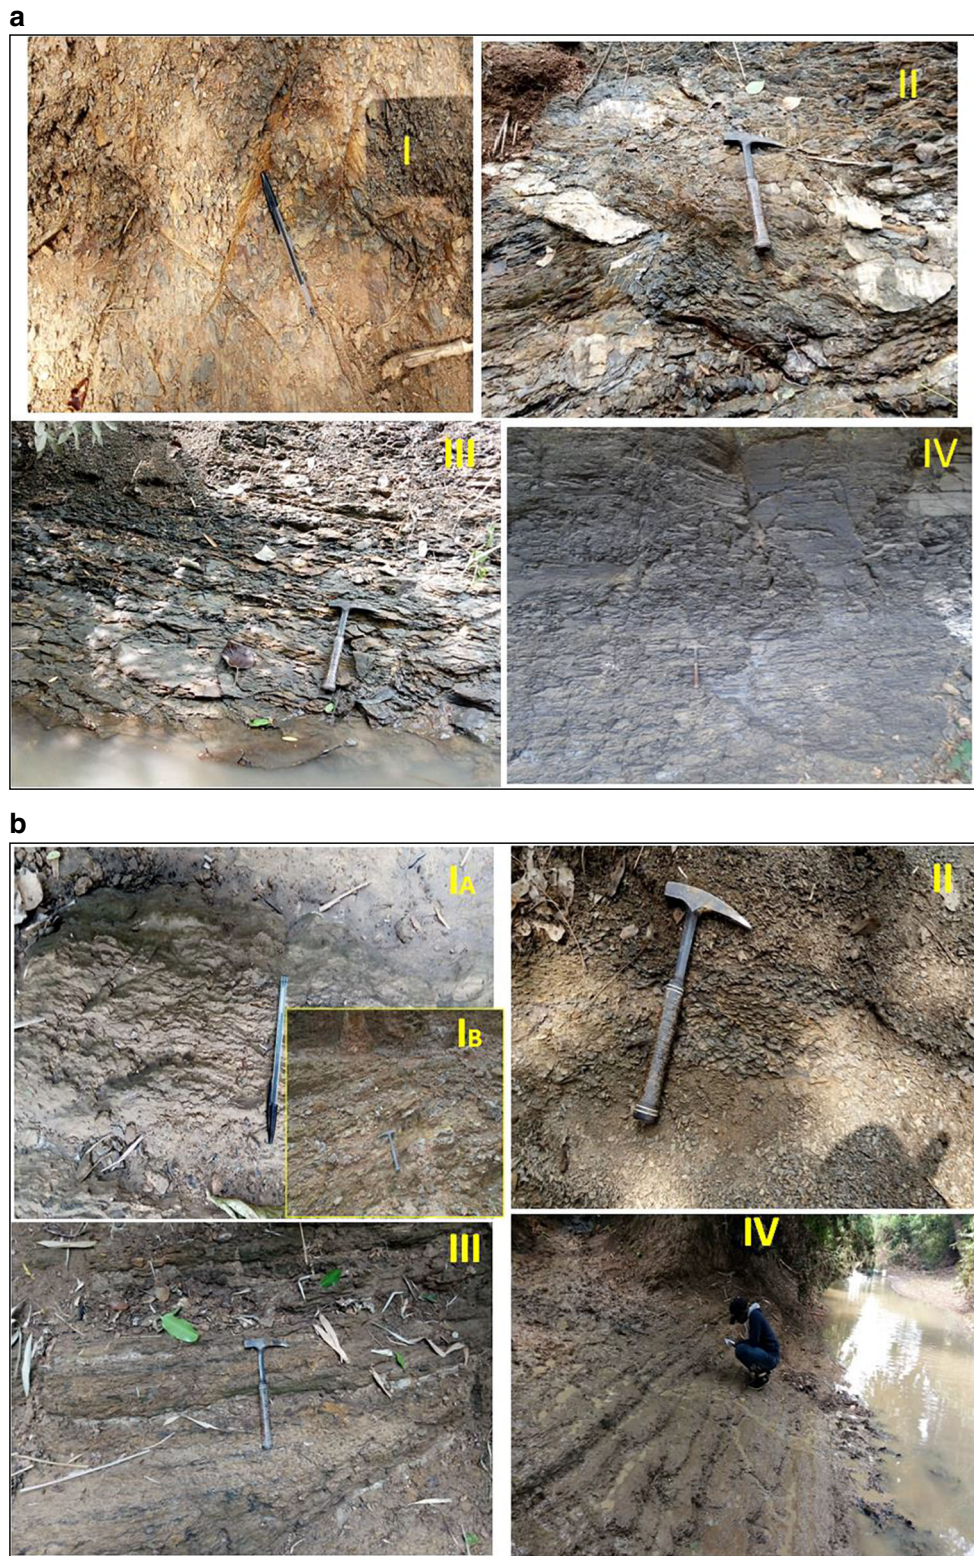
Fig. 5 a Outcrops of Asu River Shales. (I) Highly ferruginized shale in Iza Ovum (OU/L2); (II) micaceous and in hard flakes (OU/L17); (III) in hard seam-like form at upstream river bank of the dam site (around OU/L15); (IV) bluish colored at a derelict quarry pit near Okpanku Area (OU/L3). **b** Outcrops of Ezeaku Shales. (IA) Clayey, laminated, and flaggy around Aguenyi area (OU/L5); (IB) siltstone outcropping in Ezeaku Group along

traverse 2 (OU/L1) near tailwater section; (II) fissile at eastern boundary between Ezeaku and Asu River Group; (III) iron-stained, dark-gray carbonaceous, slickensided shale with siltstone lens at downstream axis of the dam site (OU/L1); (IV) slickensided with interbedded siltstone lenses at Okwa Ovum River Bank around Onovo-Obeagu

Reaction in Eqs. (13) and (14) is possible because the pore water (solution) is more alkaline by which oxidation of Fe takes place. Evidence of iron oxides can be explained by brownish and red colors as mainly seen in Fig. 5I and signifies rusts (Duarte et al. 2018) such as the product of Eq. 13, i.e., Fe_2O_3 (hematite or iron [III] oxide) being a common feature of alkaline corrosion of steel (Bignold 2003). This corrosion was mainly ignited because Fe_2O_3 is water adsorption medium (Kvamme et al. 2012), although could get hydrated to $2\text{Fe}(\text{OH})_3$ (see Eq. (14)) and precipitated out of solution at higher

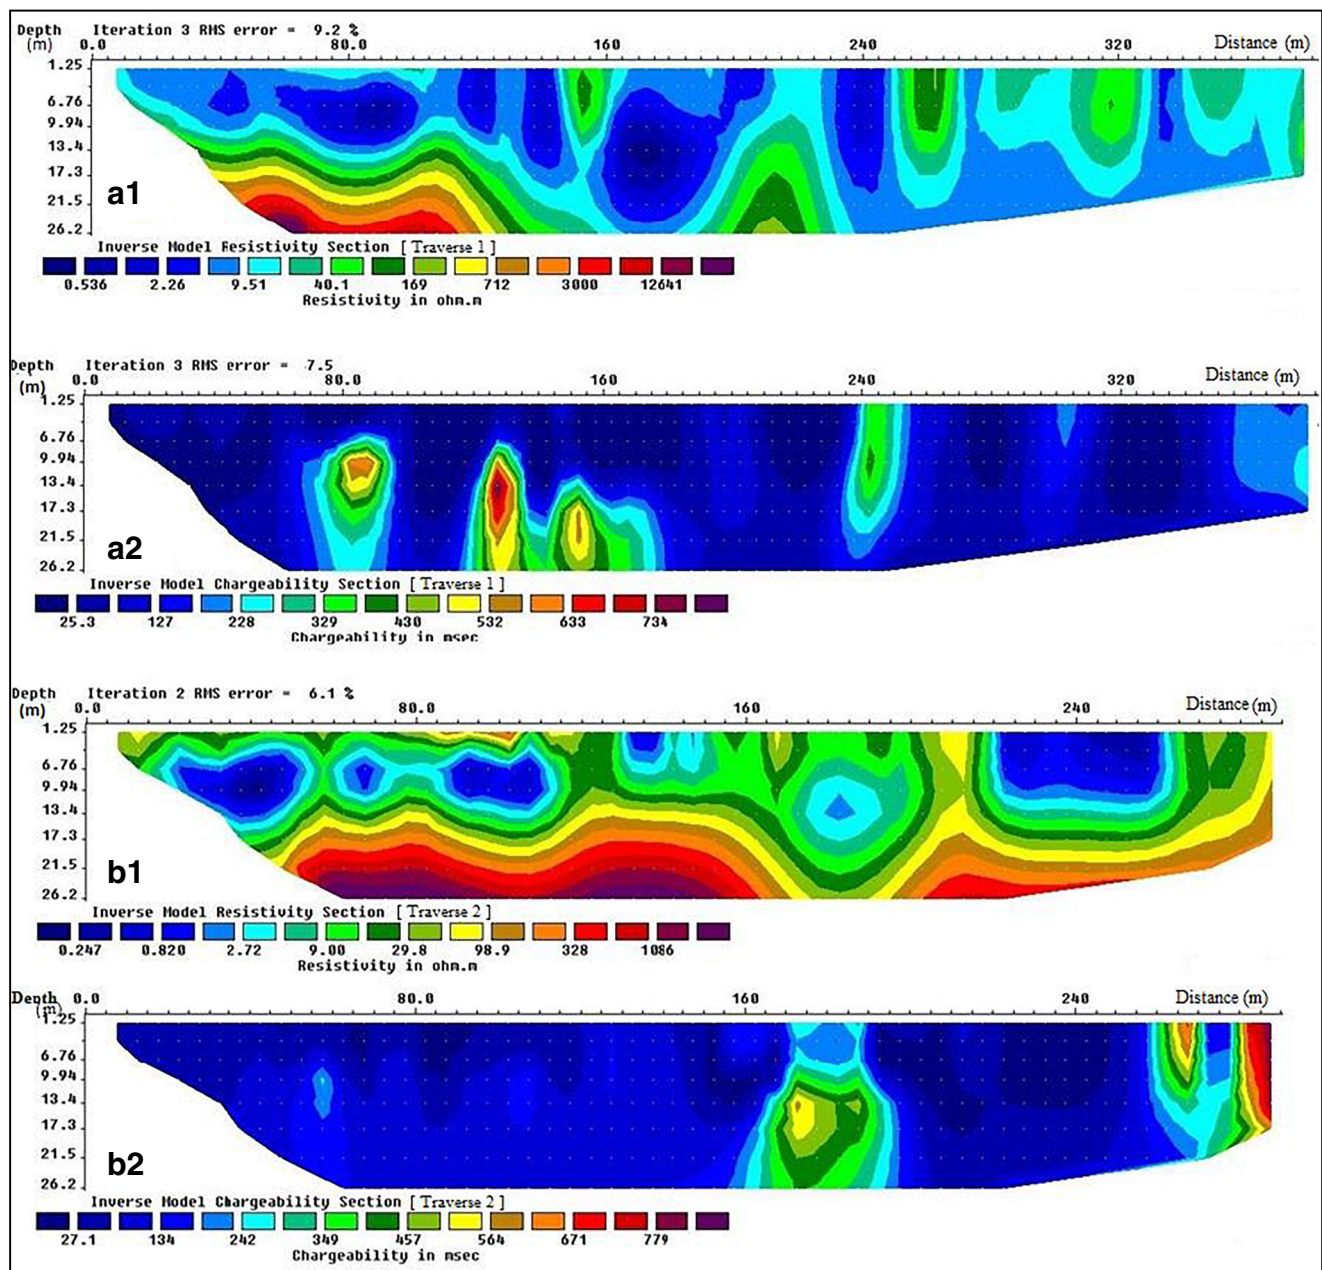
that the layer earlier interpreted as clay is a mixed argillaceous unit that comprised siltstones (see Fig. 6IB). Furthermore, results of the 2D VES-IP (see Fig. 9) showed pseudosections which delineated discrete low chargeabilities with deeply dark

blue band (Fig. 9A2) coinciding with dark blue band for extreme low resistivity anomalies (Fig. 9A1) along the geoelectric pathway earlier deciphered and validated as silty/clayey unit. By implication, the extremely low resistivity (dark blue)

Fig. 8 Tomographs. (A1) Apparent resistivity pseudosection for traverse line 1. (A2) Apparent chargeability pseudosection for traverse line 1. (B1) Apparent resistivity pseudosection for traverse line 2. (B2) Apparent chargeability pseudosection for traverse line 2

sandwiched within blue background of low resistivity (Figs. 9A1 and B1) signified pore water mounds (i.e., the dark blue) confined within the clay/siltstone layer (represented in blue band). According to Gance et al. (2015), argillaceous units like clay/silt reflect low resistivity, whereas Rehman et al. (2016) reported that the argillites reflect high/moderate chargeability. Analogically, clay minerals reflect low resistivity, as well high or even moderate chargeability. As Ukpai and Okogbue (2017) had noted that very low resistivity is a sign of pore water concentrated with chemicals, mainly salt, it is safe to deduce that the mixed clay/silt layer infused pore water to the foundation of the dam.

It is important to note that high resistivities in Fig. 9A1 and B1 from 169 to 1086 Ω m portrayed the bedrocks with relative discrete high chargeabilities in Fig. 9A2 along traverse 1 as similarly seen in Fig. 8, but the bedrocks reflected low chargeability signal along traverse 2 (see Fig. 9A2 and B2), signifying that bedrock of Ezeaku Group is highly argillaceous. However, high chargeability anomaly is observed at the distance of about 200 m, near the tail water axis along traverse 2, and coincided with low resistivity anomaly at same distance (compare Fig. 9B1 and B2), hence, indicated confined pore water, possibly concentrated with dissolved solutes. Moreso, at about 240 m along traverse 1, a nodule-like

anomaly was identified and protruded from top of the section. This anomaly reflected low resistivity and high chargeability (compare Fig. 9A1 and A2) and was inferred as plume concentrated dissolved solutes that perhaps advected from the water reservoir through the sagging (crack) defect at the tail water axis. Similarly, from points 260 to 440 m along traverse 1, isolated noddle-like anomalies also aligned vertically from top of the pseudosection. These particular discrete anomalies reflect moderate-high resistivity between 40.1 and 169 Ω m but low chargeabilities, and were inferred as traces (trails) of iron residues. Based on the assertion of Berry et al. (2012) who noted that soil-hematite bodies reflect high resistivity and low chargeability, it means that chemicals leak into the foundation zone, especially as most outcrops are banded with iron materials (see Figs. 5I and 6). Justifiably, the concentrated chemicals confined in sediments underlying the dam can be related to ions (or dissolve solutes) flushed by surface flow and seeped into the subsurface through some exposed sandy shale (see Fig. 6II) or silty/clayey sand (see Fig. 5IB) that formed aquitards into the dam foundation.

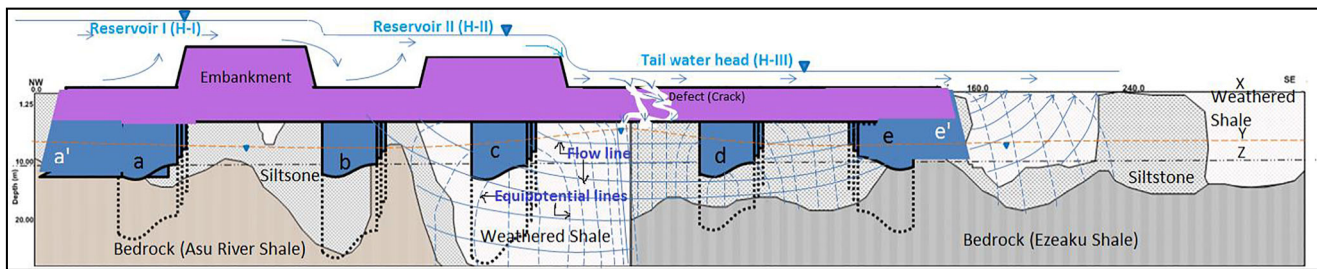
Fig. 9 Schematic representation of geologic and hydrogeologic conditions at the dam site. **a, b, c, d,** and **e** represent piled foundations, and **(a', e')** represent abutments, and **x, y,** and **z** represent ground surface, water table, and initial depth to rock heads, respectively

Presently, as the foundations are just ≤ 10 m deep (see Fig. 10), the dam weight rests on the rock head near the surface where it has been gradually weakened by reaction of dissolved iron to form hematite (Ukpai et al. 2017), as shown in Eq. (13), thus (Roberge 2006):

During rehabilitation measures or in designing a new dam, prerequisite should be taken on the basis of Eqs. (15), (16), (17), and (18). Grouting leakage zone using quality cement of $UCS \geq 20$ MPa can knit with the UCS of the bedrocks. Particularly, jet-grouted diaphragm cut-off wall can water-tighten as much as possible, and in case of constructing new dams, it should be emplaced after wall construction for quality control against defect (Pan and Fu 2020). Although defects in cut-off walls were regularly reported (Tan and Lu 2017; Hwang et al. 2016), attention should be devoted to penetrate the cut-off very well into the leakage axis being treated to prevent deviations. Moreso, further precautions should be keenly taken to avoid variations in the dimensions (lengths or widths) of the diaphragm columns in order to close up the targeted seepage gap. By similar styles of grouting these cut-off walls, Mansuri et al. (2014) proposed hydraulic barriers at dam foundation via sufficient head loss that decreases uplift pressure and reduces the exit gradient. Even so, inclined cut-off wall is better than vertically grouted type. In this respect, the cut-off columns will effectively cover the seepage pathway modeled in Fig. 10, if placed in inclined angles from piles b to d, and from abutment e' into the downstream. Moreso, option of minimizing the initial seepages in blanketing the aquitards by cement treating the composite clay should be considered. It could be expensive (Stephens 2010) but cost-effective, especially in cases of large hydro dams. More remedial approach includes piling into the bedrock to eliminate failure uncertainties, even as $FS \geq 2.5$ would limit settlements empirically.

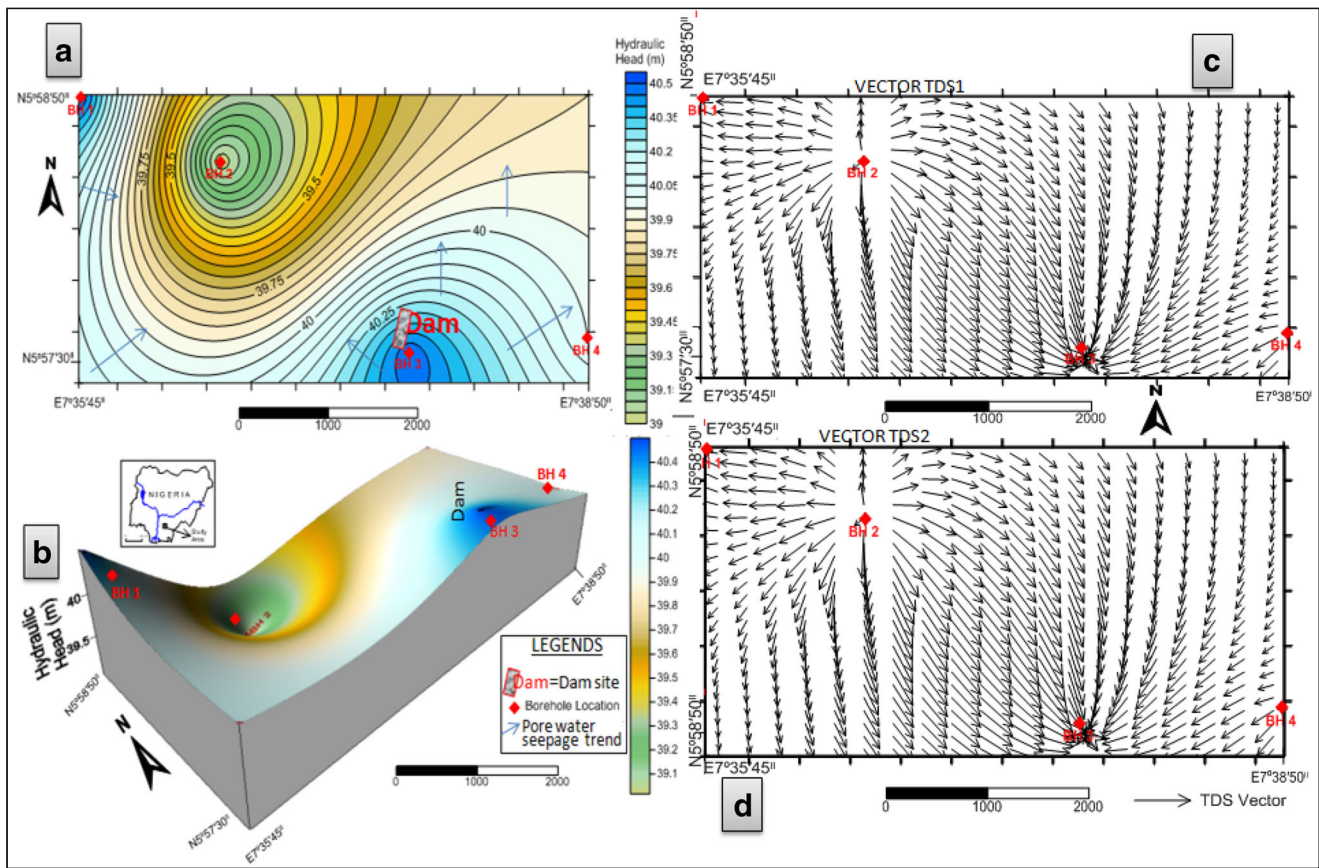
Fig. 10 Maps showing (a) hydraulic head in 2D depicting seepage trend, (b) surface configurations of hydraulic head in 3D, (c) dispersion vectors for TDS 1, and (d) dispersion vectors for TDS 2

It implies that failure modes within the dam were orchestrated by physical condition of the damsite (Mansuri et al. 2014) like the undulated nature of the bearing surfaces due to chemical degradation of the near surface rock heads, as well as the confinement of the seeped water under the dam through a composite aquitard. It is believed thus that at the onset, the aquitards streamlined seepages from its outcrops at upstream vicinities of the dam into the massively weathered boundary zone, between piles c and d (see Fig. 10). Consequently, the hydraulic head was locally heightened at BH 3 nearest to the

dam foundation (see Fig. 11a and b), hence, compromised stability of the dam by developing the crack-forming defect on portion of the embankment where the dam weight rested directly on weathered rock heads. This heaved the foundation columns, resulting in the settling cracks at the tail water axis. Thus, with increasing volume of confined pore water due to vigorous inflow of water from the reservoir into the foundation through the vertical crack, and with increasing pore water mass due to the concentrating salinity from chemical reactions, uplift pressure (P_u) is strongly induced as locally observed at the base of the dam between piles c and d. Seeing that the P_u was built up into the downstream seepage exit around the toe axis (at BH4) against typical setting by which it should have decreased towards the downstream means that the pressure will eventually inflate the dam weight and jeopardize the overall stability.
