Kinematic process and mechanism of the two slope failures at Baige Village in the upper reaches of the Jinsha River, China

On Oct. 10 and Nov. 3, 2018, two landslides, i.e., the “10.10” and “11.3” rockslides, occurred successively at Baige Village, Jiangda County, Tibetan Autonomous Region, P. R. China. The two landslides are located in the upper reaches of the Jinsha River and both dammed the river. Immediately since the slides, the authors have been working on the slides and help disaster reduction. Based on the data collected by April 2020, this paper is aimed at clarifying the geological condition of the slides and at explaining why the slides occurred and what the whole sliding process was. Conclusions are summarized as follows. First, the two landslides occurred in the suture belt of the Jinsha River and the rocks are composed of tectonic *mélange* slices of mainly gneiss intermingled with carboniferous slate and marble and with intruded serpentine and granite porphyry. The gneiss generally bears a schistosity plane with an averaged attitude of N47° W/47°, dipping into the slope. Secondly, long-term geomorphological evolution of the bank slope due to river incision contribut

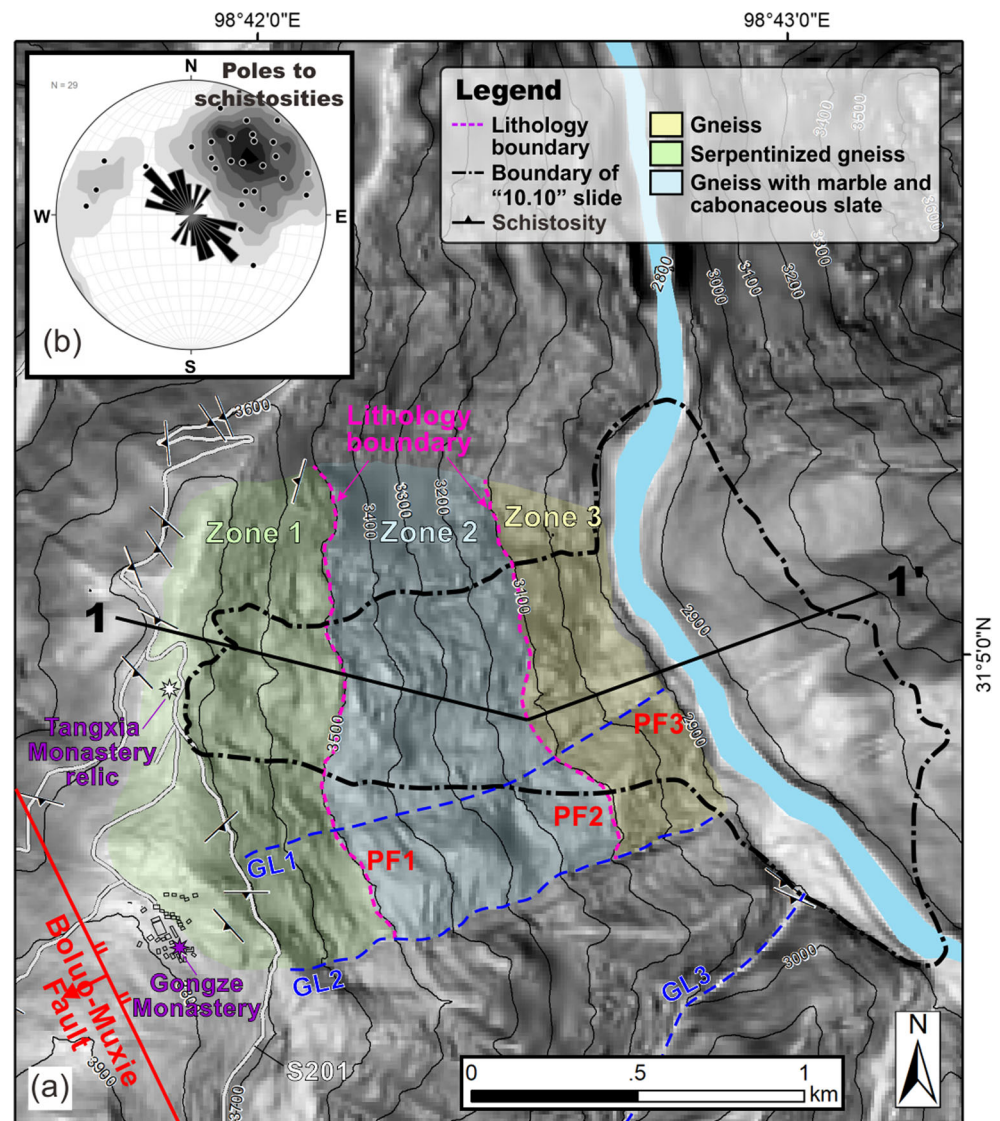
Fig. 3 Geomorphology and geology of the Baige hillslope before the 2018 landslides

The lithological setting indicates that the rock mass quality in the sliding area is poorer than those both in the upstream slope and the downstream slope, which may explain why the “10.10” rockslide occurred at exactly the place. As to rock mass quality, the Zone 3 is composed of rocks with comparatively strong strength and is resistant to a slope failure; Zone 2 is weaker compared to the lower portion; and the rock in Zone 1 is the weakest and is favorable to a sliding. Attitudes of 27 schistosity planes were measured during field investigation (Fig. 3b). Except for the schistosity plane, no preferential joint is well developed.

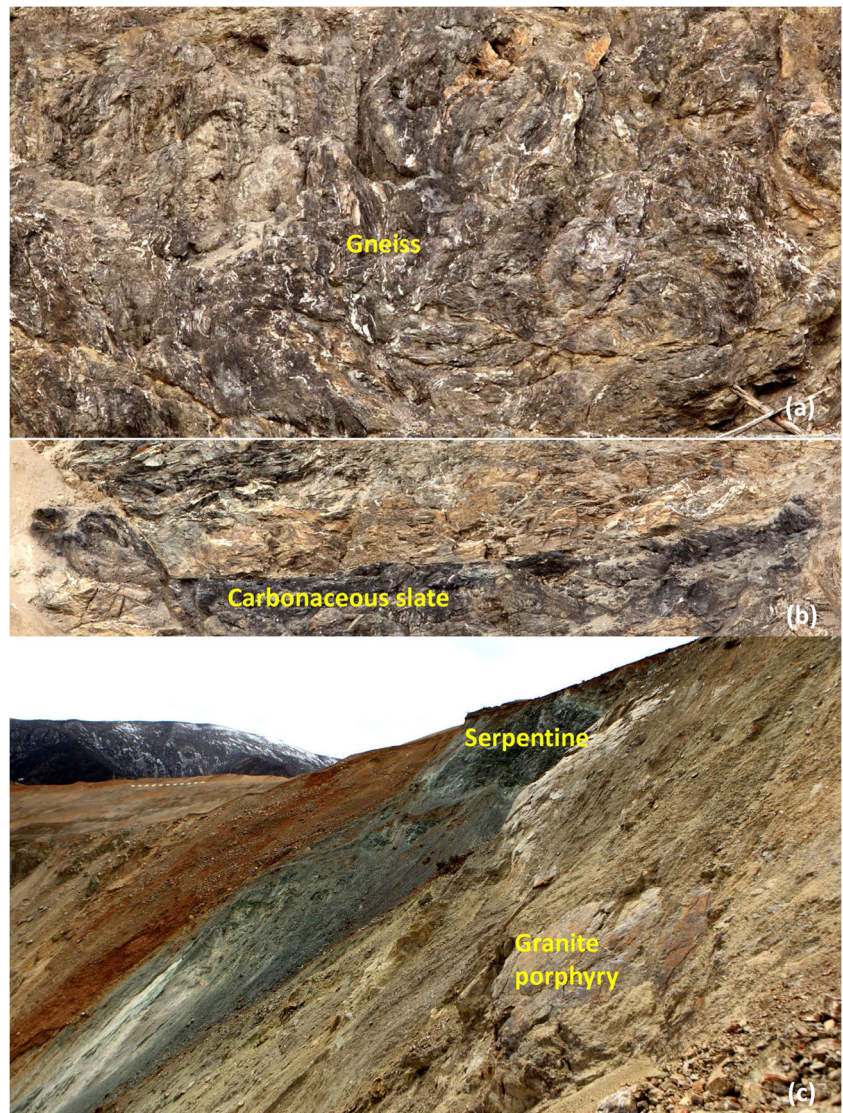
Fig. 4 Characteristics of bedrocks in the sliding area. See Fig. 6 for the locations

Bedrock in the sliding area is mainly gneiss of the Xionsong group (Ptxn^a). However, due to the periodically tectonic movements of the Jinsha River suture belt, the gneiss is separated into *mélange* slices (Fig. 4a). Blocks of carbonaceous slate and marble exist locally and are in contact with gneiss by small faults (Fig. 4b). Serpentine and granite porphyry can also be found in the sliding area (Fig. 4c).

Except the gneiss, other rocks are distributed quite locally. Serpentine is mainly located around the left portion of the main scarp of the slides and is completely weathered (Fig. 4c); granite porphyry appears as dykes along the schistosity planes of the gneiss mainly at the left (Northern) boundary of the slides, and its thickness varies from tens of centimeters to a few meters. It can also be found in the fractured rock at the right portion of the main scarp, and the thickness is only tens of centimeters. Granite porphyry is not metamorphosed or altered, but moderately weathered, suggesting that it was most likely to be intruded in the Yanshan Phase; carbonaceous slate is concentrated at the platform PF1 at the right (Southern) boundary, and small slices can also be found in other parts in Zones 2 and 3; marble can only be occasionally found in the source area; however, it is quite common beyond the right boundary and below the platform PF1.

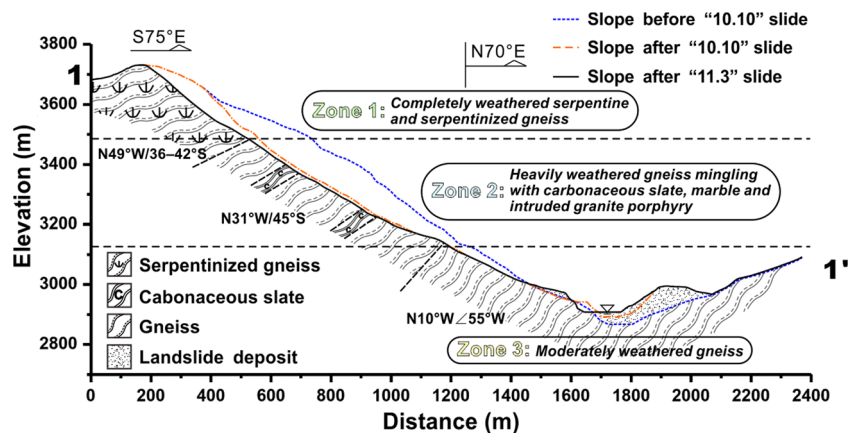
Fig. 5 Cross section 1–1' of the “10.10” rockslide

Even though the tectonic background, the gneiss generally bears schistosity plane with an averaged attitude of $\text{N}47^{\circ} \text{W}/47^{\circ}$, that is, dipping into the slope (Fig. 5). In accordance

with the three platforms, three lithology zones can also be conceptually divided for the slope in terms of the extent of weathering and alteration. Zone 1 is above the elevation of platform PF1, and its rocks are adversely affected by the intrusion of the ultramafic rock and serpentine ($\varphi_{\omega 4}$), and are heavily serpentinized and completely weathered. Zone 2 is between PF1 and PF2, consisting of heavily weathered rock; and Zone 3 is located below PF2, and its rock consists mainly of moderately weathered gneiss (Fig. 5). The dip angle of schistosity planes reduces gradually from Zone 3 to Zone 1; the angle reaches as steep as 58° in Zone 3 but as gentle as 15° in Zone 1, suggesting toppling deformation of the strata.

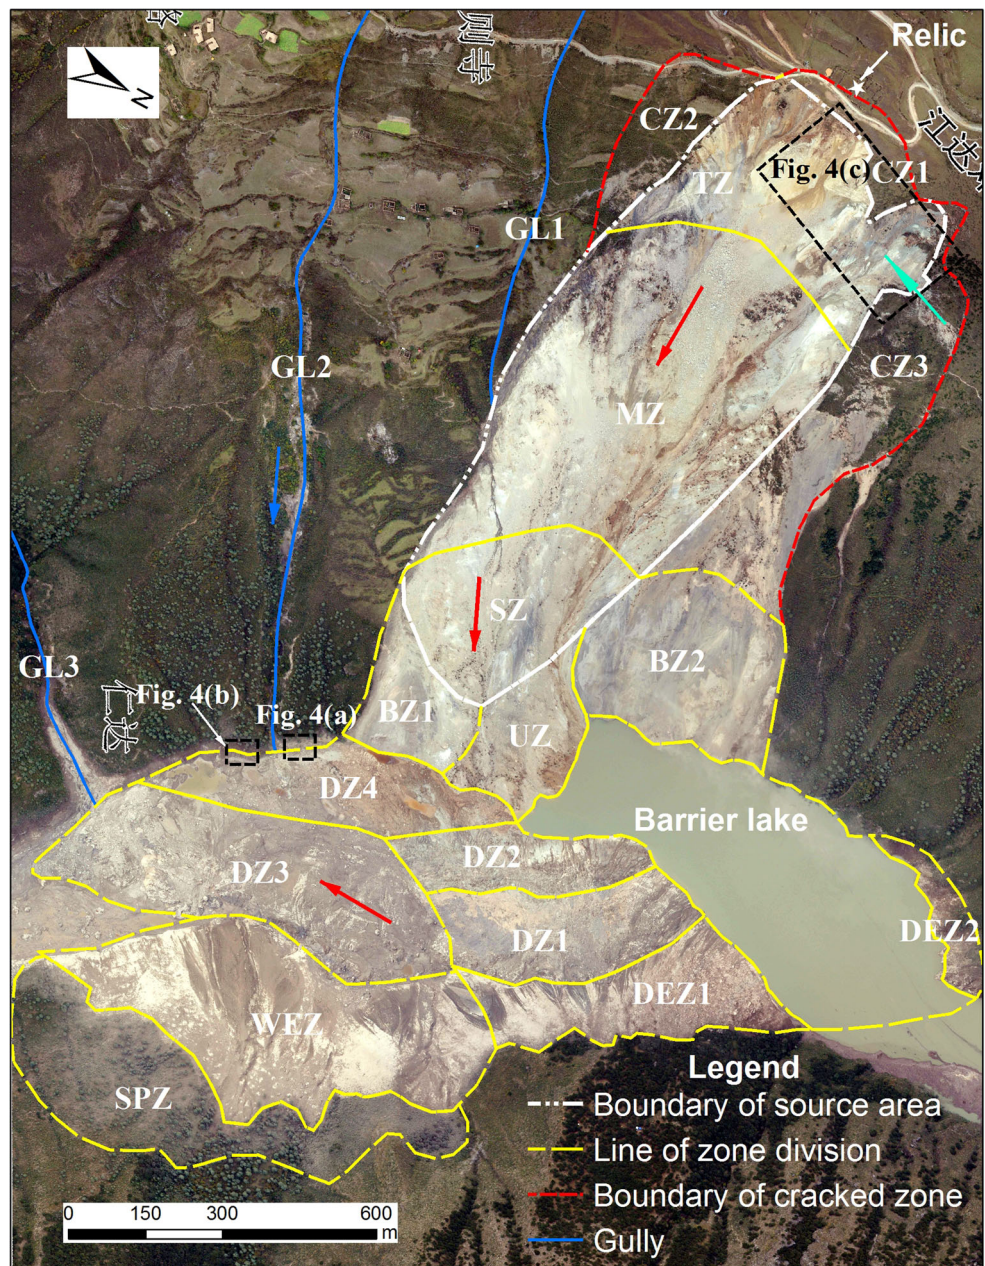
Fig. 6 Orthograph of the “10.10” rockslide

The source area of the “10.10” rockslide, converging at the toe and covering an area of $\sim 575 \times 10^3 \text{ m}^2$, is on the right bank as shown in Figs. 6 and 7a (outlined by dashed double-dot line). Outside the outline and near the toe of the slope, the zones of BZ1, BZ2, and UZ are not taken as part of the source, as they follow different mechanisms and contribute little volume to the source. Formation of the three zones will be discussed later.

After the slide, two newly formed platforms are left respectively at the elevations of $\sim 3500 \text{ m a.s.l.}$ and 3100 m a.s.l. , basically corresponding to the elevations of PF1 and PF2. Thus, the source area is further divided into three zones, i.e., the trailing zone TZ, the major sliding zone MZ, and the sliding-resistance zone SZ, based on their function in the sliding process. The three zones cover an area of $145 \times 10^3 \text{ m}^2$, $330 \times 10^3 \text{ m}^2$, and $100 \times 10^3 \text{ m}^2$, respectively, and the

corresponding volume is $4.6 \times 10^6 \text{ m}^3$, $13.3 \times 10^6 \text{ m}^3$, and $0.8 \times 10^6 \text{ m}^3$, with a total volume of $18.7 \times 10^6 \text{ m}^3$ and an average depth of 32 m.

The sliding-resistance zone is of tetrahedron shape and is composed of comparatively intact gneiss with no continuous and well-developed joints. Its failure plane is slicken sided with little debris left, demonstrating both high stress concentration and ability to resist sliding before the final failure. Based on the slickensides, the zone slides in the direction of $N65^\circ \text{ E}$ and the shear outlet is at the elevation of 2980 m a.s.l. Grass is well reserved below this elevation (Picture P1 in Fig. 7), where the zone is named as the undisturbed zone UZ, even though some debris can be found on its surface. Formation of the undisturbed zone suggests that the initiation of the slide bears a velocity and the debris in the deposition zones DZ1 and DZ2 was projected to the left bank. This inference makes sense as the shear outlet is 100 m higher above the normal water level of the river, and there exists a cove in the barrier

lake between UZ and DZ2 (Figs. 6 and 8). The initial velocity resulted from the abrupt energy release in the sliding-resistance zone, similar to strain-type rock burst in mechanism.

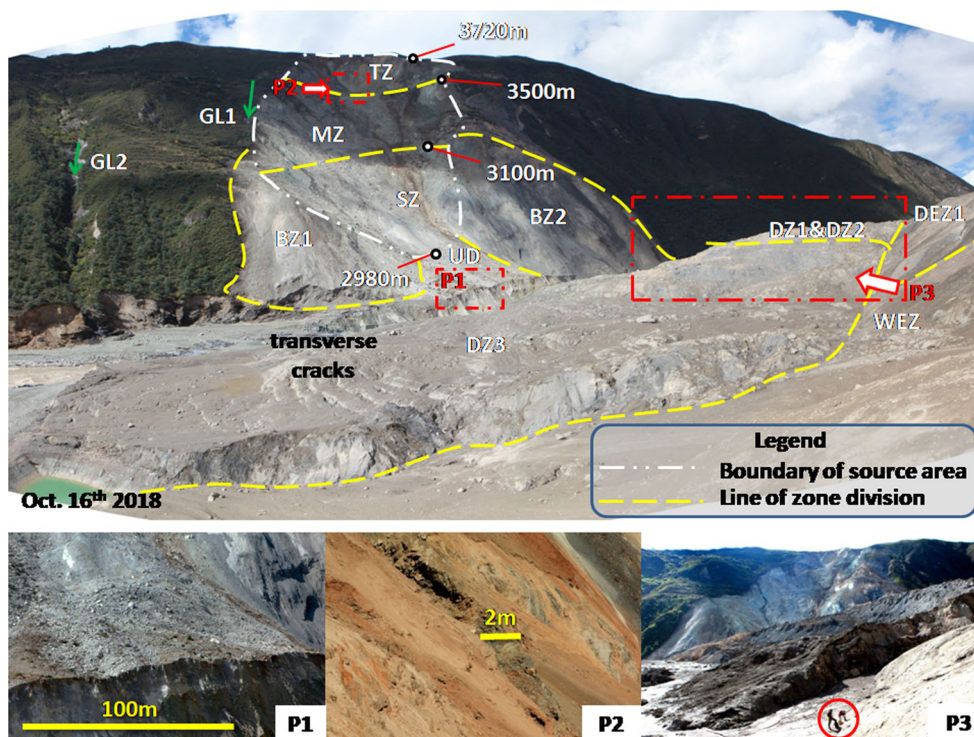
Fig. 7 Photograph of the “10.10” rockslide (mirror to west)

locally, as can be evidenced in the main scarp (Picture P2 in Fig. 7), which is composed of heavily weathered and serpentized gneiss mingled with moderately weathered thin-layer granite porphyry and controls the behavior of TZ and the cracked zone CZ1.

The surface in the deposition area was scoured by both rainfall from the surged water mist and the flow running down from the WEZ. In general, DZ1 and DZ2 were only slightly scoured, whereas the scouring on the downstream zones DZ3 and DZ4 was more severe due to water confluence from higher sites (Fig. 7).

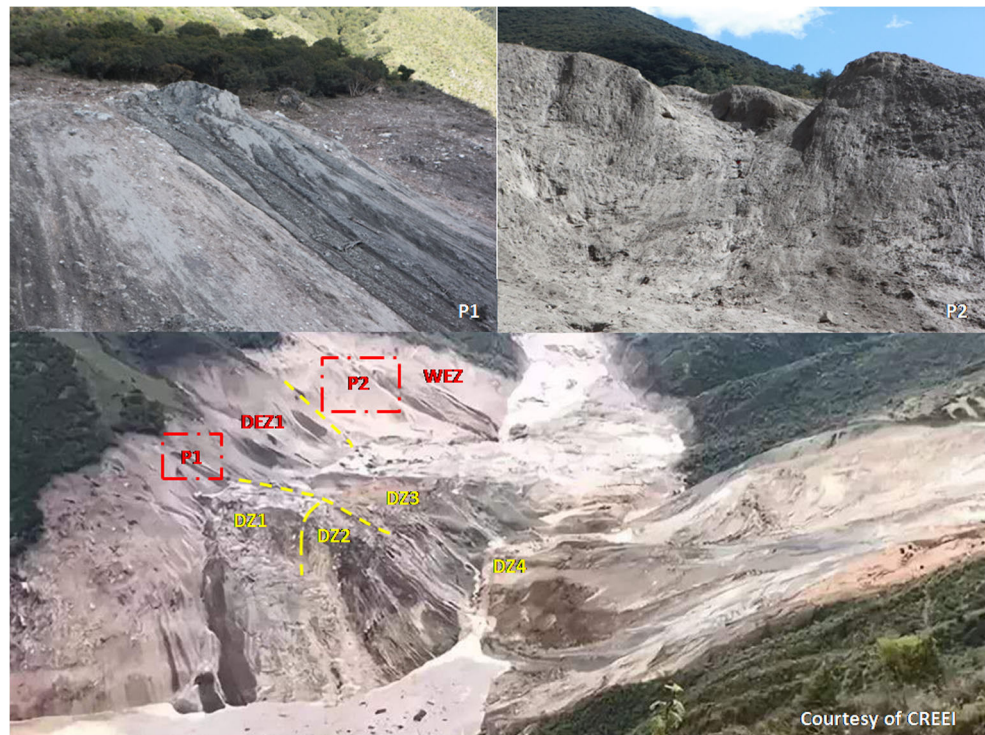
Fig. 8 Distribution of eroded areas on the left bank

Bank erosion is a typical feature of the “10.10” rockslide, and it mainly occurs on the left bank (Sichuan side) as shown in Figs. 6–8. The lower left bank consists in well-cemented colluvium, on which cypress, bush, and grass grow. After the “10.10” rockslide, an area of $285 \times 10^3 \text{ m}^2$ is badly eroded, with rarely any plant kelp. In terms of eroding agents, the eroded area can be divided into two types, i.e., debris-eroded zone DEZ1 and waterjet-eroded zone WEZ. For the debris-eroded zone, downslope slickensides can be witnessed and debris is kept locally (Picture P1 in Fig. 8). The debris can reach as high as 3050 m a.s.l. While for the waterjet-eroded area, only a thin layer of silt is kept along with locally scattered branches and barks of former cypress and bush (Picture P2 in Fig. 8). The waterjet-eroded area is located mainly to the downstream, and its highest point is 2985 m a.s.l. A third zone can also be seen outside the boundary of

began to slip downward under gravity, leaving some debris on relatively gentle steps and resulting strips (similar to slickensides) along the left bank (Fig. 8).

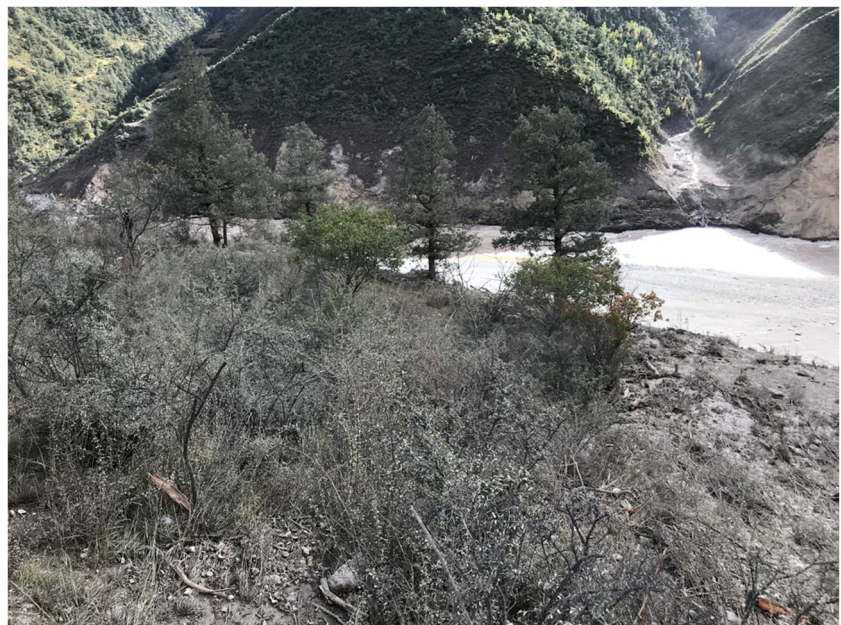
Fig. 9 Cypress and bush polluted by silt in zone SPZ. See Fig. 6 for the location

WEZ, where leaves of cypress and bush are polluted by silt carried by the surged water mist and is thus named as silt-polluted zone, i.e., SPZ (Figs. 6 and 9).

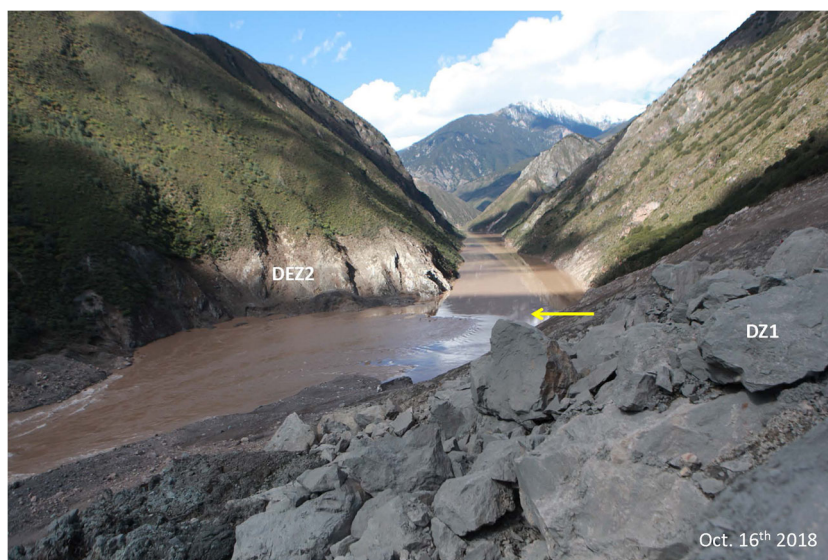
Fig. 10 Characteristics of deposition zone DZ1 and debris-eroded zone DEZ2

For DZ1, moderately weathered gneiss boulders are common, suggesting their origin in the sliding-resistance zone SZ (Fig. 10). While for DZ2, it contains more fines of carbonaceous slate, which should be from the major sliding zone MZ. DZ1 and DZ2 constitute the left portion and also the highest portion of the landslide dam, and their highest point is 3005 m a.s.l.

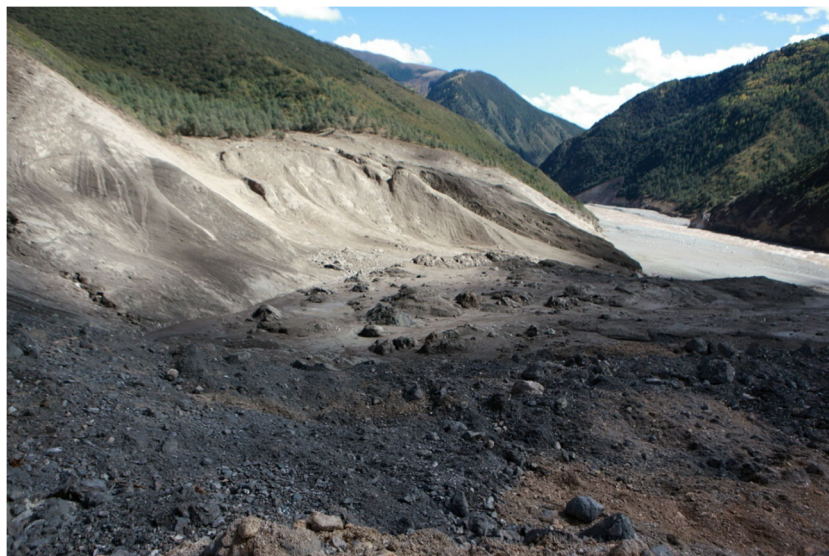
Fig. 11 Debris features in the deposition zone DZ3

DZ3 is a secondary landslide within landslide deposit of the “10.10” rockslide, as can be seen from the three scarps in its upstream and the transverse cracks in its downstream (Fig. 7 and its Picture P3). DZ3 should be part of DZ1 and DZ2 before further sliding, as can be evidenced by the boulders of gneiss and granite porphyry, and carboniferous-slate dominated fines in DZ3 (Fig. 11).

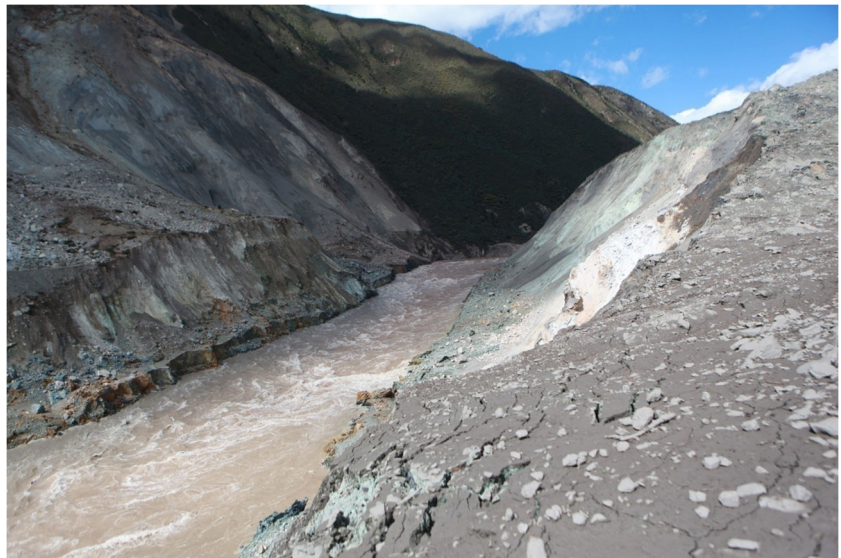
Fig. 12 Photograph of the sluice channel and its left bank debris

overtopping failure of the natural dam occurred at DZ4 on Oct. 13, 2018, and a sluice channel (Fig. 12) was quickly formed by dam-beaching flood. Not much debris was left in the zone after the flood.

The sluice channel is ~1000 m long, ~80 m wide at base, and ~152 m wide at the right wall crest. The heights of the left and right walls are ~76 m and ~52 m, respectively. The right wall is composed of the former colluvium, while the left wall

is of landslide deposit. The left wall is quite stable although some longitudinal cracks can be found behind its crest. No collapse was ever witnessed during field work.

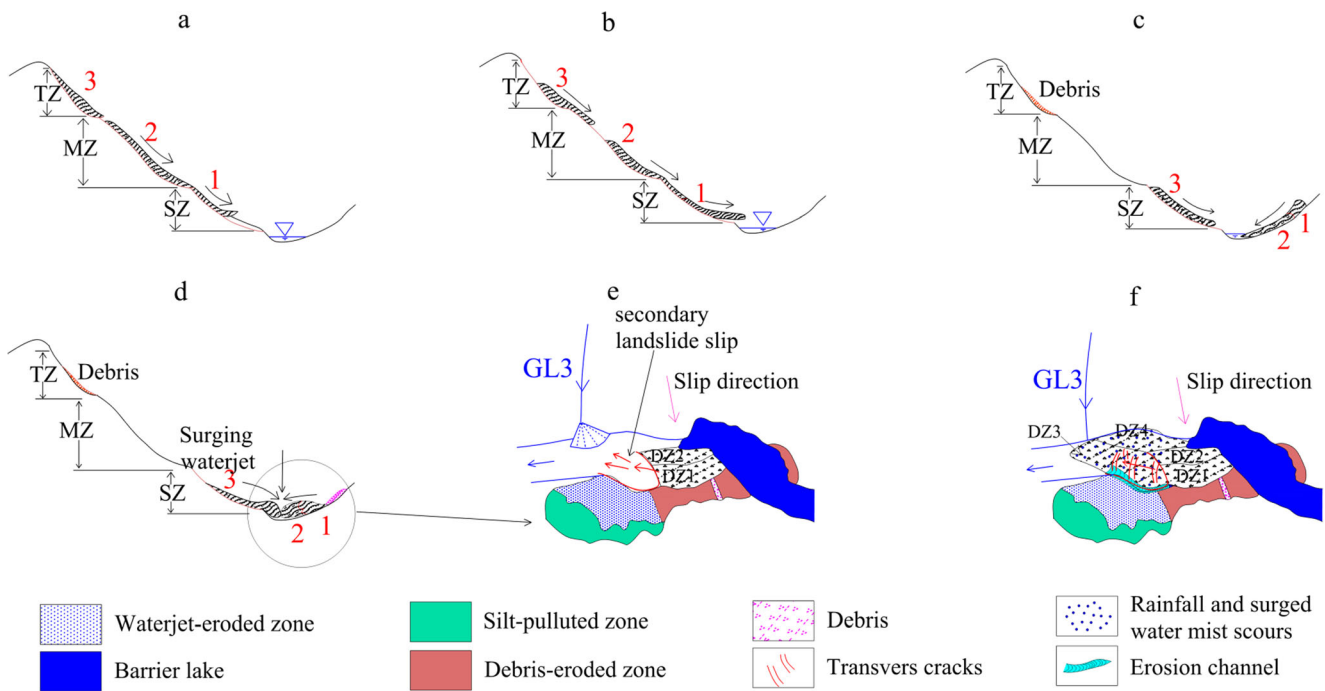
Fig. 13 Kinematic process of the “10.10” rockslide

The deformation initiated from up to down; however, the actual sliding process is just converse. Based on the features in the deposition area and the eroded left bank, the kinematic process of the slide can be divided into six steps (Fig. 13).

The sliding-resistance zone was firstly sheared off, and the sudden energy released from the brittle failure makes the sliding-resistance zone SZ and the major sliding zone MZ slip out with an initial speed. The movement was initially towards the direction of $N65^{\circ} E$; then the moving direction changed to $S75^{\circ} E$ due to the inertia of the major sliding zone, which eroded PF3, leading to the broadening of the shear outlet and the exposing of the bedrock zone BZ1.

By losing the support from the major sliding zone, the trailing zone began to collapse and gravitationally moved downward along the direction of $S75^{\circ} E$. As the trailing zone is mainly composed of completely weathered rocks, its sliding bears no initial velocity. That is, its velocity is much lower than that of the major sliding and sliding-resistance zones, so its deposition is at the toe of the slope (DZ4). The debris slid directly, overtopping the bedrock zone BZ1 and making it further eroded.

After startup, the major and sliding-resistance zones were projected at an initial speed that then accelerated under gravity. Finally, the landslide body bumped the left bank (Sichuan side) at high speed and run up the left bank for ~ 70 m. The bumping leads to the further fragmentation and side-spreading of the debris, resulting in the debris-eroded zone DEZ1 (Fig. 6). Due to the convex shape of the left bank, partial debris moves upstream to the right bank (Tibet side), forming a small debris-eroded zone DEZ2 (Figs. 6 and 10). When the debris reached the highest point (3050 m a.s.l.) on the left bank, it

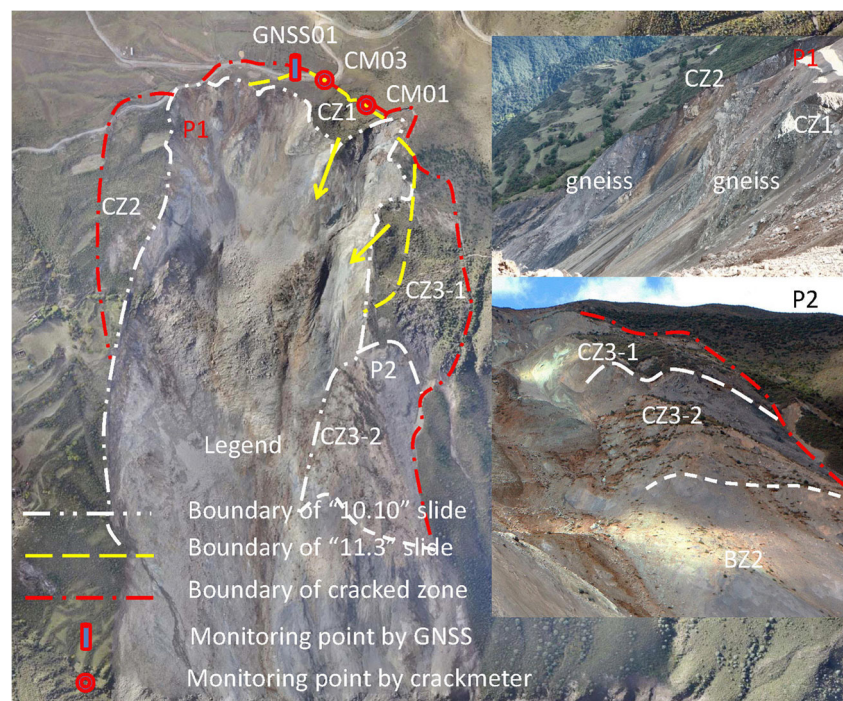
Fig. 14 Distribution of the cracked zones and the boundary of the “11.3” rockslide

After the “10.10” rockslide, there exist three cracked zones CZ1, CZ2, and CZ3 beyond its boundary, constituting

potential portions for a further sliding (Figs. 6 and 14). The area of CZ1, CZ2, and CZ3 is $52 \times 10^3 \text{ m}^2$, $66 \times 10^3 \text{ m}^2$, and $130 \times 10^3 \text{ m}^2$, respectively, and the estimated volume is $4.6 \times 10^6 \text{ m}^3$, $1.5 \times 10^6 \text{ m}^3$, and $2.6 \times 10^6 \text{ m}^3$, respectively.

CZ2 is similar to CZ1, and there exist fractured rock lumps at its toe (above 3500 m a.s.l., Picture P1 in Fig. 14). But the slope in CZ2 is much gentler than the main scarp in CZ1. CZ3 actually comprises two small sliding blocks overlain by shallow overburdens (Picture P2 in Fig. 14). The first one CD3-1 is located above the platform PF1, and the second one is located between PF1 and PF2. Both CD3-1 and CD3-2 have been deforming rather fast, and their depths are confined in-depth, respectively, by intruded granite porphyry and moderately weathered gneiss. Majority of CZ3 deforms in the down-slope direction, demonstrating an independent deformation. The debris, collapsed at its toe, eroded the surface of the lower slope, forming the bedrock zone BZ2. Only the portion adjacent to the source area of the “10.10” rockslide deforms towards the groove.

During field investigation, no collapse ever occurred along the boundary of the “10.10” rockslide. It is so at the main scarp, even though it is quite steep and high. Deformation of the cracked zones was monitored by both crackmeters and Global Navigation Satellite System (GNSS) during emergency response and results indicated that the deformation tends to cease and the cracked zones are not prone to a landslide (Fig. 15). Unfortunately, on Nov. 3, 2018, part of the CZ1 and CZ3-1 (Fig. 14) slid down and the Jinsha River was dammed again as shown in Fig. 16.

The slide occurred at around 15:40. The sliding portion in CZ1 and CZ3-1 covers an area of $30 \times 10^3 \text{ m}^2$ and $19 \times 10^3 \text{ m}^2$, respectively, and the calculated volume is around $2.8 \times 10^6 \text{ m}^3$, based on the DEM before and after the “11.3” rockslide. Adding the entrained debris in the groove, total volume can attain $6.3 \times 10^6 \text{ m}^3$.

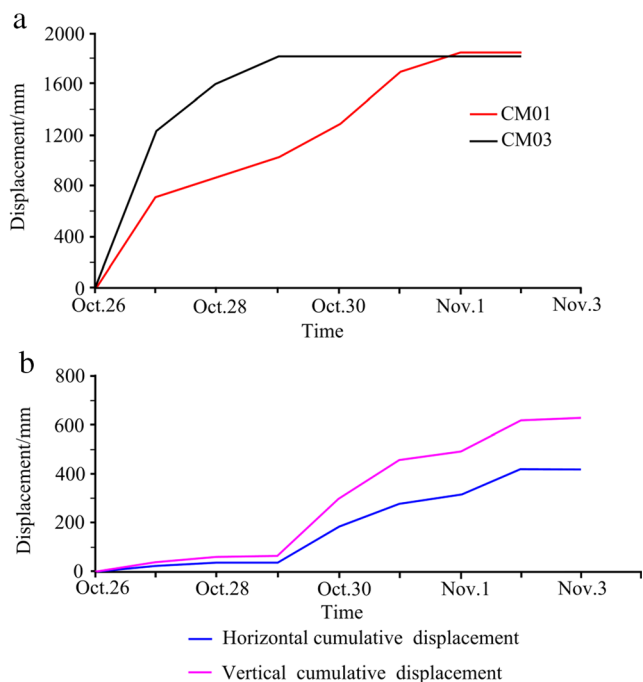
Fig. 15 Monitored displacements by GNSS and crackmeters before the “11.3” rockslide. See Fig. 14 for the location of the instruments

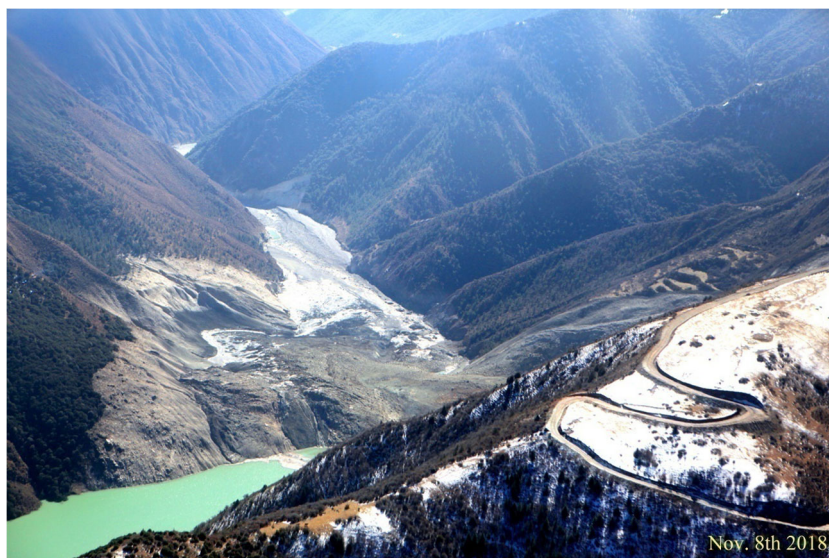
Fig. 16 Photograph of the landslide dam produced by the “11.3” rockslide

The deposition area is mainly distributed on the sluice channel of the “10.10” rockslide (Fig. 16), due to the relatively lower speed and smaller volume of the slide. The area is quite similar to DZ4 of the “10.10” rockslide, but the elevation of the new dam is much higher. The bealock of the new landslide dam is still at the right side, and its elevation can attain as high as 2967 m, ~36 m higher than that of the “10.10” rockslide. As a disaster reduction measure, an artificial channel was excavated, starting at night on Nov. 8, 2018, and ending at 11:00 on Nov. 11, 2018. The artificial channel follows basically the sluice channel of the “10.10” rockslide, and its bottom elevation is 2952.5 m. Flood passed through the channel at approximately 10:50 on Nov. 12, 2018, and the river’s flow rate returned to a normal value of $700 \text{ m}^3/\text{s}$ at 7:40 on Nov. 14, 2018. A new sluice channel was formed as shown in Fig. 17.

Waterjet is also surged by the debris, but its projected distance is not as long as the “10.10” rockslide (Fig. 16). The debris was fluidized too, flowed downstream, and was finally intercepted by the alluvium fan at the estuary of gully GL3. As the source is above the platform PF1 belonging to the

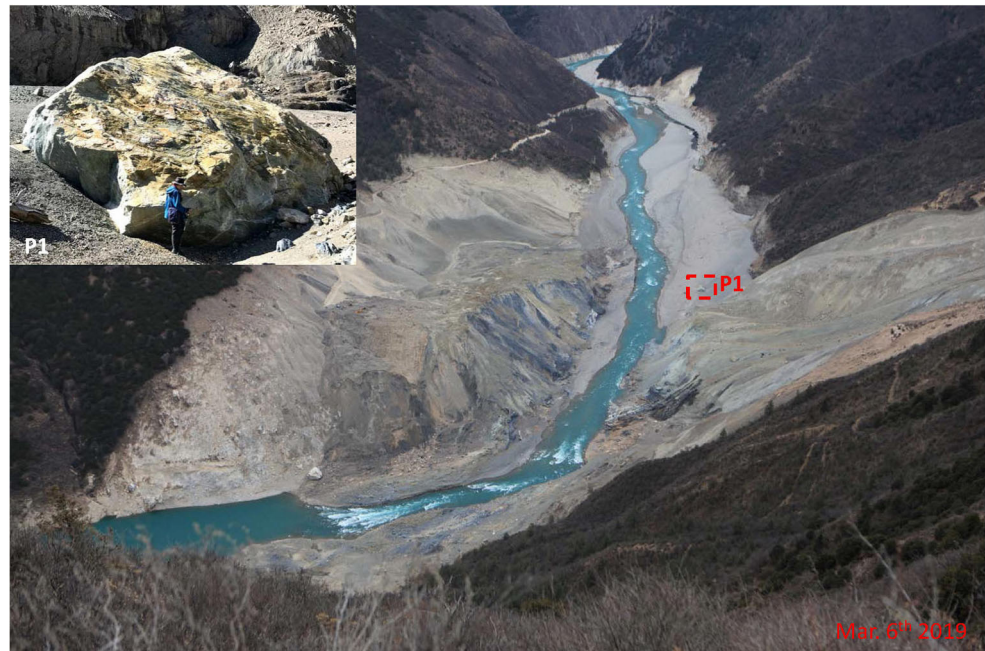
Fig. 17 Sluice channel after dam breaching of the “11.3” rockslide dam

completely weathered Zone 1, the debris is basically fine-grained gneiss and serpentine. However, a huge boulder of granite porphyry exists locally (Picture P1 in Fig. 17), which is originated from the toe of CZ3-1. This may suggest that the sliding of CZ1 and CZ3-1 did not occur simultaneously and the debris from CZ3-1 lags behind that from CZ1, as can be evidenced by the rock types in the deposition area. The sliding direction of $\sim S75^\circ E$ corresponds to the route of the major sliding zone; as a result, the surface of bedrock zone BZ1 was further eroded and the failure outlet is further broadened.

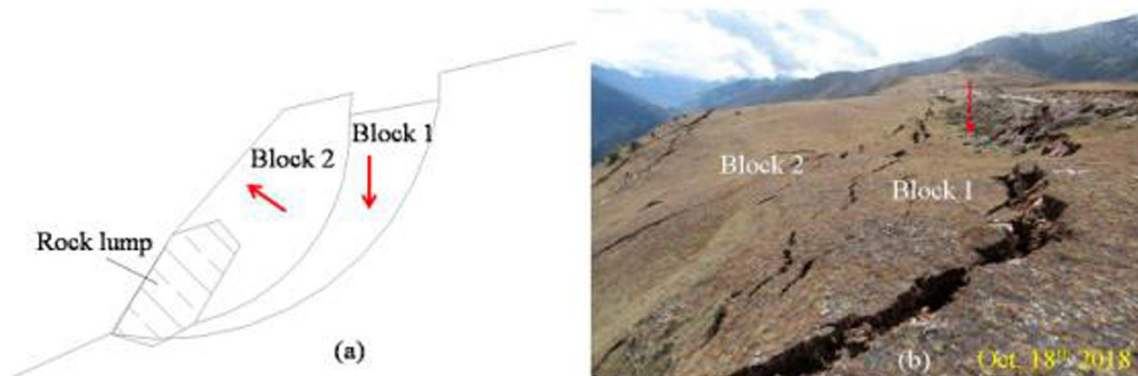
Fig. 18 Schematic failure model and photograph of the “11.3” rockslide

The mechanism of the “11.3” slide can be shown in Fig. 18a. The failure mode was first proposed by Min et al. 2005. In the failure mode, the fractured rock lump behaves as a retaining wall and cannot be easily sheared off. But due to its existence and the valley ward deformation of the potential sliding mass in the cracked zones induced by the “10.10” rockslide, the sliding mass may disintegrate into two blocks (Blocks 1 and 2 in Fig. 18a). Block 1 may subside under gravity, acting as a wedge and making Block 2 revolve. The gradual revolving of Block 2 will reduce both the compressive stress and the shear strength at the toe of Block 2, making the rock lump (Fig. 18a) more prone to a failure.

The failure in the cracked zone CZ1 follows this mode, as can be evidenced by the ground subsidence (Fig. 18b) just behind the crest of the main scarp. This type of failure mode may be named as wedge cleaving effect and can easily trigger a landslide without much prior deformation. As to the failure in CZ3-1, debris erosion at its toe is the major trigger.

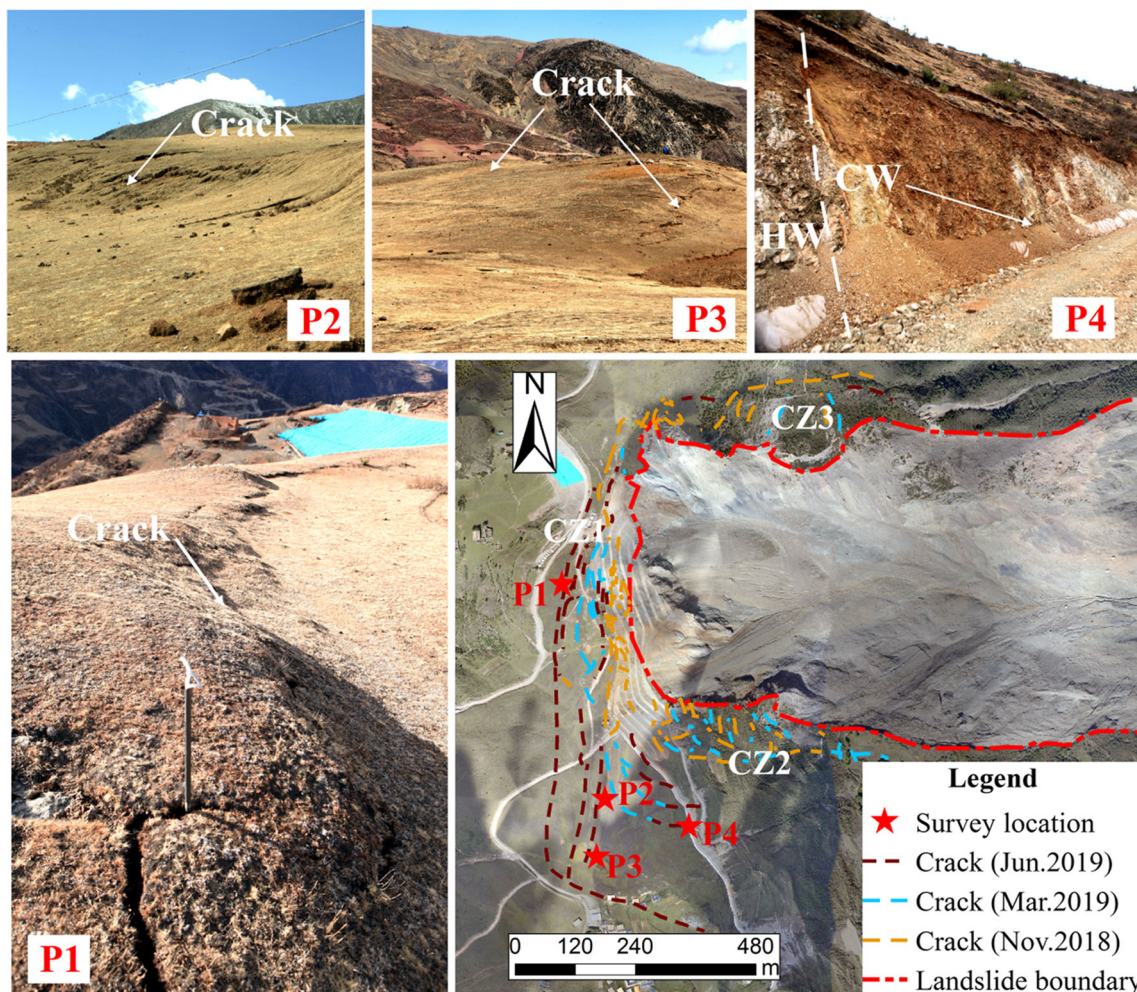
Fig. 19 Development of cracks and their relation with microtopography

After the “11.3” rockslide, a series of new cracks, as shown in Fig. 19, generated behind CZ1 and CZ2 and the generation sustains until June 2019, when all the cracked zones have reached an area of 258×10^3 m² and the estimated volume is $\sim 9 \times 10^6$ m³.

Collapse frequently occurs in small scale from the main scarp during our field investigation. What concerns us most is the future development of the cracking zones, and it seems that the risk of another landslide damming event may happen sooner or later.

In order to reduce the risk, two measures were conducted in the year 2019 besides deformation monitoring. First, soil of 0.56×10^6 m³ was removed from the crest of the main scarp in an effort to lower down the stress concentration at its toe. Secondly, debris of 2.45×10^6 m³ was excavated from the landslide dam and moved to its downstream and to the left bank, so more space is left at the former dam site to reduce the dam height by a potential landslide.

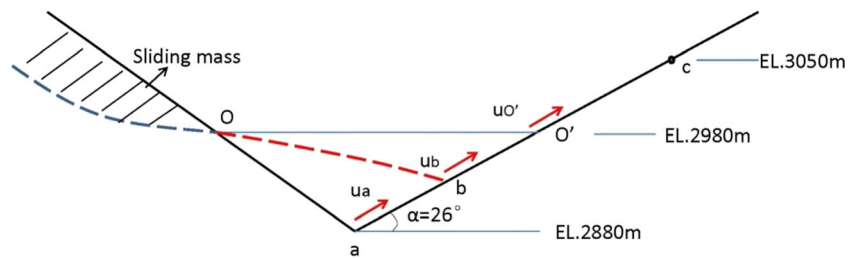
Fig. 21 Schematic view for velocity estimation

With reference to the schematic view in Fig. 21, the upclimbing height is used to estimate the sliding velocity. As suggested by Scheidegger (1973), the velocity can be written as

Two extreme trajectories are assumed. The first one is along the route O-a-b-O'-c, corresponding to the status that the slide starts at rest and the upclimbed height is 170 m. A velocity of $u_a = 81 \text{ m/s}$ is then got. The second route O-O'-c assumes the slide is projected from the shear outlet O to the

point O' , which is at the same elevation of the shear outlet O on the opposite bank. The upclimbing height is 70 m, and the estimated velocity is $u_{O'} = 52$ m/s. The true route is along O - b - O' - c , lying between points a and O' , so the velocity of u_b should be between 52 m/s and 81 m/s.
