# Interpreting the formation mechanism of a complex landslide: a case study of a reactivated landslide of a reinforced embankment slope

Qiuxiang Huang<sup>1,2</sup> · Jialin Wang<sup>1</sup> · Pinnaduwa H.S.W. Kulatilake<sup>2</sup> · Haofeng Guo<sup>1</sup> · Jipeng Shen<sup>1</sup>

Received: 27 April 2023 / Accepted: 17 November 2023 / Published online: 1 December 2023  
© Springer-Verlag GmbH Germany, part of Springer Nature 2023

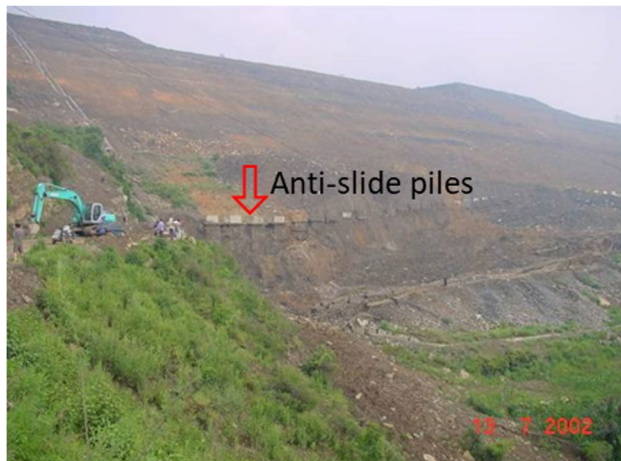
**Fig. 2** Anti-slide piles exposed after a slide occurred in July 2002 (mirror to upslope)

Possibly influenced by the construction, the YJP landslide began creeping with bulging developing in the upper slope part, coincident with cracks appearing in the embankment area, in January 2001. The opening of new fractures on the slope enabled infiltration of rainfall into the slope body resulting in softening and weathering of the sliding mass and a decrease in shear strength. This, was coincident with a rise in precipitation, resulting in a slide at the foot area of the embankment slope about 300 m in width, in July 2002. This instability damaged the constructed anti-slide piles as shown in Fig. 2.

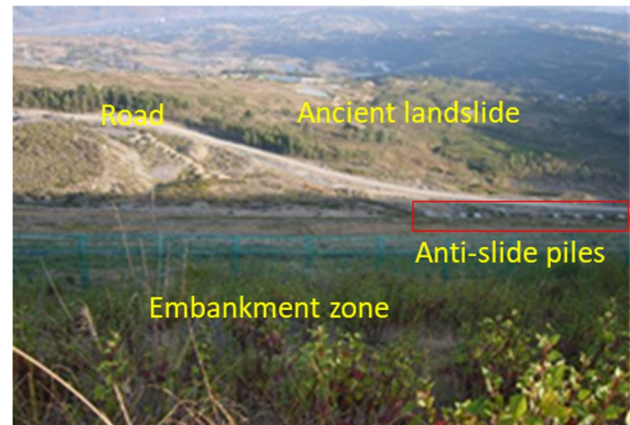
**Fig. 3** Contact relation between the embankment slope and the YJP landslide before failure occurred (mirror to downslope)

were constructed in 2002. Two lines of anti-slide piles were installed at the middle-lower part of the embankment slope, while the third line of the anti-slide piles was installed at the toe area. The two drainage ditches were installed on both sides of the slope to reduce the surface water infiltration into the slope body. Hence, the slope became stable again. The contact relation between the embankment slope and the YJP landslide is shown in Fig. 3.

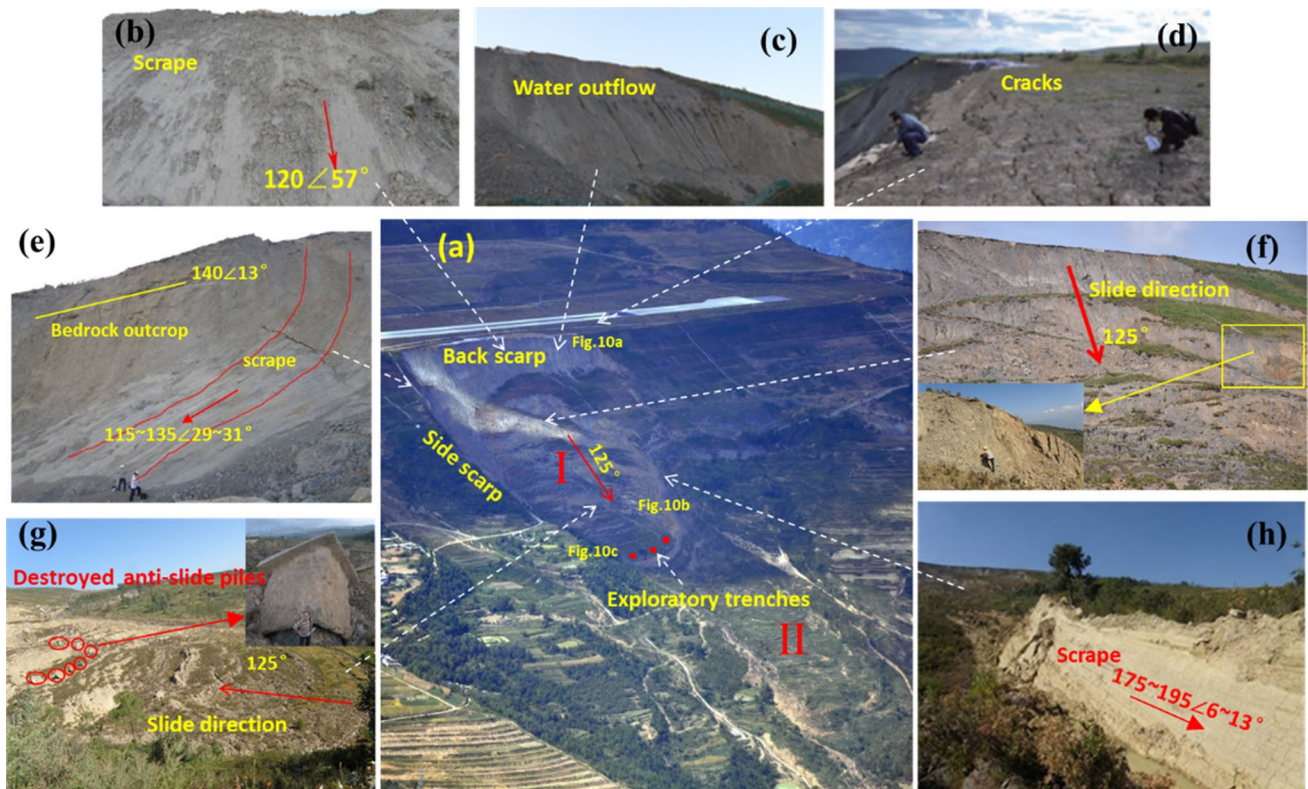
After the embankment instability occurred, rear and flank scarps could be seen clearly. The main back scarp was located at 1975 m a.s.l. with vertical movement of 30–35 m and a head width of 350 m (Fig. 6a), with a scrape of 3–5 mm, maximum value up to 20 mm in depth (Fig. 6b), while successive minor scarps with vertical movements of 5–10 m were observed within the embankment sliding zone (Fig. 6f). Rear south flank scarp had a height of 15–20 m, with bedrock outcrop as the top layer. The attitude of scarps at this position varied differently with a circular shape, having a direction ranging between  $115$  and  $135^\circ$  and an inclination changing from steep to gentle with dip angles of  $29$ – $31^\circ$  in the translational part, as shown in Fig. 6e. This type of phenomena indicated a rotational movement in the rear section of the embankment. Scarp was also obvious in the north flank. Figure 6h shows the characteristics of the scarp on the front middle part of this flank, which is 3–5 m high; the scrapes have resulted from sliding in the direction of  $175$ – $195^\circ$  with dip angles of  $6$ – $13^\circ$  and depth of 2–4 mm.

**Fig. 6** Comprehensive photos show destroyed phenomena. **a** General view of failure zones. **b** Scrape at the back scarp. **c** Water discharge at the back scarp. **d** Cracks at crown. **e** Scrape at the south flank. **f** Sec-

ondary scarps at the back part of zone I. **g** Destroyed anti-slide piles at the lower part of zone I. **h** Scrape at the north flank

near the crown area (see in Fig. 6d). The cracks developed perpendicular to the slid direction, with variable widths, from 2 to 50 cm, and variable vertical offsets from 2 to 40 cm.

With the failure of the embankment slope, the material slipped away, forming smooth walls and scratches on the rear and both flanks (Fig. 6b, e, h). These exposed sliding zones on the surface show that the thickness of the sliding zone is 10–20 cm, and the material of the sliding zone is mainly gray-yellow and yellow-brown silty clay, containing a small amount of strongly weathered sand and mudstone fragments, and the size of individual stones can reach 50 cm. The large particles contained in the sliding belt made deep scratches on the sliding surface during the sliding process.

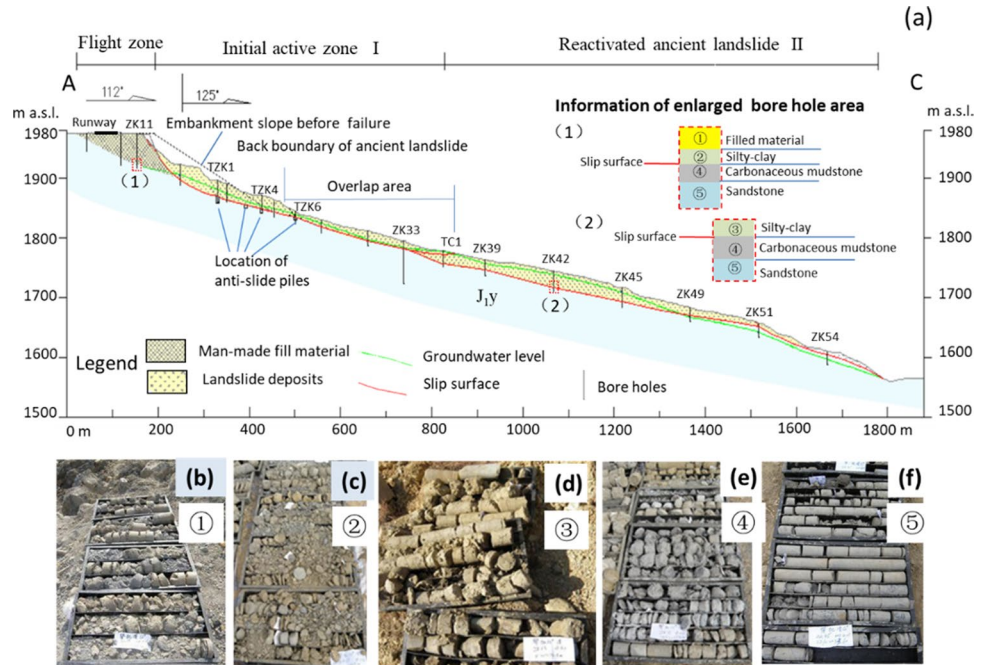
Sliding body thickness of zone I ranged between 12 and 25 m, with 20–25 m at the upper part, and decreasing proceeding downwards, with ending at 12–15 m. Sliding mass of this section includes two different units, an upper layer (①, see in Fig. 8) made of embankment material (Fig. 8b) and a lower one (②, see in Fig. 8) made of grayish-yellow and yellowish-brown silty clay with fragments derived from the strongly weathered sandstone and mudstone (Fig. 8c).

**Fig. 8** Drilling work revealed the structure of the landslide body, including the material, thickness of each layer, and groundwater condition. **a** Cross section of the landslide along the trace line A-C depicted in Fig. 4a. **b–f** Typical corings showing the material of ①, ②, ③, ④, ⑤; see Fig. 4a for the drilling location. ① Man-made fill material; ② dynamically compacted grayish-yellow and yellowish-brown silty clay; ③ grayish-yellow and yellowish-brown silty clay with high water content; ④ strongly weathered mudstone; ⑤ moderately weathered mudstone and sandstone

The core samples from the moderately weathered sandstone layer were mostly in long columnar form and occasionally in short columnar or fragmented form, with light yellow or grayish-white color (Fig. 8f). Due to intense fracturing, the core was highly fragmented and easy to be crushed by hand. The test results indicated that the saturated compressive strength of the sandstone ranged between 10 and 139 MPa, with an average value of 47.5 MPa and high dispersion. The main reason for the variability was the presence of fractures.

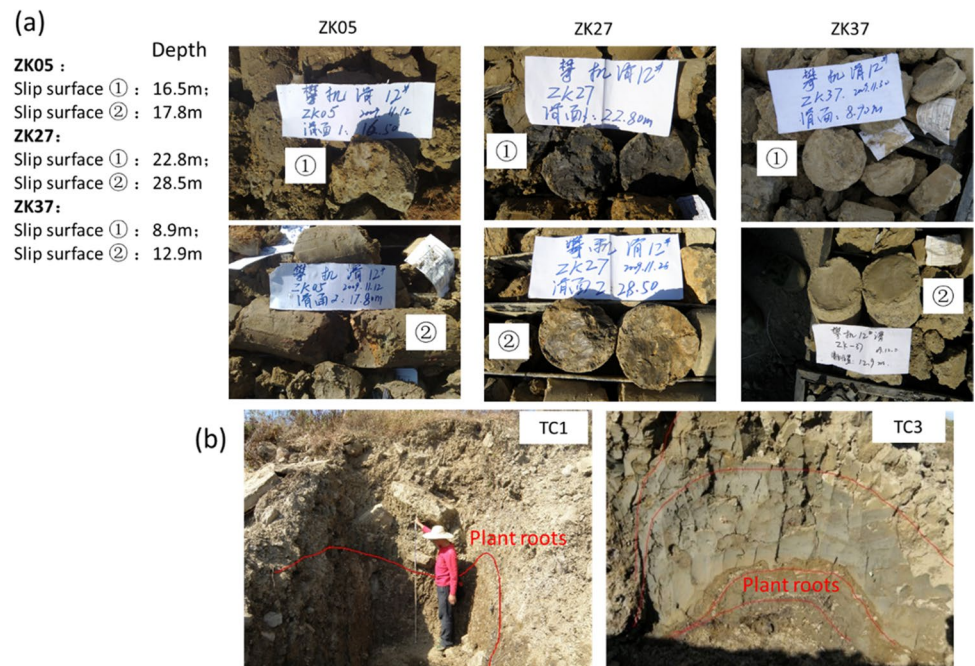
**Fig. 9** Details of the typical borehole coring and trenching showing the material and characteristics of the slip surface. **a** Morphology of slip surface revealed by drilling, text on the left side showing the depth of the slip surface. **b** Morphology of the slip surface at the front edge of zone I and shear outlet exposed by the trench

The results of exploratory trenches (location shown in Fig. 6a) indicated that the filled material overlaid on the landslide deposits directly, with abundant plant roots at the interface (Fig. 9b). In addition, the interface was undulating and a steeply inclined slip surface with scrape was found in the sliding body (Fig. 9a, ZK05). These types of phenomena indicated that there were secondary slid surfaces developed in the embankment sliding zone, resulting in sliding mass deposited on the landslide, while a deeper movement occurred along the ancient slid surface.

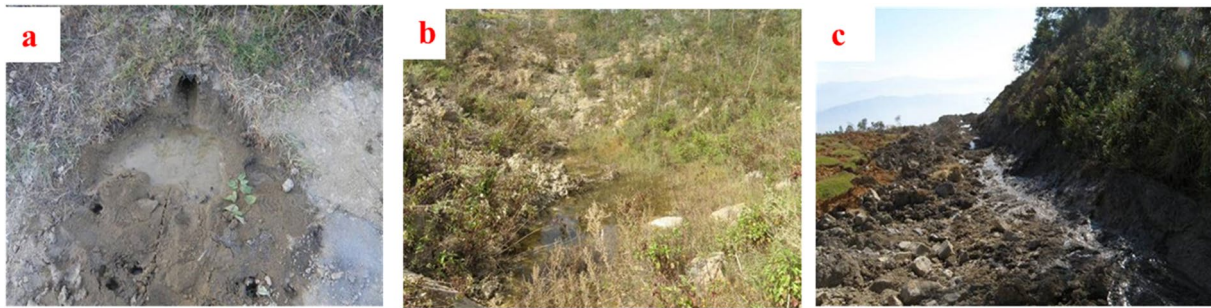
**Fig. 10** Surface water exposures observed in the landslide area during field investigations (the approximate locations are shown in Fig. 6a). **a** Groundwater outflow from part drainage holes seated in the filled

body. **b** Water pond on the north side of the landslide. **c** Water groove on the south edge of the landslide

holes were made in the filled body. Some of those holes had groundwater outflow and the rest were dry holes (Fig. 10a). So, a conclusion can be made that there was no continuous water level in the filled slope body, and the groundwater was a kind of perched water, formed from direct infiltration of rainfall.

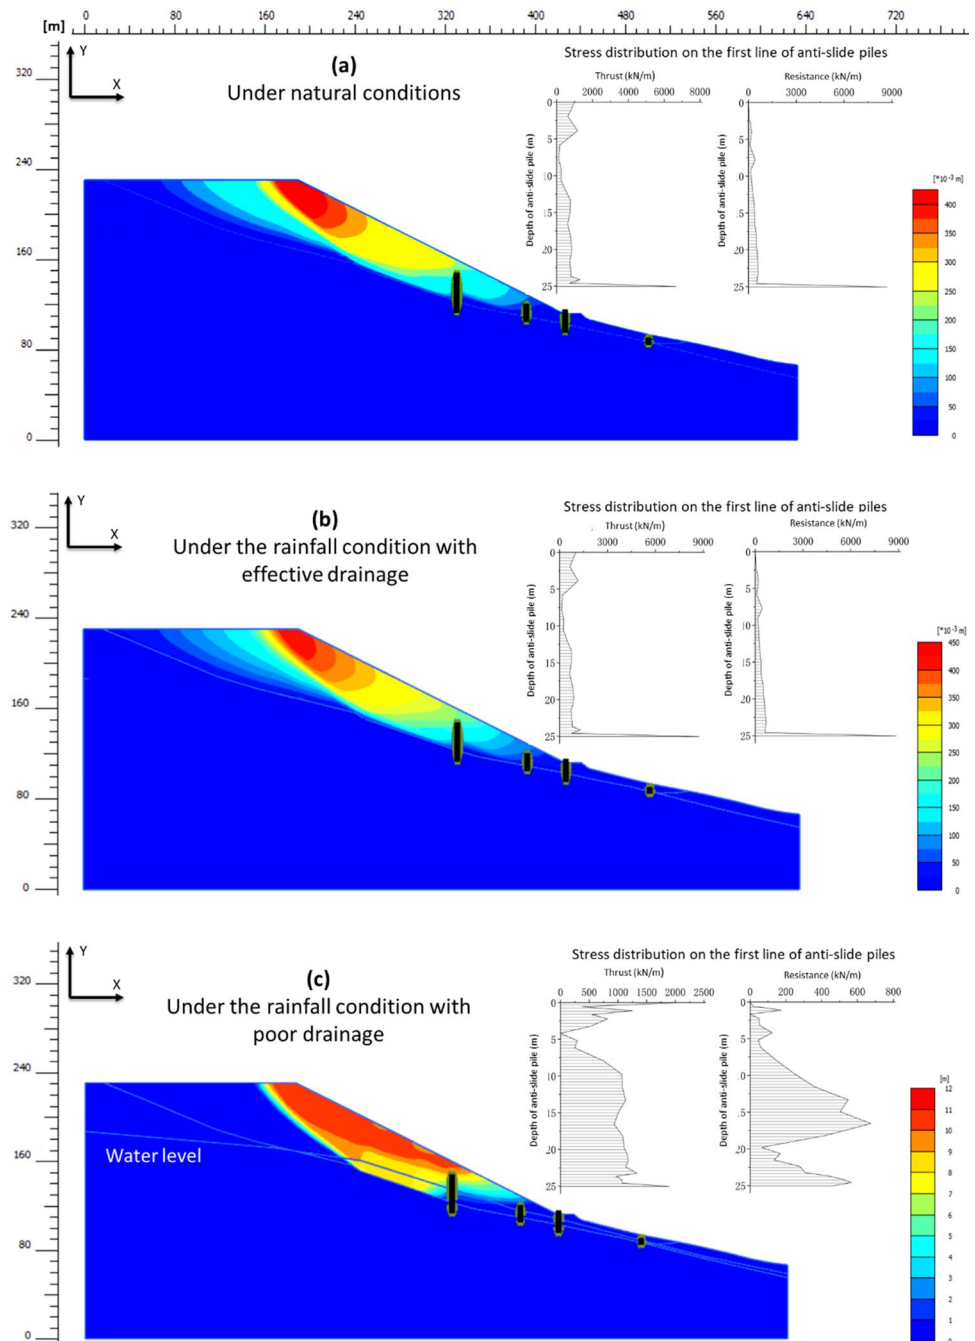
Case 1: the calculation results under the natural condition show that the deformation mainly occurs in the interior of the filled section, and a high deformation is distributed around the top of the fill slope (see Fig. 13a). The calculation result of landslide thrust borne by the first row of anti-slide piles is 4113 kN/m. According to the design data, the design capacity of anti-slide piles is 5000 kN/m; so the force on the pile body is less than the design standard, and the slope is in a stable state.

Case 2: under the condition of rainfall, when the drainage is effective, the influence of the groundwater only includes the saturation effect on the fill material, which increases the sliding force of the fill slope. The results show that the deformation distribution is similar to the natural condition, but the deformation is a little higher (see Fig. 13b). The calculation result of the landslide thrust borne by the first line of anti-slide piles is 5734 kN/m, which is greater than its design capacity value. Therefore, the anti-slide piles are at risk of being broken.

Case 3: under the condition of rainfall, when the drainage is poor, it includes the softening effect of the groundwater. The strength parameter values at the foundation cover interface are reduced by a reduction coefficient of 0.67. Under this condition, the landslide thrust borne by the first line of anti-slide piles is 13,714 kN/m, which is close to three times the design capacity. At this condition, it can be considered that the first line of anti-slide piles is damaged. According to the displacement distribution (see Fig. 13c), the deformation area of the slope is consistent with the actual sliding part observed in the field.

**Fig. 13** The numerical calculation results show displacement distribution and the stress distributions of the first line of anti-slide piles under different conditions
