Remedial measures to control seepage problems in the Kafrein dam, Jordan

Osama K. Nusier · Ahmed Shlash Alawneh · Abdallah I. Husein Malkawi

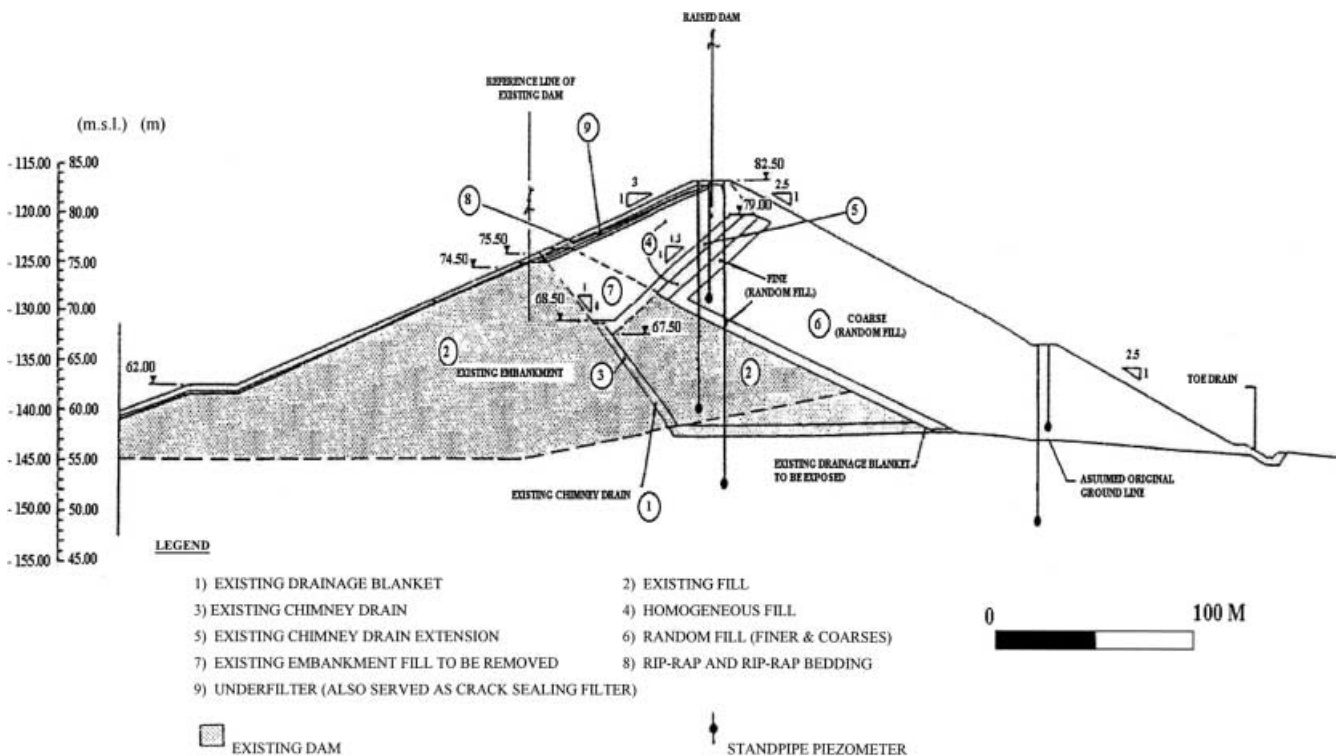
Fig. 2 Cross section through the Kafrein dam

The dam was built in 1968 with a storage capacity of 4.5 Mm³. It is basically a homogeneous earthfill dam some 30 m high and 480 m long, constructed of a compacted clayey core protected by a compacted rock fill on both sides (Fig. 2). To overcome the problem of sediment deposition, probably in the order of 2.5 Mm³ and to meet the ongoing demand for agricultural water in the Kafrein area, it was proposed to increase the height of the dam by 7 m to provide an additional 6 mcm of storage.

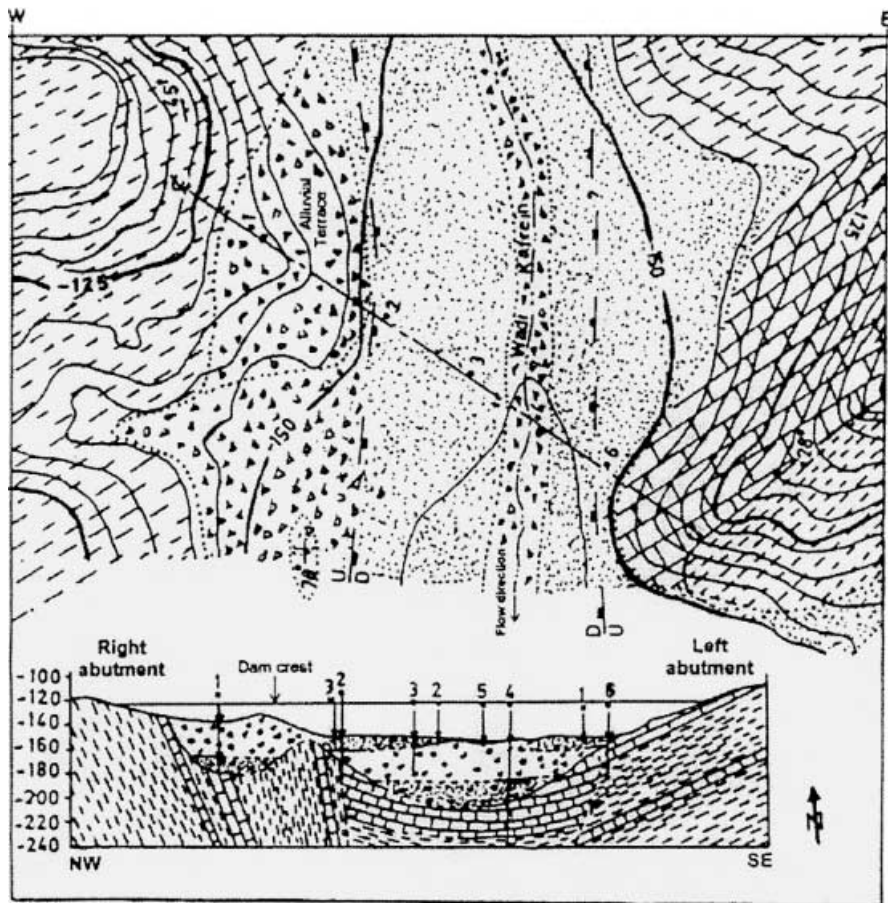
Fig. 3
Geological map and section with borehole locations

The boreholes drilled along the dam axis (BHs 1, 2, 3, 4 and 6) indicated 60 m of alluvial deposits comprising poorly sorted silty clay, sandy gravels with occasional lenses of boulders or silty sands with varying degrees of cementation (Fig. 3). Two channels have been eroded into the bedrock. The main one, between the two faults, is approximately 60 m deep, while the depth of the second, beneath an alluvial terrace at the right abutment, is unknown but at least 36 m.

The bedrock is dominantly the limestone, marlstone and dolomites of the Fuhais Formation (A3) and the massive crystalline limestone of the El-Hummar Formation (A4). In the area of the right abutment, however, the Na'ur Formation is present, dipping steeply to the northeast and of varying thickness. The El-Hummar Formation is the bedrock material at the left abutment, dipping to the northwest and characteristically coarse to medium grained and well jointed. This unit is underlain by the well-jointed fine-grained limestone, marly limestone and marlstones of the Fuhais Formation (A3) although the El-Hummar Formation is probably the bedrock of the main valley floor.

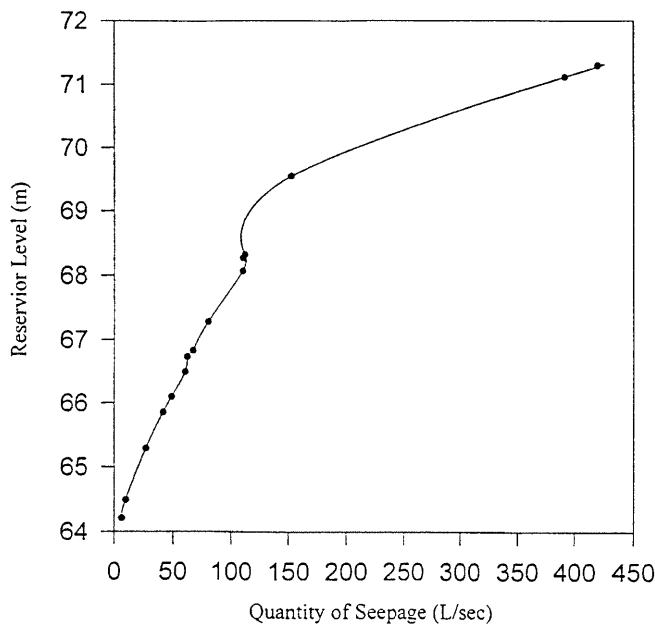
Fig. 5
Variation of seepage water with reservoir level

In addition to the very clear visual evidence of water coming out of rather than through the spillway or the outlet pipes from the dam, a sudden increase in the quantity of water collected at Batous was noted as the reservoir level reached an elevation of –69 m. The most obvious evidence of developing seepage problems is that a seepage outflow increases disproportionately to the rise in water level, or with time when the water level is generally consistent. A further indication may be provided by the

The quantity of seepage is expected to rise to about 700 l/s when the reservoir is completely filled and it is known that seepage increases sharply as the reservoir level reaches an elevation of 69 m (see Fig. 5). Most of the water seeping from the dam passes through the alluvial foundation material, although the exposed high-permeability material in the upstream area, the open joints and channel in the right

abutments as well as the numerous minor faults also provide water pathways.

It is clear, therefore, that some remedial action is required, as suggested in Table 6. The most practical options would be to construct an upstream blanket, to improve the capacity of the downstream relief wells and blanket and to enhance the efficiency and capacity of the Batous collecting station. Periodical grouting in the most likely seepage areas would also be desirable; acoustic emissions is a promising method of identifying the location of active seepage and/or embankment deformation.
