Causes and Effects of Uncontrolled Water Inrush into a Decommissioned Mine Shaft

Krzysztof Polak¹ · Kazimierz Rózkowski¹ · Piotr Czaja¹

Abstract Central Europe experienced catastrophic rain-falls and flooding in 2010. This paper discusses a decommissioned shaft that was flooded by surface water, which led to displacement of shaft backfill and an inrush of large amounts of water into an underground pumping station. The weather conditions for the period preceding the inrush, the hydrogeological conditions, the quantity of water that entered the mine dewatering systems, and the underground hydraulic connections are all described. Uncontrolled inflow of water as a cause of backfill saturation and the hazard for active underground infrastructure were analysed. A need to rebuild damaged infrastructure was identified. The case study highlights the need to improve underground mine closure requirements to ensure safe conditions above ground, particularly in densely populated areas.

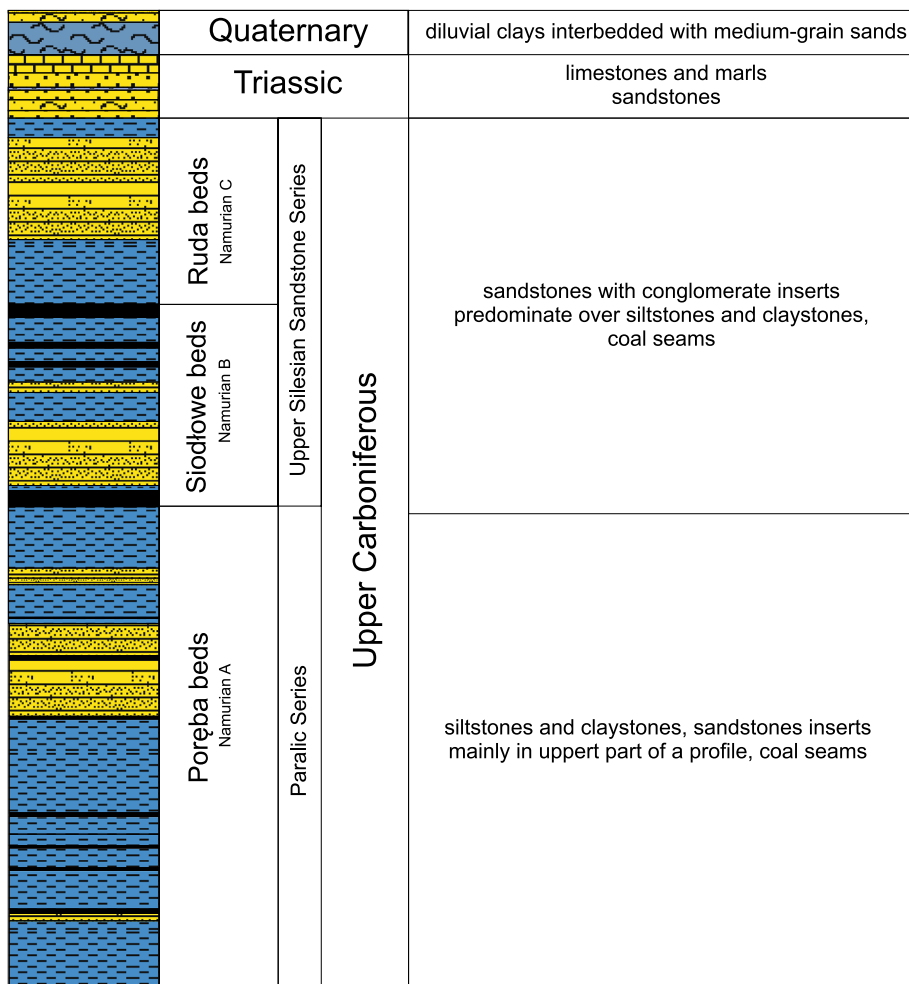
Fig. 1 Hydrogeological profile of Park shaft

The area of water inrush was located within a local structural trough, with its axis aligned in a NW–SE direction. Slightly to the south of the basin’s axis is the Park shaft. In this part of the structure, the overburden is mainly Quaternary strata

deposited as interbedded medium-grain sands and diluvial clays that range in thickness from a few metres to about 20 m, and locally thin Triassic deposits. Further underground, there are Carboniferous Ruda and Siodłowe beds of the Upper Silesian sandstone series (GSP), in which the coal is found. This series is dominated by sandstones, with conglomerate over siltstone and claystone strata. The aquifers within the GSP complex are linked by thick sandstones shoals, ranging from 0.2 to 44.5 m in thickness (Kotas 1994; Fig. 1). The permeability of the water-bearing beds decreases with depth, ranging from 2.5×10^{-5} to 4.0×10^{-11} m/s. Effective porosity also decreases with depth, from 20.9 % to just 0.1 % (Rogoż et al. 1987; Rózkowski 2000, 2004).

North from the axis of the trough, the overburden contains sands of variable grain size up to 20 m thick. These sands fill a subordinate, local erosion trough. The Muschelkalk limestone (Middle Triassic) strata, composed of limestones, marls, and limestone marls, are deposited at the base of the Quaternary, sometimes with crystalline limestone debris or gray crystalline limestone rubble, with a maximum thickness of 80.0 m. The Triassic sediments lay directly on the Ruda beds.

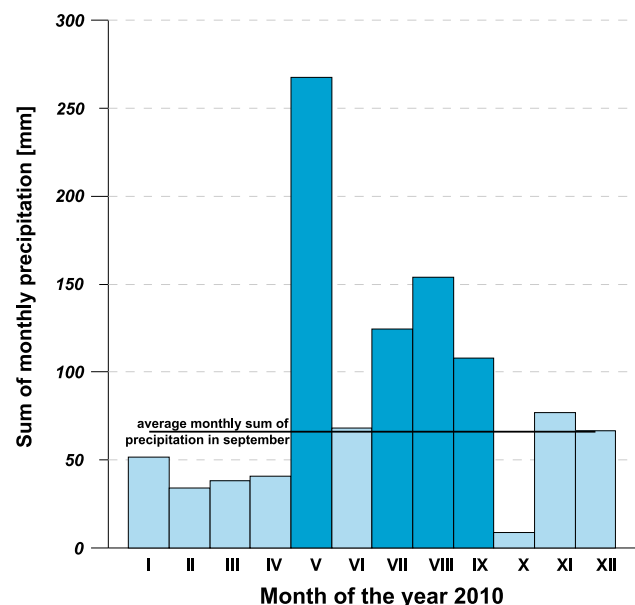
Fig. 2 Monthly precipitation at the IMGW Czeladź station in 2010

particularly the direct and indirect connections of neighbouring mines to the surface, the inflows to adjacent pumping stations, and finally the spatial and temporal rainfall structure. Annual discharges pumped from abandoned mines from 1997 to 2007 in the USCB were compared with annual rainfall data by Janson et al. (2009). The distribution and intensity of rainfall in Poland and Central Europe in 2010 was very unusual, and caused a series of major floods. The nearby Institute of Meteorology and Water Management (IMGW) station at Czeladź recorded 1038 mm of rainfall in 2010; the average rainfall in this region is \approx 650–700 mm. The monthly distribution of rainfall was also highly unusual, with a maximum in May (Fig. 2).

Rainfall during May 2010 totalled 267 mm, exceeding the mean value by several times. Torrential rainstorms generated greater surface runoff than many drainage systems could handle. Surface flooding occurred in many places, including the area where the analysed inrush of water into the mine workings took place 5 months later. The area affected by the flooding, dictated by the morphology of the area, was in Zwycięstwa Street in Siemianowice Śląskie, northwest of the Park shaft. The flood covered an undeveloped area, mainly used for agricultural purposes, with an area of 3.136 ha. The volume of accumulated water was estimated at 47,000 m³. After a reservoir was created, the ditch and the culvert at Zwycięstwa Street was cleaned, and drainage was directed towards Rzęsa Pond. In September 2010, 108 mm of rainfall was recorded, mostly in the last days of the month. The average September rainfall from 1991 to 2010 for the IMGW station at Czeladź is 66 mm.

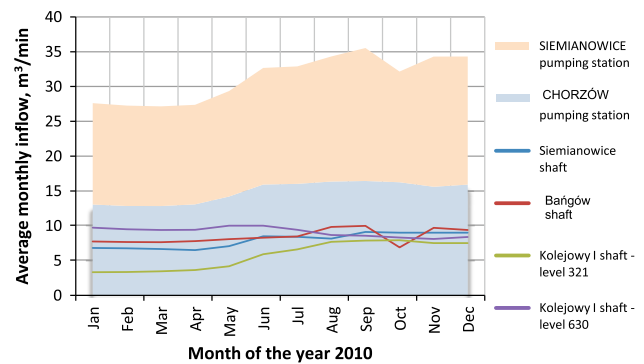
Fig. 3 Inflows to the individual pumping stations in the Siemianowice drainage area (CZOK)

The high May 2010 rainfall intensified inflows into the Siemianowice and Chorzów drainage systems by nearly 20 %. From May to September 2010, the Siemianowice pumping station pumped 600,000 m³ of water more than average. Variation in the mean monthly inflows reached 34 % in the case of the Siemianowice system, and 28 % within the Chorzów system. In both cases, the largest inflows were recorded in September 2010, and the smallest occurred in March and April 2010. The summary of inflows to the individual pumping stations of the Siemianowice and Chorzów systems is shown in Fig. 3.

630 m level decreased by about 10 %. This level is much deeper than the three others interacting in this system, and most likely does not have a direct hydraulic connection with the surface. These three other pumping stations, built at the 321 m level, showed substantially increased inflows. The amount of water discharged from the Bańgów pumping station during October 2010 may have been underestimated due to the emergency operations and changes to the layout of the drainage system. The data (Fig. 2) also indicate that inflows to the individual pumping stations depended on the amount of rainfall, which indicates a connection between the pumping stations and the surface.

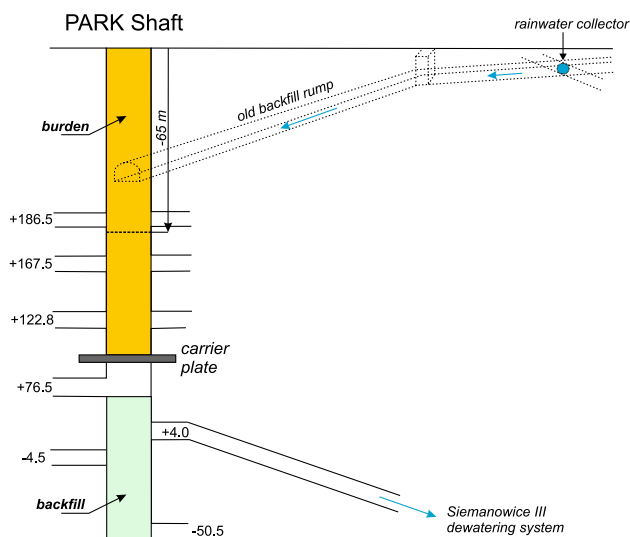
Fig. 4 Diagram of the decommissioned and existing connections in the Park shaft, with the shallow subsurface galleries

The Park shaft was decommissioned in two stages by building a reinforced concrete support plate about 127 m above the base of the shaft, i.e. at the 206 level. The backfilling was performed separately for each of the individual parts over a few years, starting in the upper part of the shaft. A schematic diagram of the decommissioning and shaft connections is shown in Fig. 4.

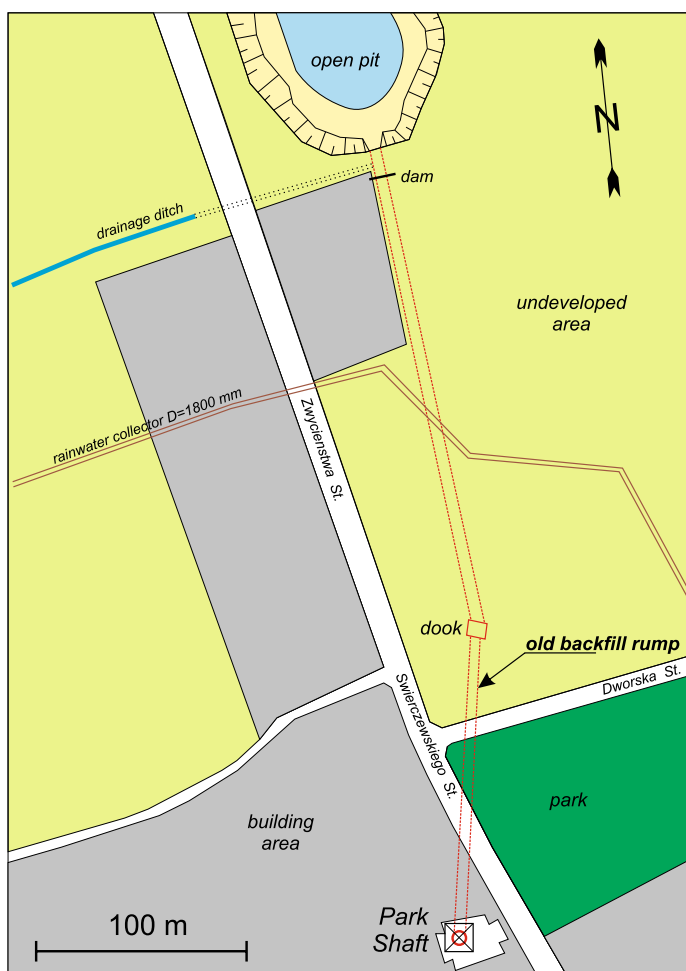
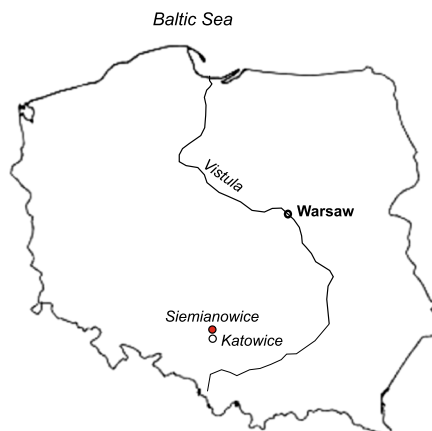
Fig. 5 Schematic sketch of the Park shaft position, showing both old mine workings and modern infrastructure

Analysis of the meteorological data and events resulting in the flooding of the pumping station at the Siemianowice III shaft indicates that the cause of backfill slippage might have been a sudden uncontrolled flow of rainwater from the surface to the decommissioned shaft. Analysis of the hydraulic connections between the Park shaft and the mine workings indicate that the shaft was connected to the backfill by a cross-cut and to the shallow mining galleries that had been used for delivering the backfill (Fig. 5).

Analysis of archival materials made available by the Siemianowice City Council also points to a connection between the shallow underground workings and the storm water collector. This hypothesis was confirmed during a site visit by the authors.
