# A Study of Water-Inrush Mechanisms Based on Geo-Mechanical Analysis and an In-situ Groundwater Investigation in the Zhongguan Iron Mine, China

**Abstract** The Zhongguan iron mine is strongly threatened by water inrushes because of the thick Ordovician limestone aquifer and a variety of concealed faults. An inrush event occurred at –260 m below sea level (bsl), inundating the mine during the mineral deposit developing stage. It was very important to understand why and how this occurred to prevent its recurrence. A numerical simulation of a process-based model of the excavation, together with an in-situ groundwater investigation, showed that the event was related to the normally impermeable X1 fault, which was gradually activated from the bottom of the aquifer to the mine roof as excavation developed. The activated fault transformed into an inrush channel, hydraulically connecting the aquifer and the roadway. Thus, faults and other geological structures have to be mapped before mining. Moreover, sealing possible water channels before excavation in potential inrush areas is much better than advance dewatering because of the aquifer's transmissivity and the limited effectiveness of

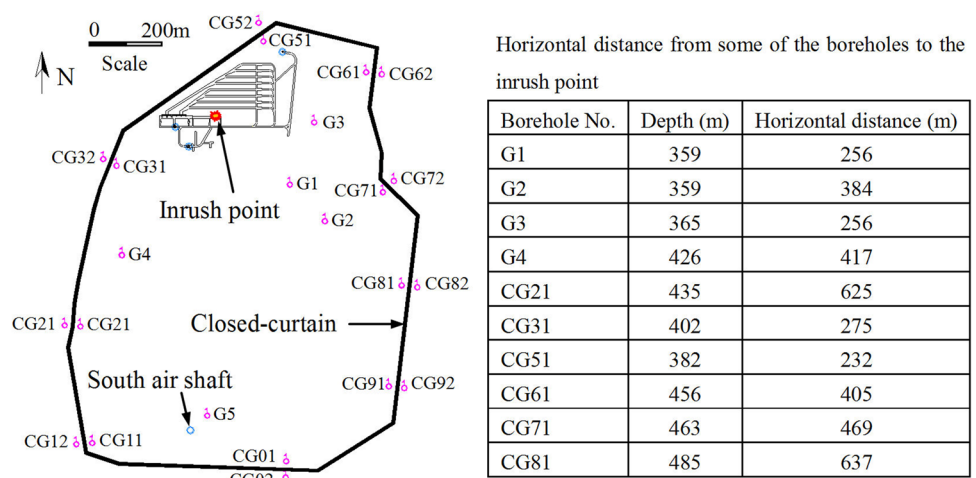
270 grouting holes. It was anticipated the completed grout curtain would exclude about 80% of the water; however, it was, in fact, much less effective than that. There were five boreholes, numbered G1–G5, in the mine area, and nine pairs of boreholes located just inside and outside of the closed curtain (Fig. 2). These holes were used for groundwater level measurements prior to and during mining.

**Fig. 2** Observation boreholes for groundwater levels in the mine area

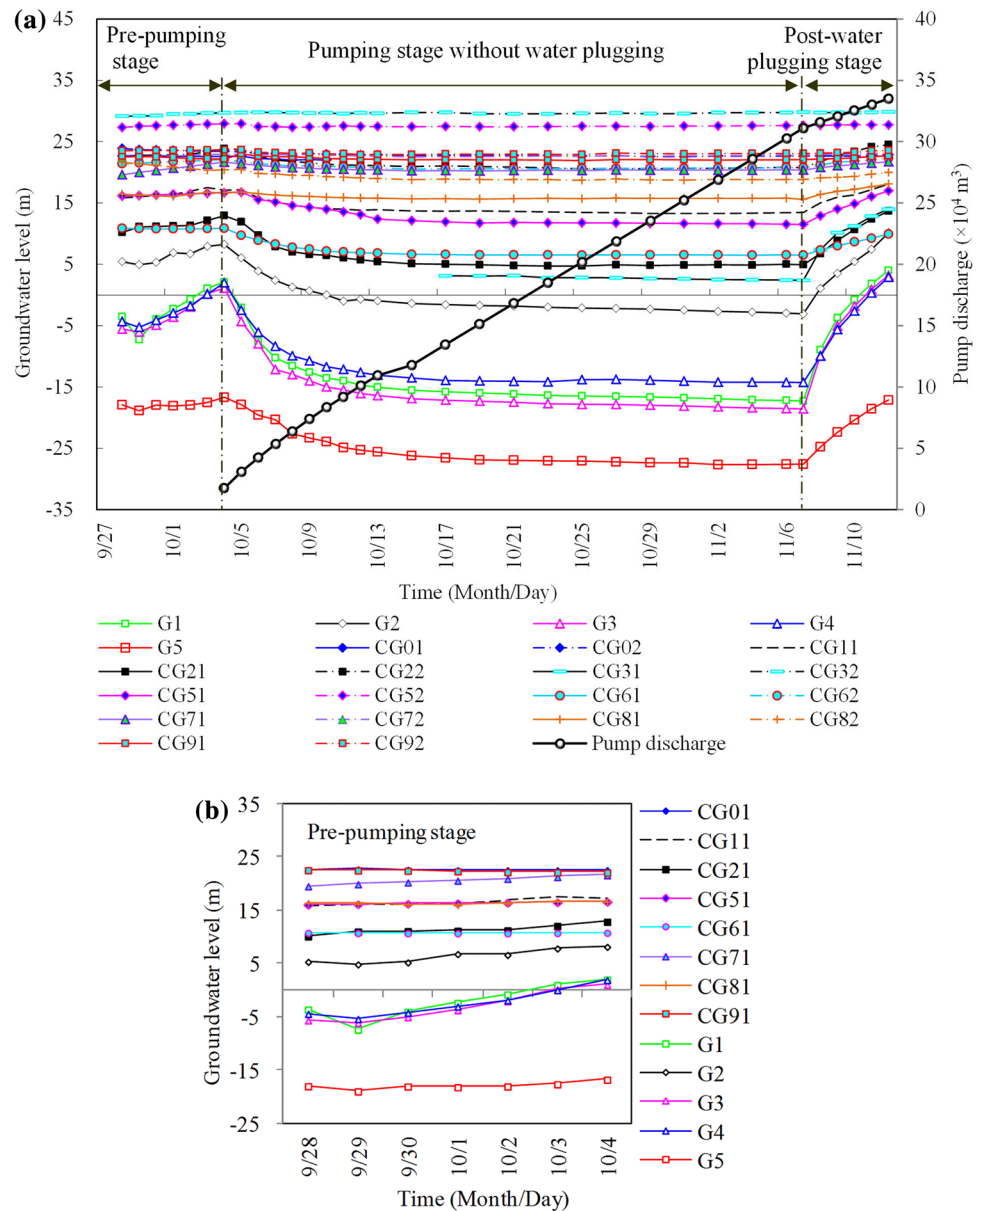
**Fig. 3 a** Changes in groundwater levels at different boreholes and pump discharges from Sep 27 to Nov 13, 2013; **b** groundwater level monitoring curves at the boreholes inside the curtain from Sep 27 to Oct 4, 2013 (Note no indication of broken boreholes at CG12 and CG31 can be observed before Oct 17)

cone of groundwater depression rising gradually, as was observed in boreholes G1–G4 (Fig. 3b). This indicates that the water-inrush sources were static water inside the closed curtain and dynamic outside.

As shown in Fig. 3a, when water was pumped from the main and auxiliary shafts on Oct 4, groundwater levels in boreholes G1–G4, close to the shafts, were observed to decline rapidly, i.e., the maximum drawdown rate was up to 29 cm/h in boreholes G3 and G4, 23 cm/h in borehole G1, and 16 cm/h in borehole G2. This shows that the hydraulic connection of the Ordovician limestone was very strong.

The total pump discharge was about  $9 \times 10^4 \text{ m}^3$  from Oct 4 to 11. After that, the pump discharge averaged about  $350 \text{ m}^3/\text{h}$ , almost equal to the water inflow, so groundwater levels in the mine area showed a stable and very slow decline. When the inrush point was plugged on Oct 7, groundwater levels in the mine area reached the same level as when pumping began in just 3 days. This once again verified the strong hydraulic connection of the Ordovician limestone groundwater and the rich water recharge outside of the curtain.

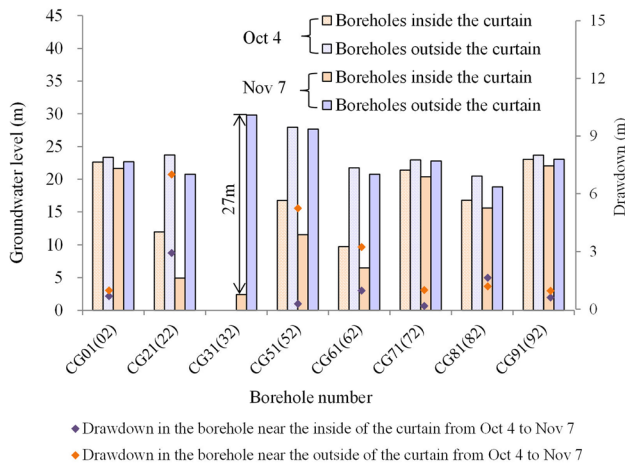
Figure 4 shows the groundwater level in each pair of boreholes on Oct 4 and Nov 7, 2013. The maximum water level difference between boreholes CG32 and CG31 was 27 m, with about 16 m between boreholes CG52 and CG51. The groundwater levels in boreholes CG32

**Fig. 4** Comparison of groundwater levels in each pair of boreholes on Oct 4 and Nov 7, 2013

and CG52 remained the same (Fig. 3a), indicating that the northwest curtain was effective. However, the quality of the curtain around boreholes CG22 and CG62 was not as good, for although the water levels were the same in the two paired boreholes, this was because of their synchronous decline. Therefore, groundwater northeast and southwest of the mine area outside of the curtain was the major dynamic water recharge source. Groundwater levels in the two pairs of boreholes, i.e. CG71 and CG72, CG81 and CG82, located downgradient of the mine, showed the same, but less obvious trends. Water-level changes in the other three pairs of boreholes located south of the curtain were mainly affected by pumping from the south air shaft. Hence, groundwater from east of the mine area outside of the curtain is a minor source of dynamic water recharge. Water recharge from outside of the curtain was not sufficiently stopped by the closed grout curtain.

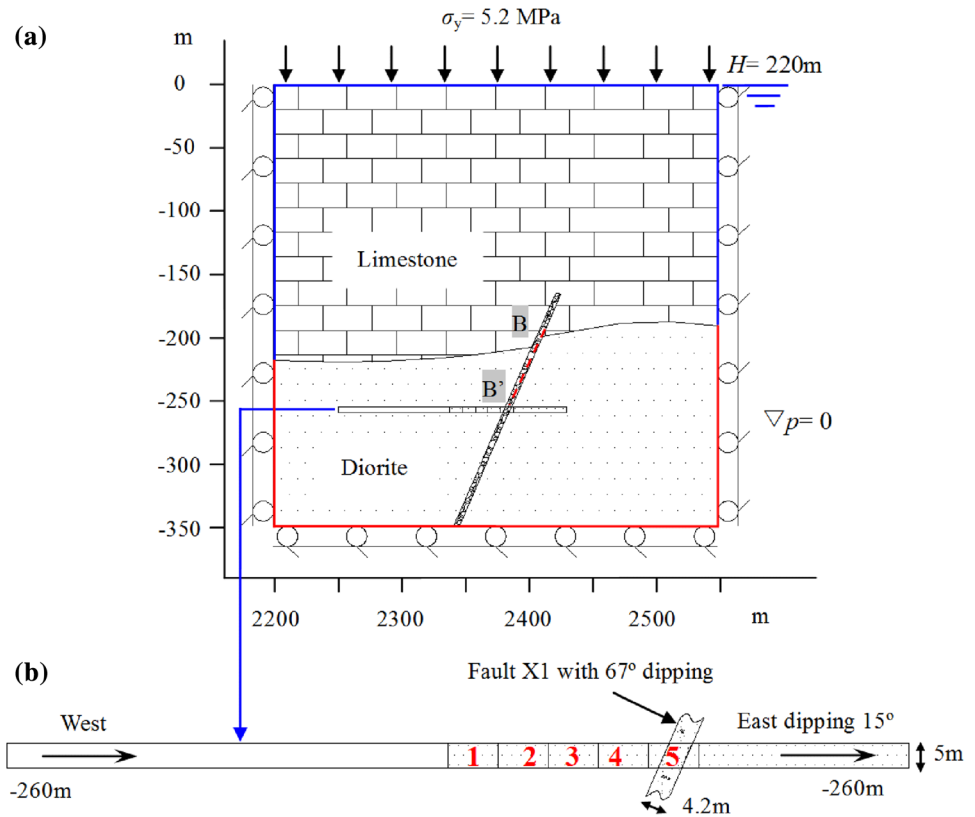
Based on the geological, geomechanical, and hydrogeological data, a simple numerical model that incorporated fault X1, was constructed according to plan strain conditions. The model was 350 m long and 350 m high, with a depth ranging from 0 to –350 m bsl, and contained two rock strata (Fig. 5a). The groundwater level in the area was about 0 before the water inrush incident in Sept, 2013, so the hydraulic pressure in the upper Ordovician limestone layer was about 2.2 MPa. The lower diorite would have sustained the water pressure if the fault did not exist, and therefore was considered a protective layer. The roadway located at –260 m bsl was surrounded by the diorite. As mentioned above, the X1 fault zone, which is filled with soft-rheology-plastic fault gouge, breccia and altered diorite, was viewed as a weak zone.

For the mechanics analysis, the external boundary stress of 5.2 MPa in the  $y$  direction  $\sigma_y$ , was applied at the top surface to be equivalent to the overburden strata weight, while zero displacement was imposed at the left and right sides and base of the model. For the seepage boundary conditions, a constant hydraulic head of 220 m was applied at the top, left, and right sides of the limestone strata. At the boundary of working face, a pressure of 0.1 MPa was applied to simulate atmospheric pressure (Zhu and Wei 2011). A Newman boundary condition with zero flux was applied at the external boundary of the diorite strata.

**Fig. 5** **a** Numerical model setup for studying the water inrush induced by the excavation; **b** detailed view of the roadway excavation

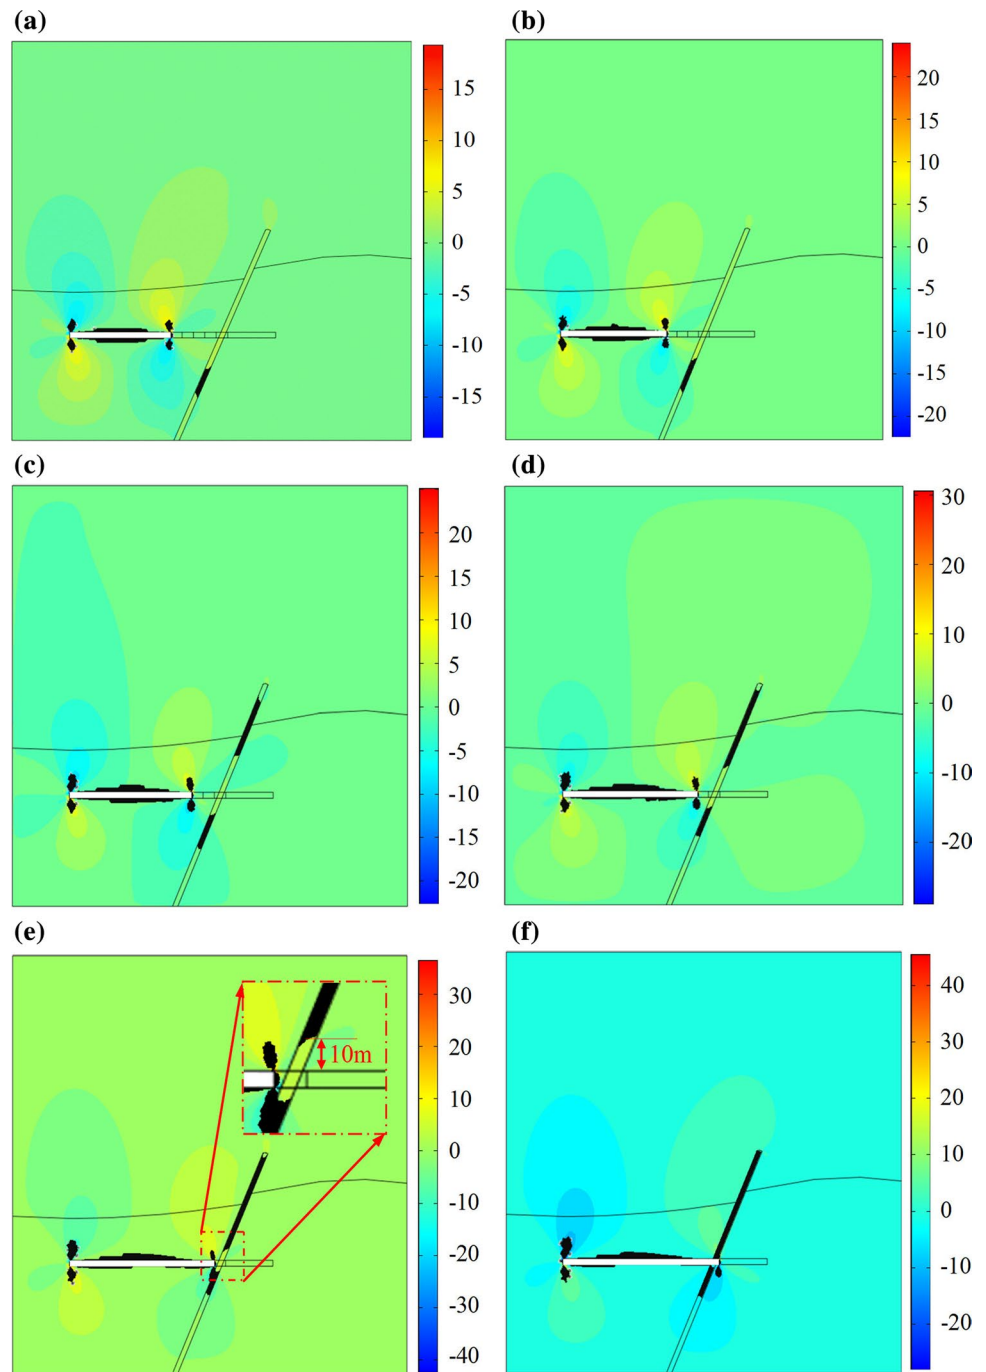
In the following section, we describe the progressive evolution of the water-inrush channel during a five-step excavation sequence with an advance increment of 10 m/step (Fig. 5b). Figure 6 shows the shear stress and damage zone distribution at different simulation steps. In these figures, the black colors denote the damaged zone. Figure 7 shows the stress and displacement distribution of the center profile of the upper part of fault X1 from  $-195$  to  $-255$  m bsl (see profile BB' in Fig. 5a) during the excavation.

With the first excavation to 10 m from the left boundary, 35 m from the center of the fault, a small amount of damage occurred in the lower part of the fault, while no damage occurred in the upper part (Fig. 6b). Therefore, the fault was still stable even through the maximum displacement at the upper part of the fault has reached 7.0 mm (Fig. 7c). When the working face was extended to 20 m (second step), the maximal shear stress of the fault at  $-209$  m bsl was 2.44 MPa, with a vertical height of 46 m from the roof (Fig. 7a). Under this ground stress and pore pressure, a small amount of damage of the upper part of the fault

**Fig. 6** Shear stress of the model and formation process of water-inrush channel induced by the excavation according to the damage zone (Unit: MPa): **a** damage zone before the excavation; **b** damage zone at excavation step 1; **c** damage zone at excavation step 2; **d** damage zone at excavation step 3; **e** damage zone and detailed view of the fault at excavation step 4; **f** damage zone at excavation step 5

first occurred at the junction of the limestone and diorite (Fig. 6c), causing groundwater in the limestone to flow into the fault’s failure zone, increasing the relative hydraulic head of the roof.

When the working face was extended to 30 m (third step), the maximal shear stress of the upper part of the fault still occurred at  $-209$  m bsl, but it increased to 2.86 MPa, with a growth rate of 17.2% (Fig. 7a). The damage zone extended both upwards and downwards compared to the second step (Fig. 6d).

and the damaged zone was about 10 m from the roof (Fig. 6e). Consequently, this 10 m high part of the fault was still stable and could prevent groundwater from flowing into the roadway, mining had not advanced further. That was confirmed by the advance boreholes, as already mentioned.

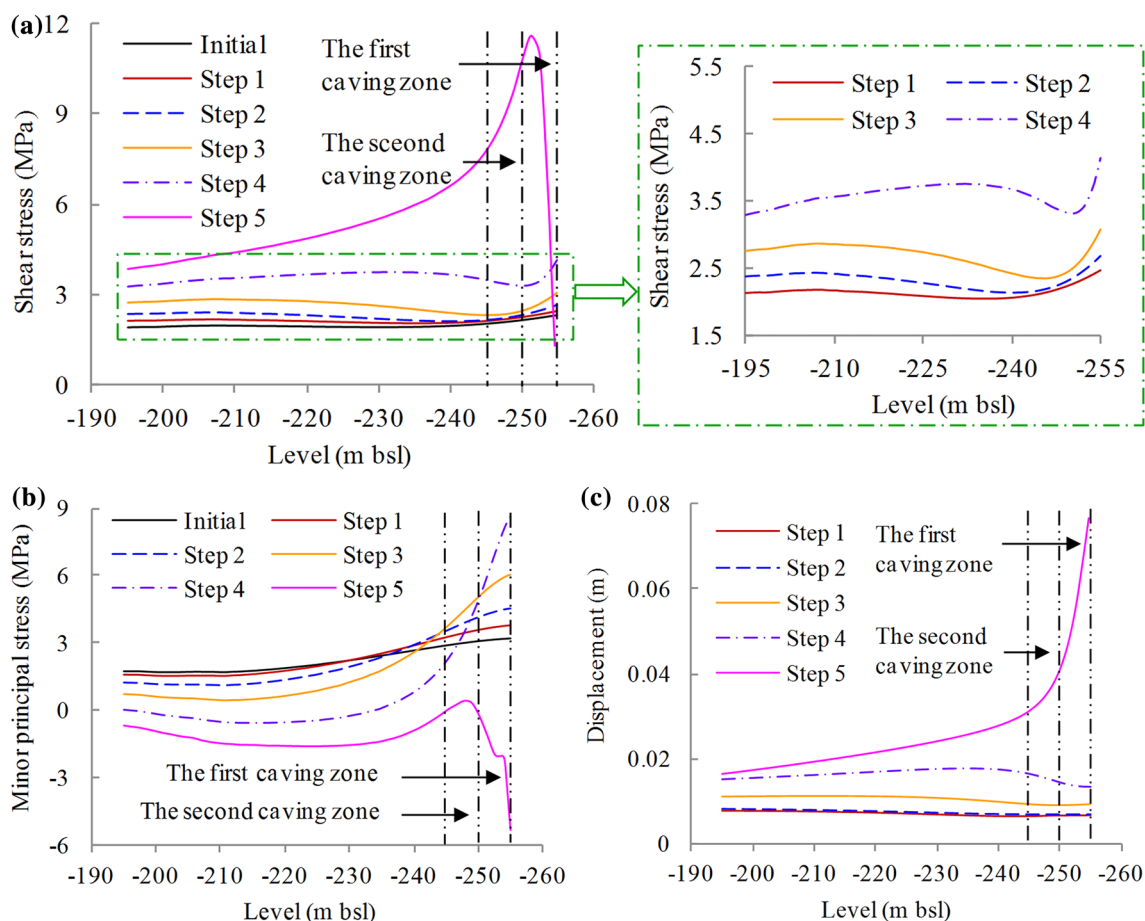
When the working face was extended to 40 m (fourth step), 5 m away from the fault center, a maximal shear stress of 3.75 MPa occurred at  $-234$  m bsl, with a vertical height of 21 m from the roof (Fig. 7a). Meanwhile, part of the minor principal stress in the upper part of the fault changed from compressive stress to tensile stress (Fig. 7b), destabilizing the fault due to the no-tension property of the fault, and increasing groundwater flow into the fault. The damage zone expansion in the upper part of the fault kept the same trend as in the third step,

**Fig. 7** Stress and displacement distribution of the profile BB' in fault X1 during the excavation **a** shear stress, **b** minor principal stress; **c** displacement

When the working face extended to 50 m, the fault was completely exposed. The maximum shear stress at -252 bsl, 3 m above the roof, increased sharply, to 11.6 MPa (Fig. 7a). The most upper part of the fault was in tension and the maximum tensile stress at the roof was 5.35 MPa, much more than the tensile strength (Fig. 7b). The roof was displaced by as much as 76.4 mm downward, due to the fault extraction (Fig. 7c). Consequently, the last 5 m of the fault collapsed under the concentrated high shear and tensile stress, causing a wedge-shaped roof collapse, and fully damaging the upper part of the fault, establishing the hydraulic connection between the limestone and the roadway (Fig. 6f). This allowed groundwater from the limestone to flow through the fault, washing out the arenaceous and pelitic karstic deposits, leading to a less obstructed flow

channel. With the second roof collapse, the channel was completely formed and the groundwater outburst occurred.

3. The water-inrush incident has shown that a naturally impermeable fault can be changed into a water-inrush channel by mining. Therefore, it is critically important to detect and map faults and other geological structures with poor mechanical properties before excavation, whether they are hydrous or not. Also, if a fault is identified as water-free by a horizontal cover hole before excavation, more acclivitous cover holes should be drilled to probe for inflow from higher positions of the fault for further confirmation, 10 m above the roof or even higher.
