A Two-Fluid Simulation of Tailings Dam Breaching

Gregor Petkovšek¹ · Mohamed Ahmed Ali Mohamed Hassan¹ · Darren Lumbroso¹ · Marta Roca Collell¹

Abstract

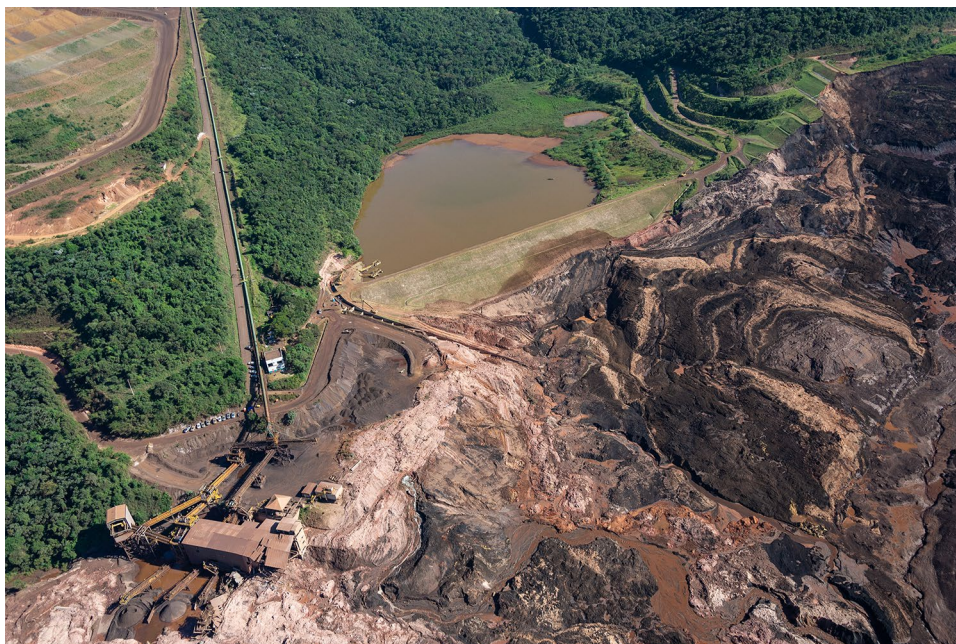
The consequences of a tailings dam failure can be catastrophic. A recent reminder of this is the failure of Dam I at the Córrego de Feijão Mine in Brazil in January 2019 (Fig. 1), where approximately 270 people died (VALE 2020). In 2015, the Fundão dam failed, resulting in the worst ever environmental disaster in Brazil, with the release of over 30 million m³ of tailings that polluted 670 km of watercourses on its way to the Atlantic Ocean, where it spread along hundreds of kilometres of the Brazilian coastline (IUCN 2018; Palu and Julien 2019). In 2014, the Mount Polley dam failure in Canada released 25 million m³ of tailings and supernatant water into the environment (BCMEM 2015). There have been more than 30 tailings dam failures per decade in the period 1960–90 and around 20 per decade since 1990s. Although the number of tailings dam-related accidents has decreased since the 1990s, the number of severe failures (i.e. those that have released more than 100,000 m³ of tailings

Fig. 1 Brumadinho tailings storage facility after dam failure. Source: Vinicius Mendonça/Ibama, under cc-by-sa-2.0 license, <https://creativecommons.org/licenses/by-sa/2.0/deed.en>

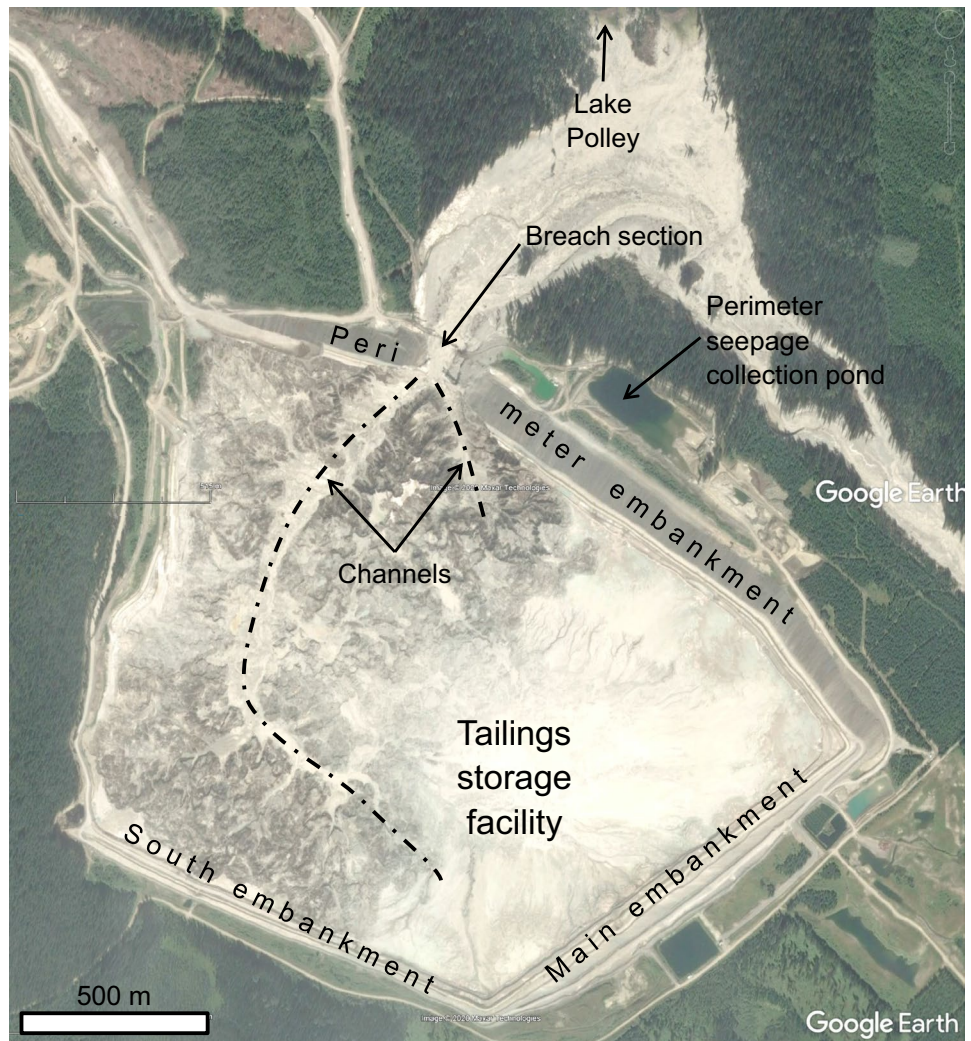
The failure started with foundation instability that caused the embankment crest, at 969.1 m at the time of failure, to sink by at least 3.3 m, below the last recorded water level measured the previous afternoon, which was 968.83 m (IEE-IRP 2015). The cross section at the location of breach after this failure, according to the hypothesis of BCM MEM (2015), is shown in Fig. 6.

Fig. 5 Satellite image of the Mount Polley tailings storage facility and the surrounding area one day after the breach occurred. Source: Google Earth

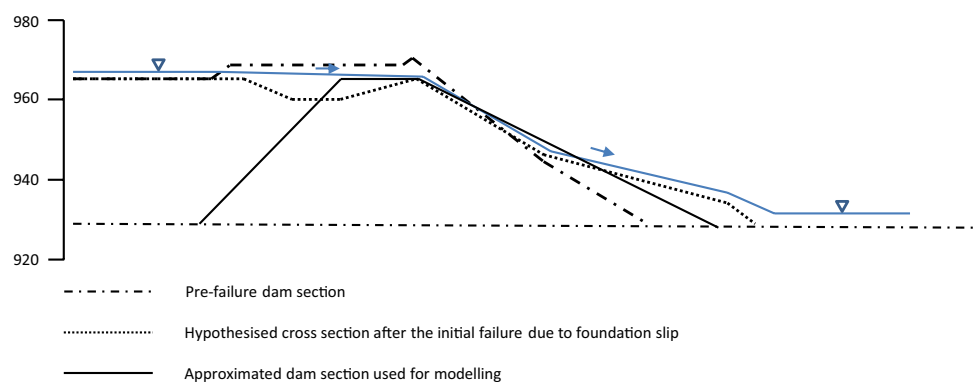
Fig. 6 Cross section of the Mount Polley dam at breach location: Pre-failure, hypothesised after initial foundation failure (after BCMEM 2015) and the approximated dam section used for modelling

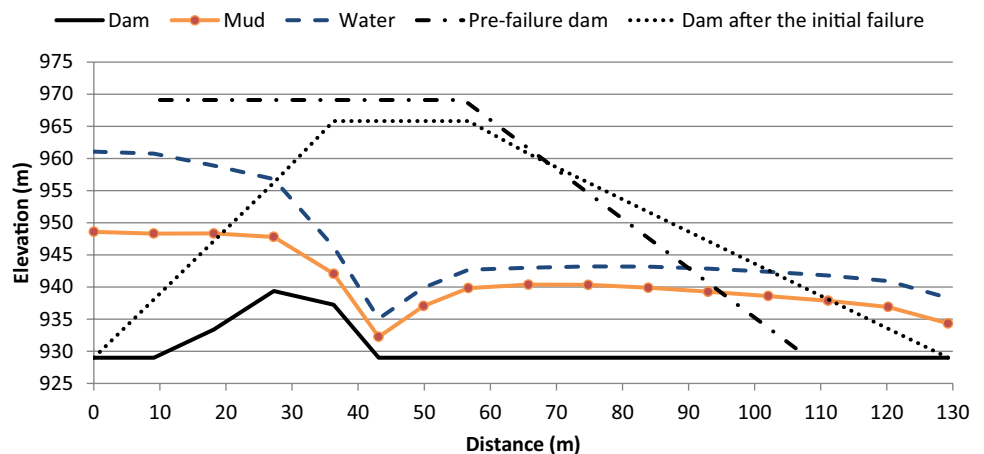
the first description of what was happening was possible at dawn, when light began to appear at 4:25. A v-notch 80 to 100 m wide at the top of the tailings dam and ≈ 30 m deep was observed. The modelled profile at the simulated time of 4:30 is presented in Fig. 8. It shows a breach depth of about 26.4 m (or 29.7 m if measured from the pre-failure crest top)

in the section at station 27.2 m. The modelled width of this section was 27 m. The modelled width of the crest sections (i.e. top of the dam) was between 32 m at the upstream end of the dam and 47 m at the downstream end, which would have been visible by observing from outside of the dam. The lower top width in comparison to observation (which was 80

to 100 m) is probably a result of the model’s assumption that the sides were stable until vertical, which is likely too steep.

Fig. 8 Breach profile after 4.5 h

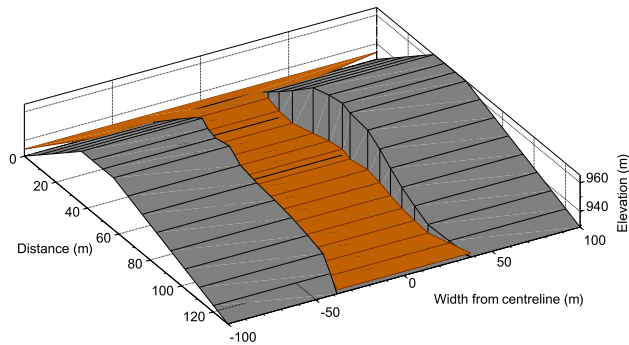
The observed final breach width at the narrowest section was 40 m (BCMEM 2015); at an average cross section, it

was 92 m. The simulated width ranged between 56 and 76 m with an average of 65 m. A possible explanation for these differences is that the model did not account for variability in the tailings dam’s properties, using an average erodibility coefficient instead. A general view of the final breach geometry is shown in Fig. 9.

Fig. 9 Final simulated EMBREA-MUD breach geometry for Mount Polley: dam (light grey), mud (orange)

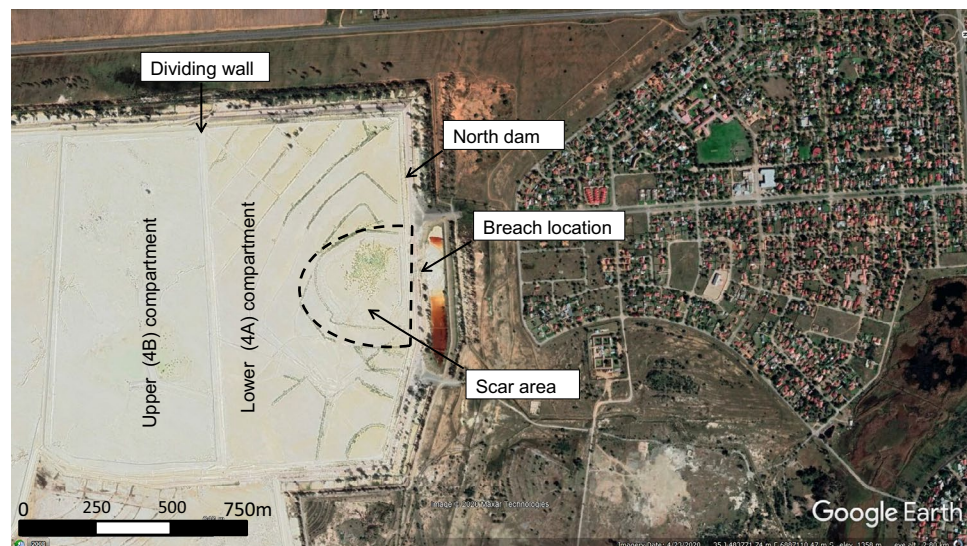
- Rainfall falling on the upper compartment (see Fig. 10), with an area of 0.60 km², flew through a gap in the dividing wall into the lower compartment (with an area of 0.72 km²). The water accumulated in a pool (with an area of 0.15 km²) near the northern wall and started overflowing
- Water flowing through a small breach at the top of the tailings dam embankment eroded material from the outer slope face.
- As the material was removed, the slope became steeper; the shear strength was inadequate to maintain these steeper slopes, leading to local slumping failures.
- This eroded material was carried away by water released from the tailings pond, preventing stabilisation of slope to be reached.
- At one point, this combination of retrogressive failure and water erosion exposed tailings that were in a metastable state in situ and instead of merely slumping, flowed as a liquid.

Unlike the channel-type scars that remained in the storage facility after Mount Polley failure, the failure of Merriespruit dam resulted in a half-funnel shape scar near the breach location (Fig. 10). This difference seems to be due to the amount of water being insufficient to scour channels in the Merriespruit case; it was the geotechnical failures that defined the extent of the mudflow. The dimensions of the scar area were about 300 m wide and extended about 200 m into the TSF (Figs. 10 and 11).

Fig. 10 Satellite image of Merriespruit tailings storage facility and dam no. 4 in 2020. Source: Google Earth

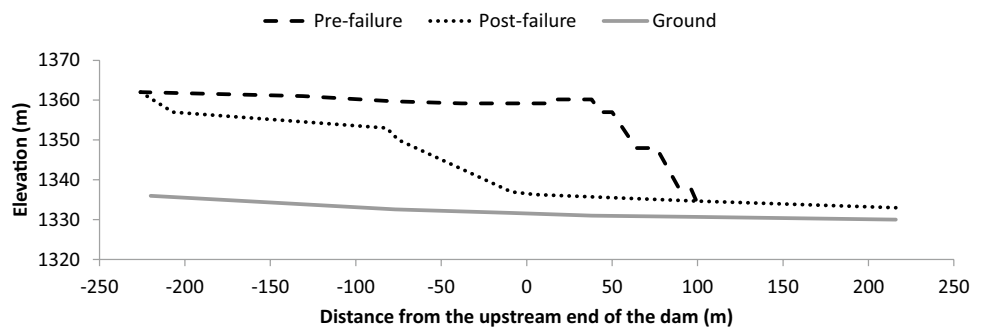
After the flow stopped, the reported slope of the tailings surface were between 2° (Blight and Fourie 2003) and 4.8° (Wagener 1997) in the breach section, while the ground slope was about 1.5° (Blight and Fourie 2003). From the

Fig. 11 Section of Merriespruit tailings storage facility and dam No 4 (adapted from Blight and Fourie 2003)

graphical material presented in Blight and Fourie (2003) and Wagener (1997), the depth of tailings at rest in the breach section was about 5 m. Slopes were much steeper around the perimeter of the scar, from 10° to 20° (Blight and Fourie 2003). Liquefaction might not have occurred in this area.
