Lessons Learned from the Two Major Tailings Dam Accidents in Brazil

Jair Carlos Koppe¹

Abstract

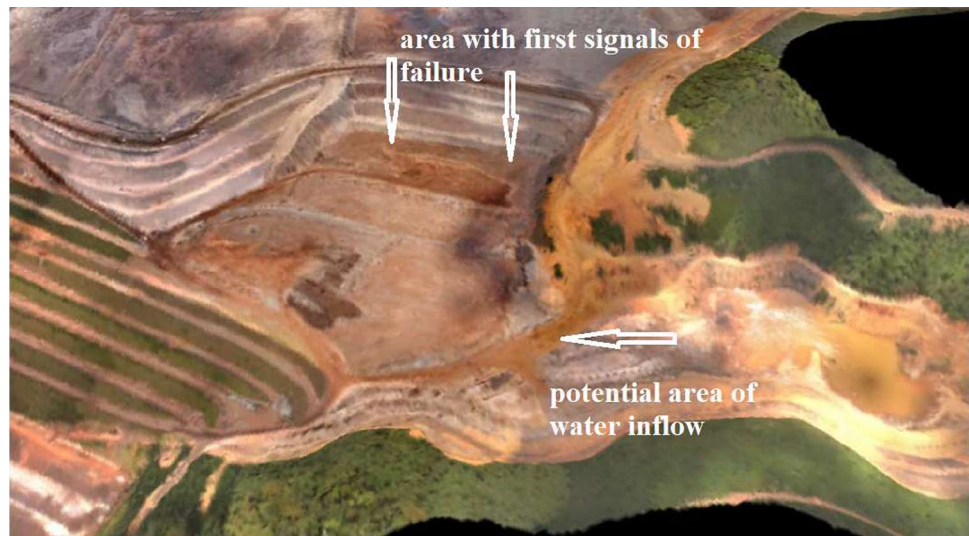
The Fundão Dam, located in Mariana, Minas Gerais, was raised by the upstream method and the construction project was complex. After several previous accidents, the dam failed on Nov. 5, 2015. The Fundão Dam failure was investigated by Morgenstern et al. (2016), who concluded that the main cause was the static liquefaction of the tailings. Approximately 61% of the tailings flowed out of the dam. Problems in the original project execution that had resulted in design changes, as well as bad tailings management, caused an increase in saturation and introduced the potential for liquefaction. Among these problems, three stand out: damage to the original Starter Dam, deposition of slimes (fine-grained mud) in inappropriate areas, and structural problems in a drainage gallery that caused the dam to be raised over these slime deposits. Although the failure resulted from several factors, Morgenstern et al. (2016) pointed out that small seismic events could have triggered the liquefaction. Despite these conclusions, it is important to highlight that there was a lot of water inside the dam and as well as an underground source of water that was flowing into the dam on the left side of the structure (Fig. 1). The first signals of the rupture showed up in the base of the dyke built over the tailings sediments, and progressed both to the top and the bottom of the dam.

Fig. 1 Change in design of the Fundão Dam with retreat of the left dam shoulder. The new dyke was raised in saturated tailings (modified from Morgenstern et al. 2016)

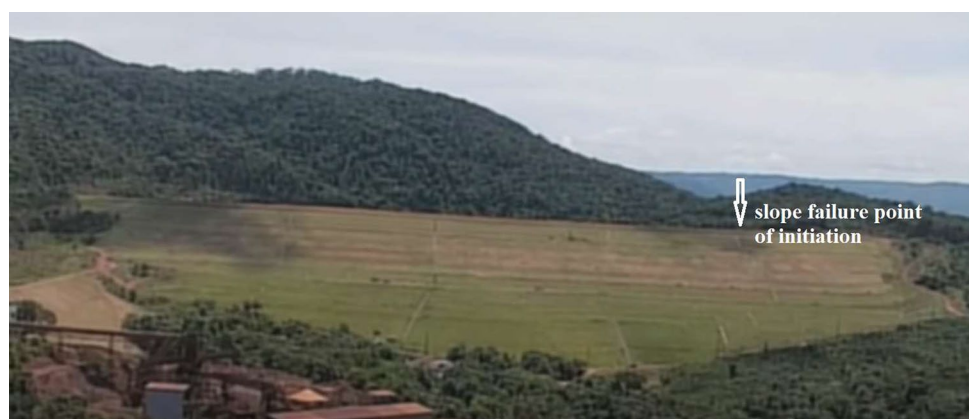
concluded that the main cause was again static liquefaction of materials within the dam. They observed that unexpected cementation of the tailings grains made the tailings brittle. This feature, not seen in other iron ore tailings dams, meant that the inclinometers and motion survey markers did not indicate significant movements before the failure. The tailings in the dam showed a sudden and significant loss of strength, and rapidly became a heavy liquid that flowed downstream at high speed. Less than five minutes was enough to liberate more than 9.7 million m³ of materials. Approximately 75% of the tailings flowed out of the dam. Figures 2, 3, and 4 shows the failure starting at the top of the dam and moving to its toe. The presence of a video camera in front of the dam allows good analysis of the failure process.

Fig. 2 Feijão Dam I initiation point of slope failure captured by video camera in front of the dam (modified from public images first shown on TV by Globo)

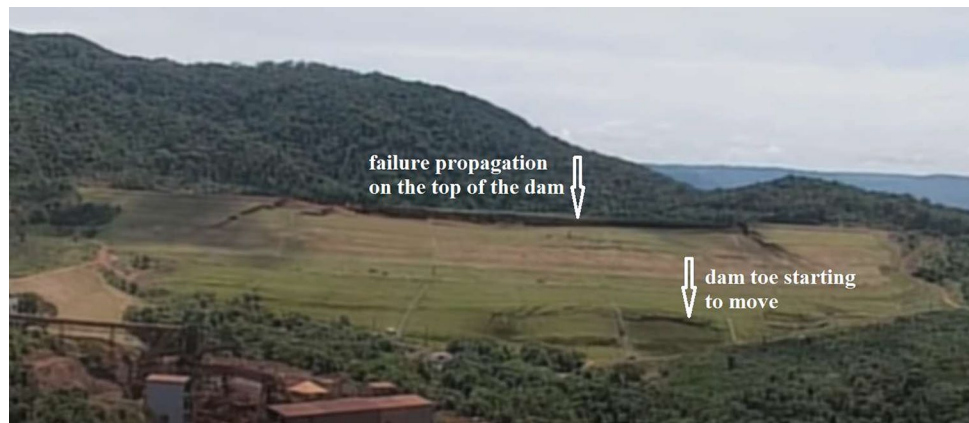
Fig. 3 Toe movement and propagation of the failure at the Feijão Dam I (modified from public images first shown on TV by Globo)
