Slope stability in slightly fissured claystones and marls

Abstract The paper deals with the behavior of some characteristic soft rocks found in the Iberian Peninsula. In geological terms, they belong to Tertiary basins, the Keuper period and the Jurassic-Cretacic transition. The discussion is organized around the following aspects: (a) the intact material and its brittle behavior; (b) the weathering action of atmospheric events; (c) the persistent discontinuities and scale effects; and (d) the modification of strength after failure. In all cases, instability phenomena are addressed in connection with several case histories. Regarding material brittleness and the initial stress state, two cases of first time failures are discussed. Practical implications concerning the selection of operative strength will be given. Field observations of the relevance of weathering and, also, on the rate of weathering, are given for a Weald claystone. Field observations emphasize the importance of sharp transitions between weathered and intact (or slightly weathered) levels. A recent long-term laboratory investigation on the nature of degradation will be summarized. Macroscopic variables such as sti

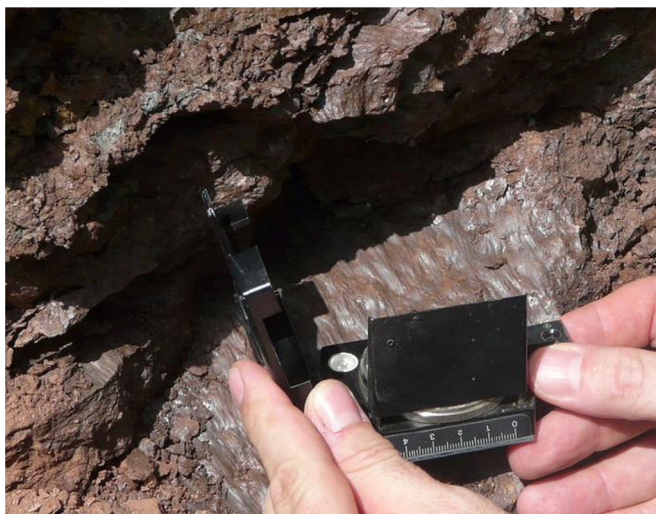
Fig. 3 A sedimentation plane in Castrovido Weald claystone. Despite the sheared aspect of this surface, there were indications of a sin-sedimentary feature. If this interpretation is correct, the observed geometry is a consequence of early deformations, including some shearing, at the time of deposition

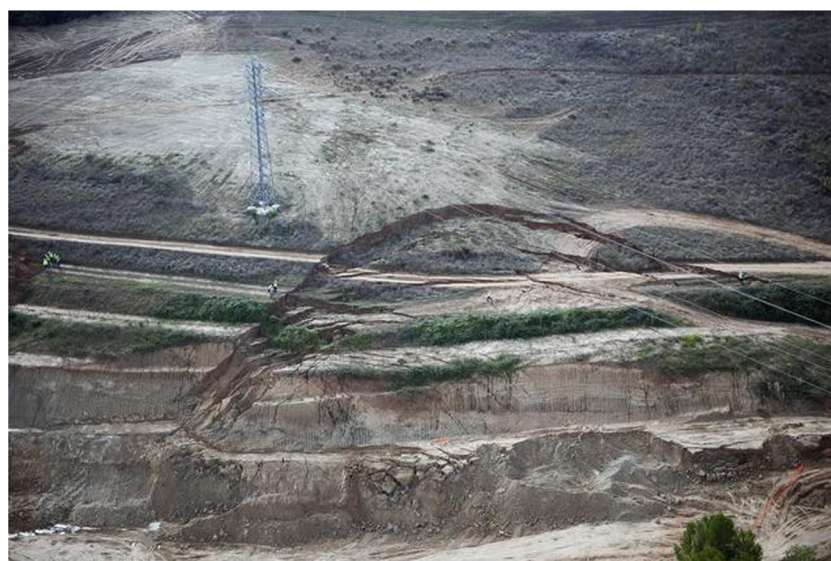
Figure 4 shows a slope failure triggered by an excavation at the toe of a relatively gentle slope ($\sim 12^\circ$). The cross section in Fig. 5 shows the sequence of Tertiary claystones, siltstones, and lightly cemented sands of Tertiary origin which characterize the slope. These are hard soils that could only be sampled by rotary coring.

claystone-siltstone contact, which followed the inclination of sedimentary layers. It was clear that the excavation favored the development of a planar motion, which daylighted at the toe of the excavated slope.

The case is interesting because equilibrium was achieved for a friction angle similar to the minimum measured residual friction angle. Stabilization was achieved by a pile barrier that was designed accepting that the minimum residual friction angle was operating on the shearing surface. The failure surface was probably located within the high plasticity claystone layer (Fig. 5).

Fig. 4 Sabadell slope failure

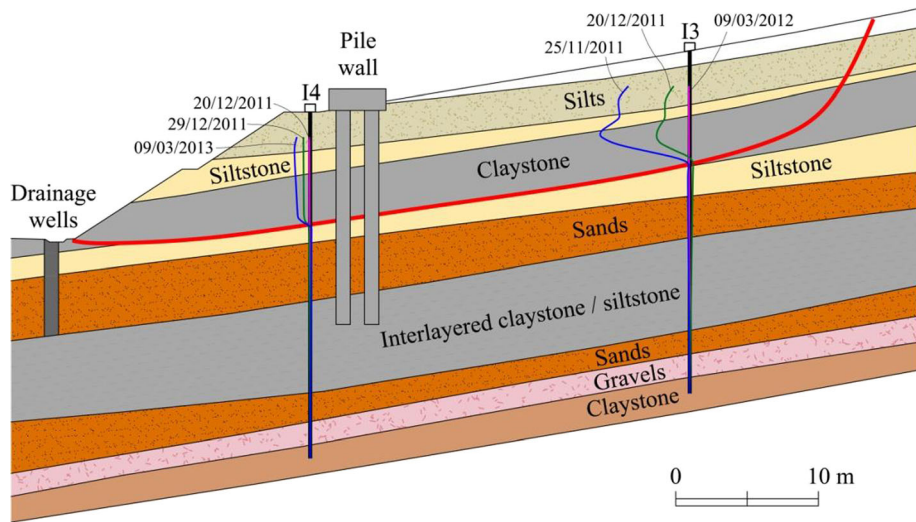
Fig. 5 Sabadell slope failure. Cross section along slide axis. The position of the sliding surface, inclinometers and remedial stabilizing measures (pile wall) are indicated

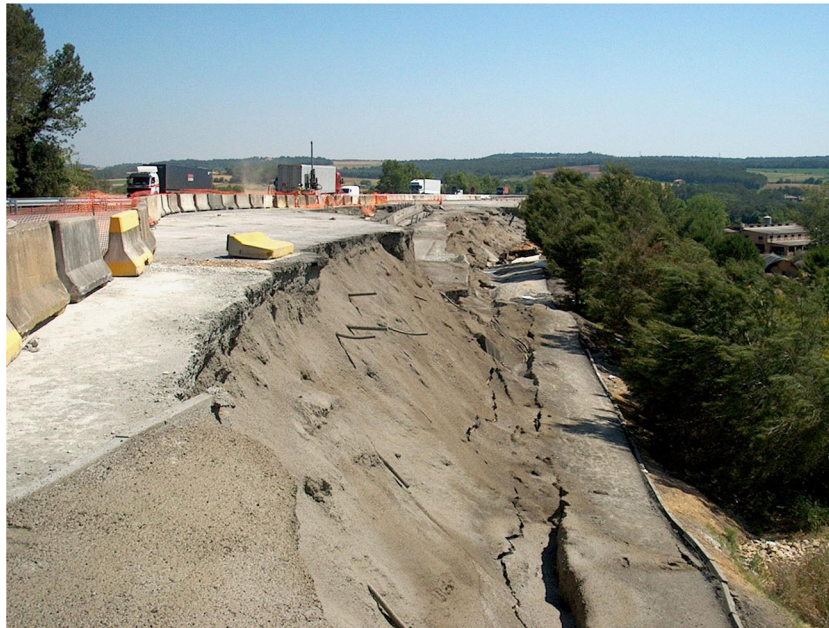
In May 2004, 200 m of a motorway embankment in the Province of Girona (Viladesens in the remaining description) experienced a progressive instability that forced the interruption of traffic. The embankment was built 30 years before and no significant incidents were recorded except for some occasional settlements. Figure 7 shows the head of the slide which destroyed one of the motorway lanes. The embankment was built on a natural clayey slope of gentle inclination (8°). The failure was unexpected because of the long period of stability after construction.

Fig. 7 Scarp of Viladesens slide. May, 2004

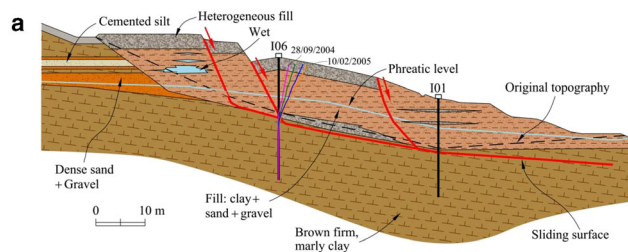
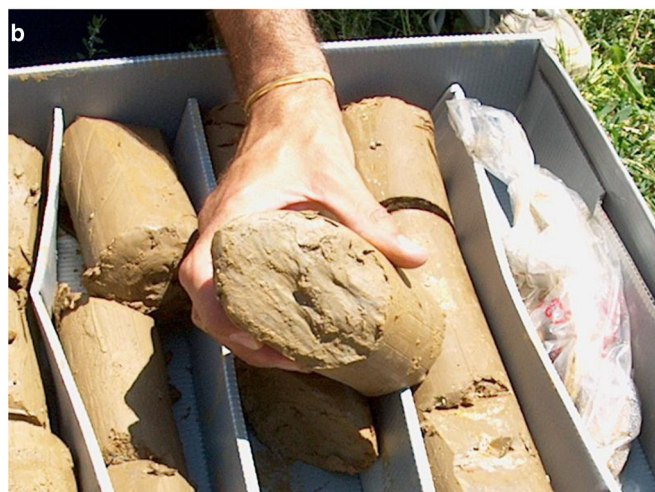
Figure 8a shows a representative cross section of the embankment. The sliding surface was located, by interpreting inclinometer readings, close to the contact between the compacted embankment and the brown stiff natural clay. The slide may be described as a translational motion essentially parallel to the natural slope. A water table was also identified in the lower third of the embankment height. During the months prior to failure, intense rainfalls were reported.

Liquid limits in the range 50–100 % were measured. Natural water content (21–22 %) was lower than plastic limit (29–30 %). Void ratios ranged from 0.5 to 0.65. In cores recovered, slickensided surfaces (Fig. 8b) were also observed. Direct shear tests were

Fig. 8 Viladesens slide. **a** Cross section; **b** striated and polished surface in brown clay observed in recovered cores

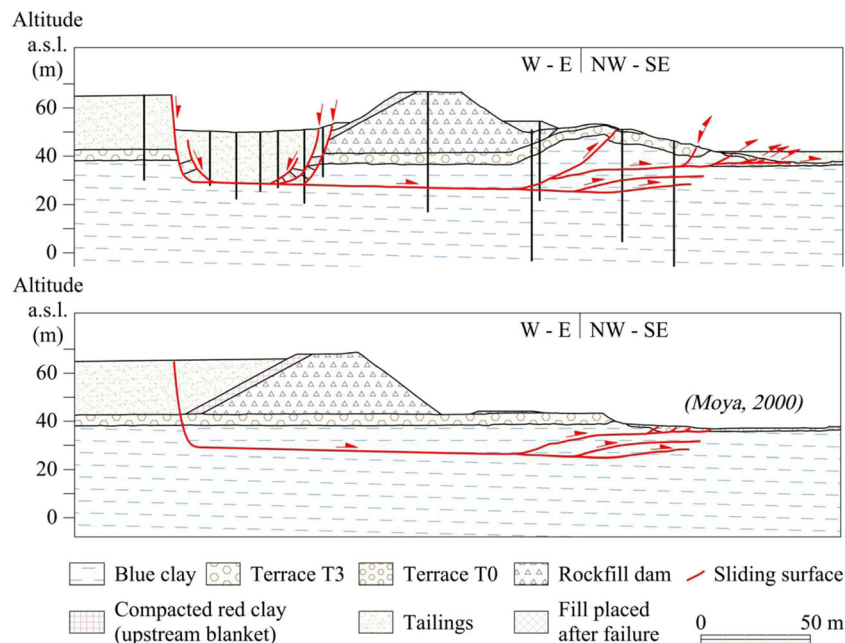
Aznalcóllar dam failure was a case of sliding of the dam and an upper slab of foundation soil on a high plasticity overconsolidated marine Miocene clay. It has been described in a number of papers (Alonso and Gens 2006a, b; Gens and Alonso 2006; Zabala and Alonso 2011). The failure represented in Fig. 10 was attributed to the persistence of high load-induced pore water pressures in the foundation clay, the brittle behavior of the clay, and the “down-stream” construction method of the dam, which generate high shear stresses under the evolving dam toe. Aznalcóllar is a good example of a progressive failure phenomenon, analyzed in Zabala and Alonso (2011). Figure 11 is taken from this reference and shows the predicted position of the shearing band, eventually transformed into a full failure surface, when the dam reached a height of 25 m, 2 m below the dam height at the time of collapse.

Fig. 10 Cross section of Aznalcóllar slide: a geometry after slide, as interpreted from borehole data and surface topography; b reconstruction of position of sliding surface before failure (Alonso and Gens 2006a)

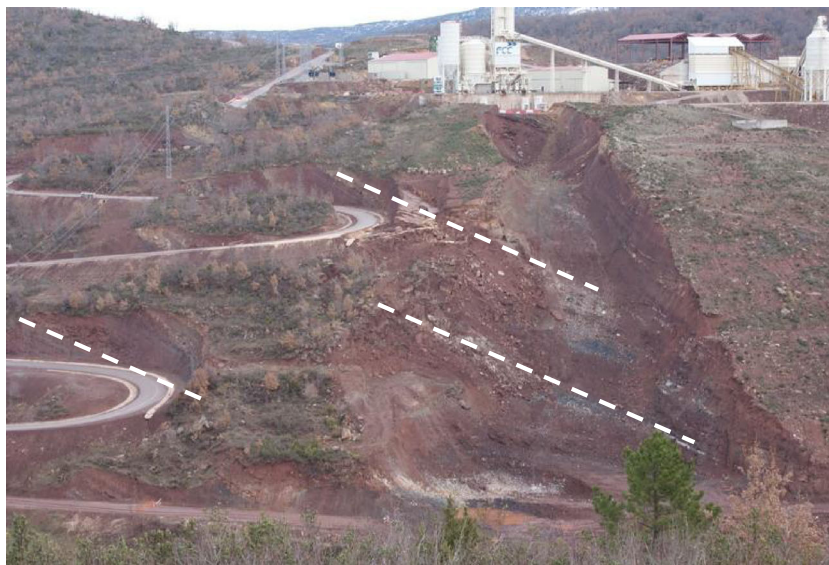
Two types of slope instability are present in the Castrovido dam area: shallow failures and planar failures controlled by sedimentation planes (Fig. 19). The photo shows the large excavation of the right abutment of the dam and a collapse of the downstream side of the excavation. The discontinuous lines show the dip of the sedimentation planes. At a large scale, the Weald formation is a sequence of claystone and interbedded sandstone layers although the claystone lithology dominates the sediments.

Fig. 19 Planar failure in Castrovido claystone controlled by sedimentation planes

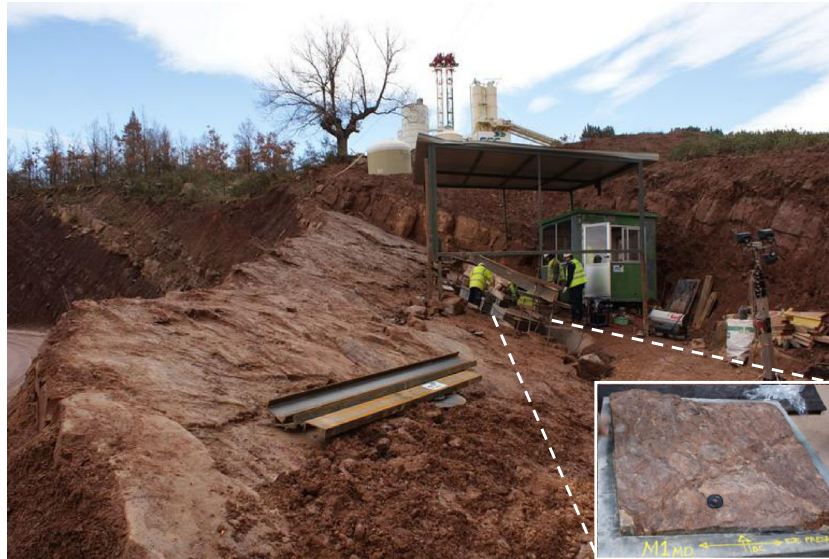
This is better illustrated if one examines the roughness of a natural claystone–sandstone contact at a much larger scale (Fig. 20). The figure shows an uncovered contact during the preparatory works to locate the large-scale “in situ” shearing tests. Subvertical local fractures led a rough surface having abundant “jumps”, difficult to characterize by a typical random roughness. The “in situ” shear tests were arranged to test the contact plane

Fig. 20 Castrovido Weald form. Exposed sandstone–claystone sedimentation surface. Zoom-in of contact after in situ shearing test
