## Slope failure in stratified rocks: a case from NE Himalaya, India

**Abstract** Mountainous regions of India experience recurrent slope failures due to rapid urbanization. The main causes of slope failure are high precipitation aided by unplanned construction of cut slopes. Such slope failures are further aggravated because of the presence of low strength, highly jointed, stratified rocks rich in clay minerals. In general, effect of weathering is more pronounced in these rocks, which causes long-term time-dependent deterioration of the rocks as well as joint strength. In this regard, the present investigation deals with the causes, behavior, and mechanism of slope failure by examining a section in the North Eastern Himalayas. A detailed field investigation was carried out for examining the existing condition of slope, slope material, and joint parameters. Laboratory experiments like compressive and tensile strength tests along and across the lamination planes along with slake durability index tests were conducted to characterize the material and investigate the role of weathering in strength degradation. Later, numerical simulation was performed employing distinct element method

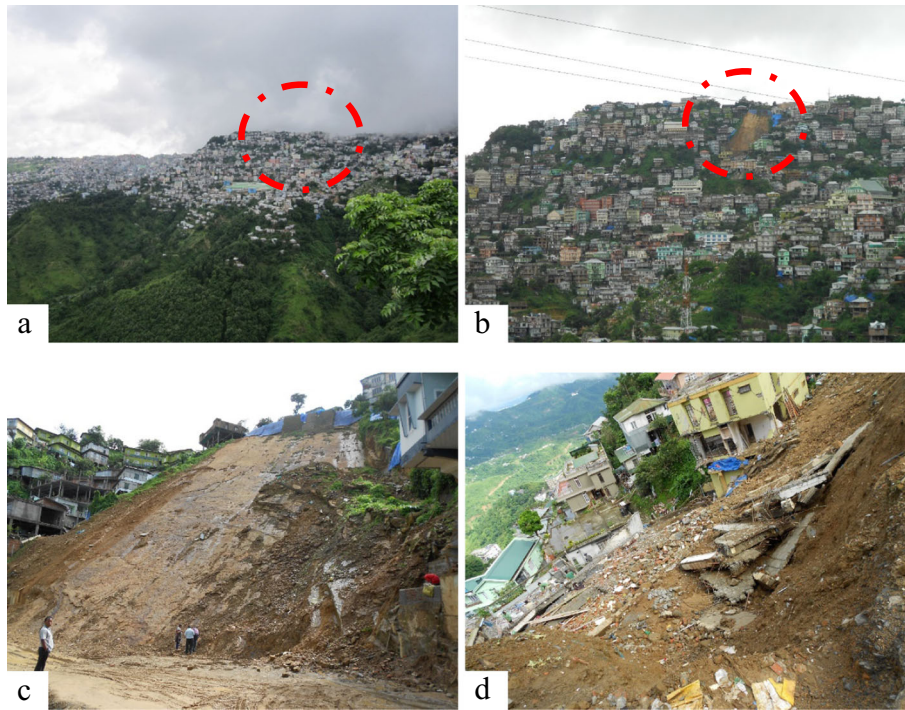
rocks in the surrounding. Weathered, variegated color, thinly bedded siltstone and shale were observed near the cut-slope failure site. The elevation of the toe and crest is 1110 and 1160 msl, respectively. Three sets of joints are present viz., Bedding plane, J<sub>1</sub> (N5° W/45° E), J<sub>2</sub> (N85° E/90°), and J<sub>3</sub> (N10° E/70° SE). The general trend of the slope face is 10° NW, dipping toward 55° NE. About 10 to 15 numbers of houses were affected due to this slope failure. It was observed that the drainage from the houses were flowing over the slope and no proper drainage channels were present. Figure 3a, b shows photographs of the investigated area before and after slope failure, respectively. Figure 3c, d shows failed cut slope and destroyed buildings below the road as well as on the slope face.

**Fig. 3** Field photographs showing a dense urbanization, stable slope before failure, b post-failure condition, c failed cut slope section, and d collapsed buildings due to slope failure

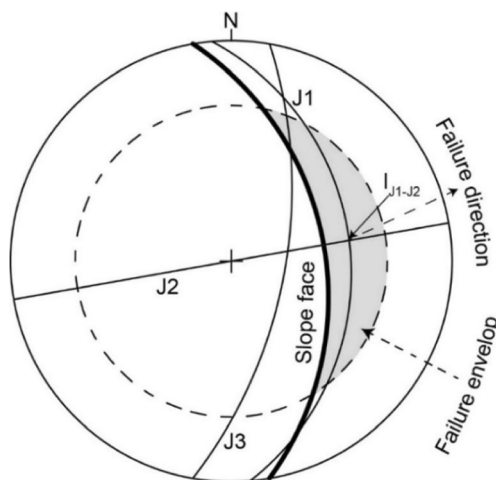
**Fig. 6** Lower hemisphere equal area projection showing kinematic stability of blocks

The failure mode observed from kinematic analysis in the studied cut slope suggests planar type dominating over other modes. The widely spaced orthogonal joint sets allow water to percolate in the near vertical available joint spaces leading to the development of pore pressure perpendicular to joint walls enabling kinematic release of the blocks (Fig. 9). A number of failure modes have been reported in laminated rocks particularly in shales, mudstones formations right from translational, toppling, rockfall, and even earthflows (Bovis 1985; Geertsema and Cruden 2009; Goodman 2013). However, flow-like movement has been reported to be the most widespread than other types by Urciuoli (1990) while studying landslides in highly fissured tectonized clay shales. Picarelli et al. (2006) further suggest that outcrops in such material are generally overlain by a veneer of soft and nonfissured clay produced by weathering and swelling which is consistent with the field observation (Fig. 9).

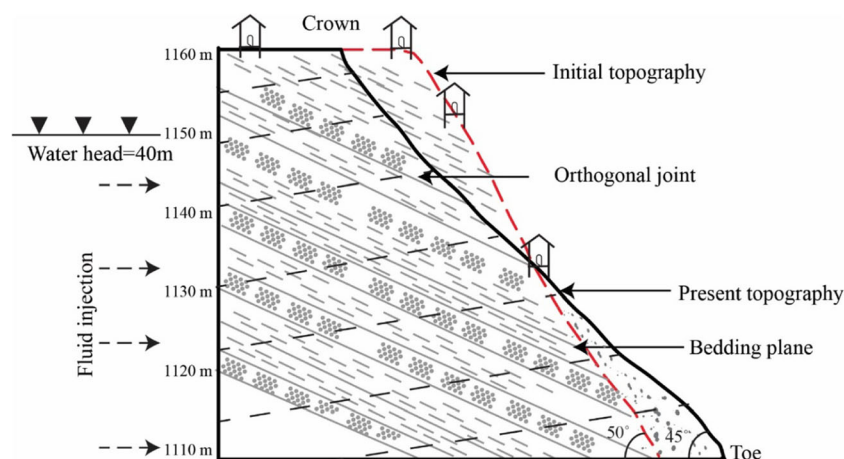
Total station survey was used to obtain the coordinates and other data points. These point data were later used for further processing in AutoCad software to obtain the topographic map. The desired profile section was obtained directly from the topographic map. Over this geological section, an assumed initial topography was superposed to highlight the conditions before failure. There are number of houses on the top of the slope which remained undisturbed while few others over the slope face were completely damaged due to failure. The assumed section which represents the initial topography was used to model the slope face to achieve the present condition. The height of the modeled slope is 50 m from the mean sea level of 1100 m. The present slope angle is  $45^\circ$  with planar to curvilinear surface, while the assumed topography represents a slope angle of around  $50^\circ$ . The upper slope material constitutes of silty shale with alternate layering of siltstone, sandstone, and shale (Fig. 7). The geometry includes two joint sets in

Fig. 7 Schematic diagram showing condition of slope prefailure and modified topography

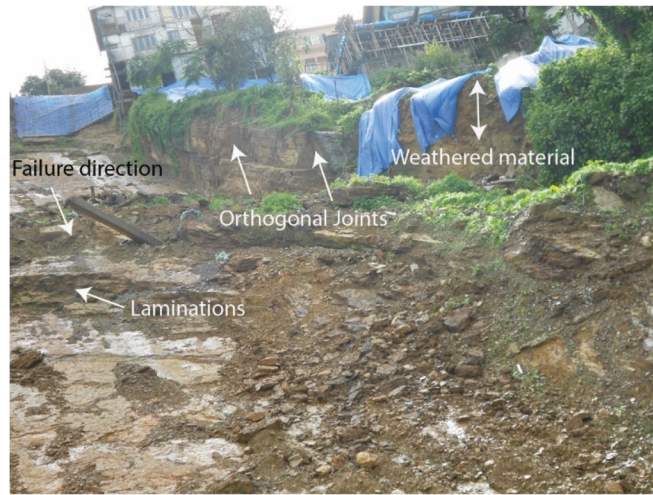
**Fig. 9** Outcrop of the failed slope showing orthogonal joints, failure direction, and a layer of weathered and nonfissured clay on top

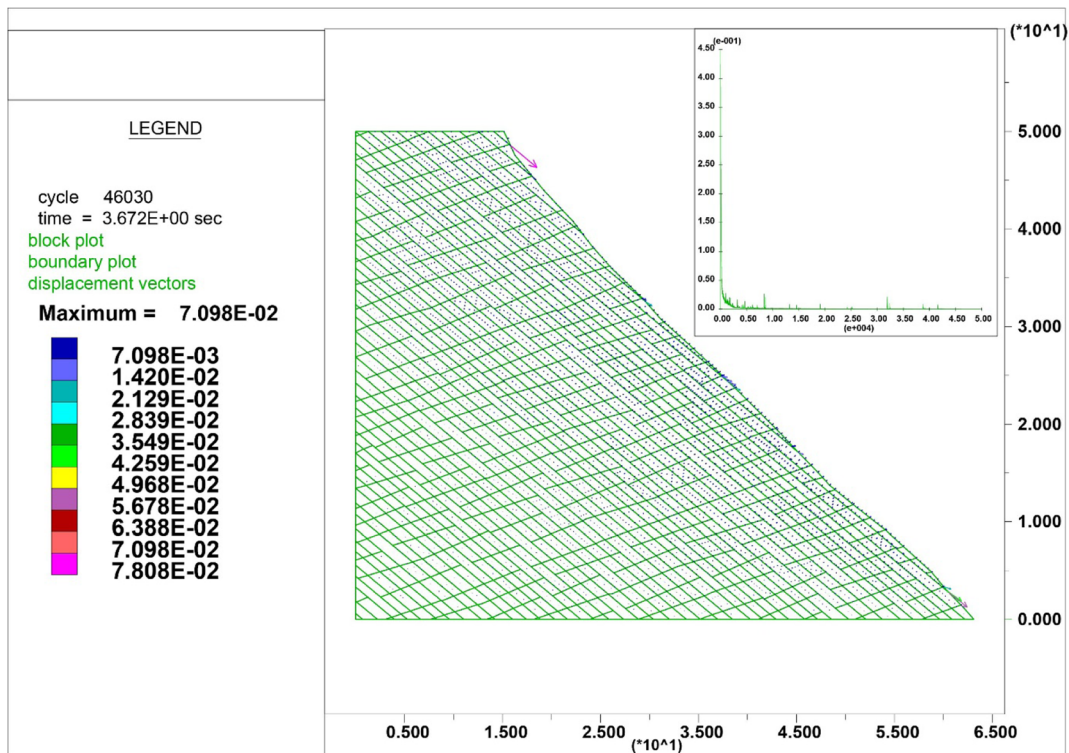
numerical study was studied in two phases. Initially, the slope was brought to equilibrium by gravity loading with a maximum displacement of around 0.07 m near the crest of slope (Fig. 10). The equilibrium state in the numerical model is a condition which is achieved when the unbalanced force tends to zero. This is shown by force vs time graph where unbalanced force on ordinate axis keeps on decreasing until the model has achieved equilibrium (Fig. 10 subset). Stress concentration and disturbance can be seen near the slope face, but the shear strength of the interface is just not enough to cause or initiate any sliding. However, time-dependent strength loss due to continuous weathering may bring the slope to failure. Eberhardt et al. (2004) points to the fact that in cases where adversely oriented discontinuities in the slope are highly persistent, failure occurs by propagation of shear plane through only intact rock bridges where kinematic release will require very less internal deformation. This means that deformation in rock mass in such cases is mostly due to weathering, which causes degradation and disintegration due to exposure to adverse climatic conditions. Utilizing the concept of crack propagation in slope highlights another important fact that when discontinuities are critically aligned to the loading direction and stress concentration near the tip of these cracks exceed the strength of the material, fracture propagation will occur in a plane parallel to  $\sigma_1$  (Eberhardt et al. 2004). When a free surface like that of a slope is created,  $\sigma_1$  aligns itself to the topography. The laminations in the rock mass are near parallel to the topography which means crack propagation will be favored in the plane of lamination and brittle failure may contribute as one of the failure mechanism (refer Fig. 5). It is to be noted that majority of these cracks developed following the above argument are tensile in nature, but secondary

**Fig. 10** Cut slope in equilibrium condition under gravity loading (note: subset indicating zero unbalanced forces at equilibrium)

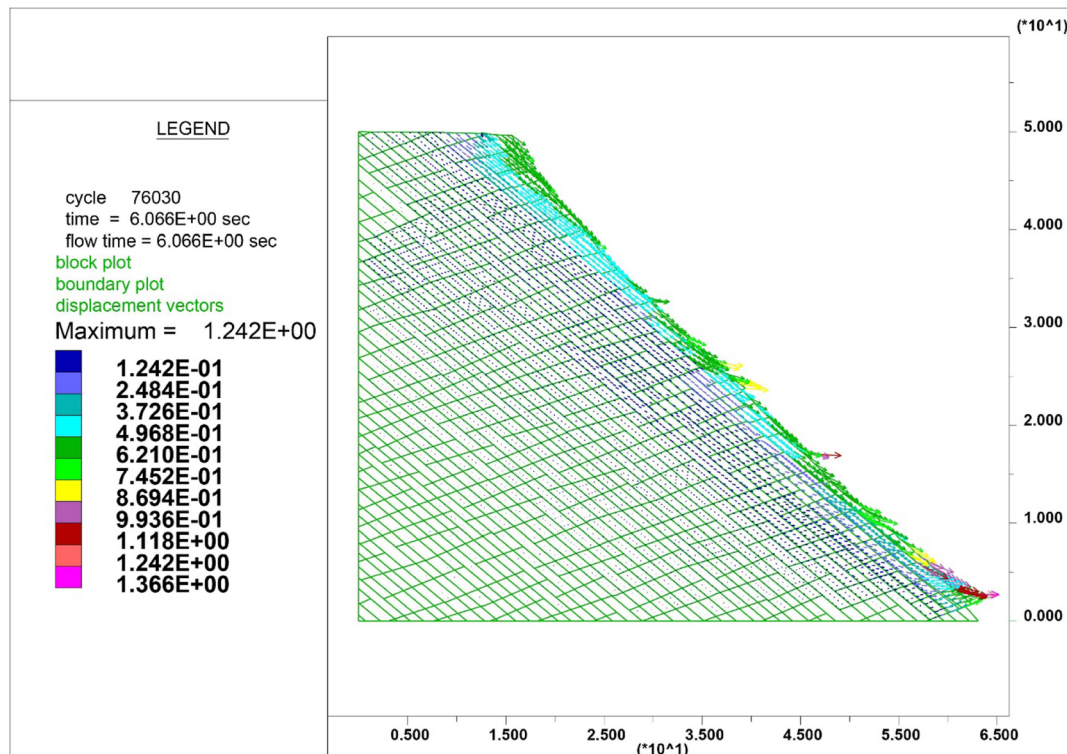
The second phase was modeled by applying 40-m head pressure equivalent to around 0.4 MPa from the left boundary of the slope. The hydromechanical simulation was stopped after 30,000 cycles as during this time water was able to migrate until the slope face. The thickness of the aperture was increased and shear strength of joints was reduced to accommodate strength loss due to fluid pressure. At a particular time when fluid reaches the slope face,

entire slope face starts showing continuous movement with the maximum displacement observed around 1.2 m near the toe. This increase in hydraulic conductivity and reduction in shear strength exerts tremendous pressure on the blocks enabling complete detachment. Due to the reduction in available shear strength, the movement becomes more pronounced along the daylighting joints, i.e., the lamination planes. The failure plane resembles that of a planar mode as has been observed in the field, also supported by kinematic analysis. The developed failure plane is very shallow, only confined to thickness reaching up to few meters. The most notable result is that the block detachment is seen from the mid portion of the slope which confirms the observation during field investigation where majority of slope mass was seen to be detached from near about similar position (Figs. 9 and 11). Researchers have observed that landslides in weak material like shales/mudstones show characteristic fissuring, dilation, softening, and negative pore pressure and generally fail due to cohesion loss where the shear strength value lies in between peak and residual shear strength (Stead 2016). Although residual shear strength has been largely related to reactivated landslides, several evidence have suggested that residual condition may exist on a part of slip surface even on first-time excavated slopes in clay shales or stiff clays (Mesri and Shahien 2003).

Fig. 11 Displacement vectors in the case of coupled hydromechanical loading condition showing block detachment

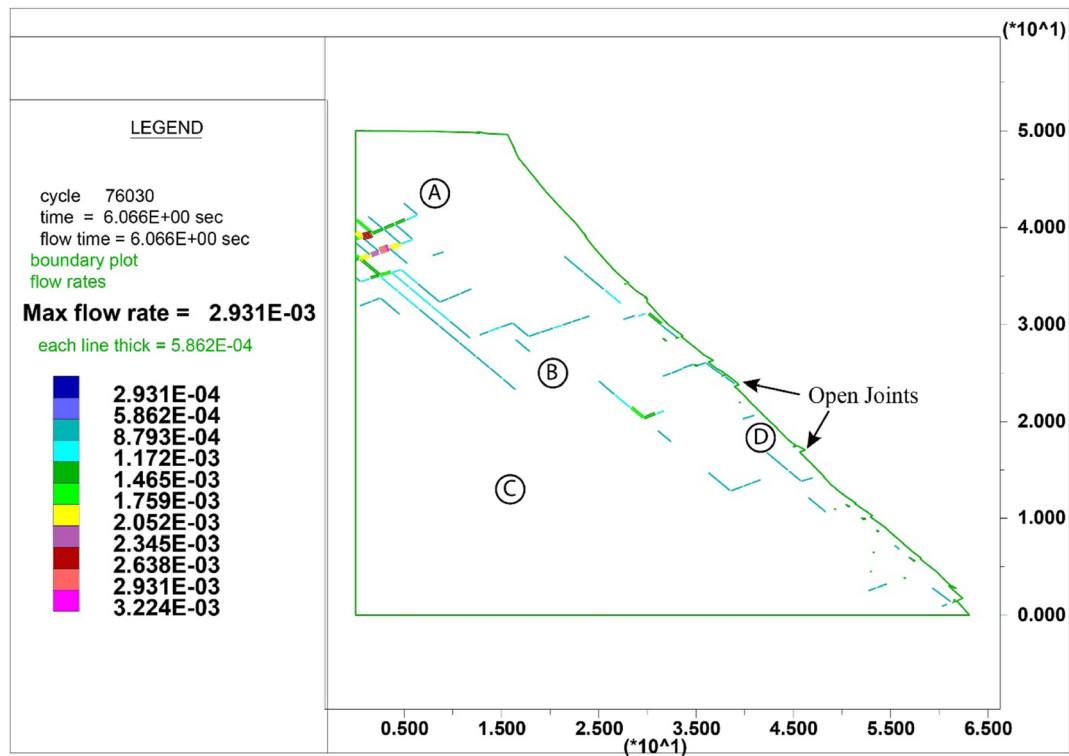
It can be observed from Fig. 12 that the maximum flow rate is  $2.93 \times 10^{-3} \text{ m}^3/\text{s}$  near the left boundary at (A) of the slope, because of point of application of flow pressure. Further, at points B and C, joints are under relatively high confining condition on contrary to the points D and A. Therefore, the inability of the fluid to transmit flow towards the slope face is counteracted by the tightness of joints under confined condition far-off the face. The continued

application of fluid pressure causes water to migrate along available pathways/interconnected fractures toward the slope face. The addition of water creates excess pore pressure within the joints (at point D, Fig. 12) forcing the apertures to open, a process more dominant near slope face with low normal and confining stress (Fig. 12). Opening of joint starts when the equivalent shear strength is just in excess of the initial strength of the joint. These results are quite consistent when compared with the observations made by earlier workers on the experimental study of fluid flow through fractured sample (Walsh 1981; Raven and Gale 1985; Pyrak-Nolte et al. 1988; Pyrak-Nolte and Morris 2000; Singh et al. 2014; Singh et al. 2016a).

Fig. 12 Flow path and flow rate along the joints leading to block detachment
